Preliminary Site Assessment

Site 1 Camden Row - Newmarket 38 kV - May 2019

Project number: PR-427640_ACM_RP_ENV_002_8E

10 January 2020

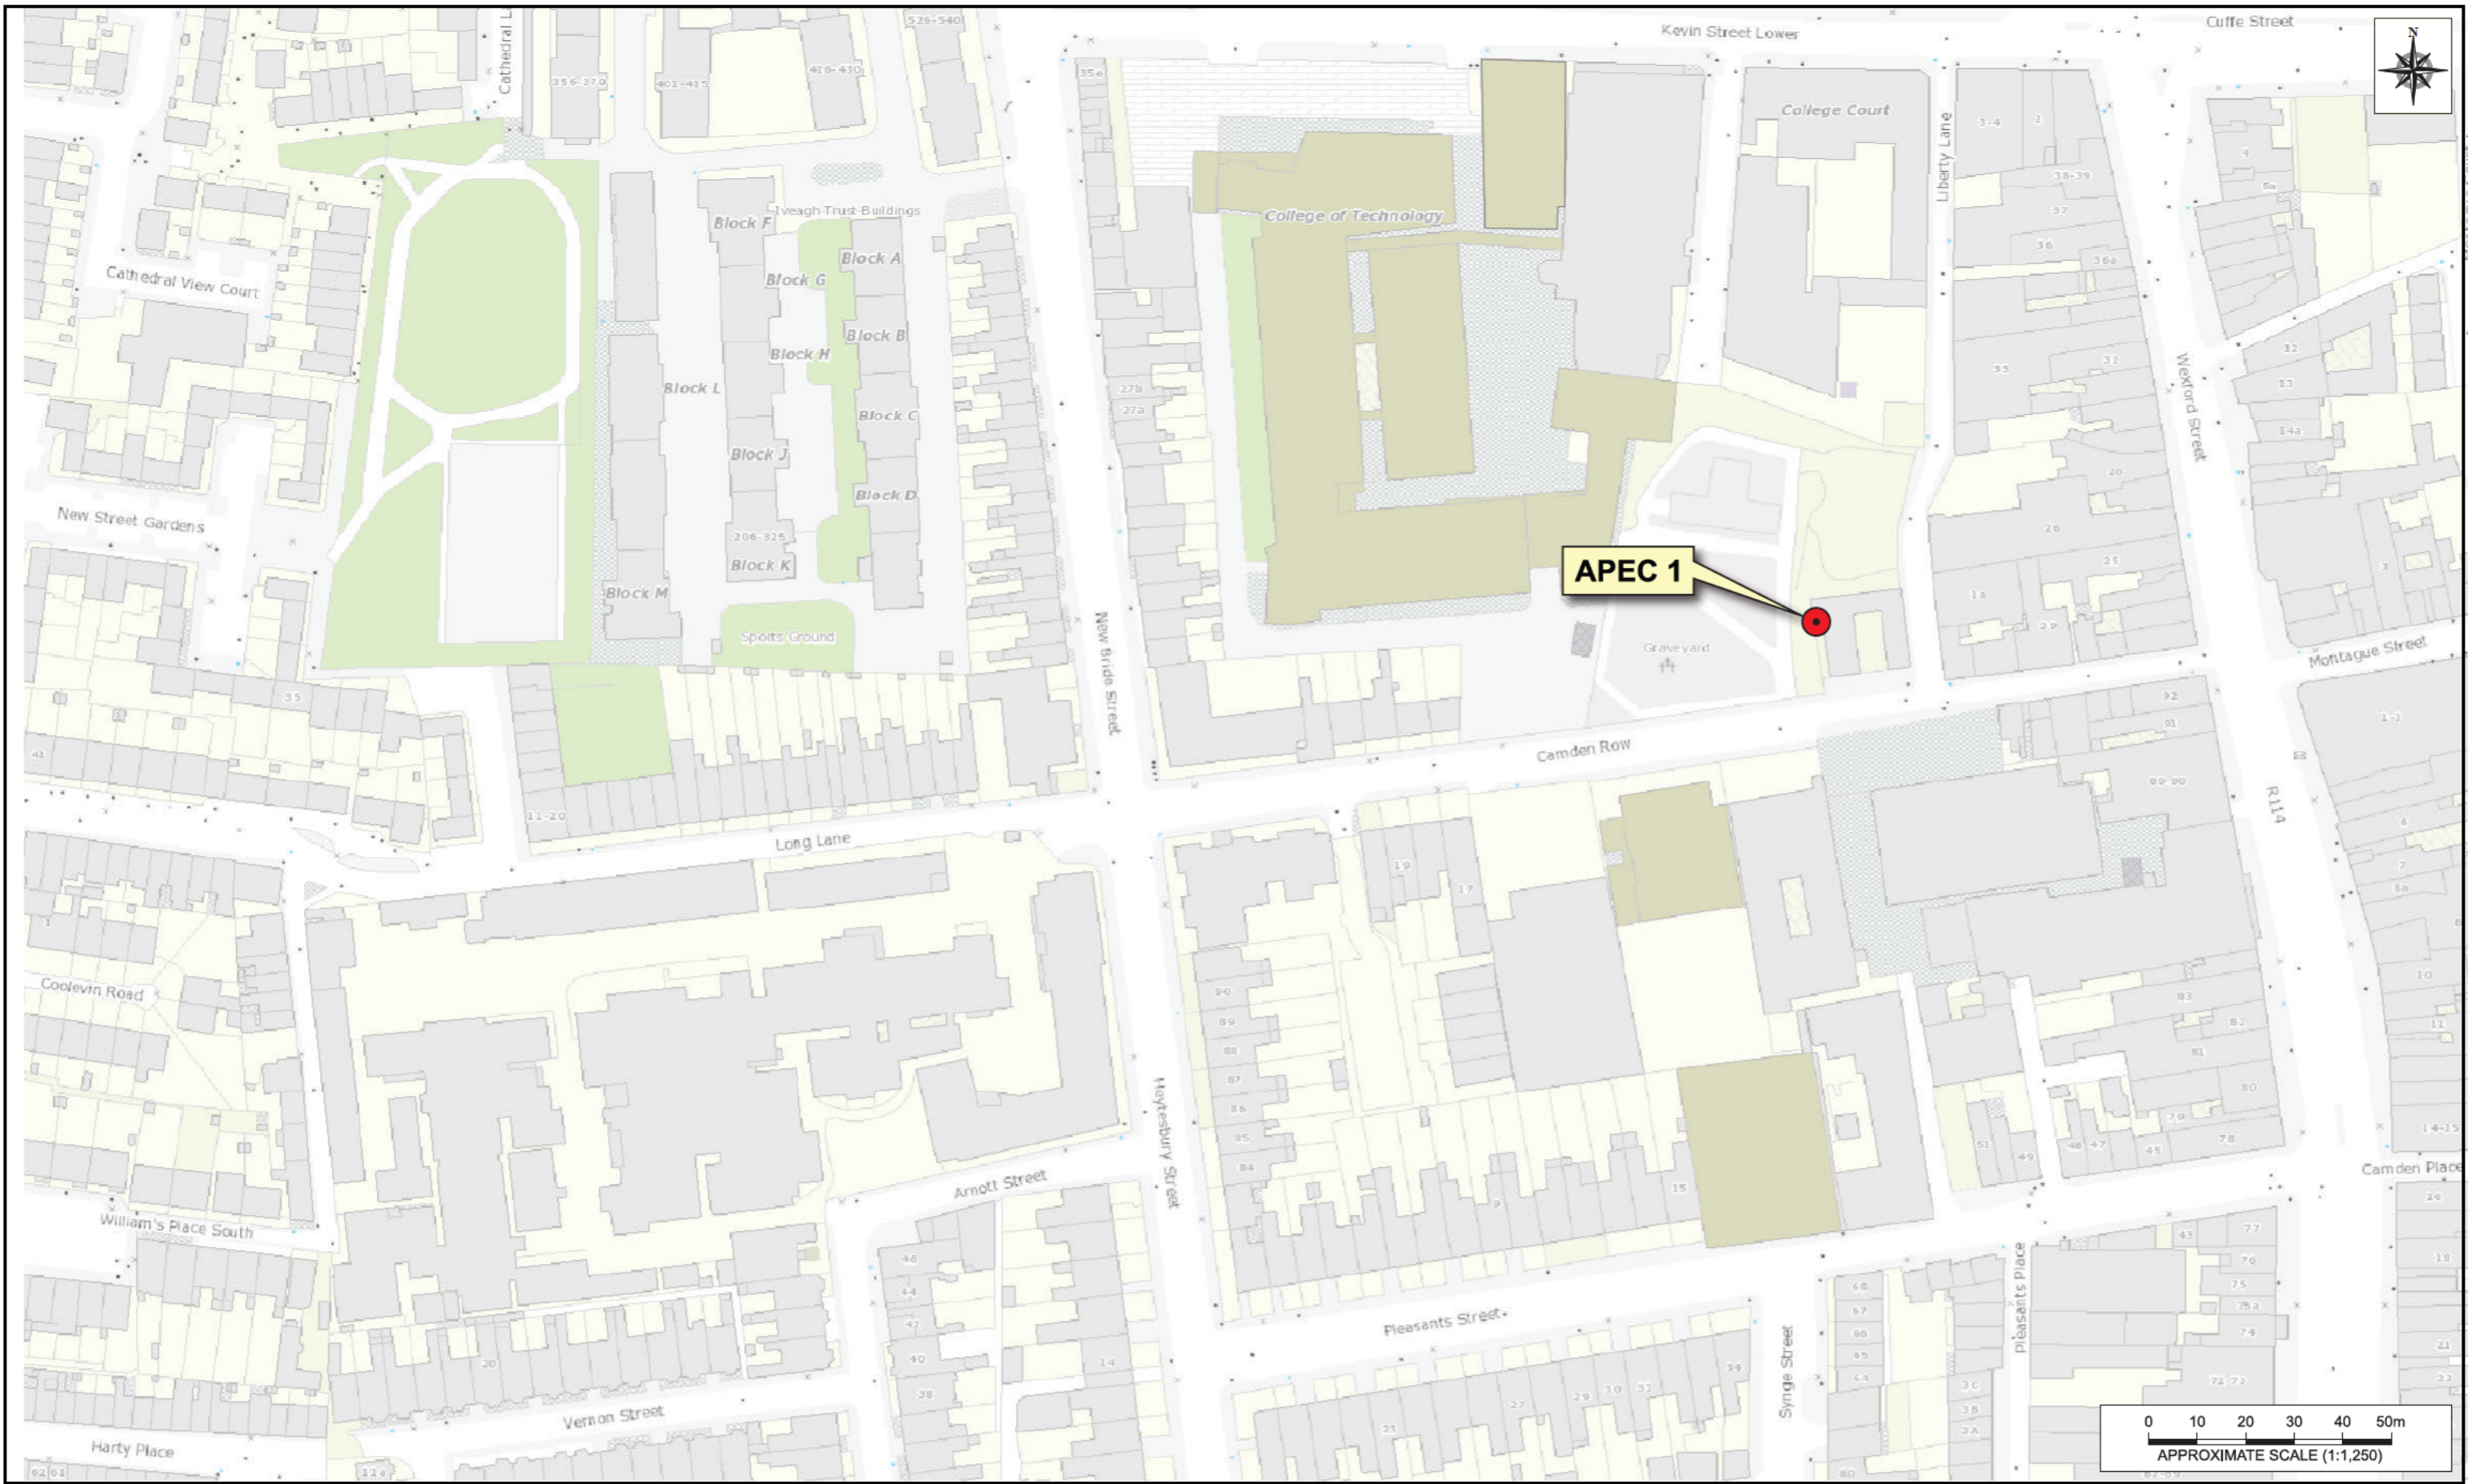
Figure 2. Areas of Potential Environmental Concern

The loss is reported to have occurred from a wall mounted tank in the substation. Observations of staining on the substation walls and floor during the site walkover indicate that this is likely.

Based on the assessment works completed, the primary APEC for this site comprises the leak location identified by ESB. This is presented in Figure 2 and a description is provided in Table 9 below.

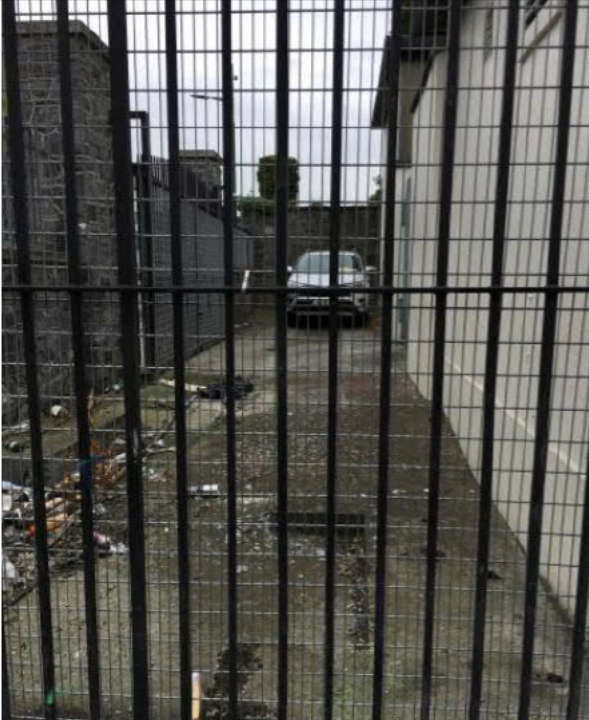
Photo 1		
Description: Front (south) of substation, Camden Row on left hand side (LHS).

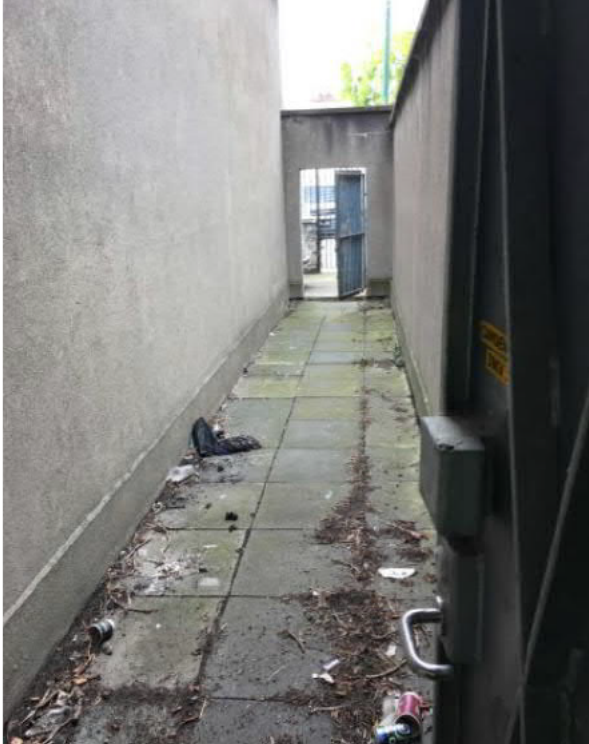
Photo 2		
Description: Access alleyway along side (west) of substation, historic graveyard / park on right hand side (RHS) of boundary wall.

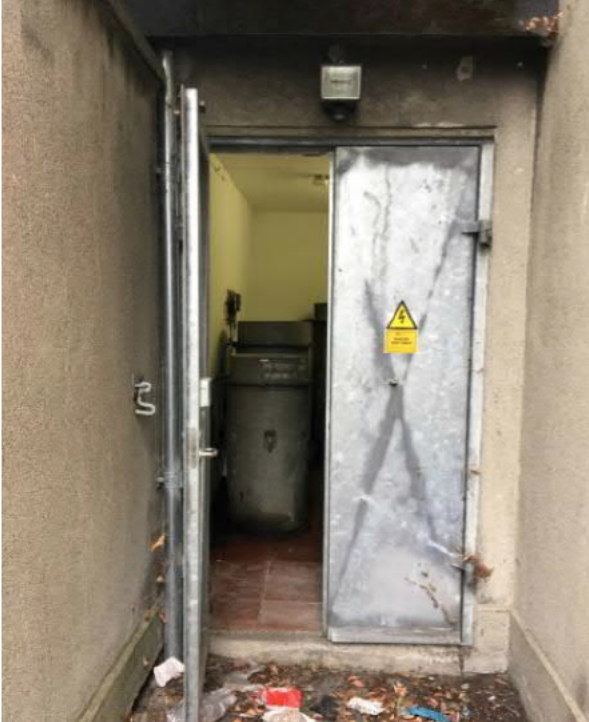
Photo 3		
Description: Access to substation from alleyway, historic graveyard / park on LHS of boundary wall.

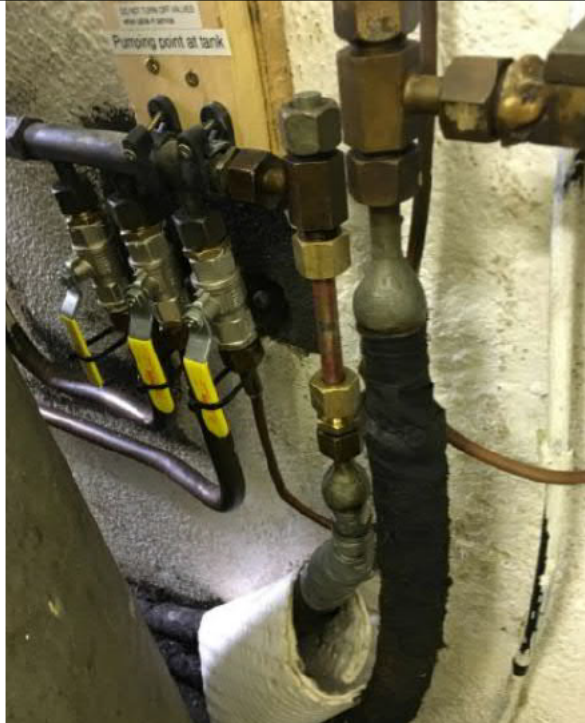
Recent repairs to cable line.

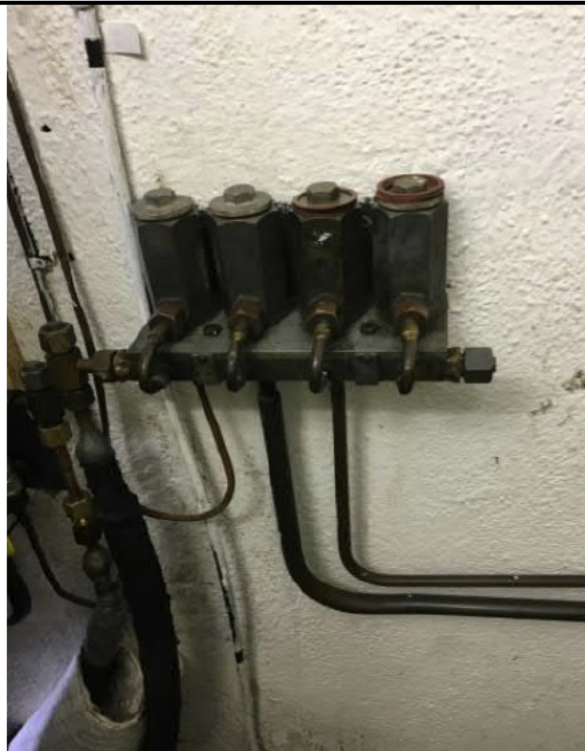
Photo 8

It was reported that repairs to valves on lines from the tanks had been conducted in May 2019.

New wall mounted valves.

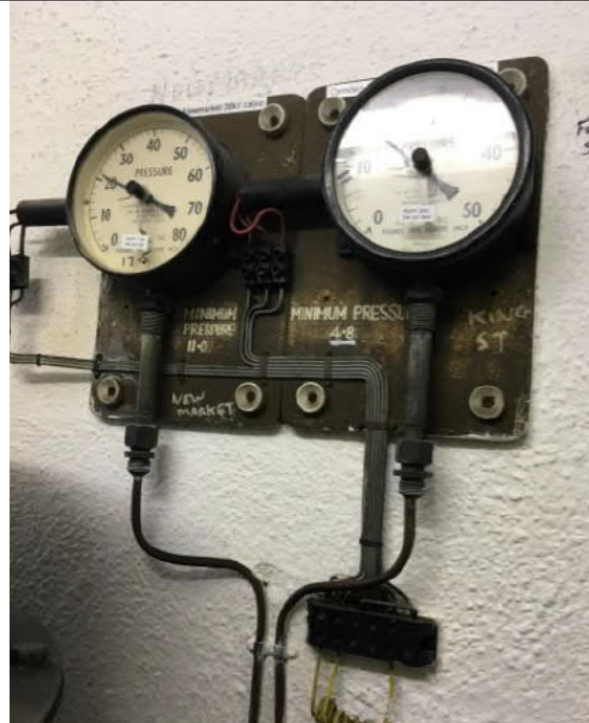
Wall mounted pressure gauges.

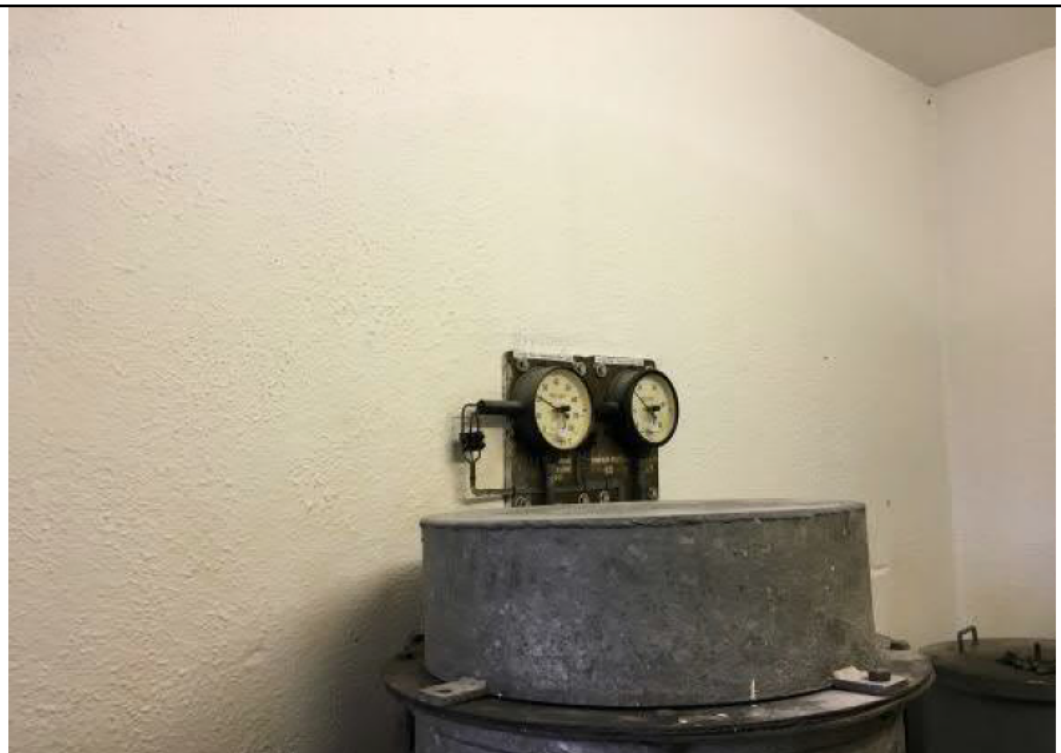
Photo 10

Staining was apparent on the tiled floor and as well as the concrete plinth. The inside walls of the substation were painted but staining was visible through the paint, reaching approximately 75% of the way from floor to ceiling. A slight hydrocarbon odour was noted within the substation building during the site walkover. Staining was also apparent on the western and northern walls of the substation building, leading onto the adjacent historic graveyard / park (St. Kevin's Park), with some of the grave headstones in contact with the substation building wall also stained. No evidence of impact from the cable fluid release was noted on the grassed surface of the park during the site walkover, with vegetation growth not visibly impacted.

Staining visible through paint on wall behind pressure gauges.

There is an aesthetic impact due to the staining of the pumping station walls and grave headstones. A suitable contractor should be appointed to clean these surfaces where possible.

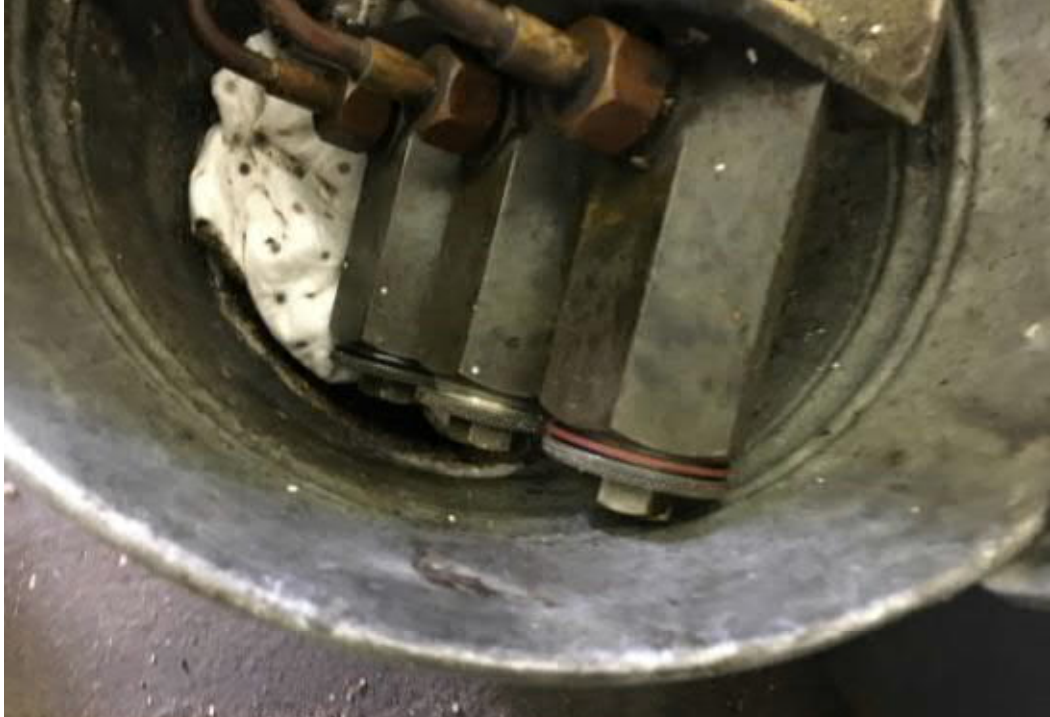
Photo 11		
Description Old valves which were removed in May 2019.

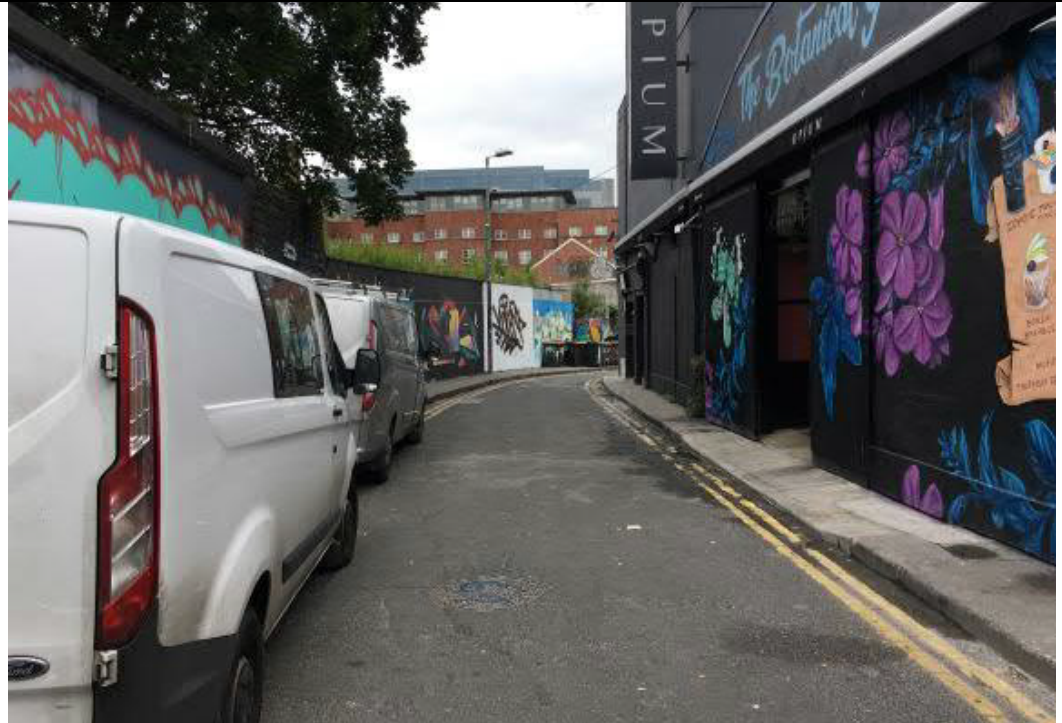
Liberty Lane,
immediately east of
substation.

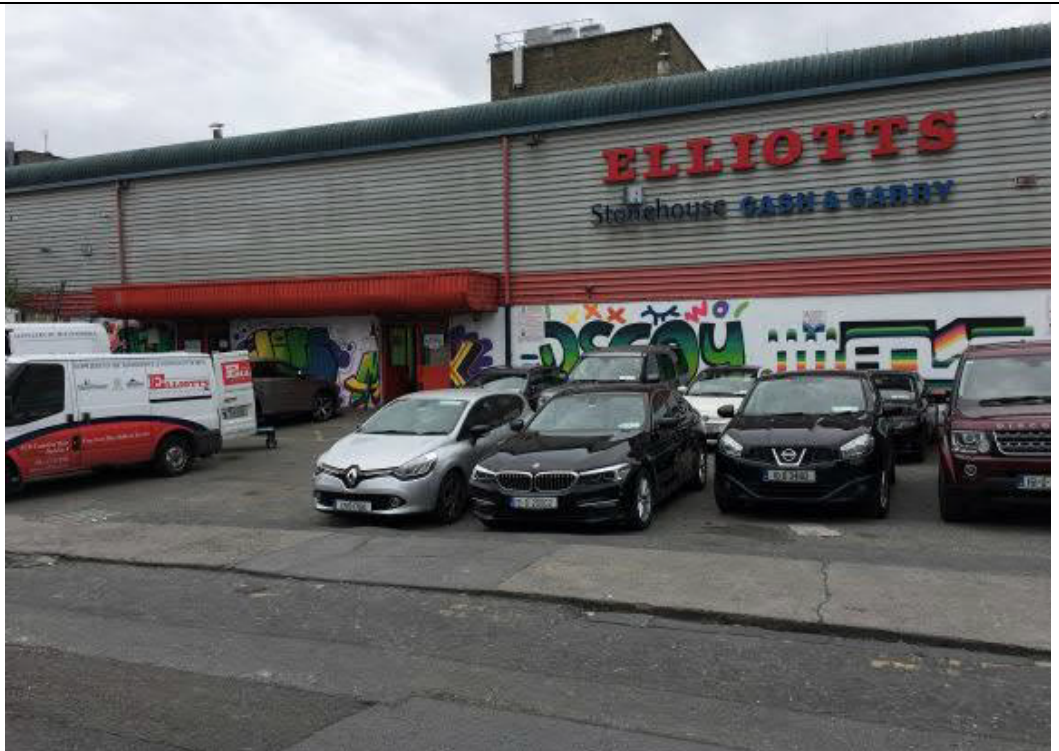
Photo 16

Commercial premises
on southern side of
Camden Row.
