Site 16 - Unidare to Whitehall 38kV: Preliminary Site Assessment Report for Historic Fluid Filled Cable Loss

ESB Engineering and Major Projects

19126590.16.A.4

22 April 2020

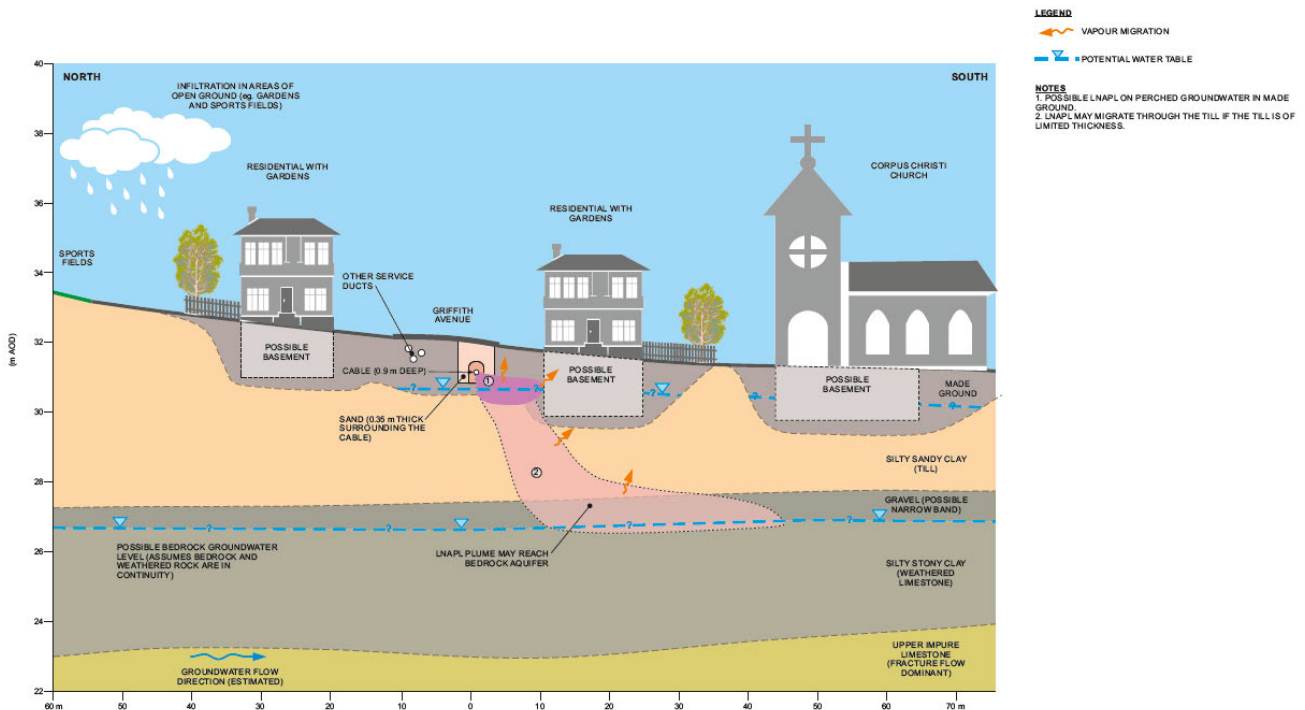
Figure 1: Preliminary CSM for Site 16 (Unidare to Whitehall).

- There is a potential moderate / low risk that groundwater could be exposed to free-phase LAB from the cable leak.

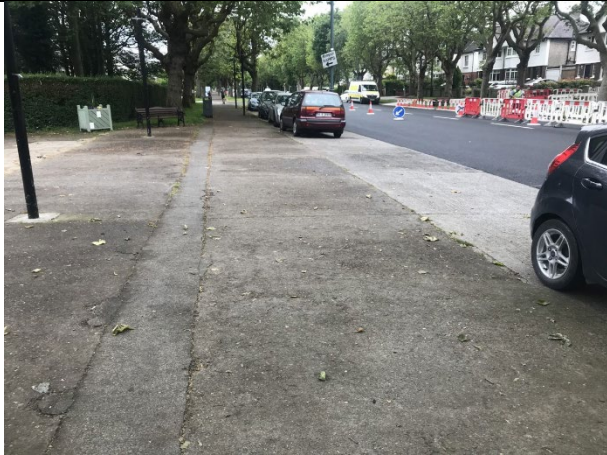
16-01 - No obvious staining on the indicative leak location outside the Corpus Christi Church.

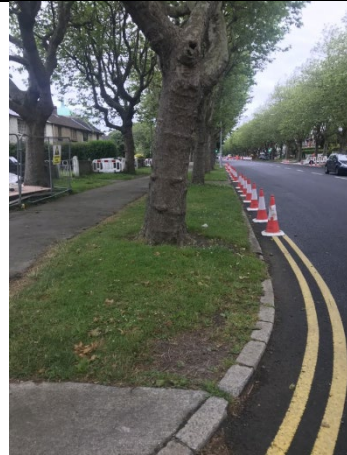
16-02 – Cabling located along footpath/grassed verge, and under concrete section where on-street parking is located outside the Corpus Christi Church.

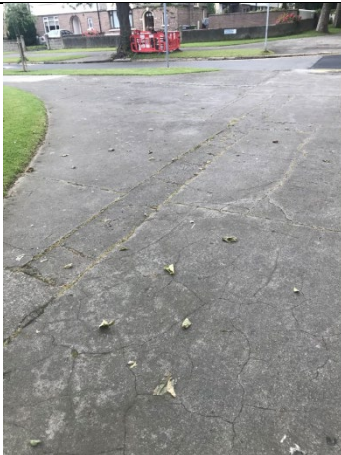
16-03 – Some patchwork noted along the concrete footpath area. Patchwork noted to follow the course of the likely cable at the junction of Clare Road and Griffith Avenue, and outside the Corpus Christi Church. No die back noted on grass.

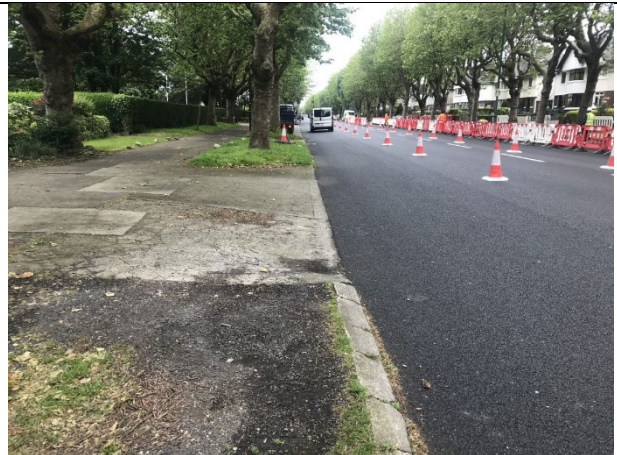
16-04 – Griffith Avenue in good condition as it is undergoing resurfacing works which are almost complete (tarmac surface).

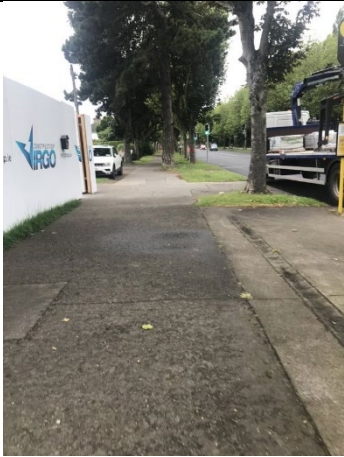
16-05 – Large mature trees noted on the grassy verge, and in particular between Bantry Road and Valentia Road. No die back observed in the area.
