Preliminary Site Assessment Report for Fairhill – Wolfe Tone Street Cork City

ESB Site Ref: 2
Fairhill – Kilbarry 38 kV

April 2020

Project Title: ESB Networks Historic Fluid Filled Cable Loss
Environmental Assessment

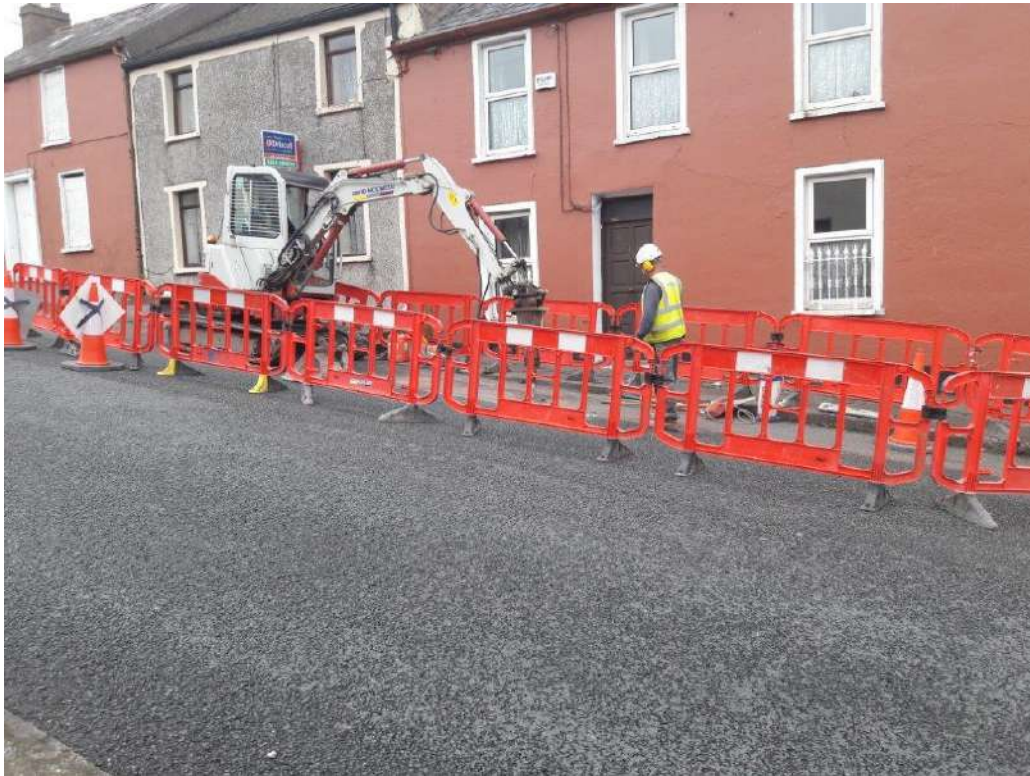
Photo 1 Cable route located on eastern side of Fair Hill.

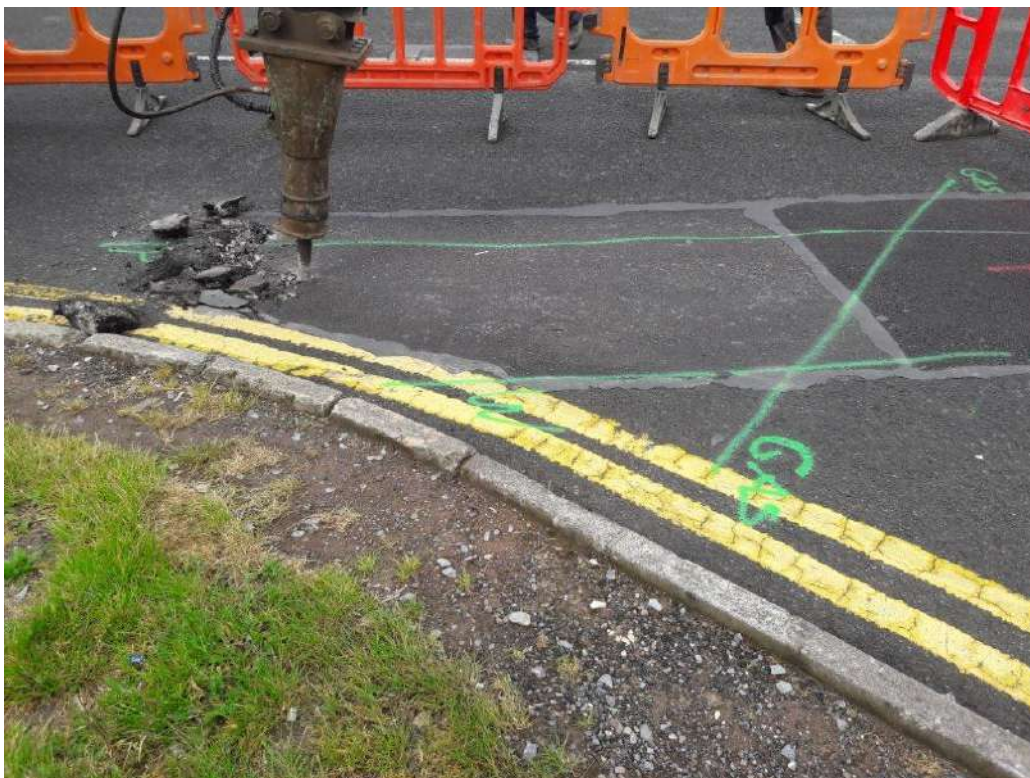
Photo 2 Location of gas and utility lines marked on road in preparation of trial pit works.

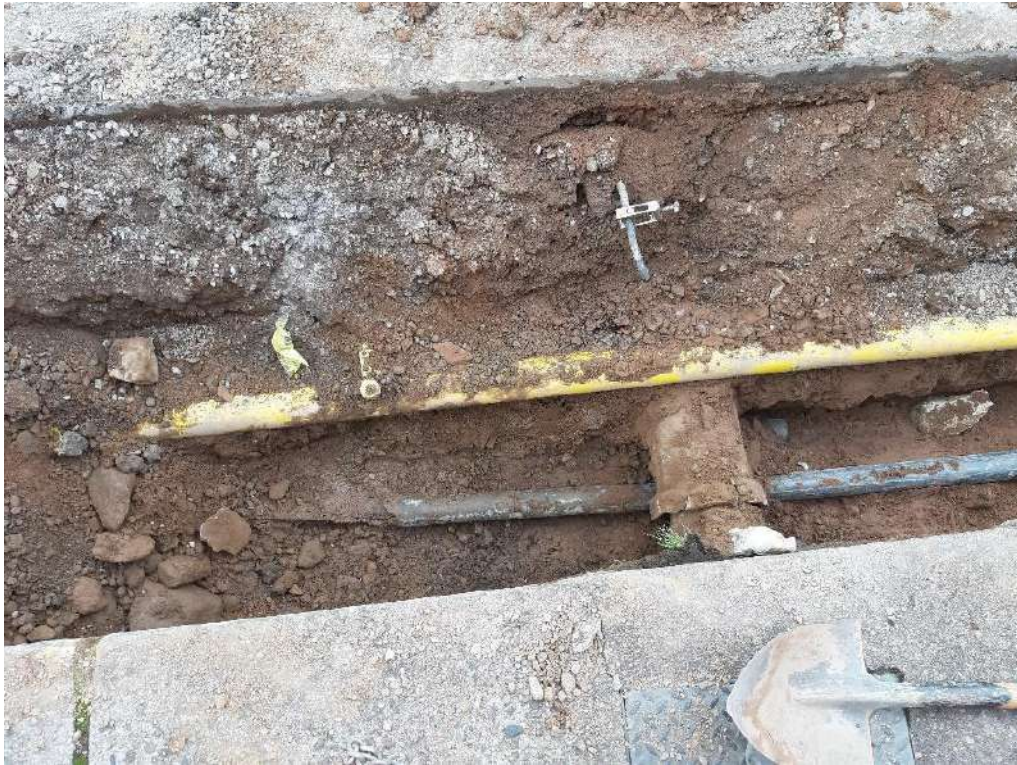
Photo 3 Occurrence of underground services during excavations. Gas, sewerage and communication ducts visible in image.

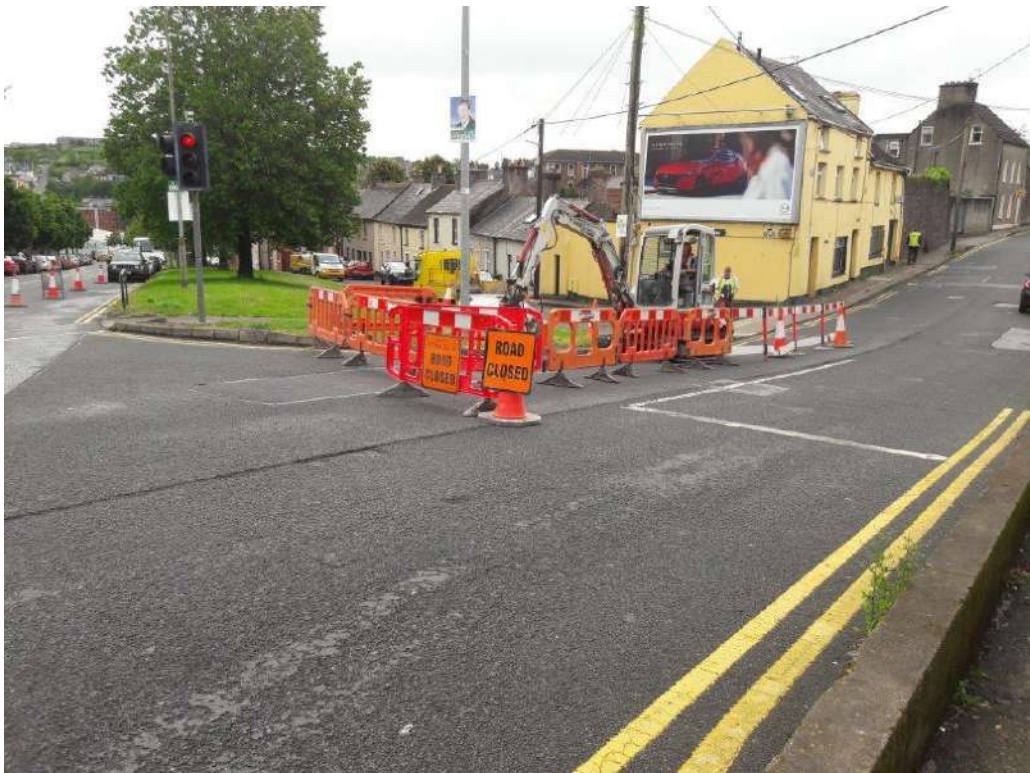
The leak point was located on the eastern side of the road as presented in Photograph 4 in Appendix C. On initial site walkover in May 2019, there was no physical evidence of hydrocarbon contamination on the surface in terms of oil odours/staining or impact to vegetation with healthy looking trees and hedges. Immediately to the east of the leak point on Wolfe tone Street is a grassed area, cul de sac avenue and footpath.

Photo 4 Location of known leak point on eastern side of Wolfe Tone Street. Trial pit works in progress.

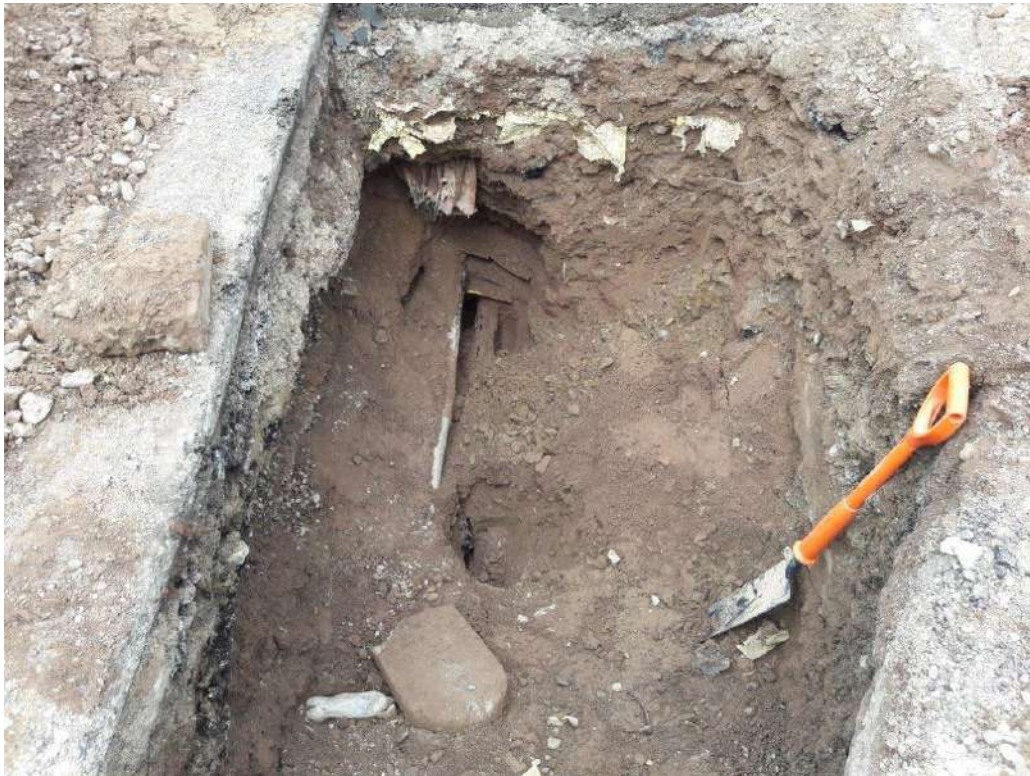
Photo 5 Trial pit and inspection hole works being completed at the location of the known leak point (ESB Ref: 2)

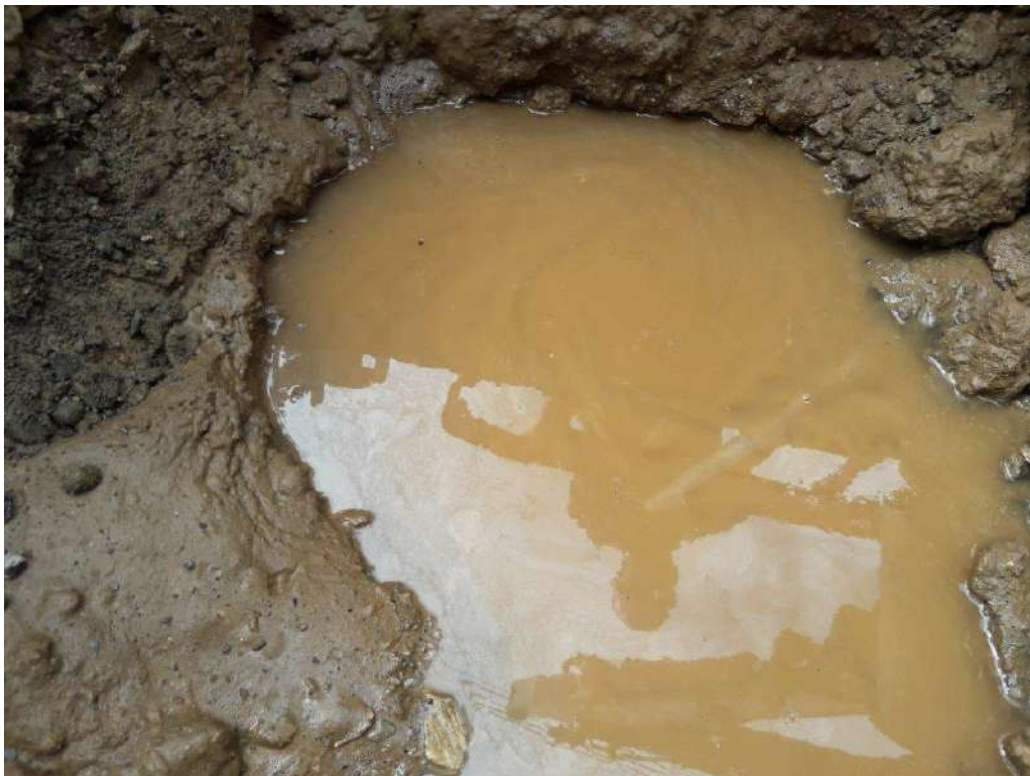
Photo 6. Image showing the ingress of water into trial pit excavation during initial site investigation activities in June 2019. Note the visible hydrocarbon sheen thought to be associated with residual cable fluid in soils.
