ESB Networks Historic Cable Fluid Losses: Preliminary Site Assessment

**Location 21: Carrickmines - Poolbeg 220 kV -
October 2012**

February 2020

Report Ref: GCU0257001/003

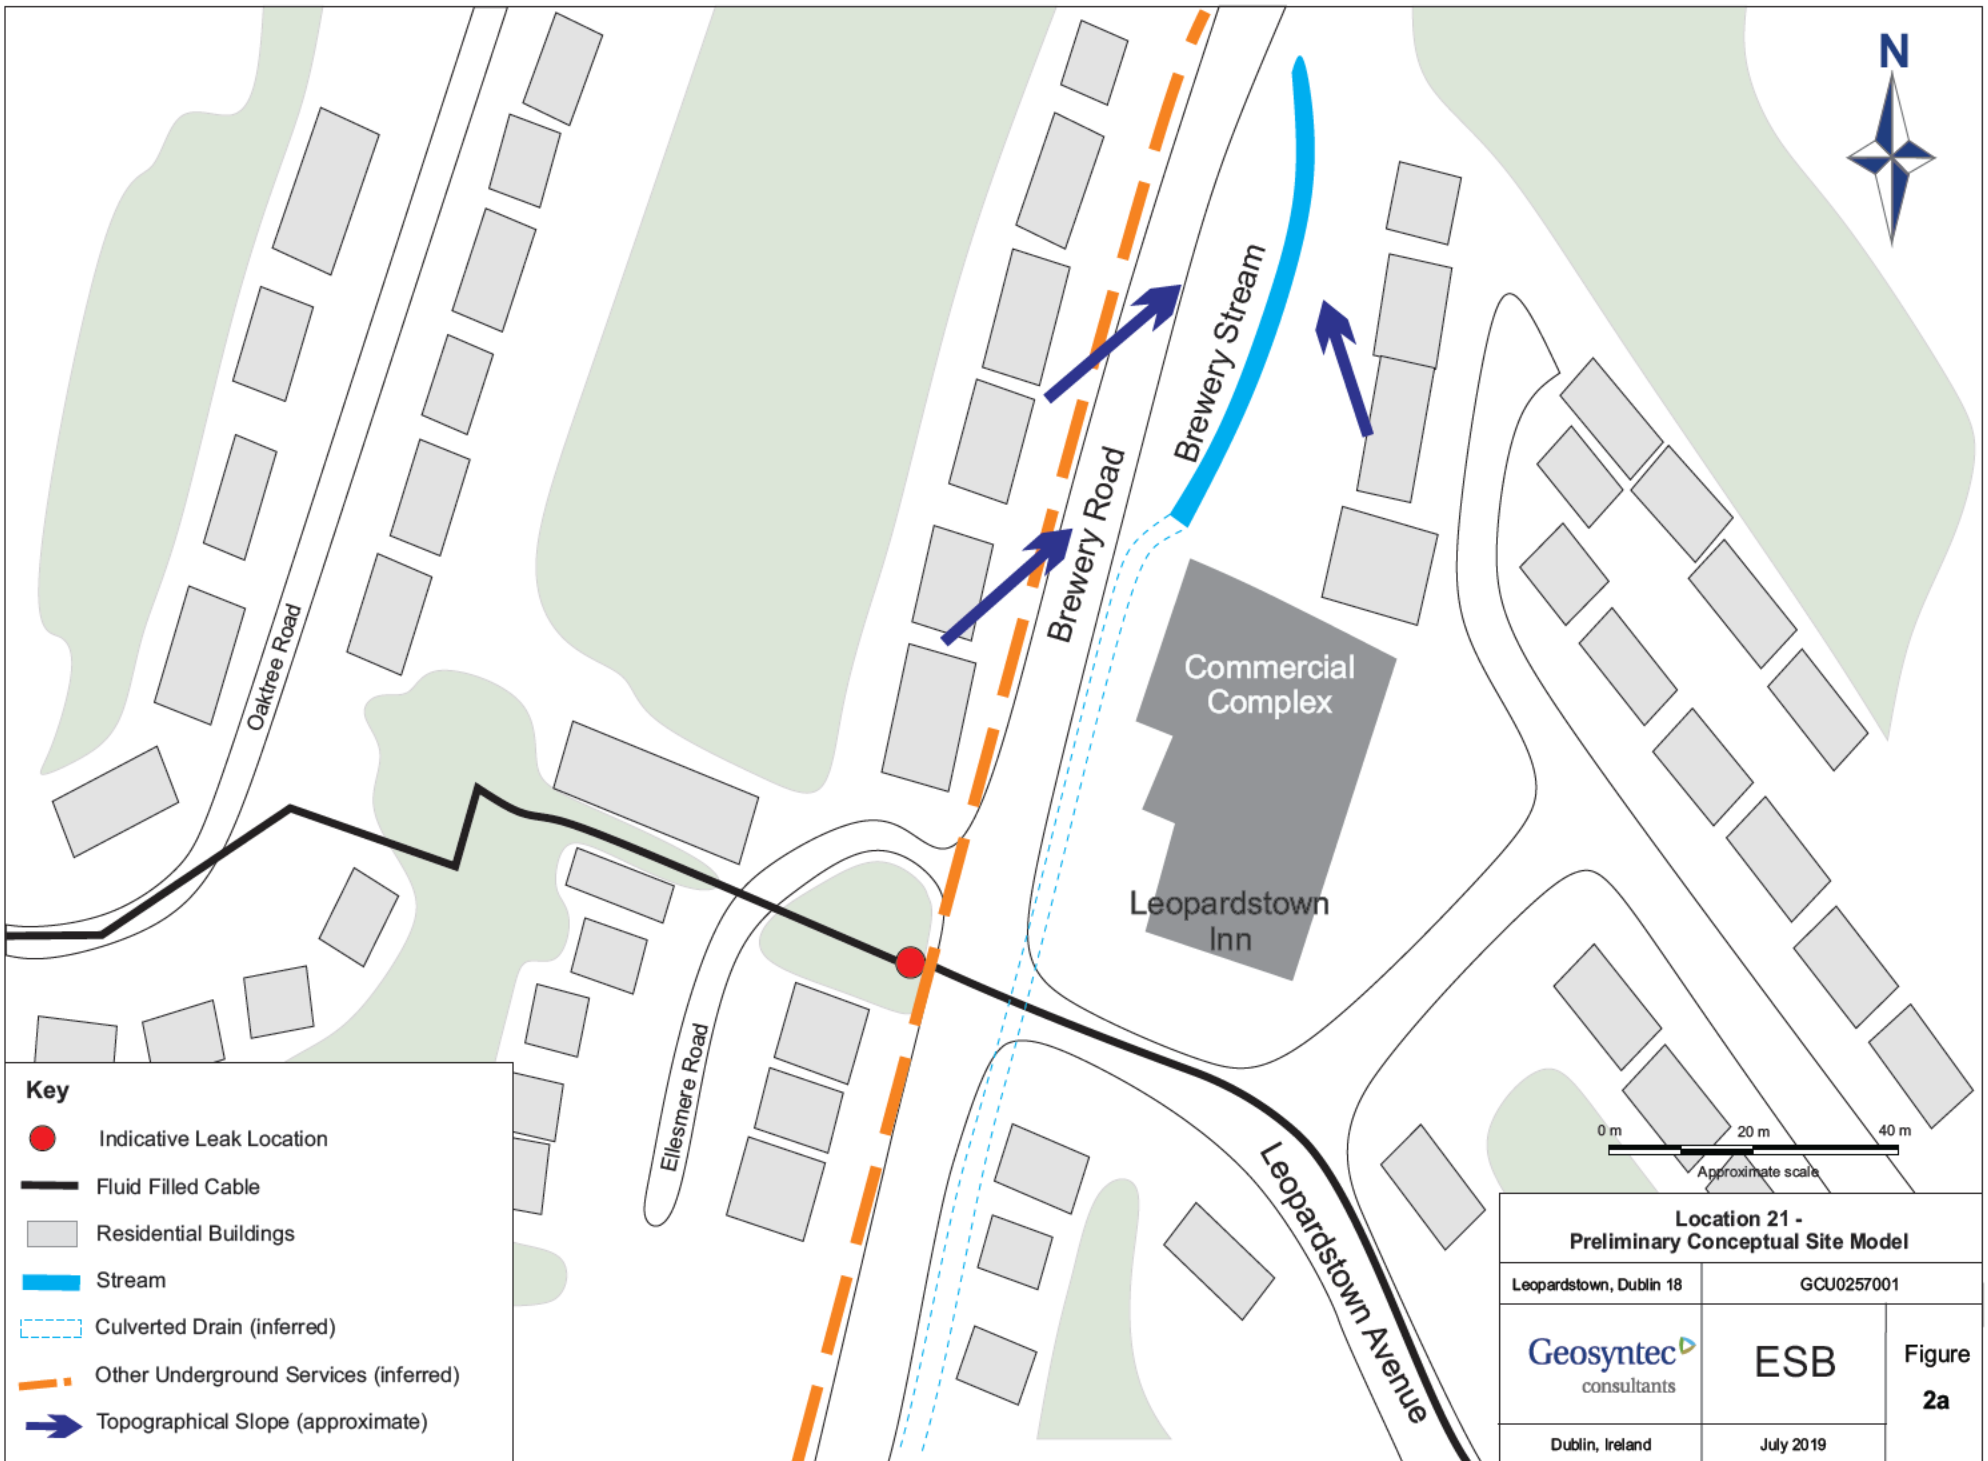
Location 21 - Preliminary Conceptual Site Model		
Leopardstown, Dublin 18	GCU0257001	
 	ESB	Figure 2a
Dublin, Ireland	July 2019

Based on the expected low permeability of overburden material in the vicinity of the leak location, cable fluid lost to ground can be expected to have spread laterally within the permeable sand bedding and possibly within the granular backfill within the cable trench. If the cable trench intersects more permeable material (e.g. deeper fill materials associated with historical development, lenses of natural sands or gravels, or another in-filled services trench – including that around the river culvert), which is considered likely in the subject case, this could result in cable fluid migrating from the cable trench and along a different route or routes.

However, given that there are likely to be other below-ground services trenches that run parallel with Brewery Road that intercept the cable trench, it appears likely that a proportion of the cable fluid will have migrated from the cable trench and along the line of these service trenches, generally towards the north/north-east. Given the relatively large volume of cable fluid lost to ground at the leak location, there is potential for cable fluid to have migrated for a considerable distance along such service trenches;

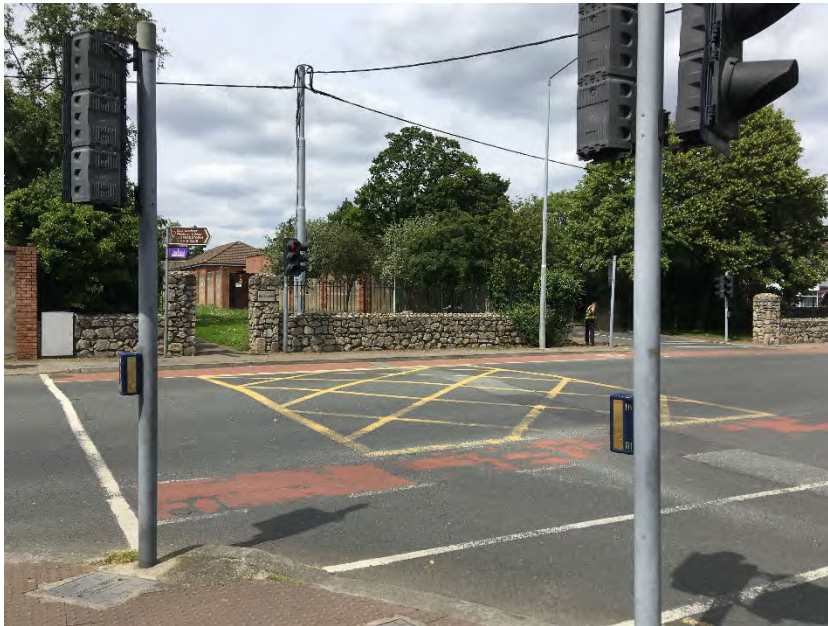
Photograph 1 – Leak location; west side of Brewery Road

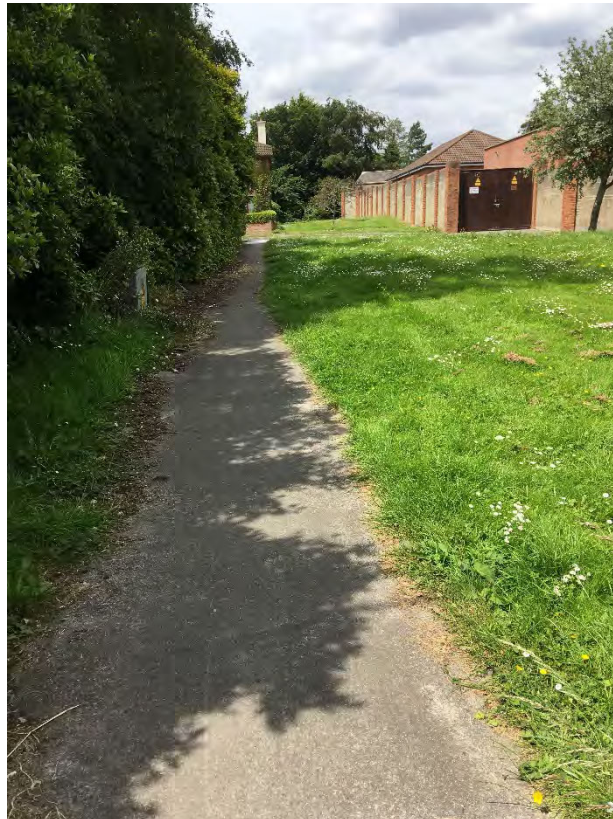
Photograph 2 – Cable route west of leak location

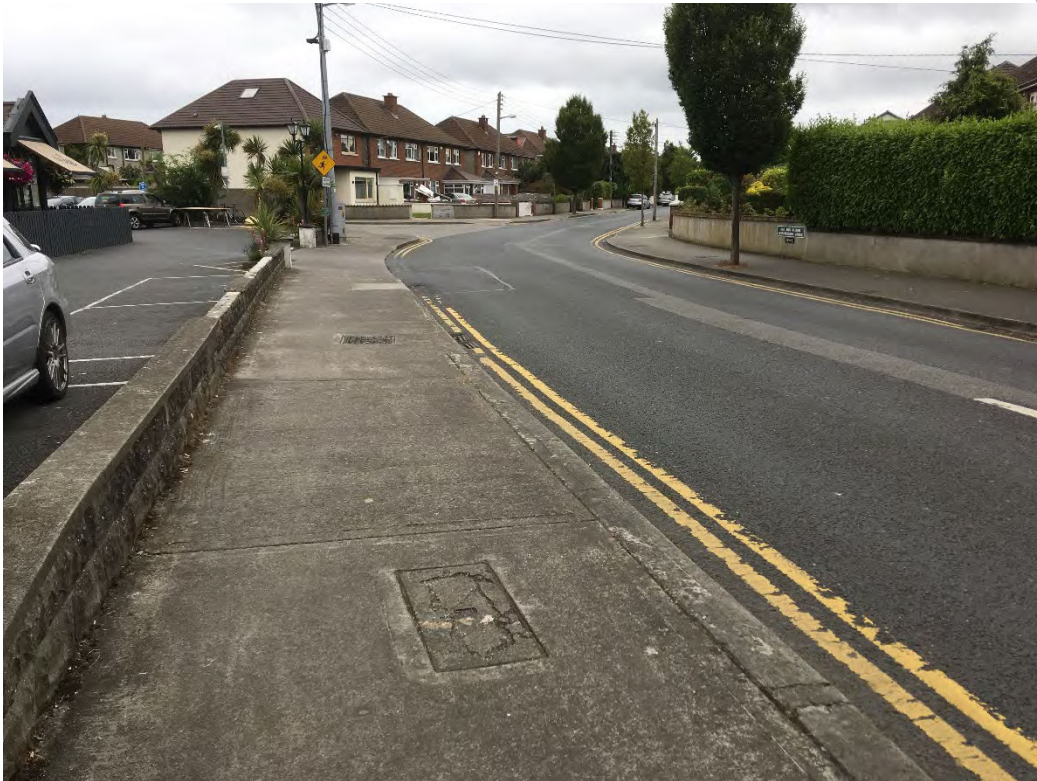
Photograph 3 – View east along Leopardstown Avenue

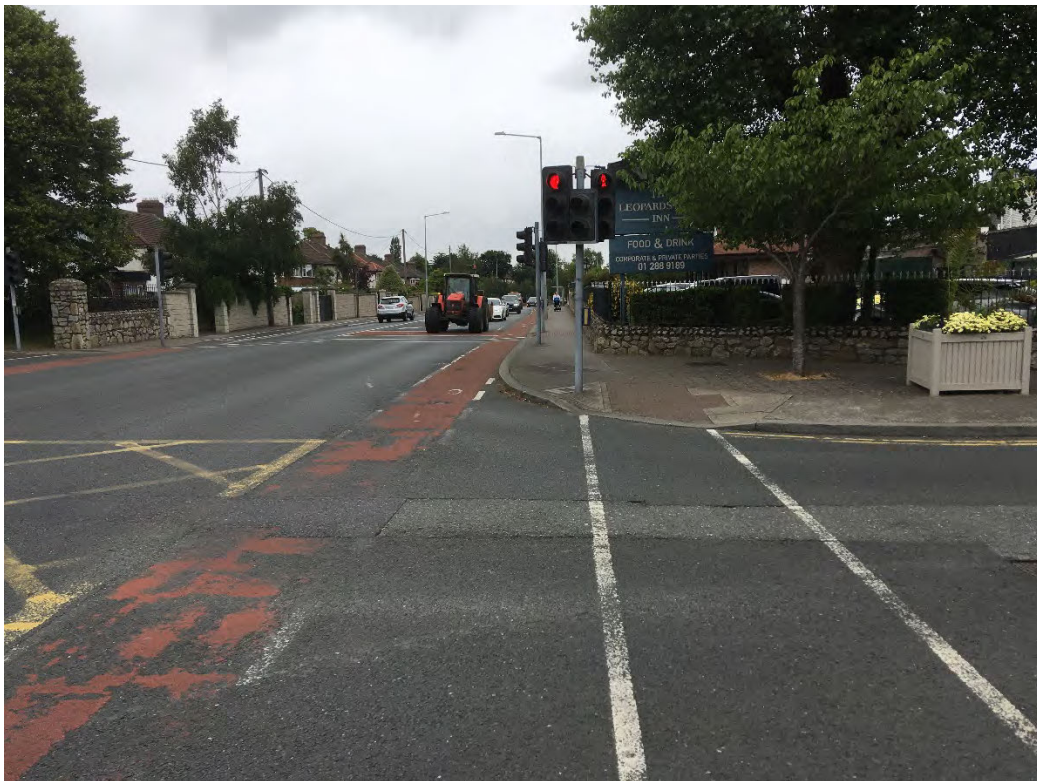
Photograph 4 – Brewery Road looking north from Leopardstown Avenue
