# ESB Networks Historic Cable Fluid Losses: Preliminary Site Assessment

**Location 28: Blackrock - Ringsend 38 kV - November 2011**

February 2020

Report Ref: GCU0257001/011

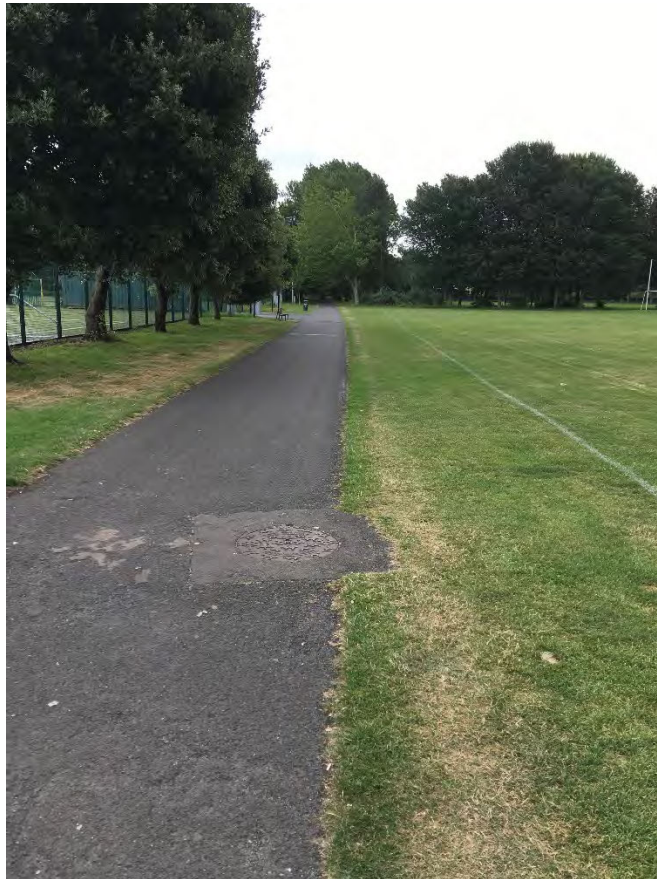
No evidence of stressed vegetation or die-back was observed in the vicinity of the leak location or along the cable route at the time of the walkover survey.

**Photograph 1 – View east from leak location**

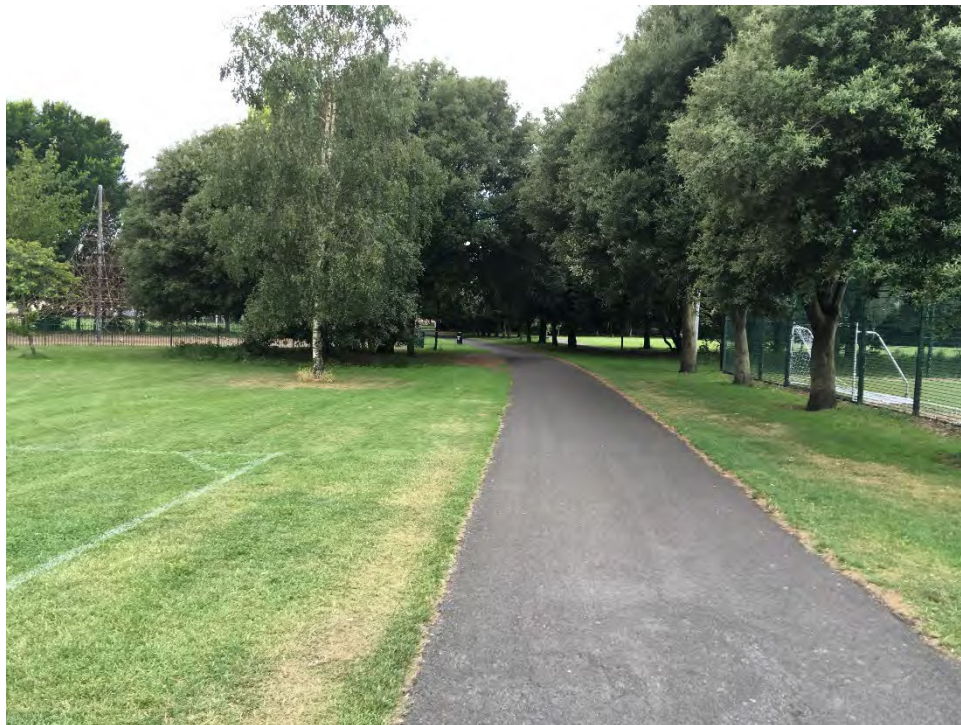
**Photograph 2 – View west from leak location**

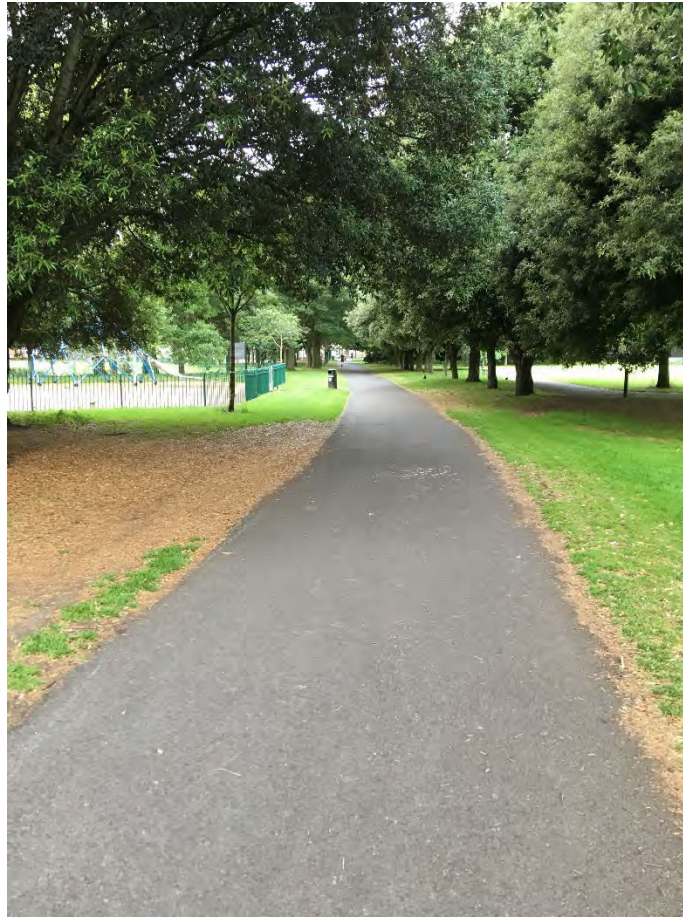
**Photograph 3 – View west past playground**
