# **Unidare - Whitehall (Site ID 29)**

Preliminary Environmental Site Assessment

602620 – R03 (02)

DECEMBER 2019

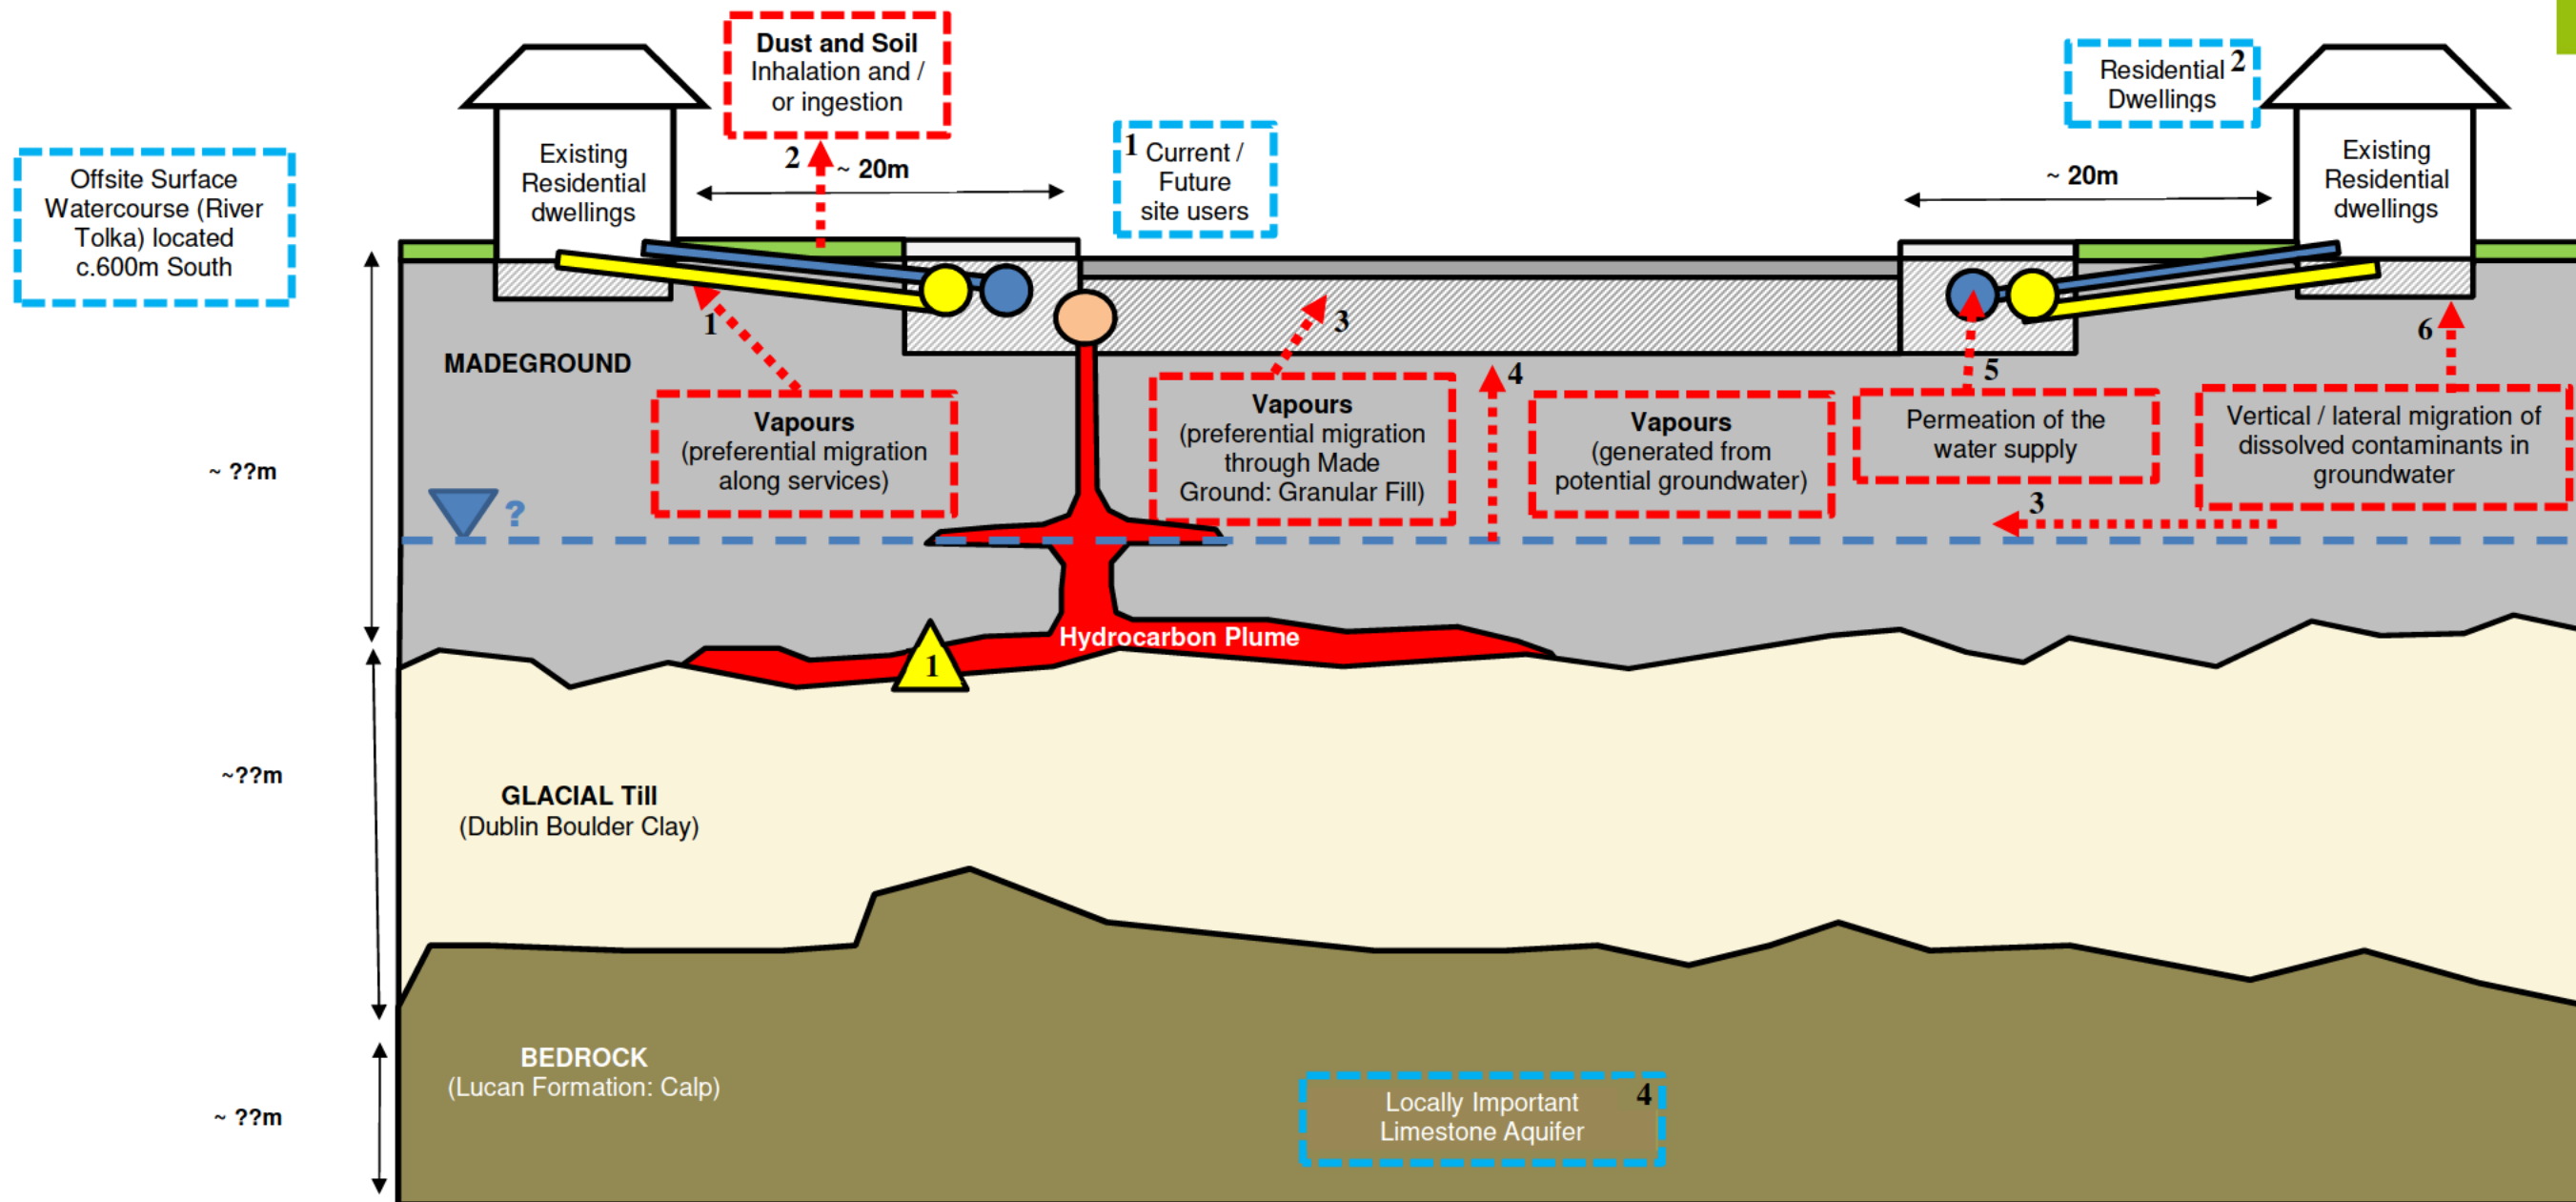
(29) Whitehall Indicative Leak Location - Graphical Conceptual Site Model

Following the completion of a risk evaluation for the identified pollutant linkages, the initial CSM has identified potential pollutant linkages with a risk class of **LOW** for all identified pollution linkages.

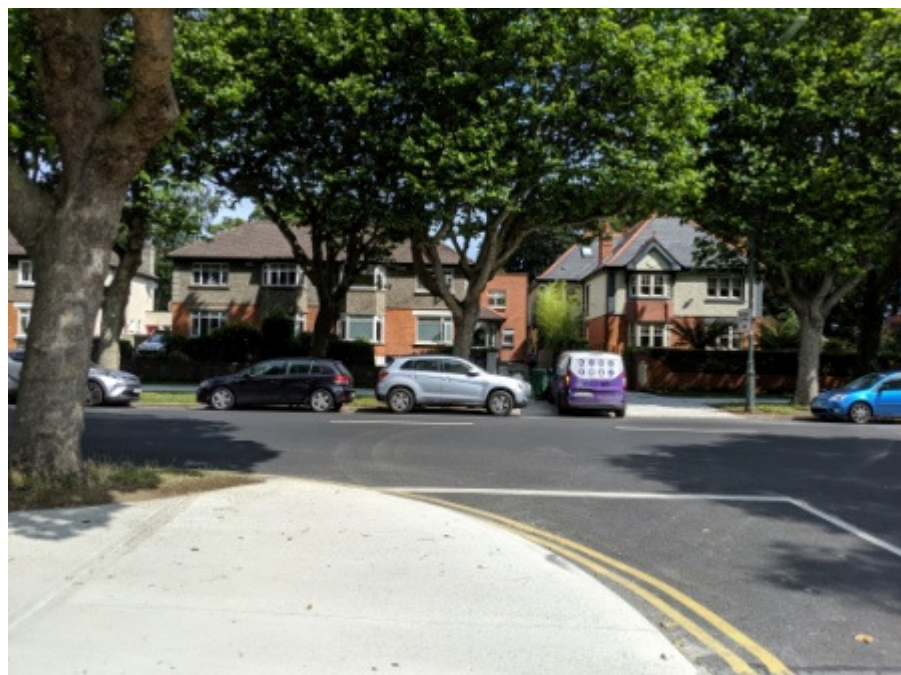
Marker (~200m east) from Indicative Leak location.

View from the junction of Lambay Road with Griffith Avenue. The street is bound on both side with detached and semi-detached residential dwellings with gardens.

Communal green bands with mature trees line the footpaths.

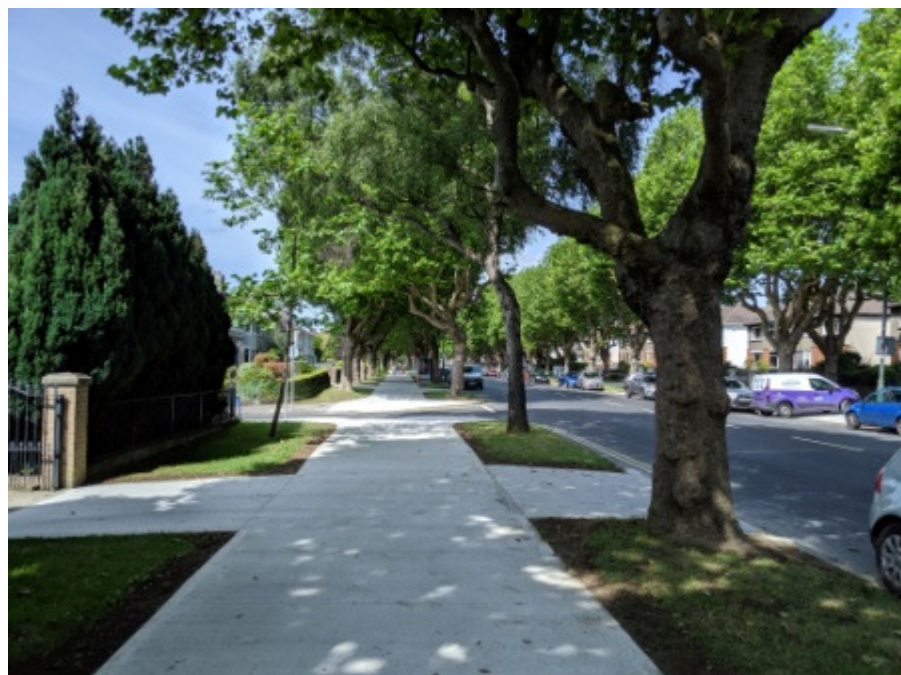
Marker (~200m east) from Indicative Leak location.

View of Griffith Avenue. The street is bound on both side with detached and semi-detached residential dwellings with gardens.

Communal green bands with mature trees line the footpaths.

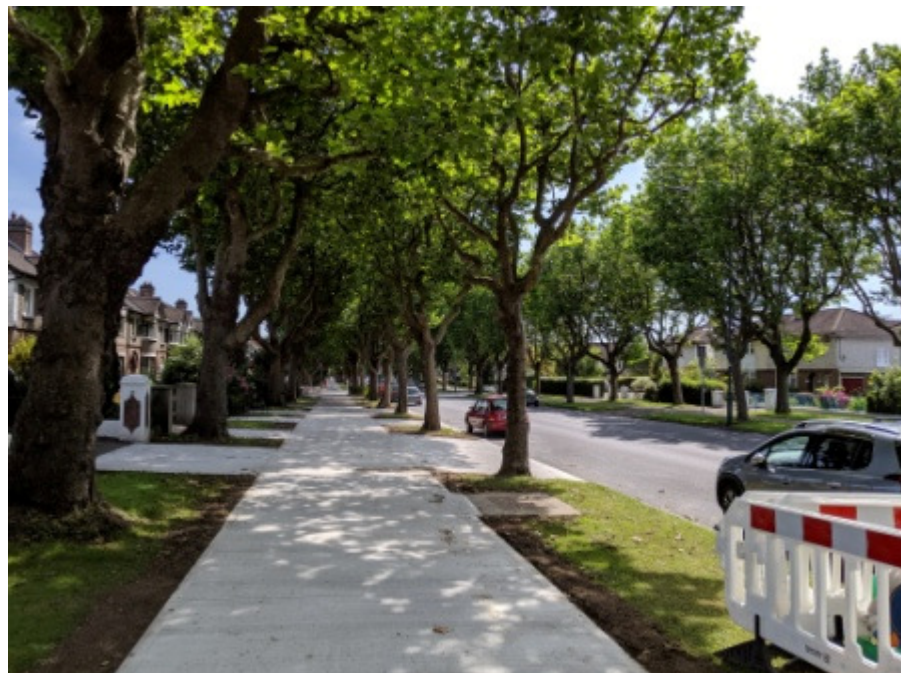
Indicative Leak location.

View of Griffith Avenue.  
The street is bound on both side with detached and semi-detached residential dwellings with gardens.

Communal green bands with mature trees line the footpaths.

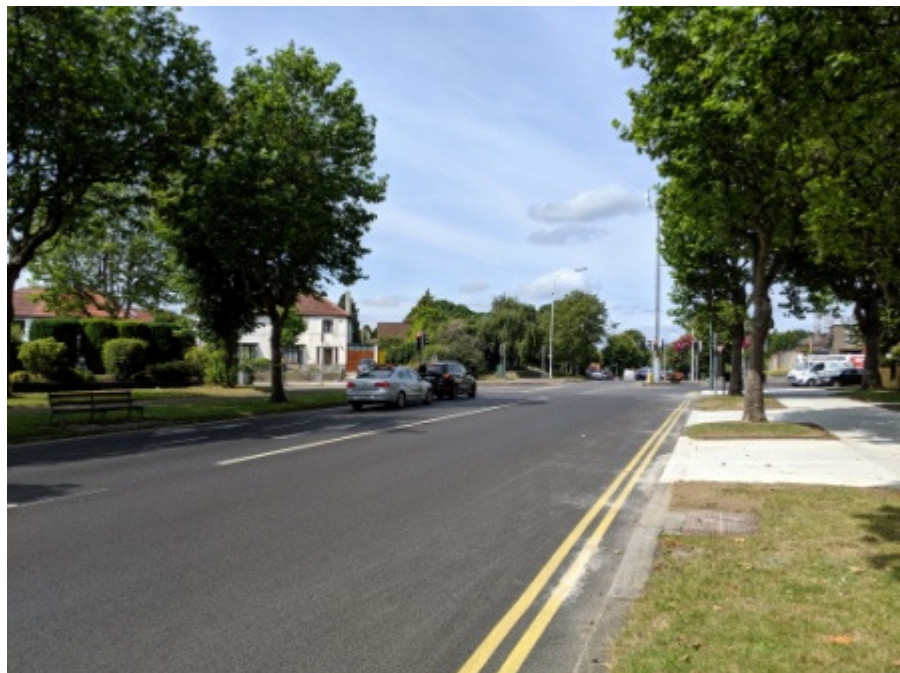
Indicative Leak location.

View of Griffith Avenue towards the junction of St Mobhi Road. Griffith Avenue is bound on both sides by

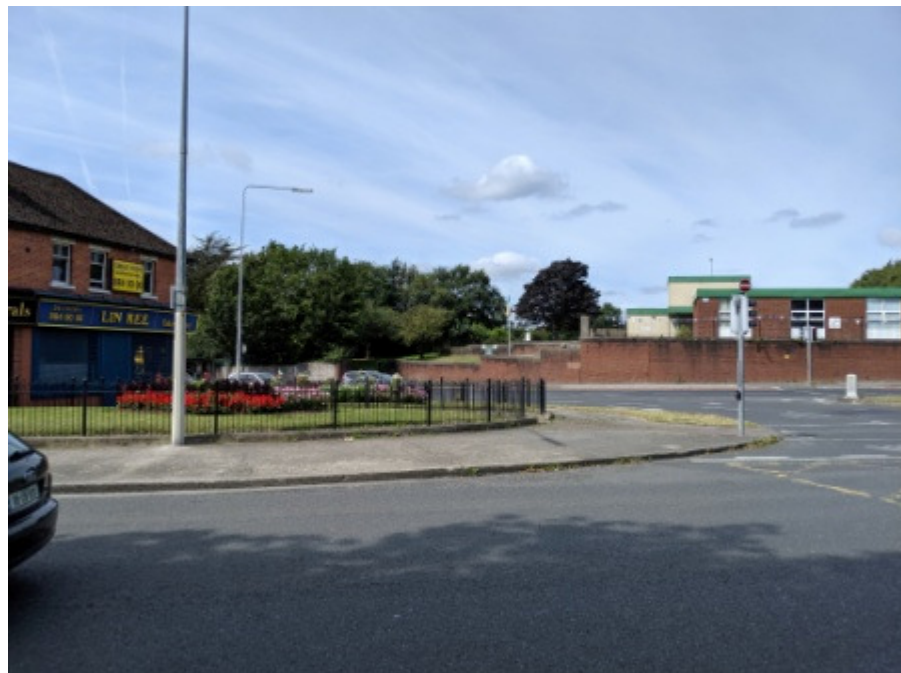
Marker (~200m north) from Indicative Leak location.

View of St Michaels House (Special Education School) located on Ballymun Road; located within 200m of the indicative leak location.

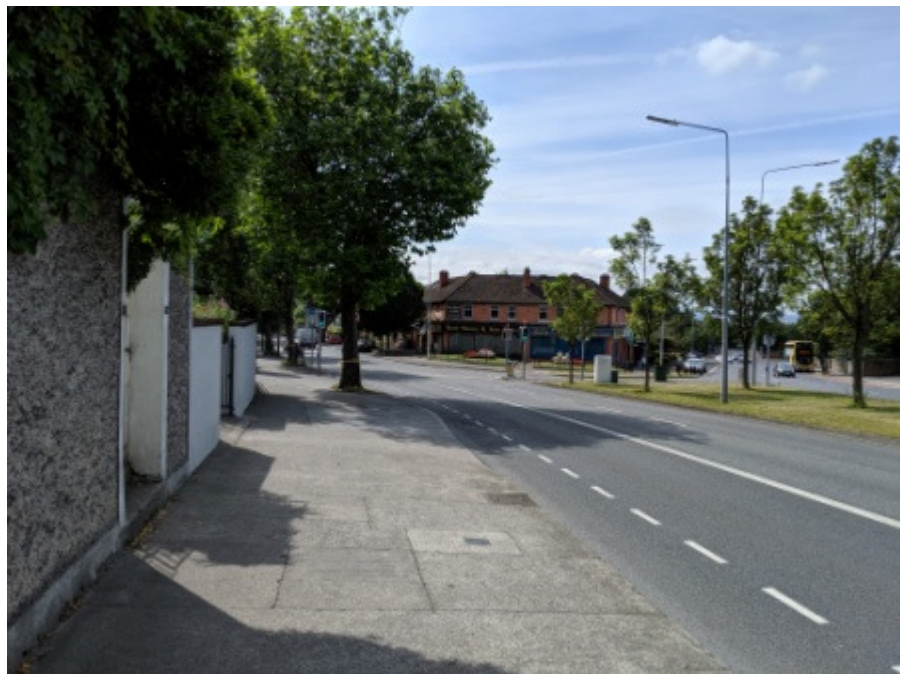
Marker (~200m north) from Indicative Leak location.

View of St Mobhi Road from the 200m marker. Road is bound by residential properties with gardens to the east, a school and commercial premises to the west.
