# Preliminary Site Assessment

Site 3 Harold's Cross - Ringsend 110 kV (January 2016 -  
November 2018)

Electricity Supply Board

27 January 2020

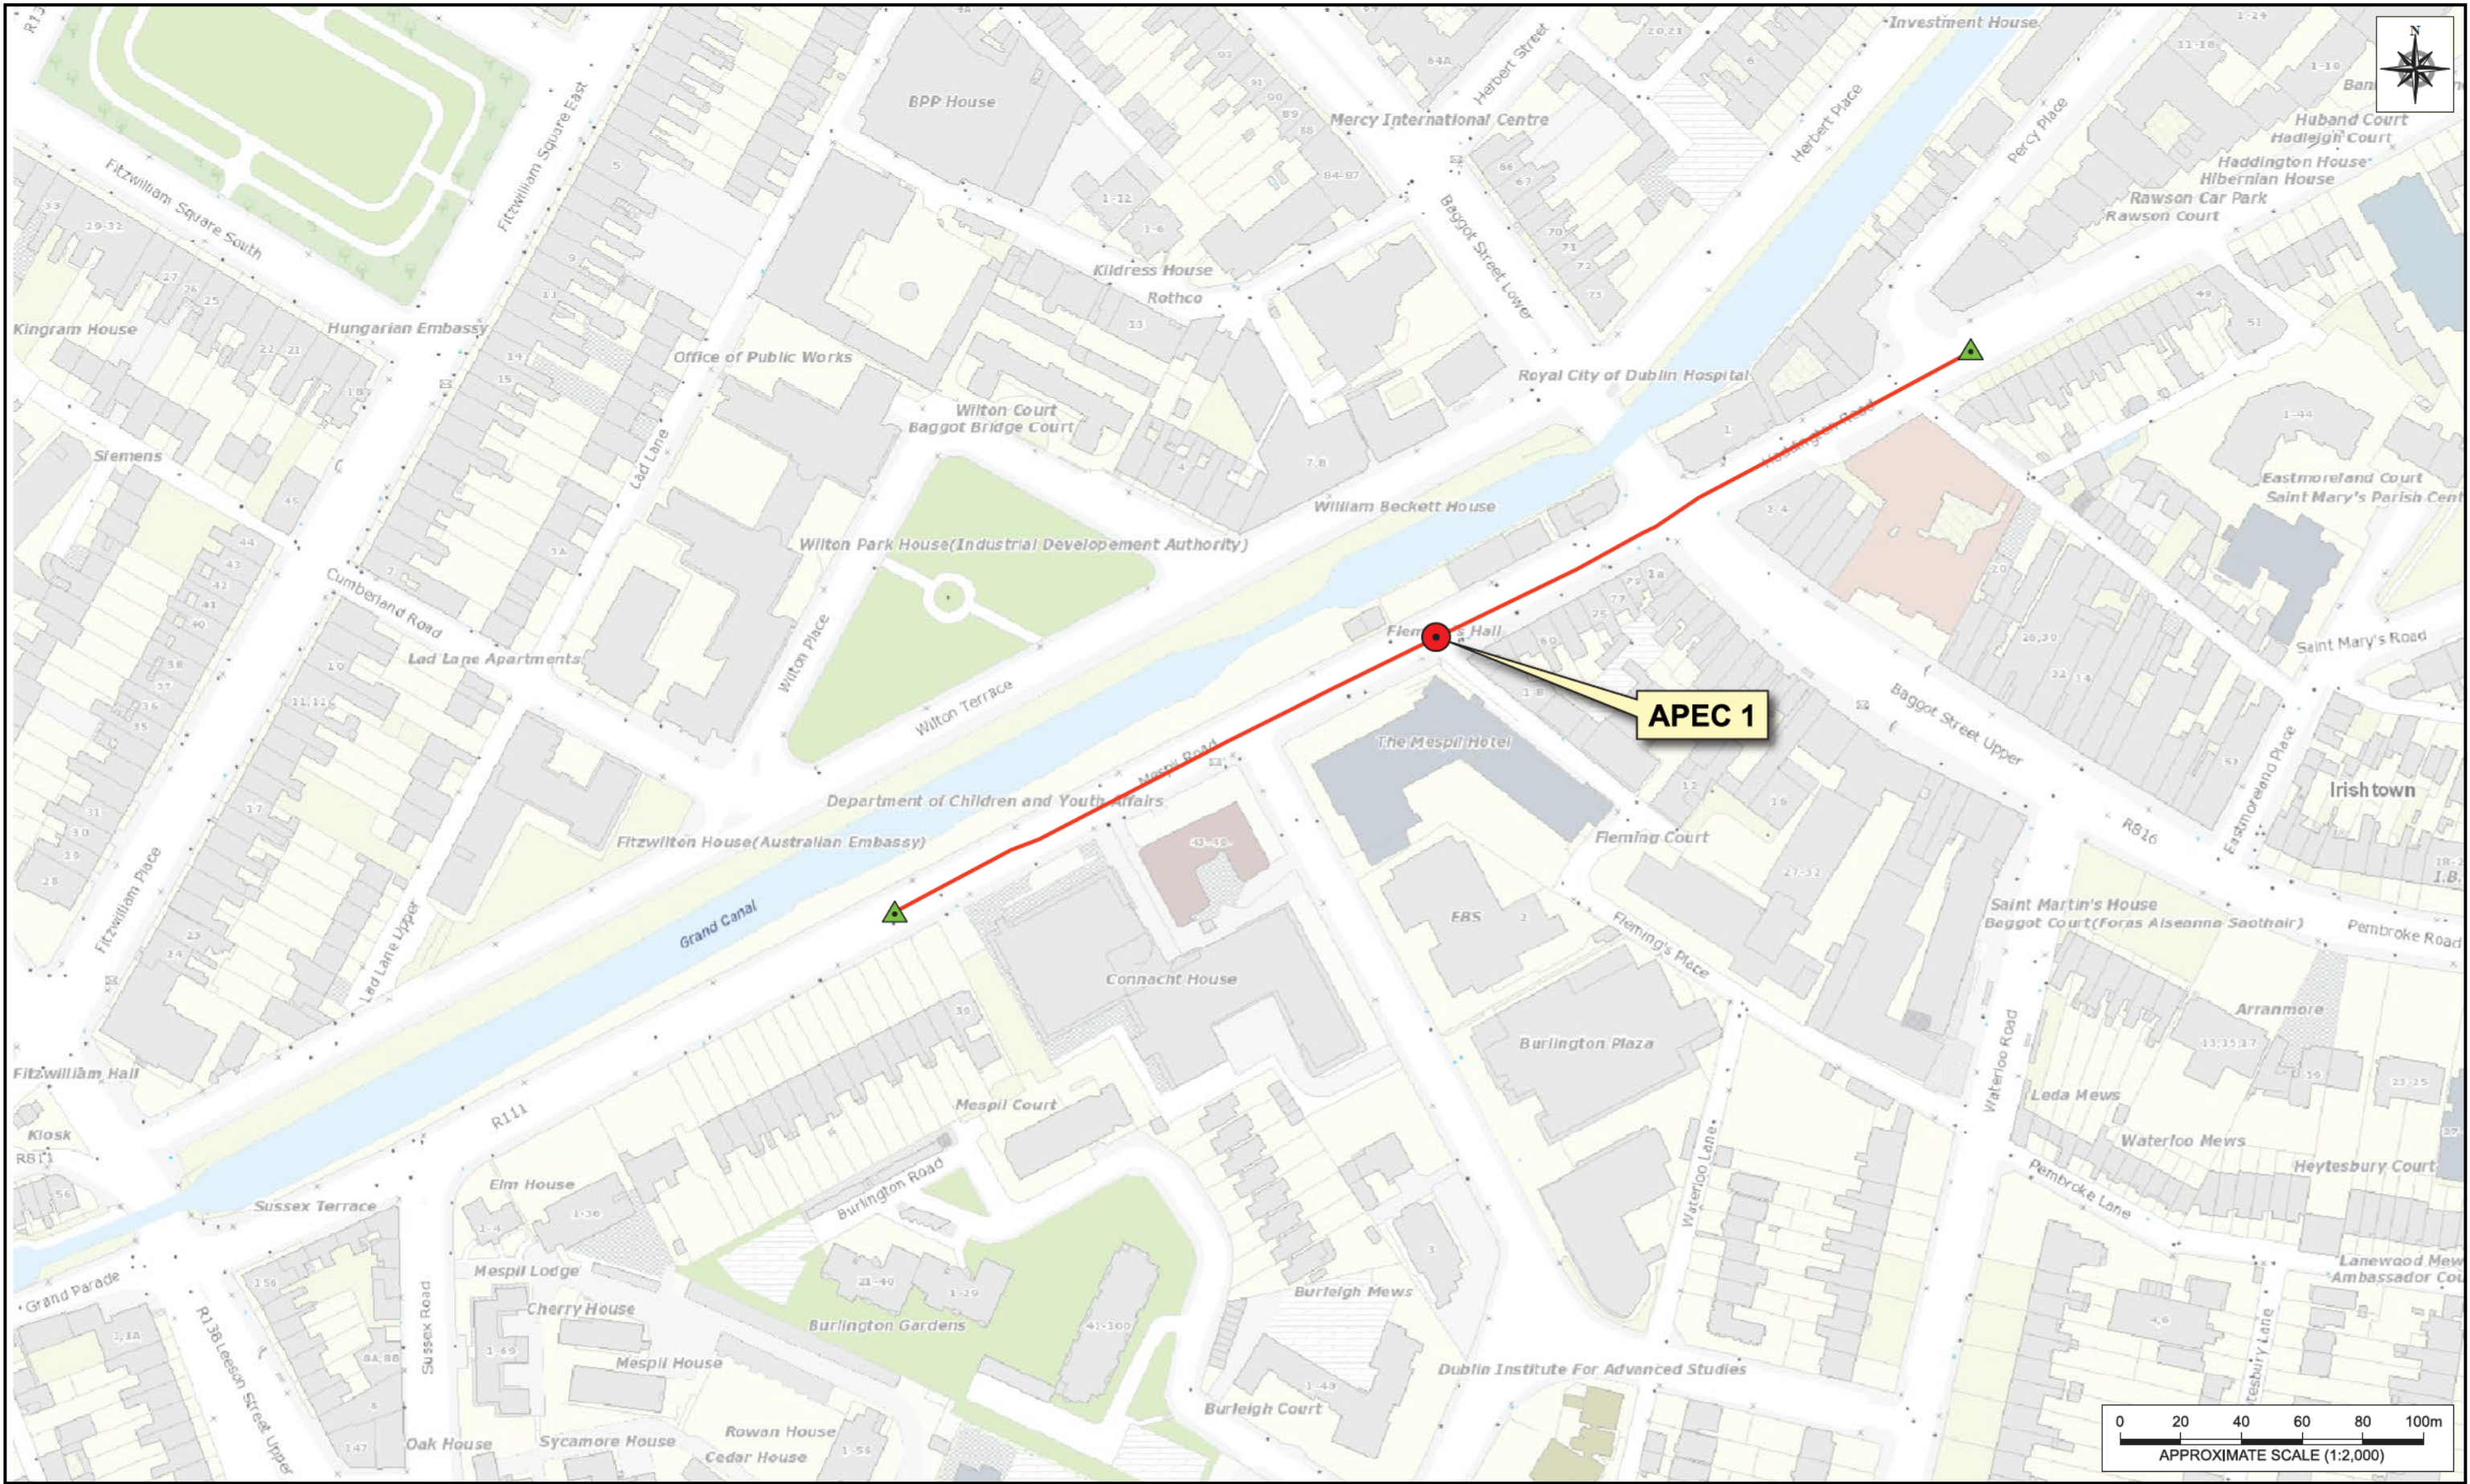
The location of the leak at cable joint No. 6 – UG0840 is located beneath Mespil Road (R111) at the junction of Mespil Road and Flemings Place (ITM 716795.74 732926.19). It is estimated that the loss of fluid from the cable occurred between January 2016 and November 2018, with an estimated fluid volume loss of 29,422 litres during that period.

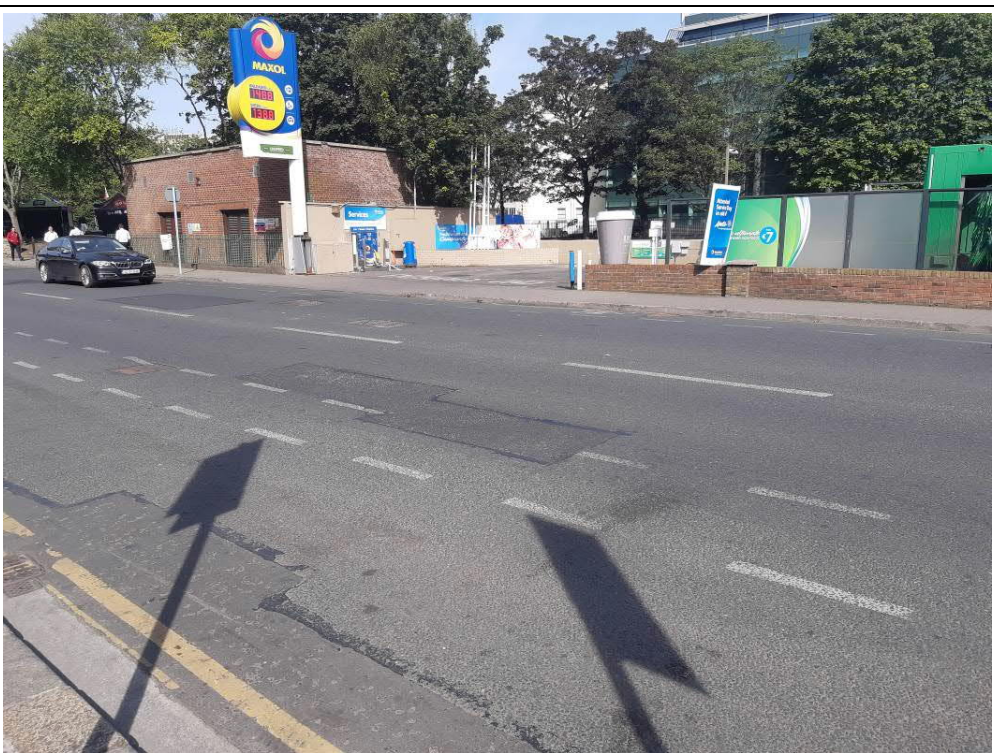
| <b>Photo 13</b> | | |

| <b>Description</b><br><br>Looking west along Mespil Road at the indicative leak location adjacent to the Mespil Hotel and Maxol petrol station | | |

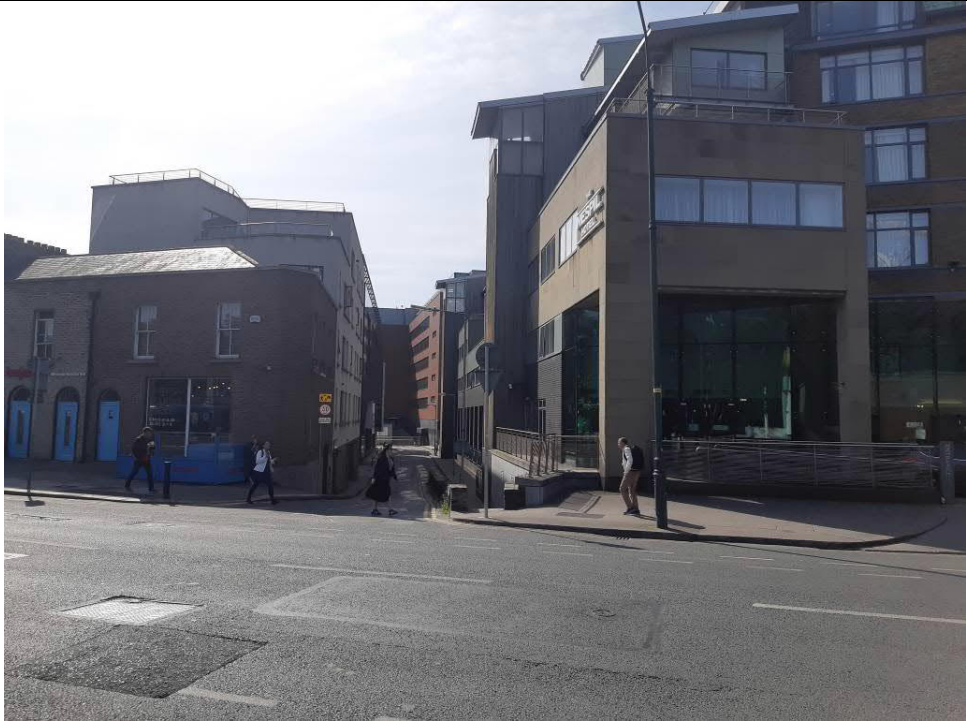
| <b>Photo 19</b> | | |

| <b>Description</b><br><br>Looking south at junction of Mespil Road and Flemings Place at indicative leak location site | | |

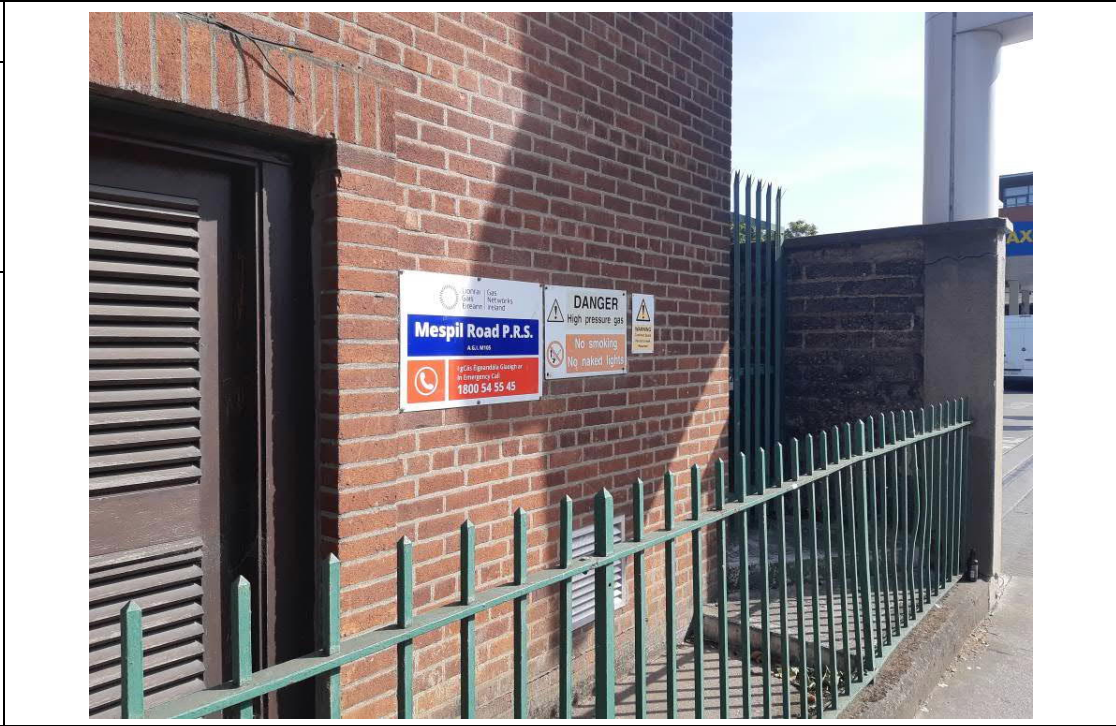
**Photo 21**

**Description**  
Gas Networks Ireland Pressure Reduction Station on Mespil road, adjacent to indicative leak location

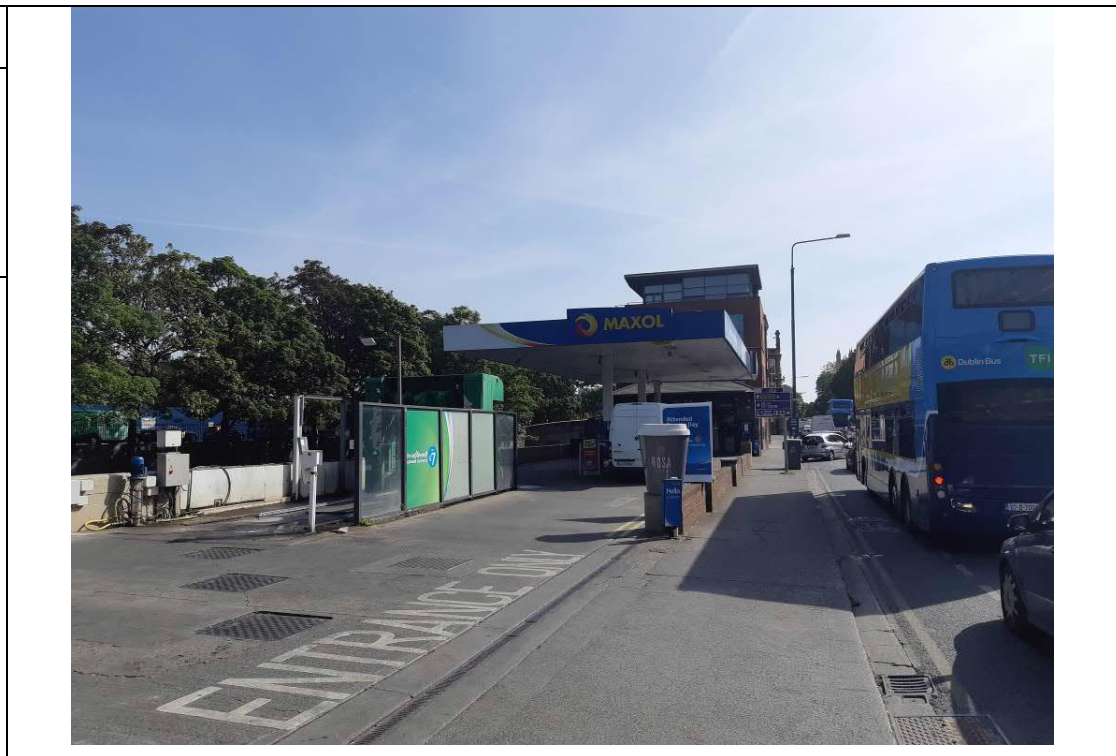
**Photo 22**

**Description:**  
Maxol petrol station adjacent to indicative leak location on Mespil Road
