Preliminary Site Assessment

Site 31 Inchicore - Marrowbone Lane 38 kV

Electricity Supply Board

Project number: PR-427640_ACM_RP_ENV_045_2

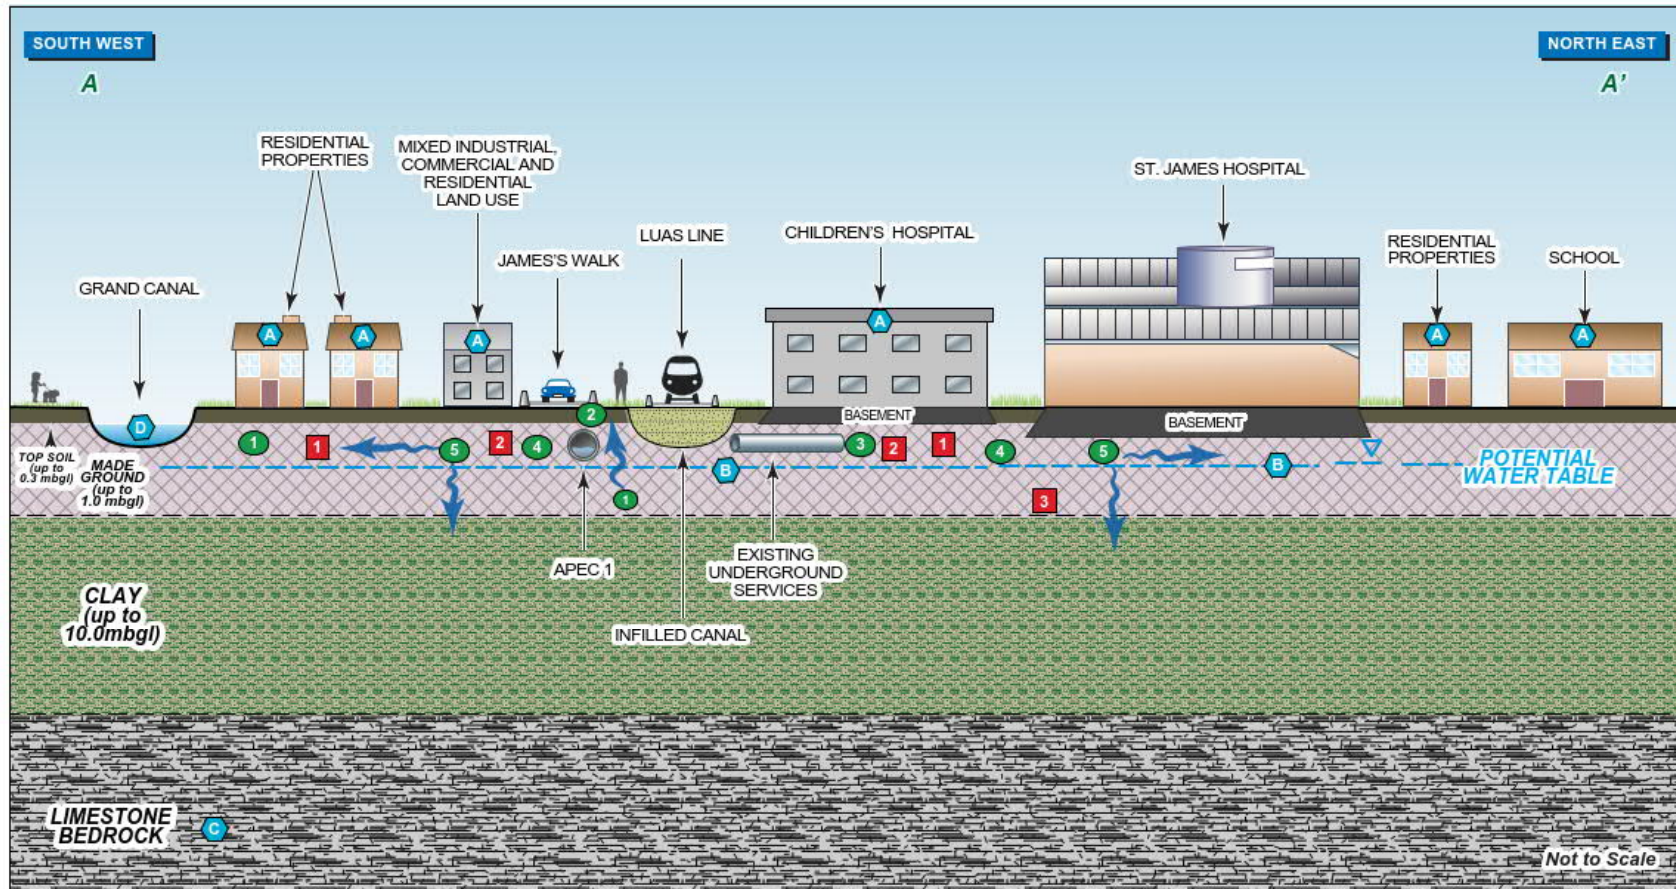
SOURCES	
1	GROUND GAS
2	NON-VOLATILE CONTAMINANTS IN SOIL
3	CONTAMINANTS IN GROUNDWATER

PATHWAYS	
1	GAS MIGRATION
2	DERMAL CONTACT / DUST INGESTION
3	PERMEATION OF AND MIGRATION ALONG EXISTING UNDERGROUND SERVICES
4	LEACHING FROM SOIL TO GROUNDWATER
5	VERTICAL & HORIZONTAL MIGRATION OF CONTAMINATED GROUNDWATER

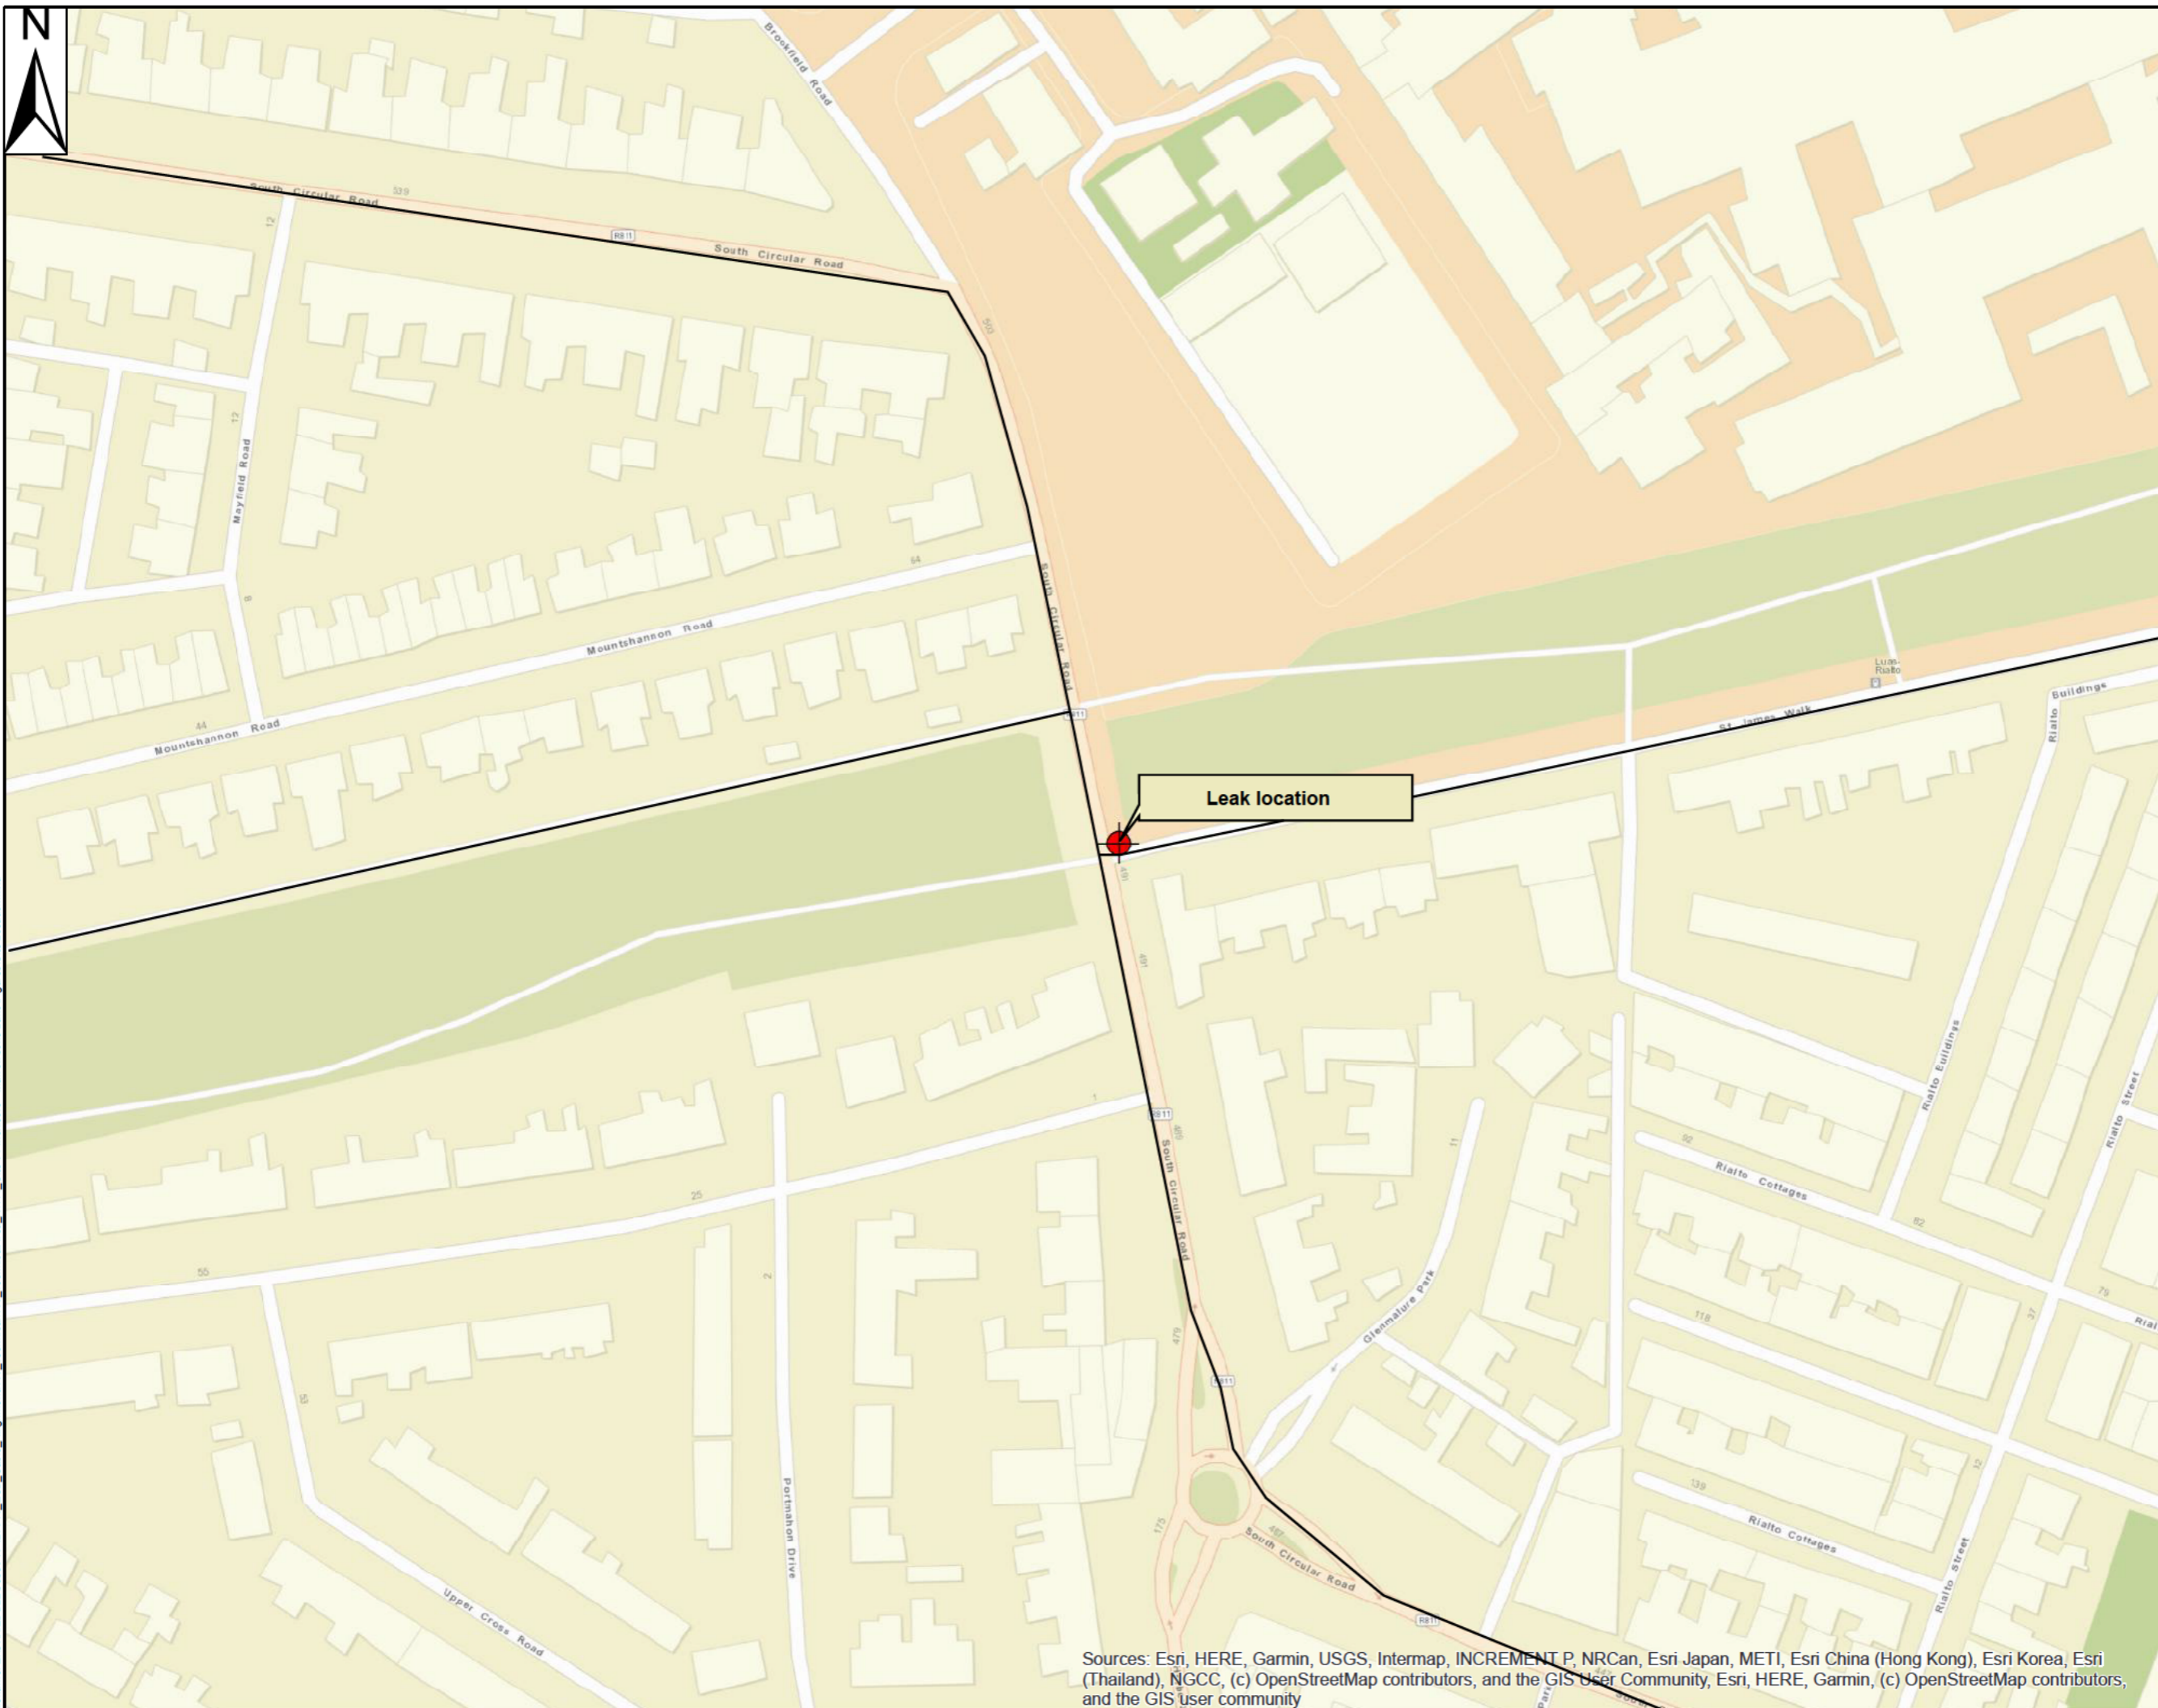
Figure 2. Areas of Potential Environmental Concern

Based on the assessment works completed, the primary Area of Potential Environmental Concern (APEC) for this site comprises the leak location identified by ESB. This is presented in Figure 2 and a description is provided in Table 7.

Number	APEC	Potential Contaminants of Concern	Potential Media Impacted
1	Leak at (31) Inchicore – Marrowbone Lane 38 kV (February 2009 – November 2009)	LABs TPH BTEX VOCs SVOCs PCBs	Soil Groundwater Soil Vapour Ground Gas

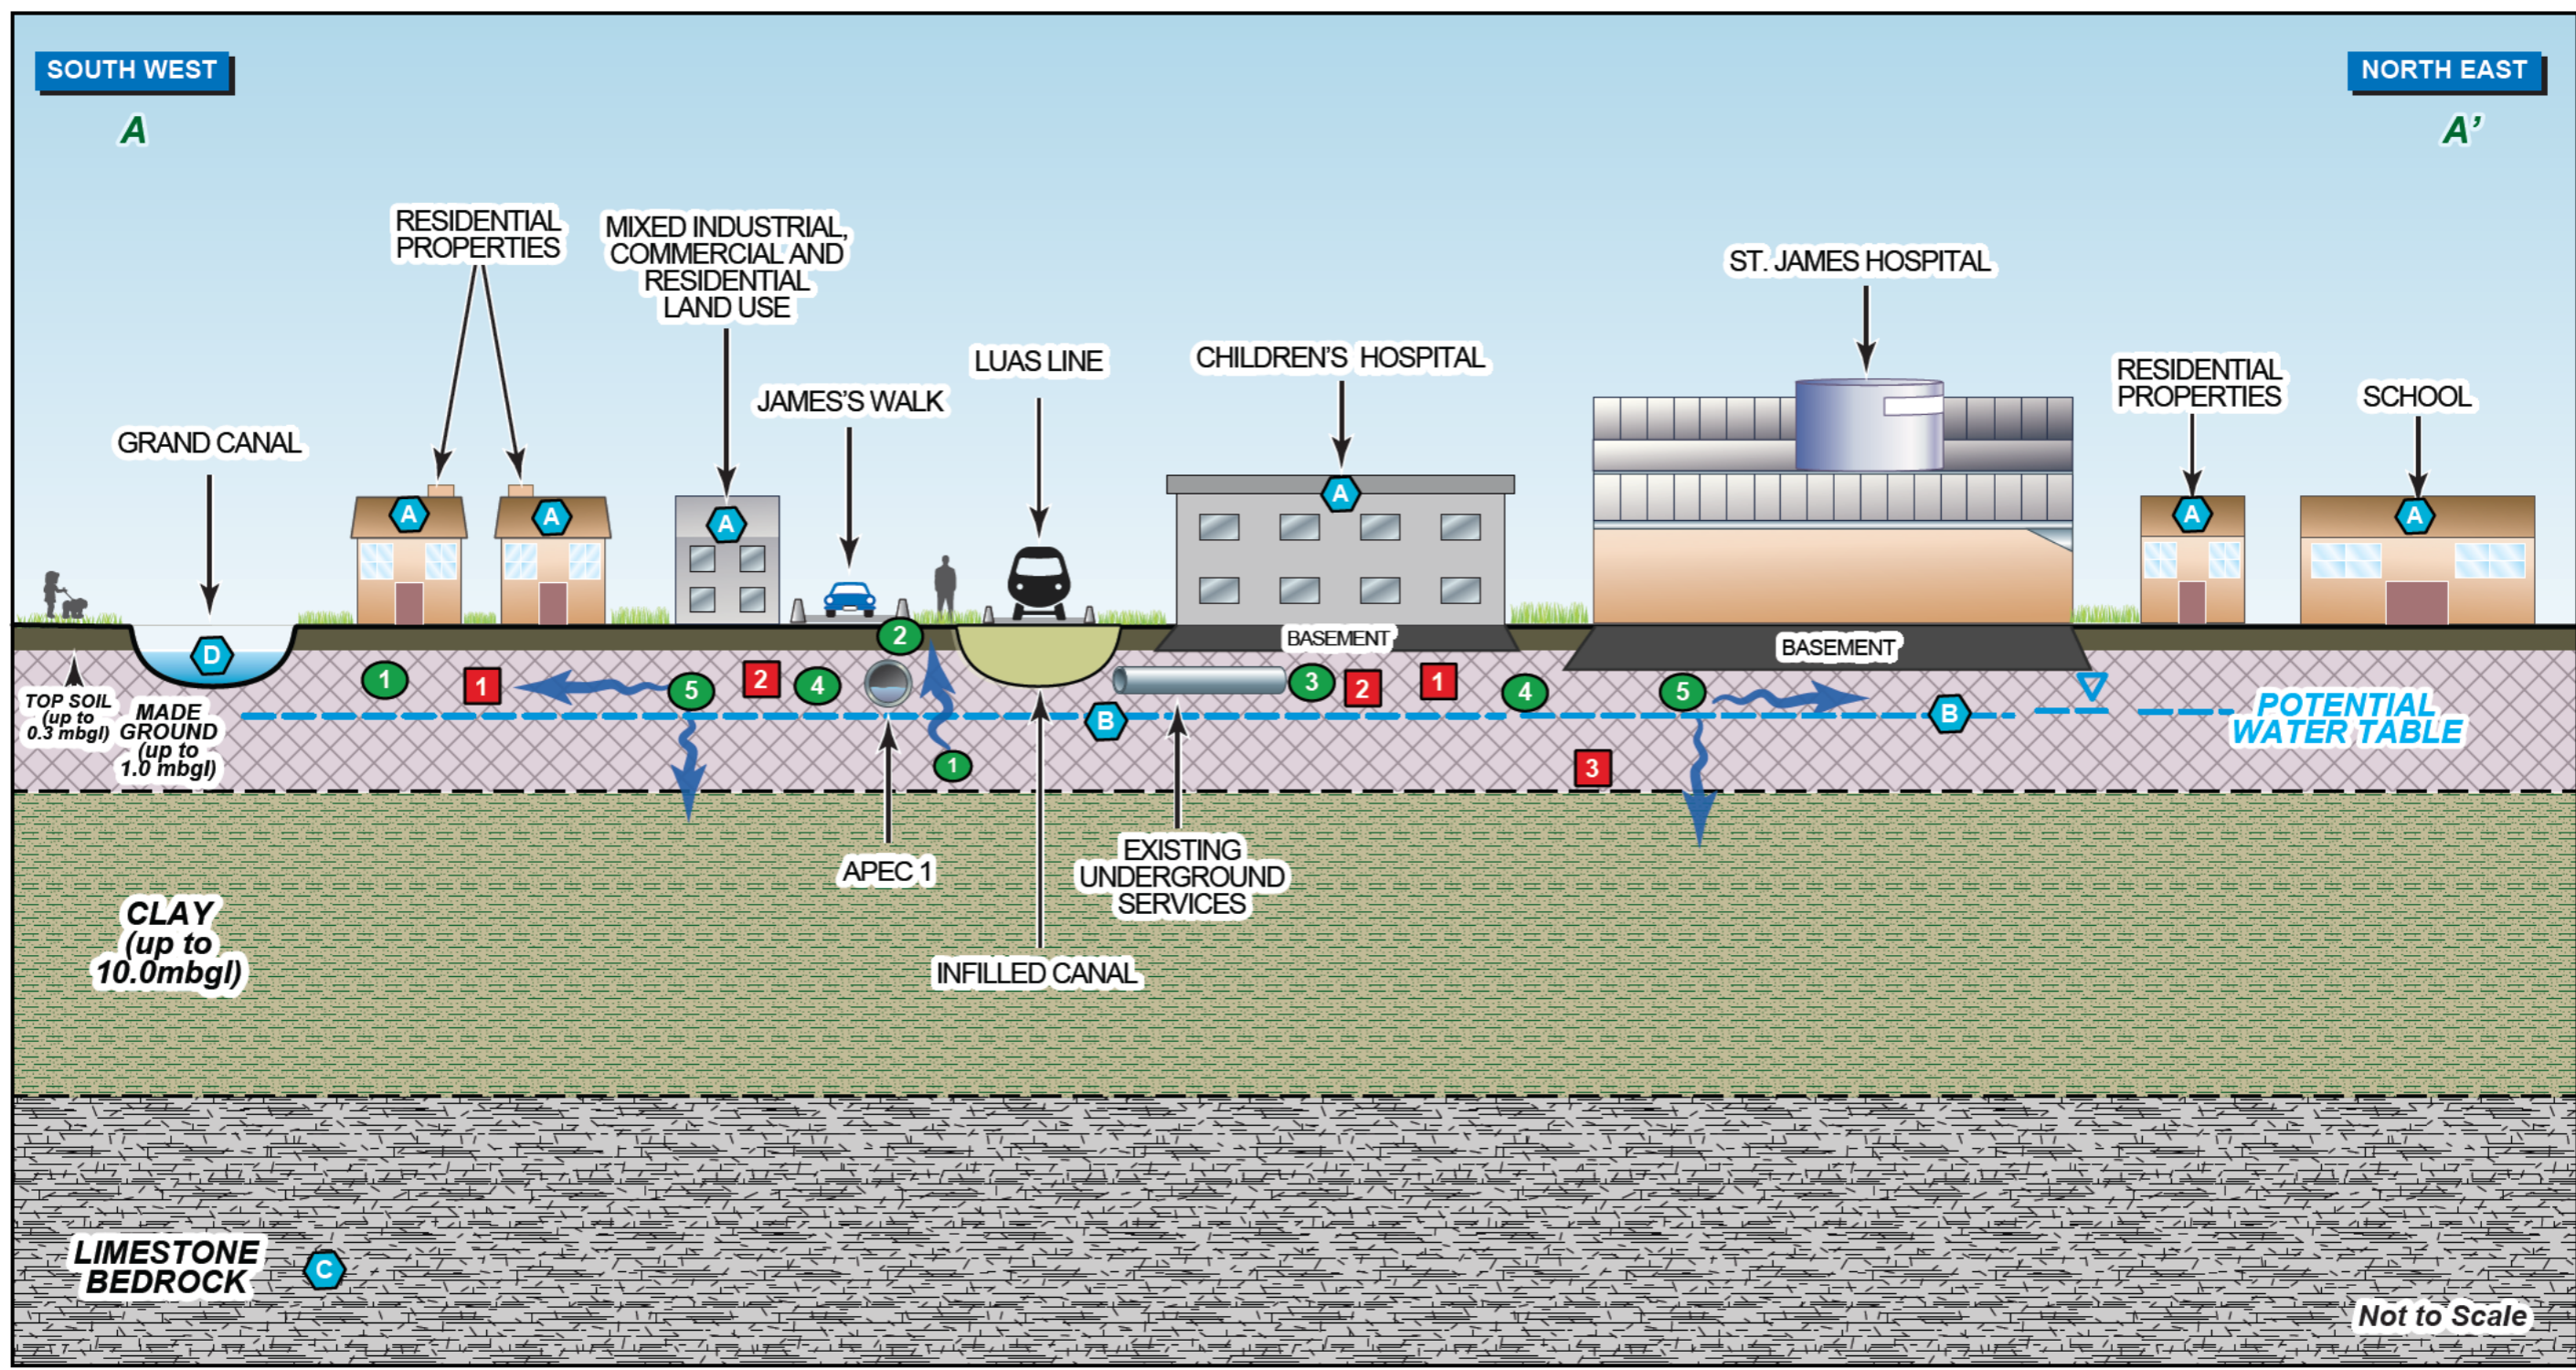
Figure 3. Conceptual Site Model

SOURCES

- 1** GROUND GAS
- 2** NON-VOLATILE CONTAMINANTS IN SOIL
- 3** CONTAMINANTS IN GROUNDWATER

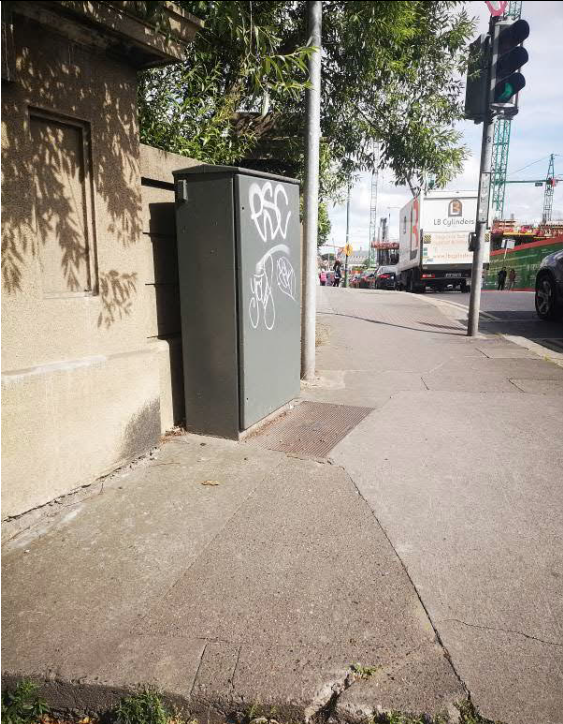
<p>Description Services located immediately west of the APEC on the junction of James's Walk.</p>

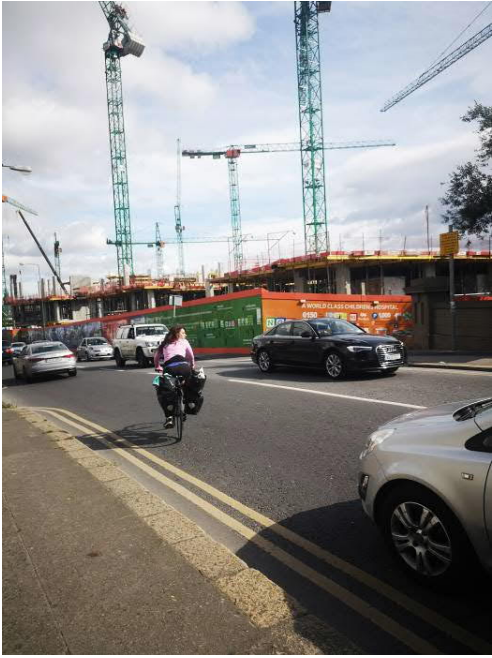
<p>Description: Immediately north of the APEC is the construction site of the new National Children's Hospital.</p>

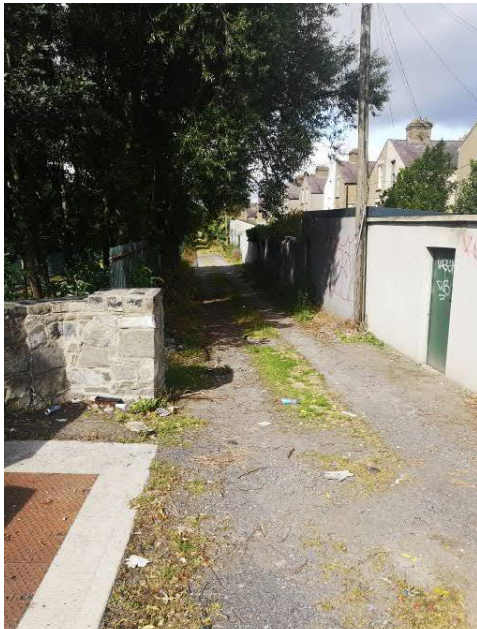
Description: Small track along the cable route to the west of the APEC. Residential houses and gardens are to the north of the cable route and the Luas line and grassy areas are to the south.

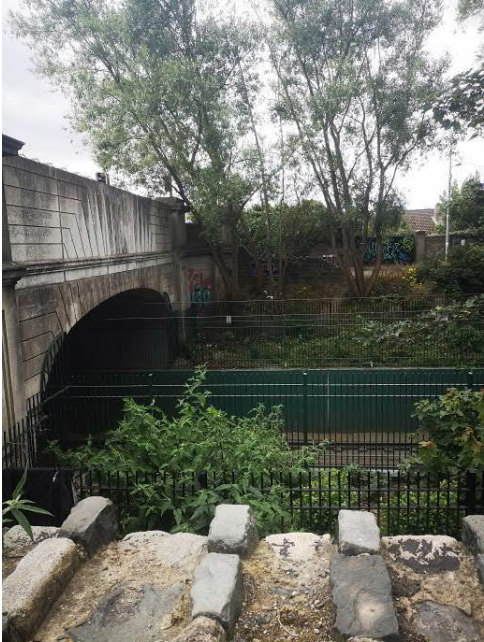
Description Bridge at the junction, Luas line running beneath the bridge, with some vegetation either side.

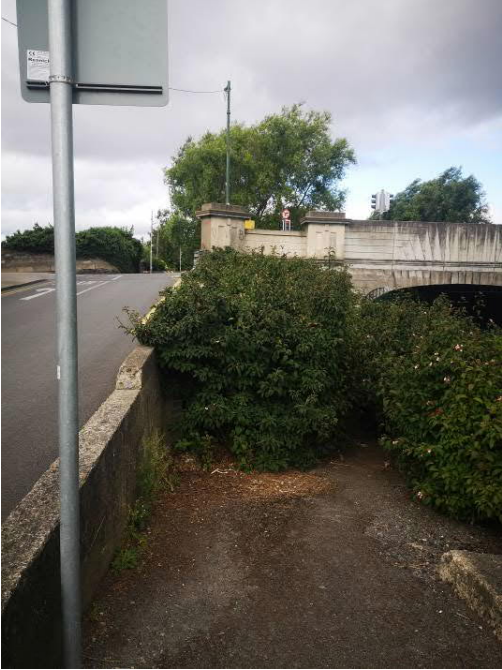
Description Location of the APEC from the east.

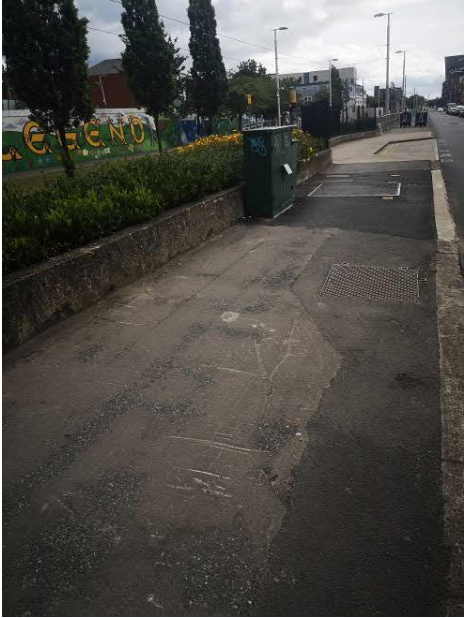
Description: Services and pavement along the eastern cable route along James's Walk and the Luas line to the north of the cable route.

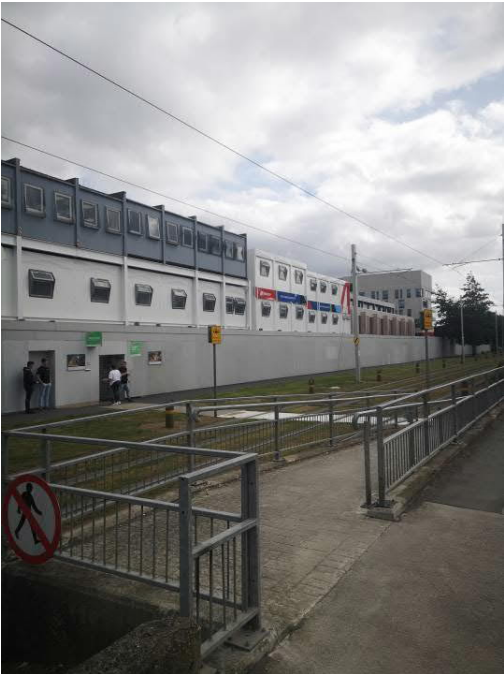
Description: Portacabins associated with St James's Hospital located north of the eastern cable route.
