# Preliminary Site Assessment

Site 32 Harold's Cross - Ringsend 110 kV

Electricity Supply Board

Project number: PR-427640\_ACM\_RP\_ENV\_048\_2

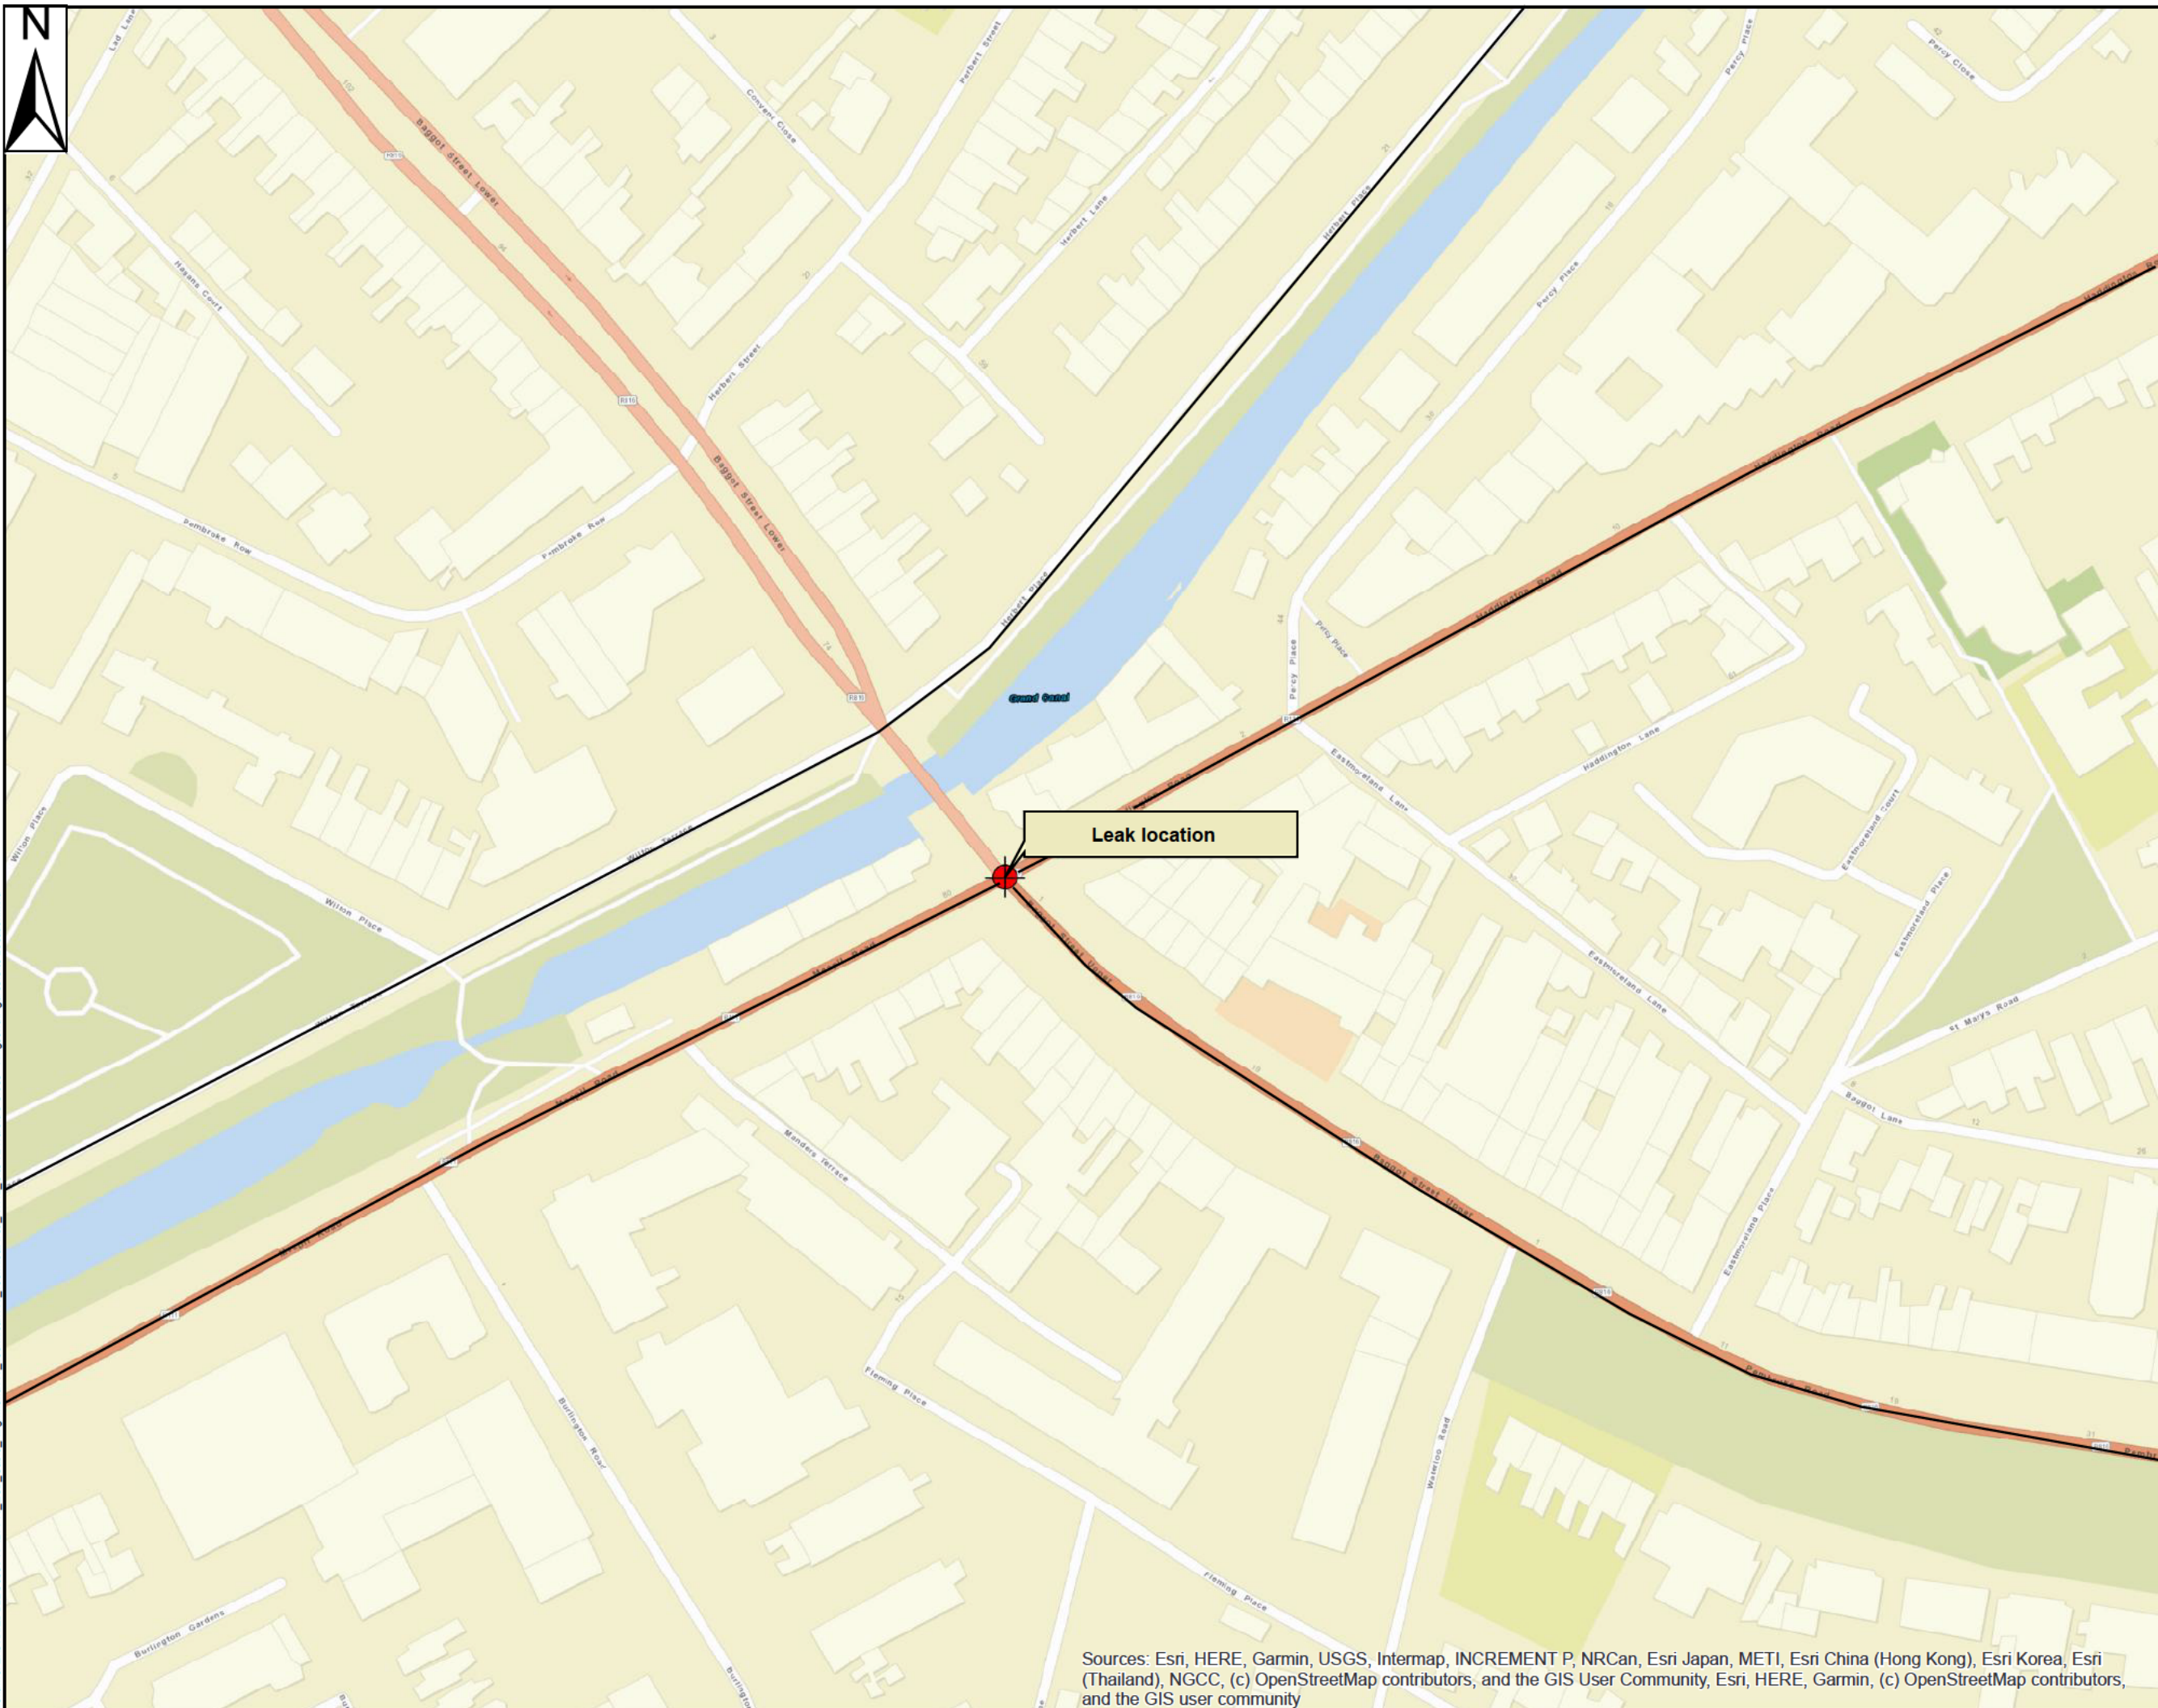
Figure 2. Areas of Potential Environmental Concern

Based on the assessment works completed, the primary Area of Potential Environmental Concern (APEC) for this site comprises the leak location identified by ESB. This is presented in Figure 2 and a description is provided in Table 6.

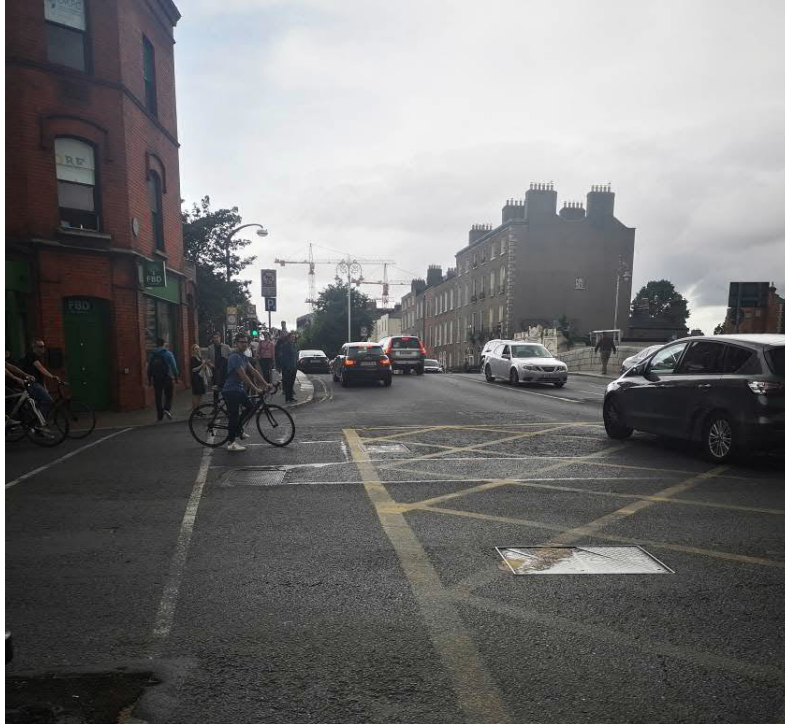
**Description**  
Location of the APEC  
at the junction of  
Haddington Road and  
Baggot Street.

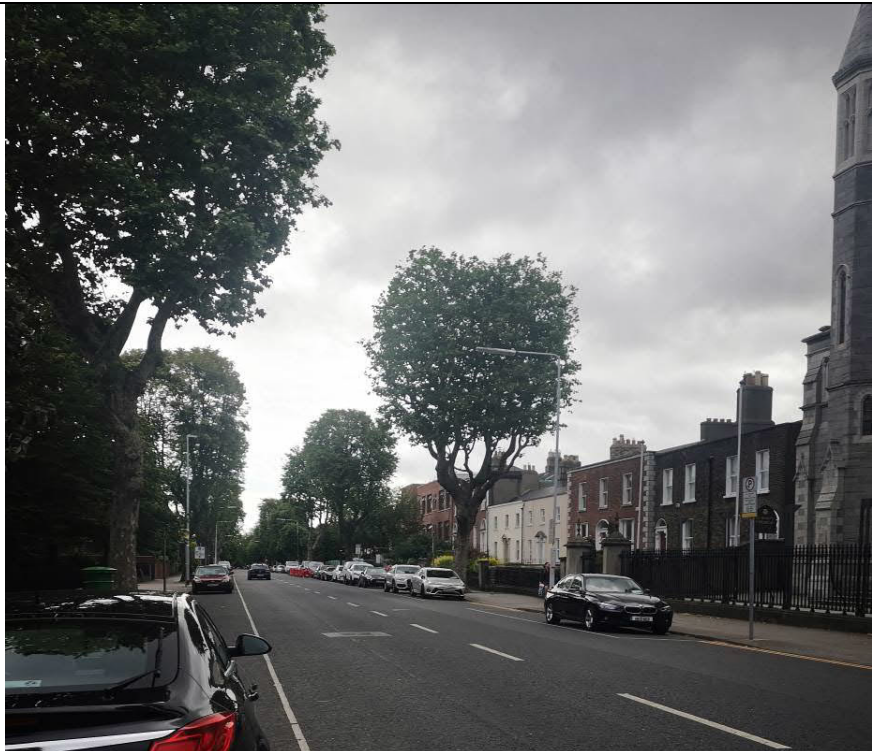
**Description:**  
Residential properties  
on the Haddington  
Road along the eastern  
cable route of the site.

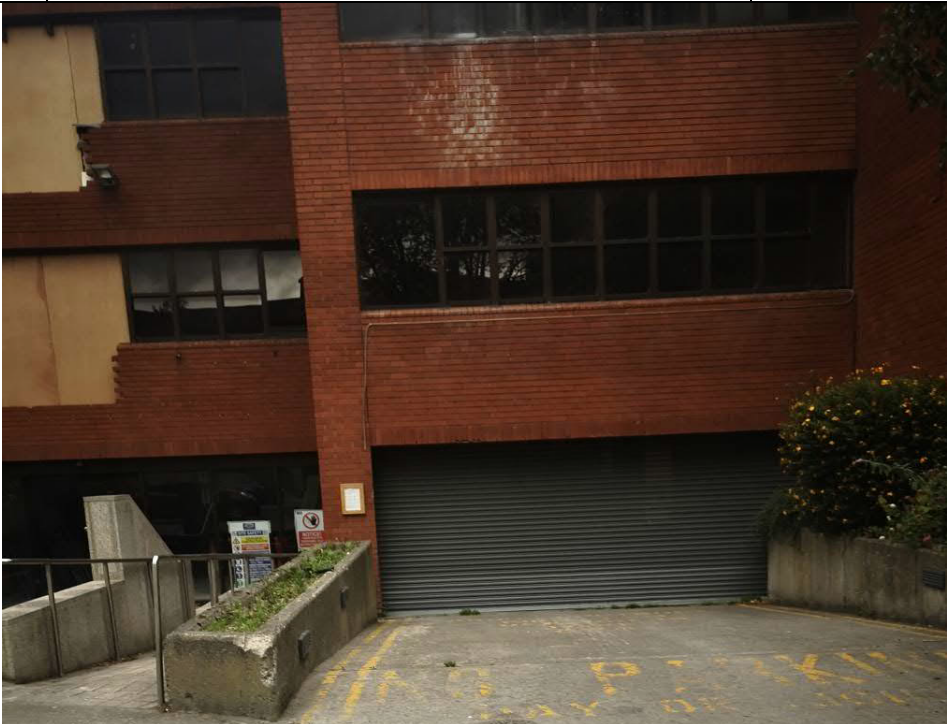
<b>Description</b> Car park with basement along Haddington Road to the north of the eastern cable route of the site. Evidence of fire damage was noted.

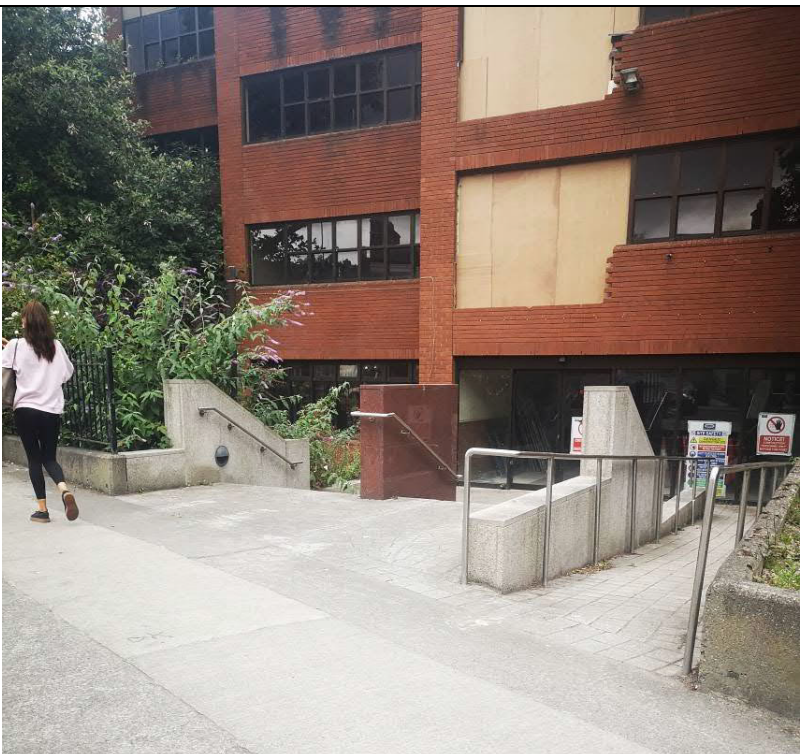
<b>Description:</b> Car park with basement along Haddington Road to the north of the eastern cable route of the site. Evidence of fire damage was noted.

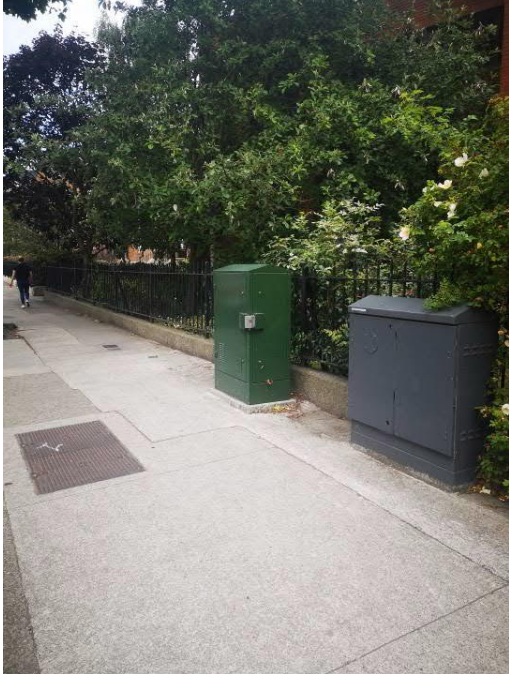
<b>Description</b> Services at the boundary of the eastern cable route of the site.

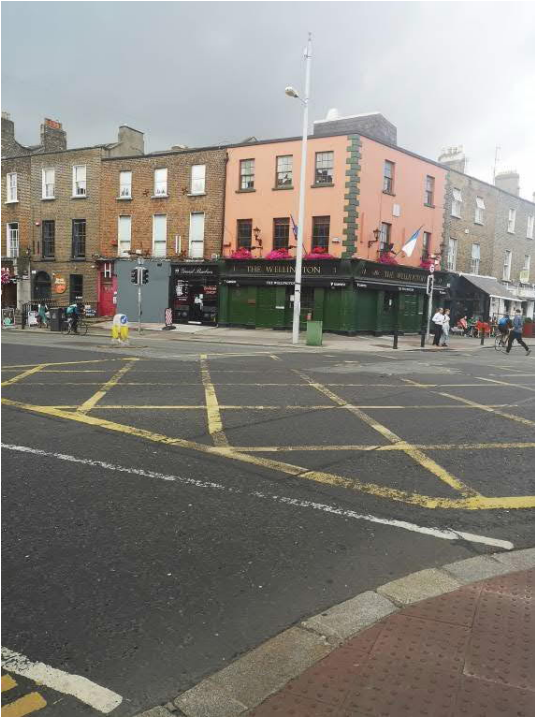
<b>Description:</b> The APEC from the eastern cable route. The APEC is the location of a busy traffic intersection.

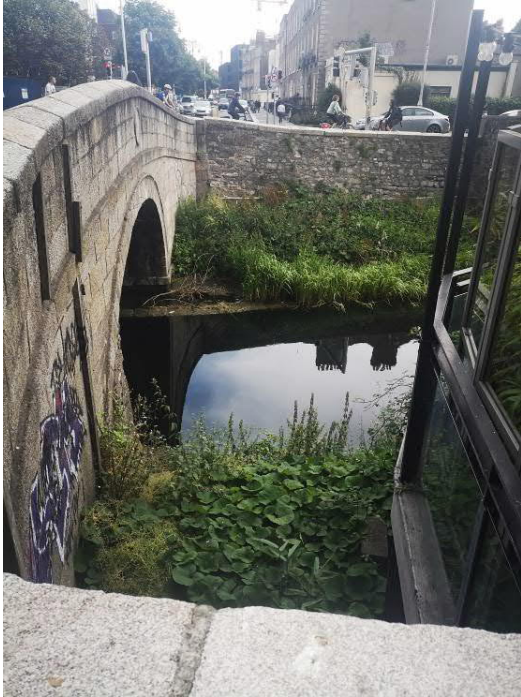
<b>Description:</b> View North of Grand Canal, APEC is located to the right of the image.

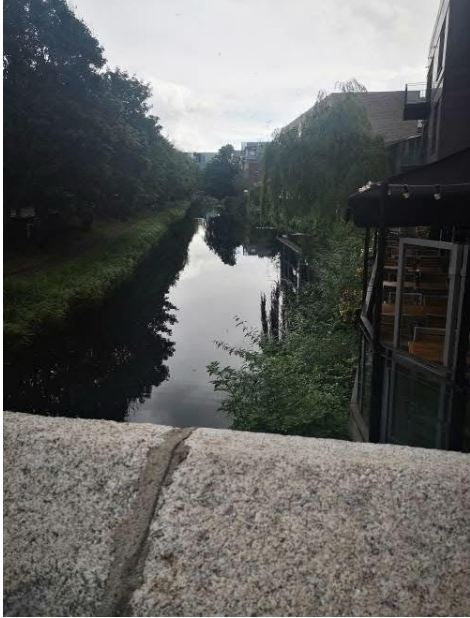
<b>Description</b> The Grand Canal adjacent to the eastern cable line of the site.

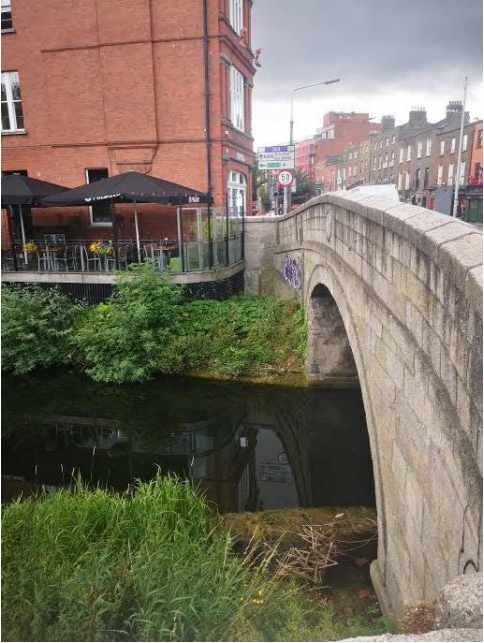
<b>Description:</b> Grand Canal the location of the APEC is to the northeast.

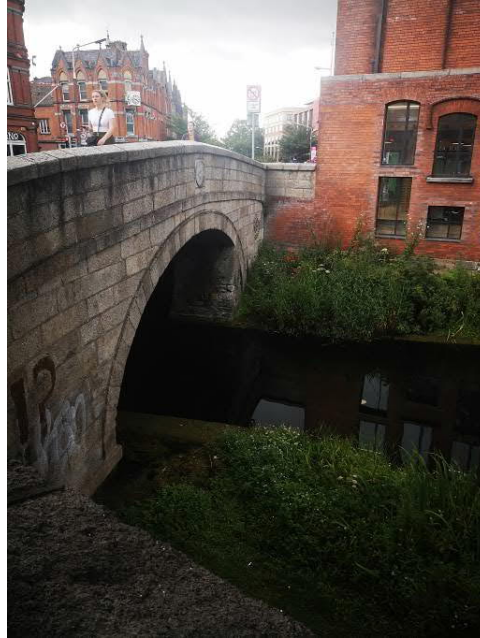
**Description**  
Grand Canal, the location of the APEC is to the northwest.

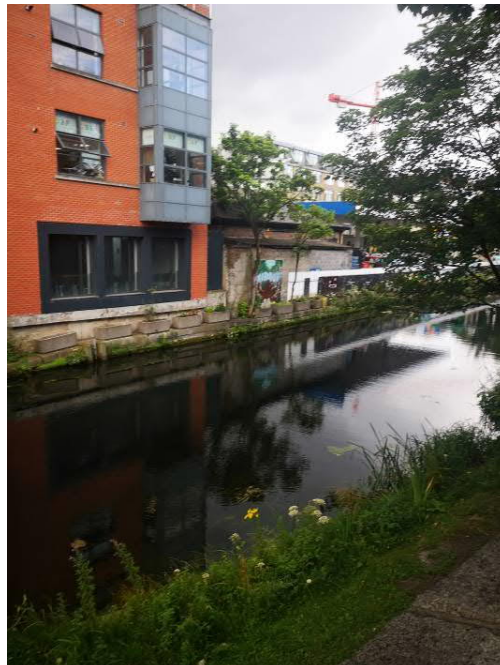
**Description:**  
Grand Canal along the western cable route of the site.

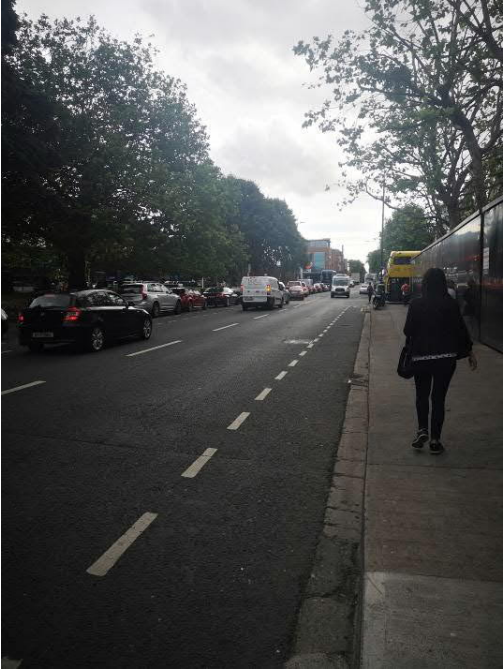
<b>Description</b> Mespil Road along the western cable route of the site.

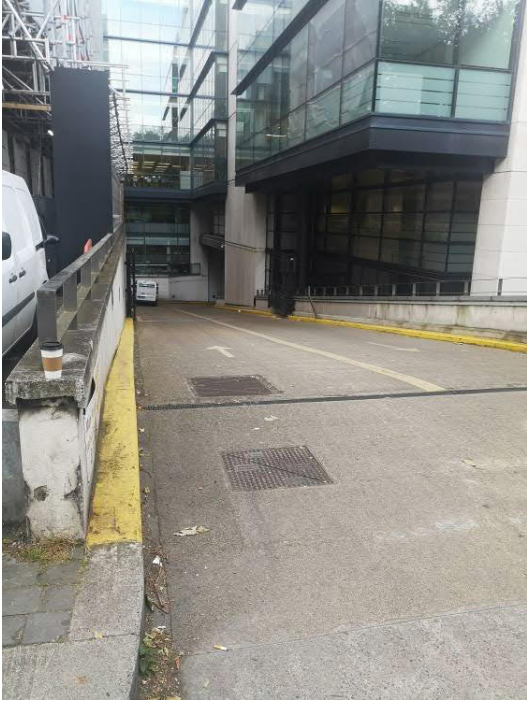
<b>Description:</b> Basement associated with the Mespil Hotel south of the western cable route.

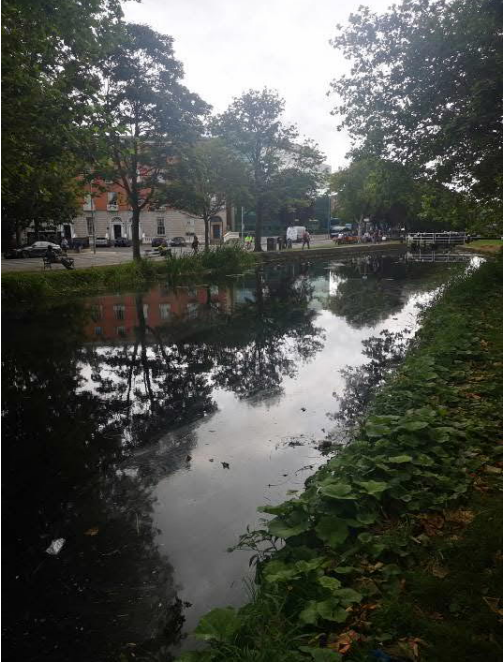
<b>Description</b> Grand Canal on the western cable route.
