# Preliminary Site Assessment

Site 36 Inchicore - Marrowbone Lane 38 kV

Electricity Supply Board

Project number: PR-427640\_ACM\_RP\_ENV\_053\_0

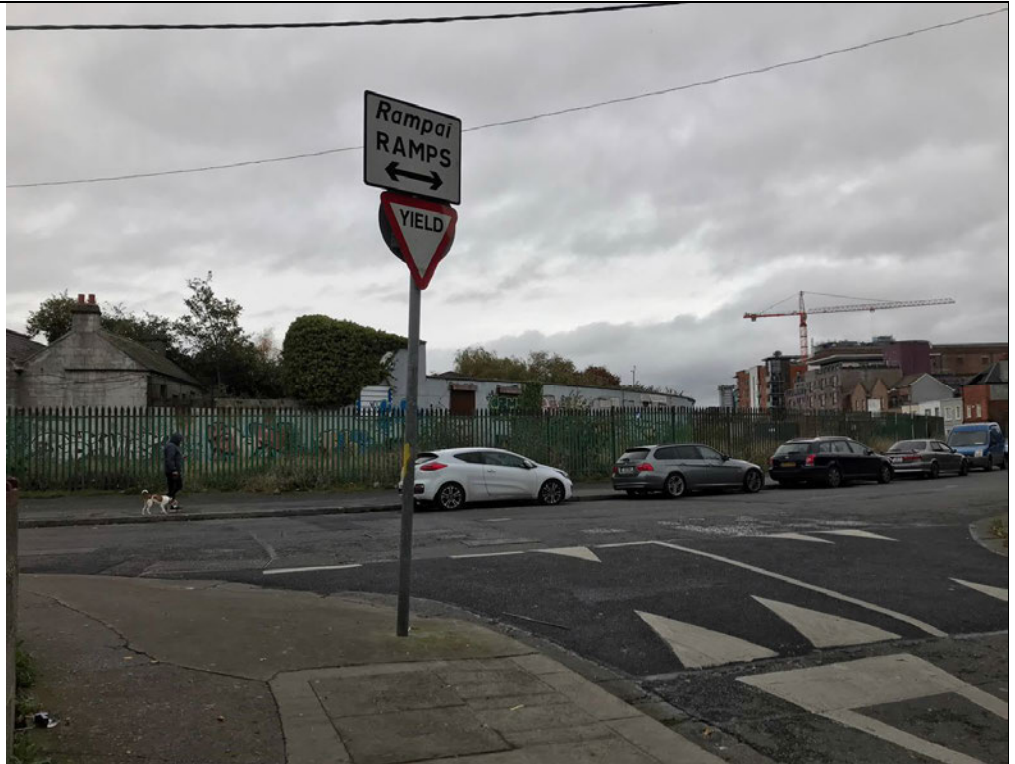
<b>Photo No.</b> <b>1</b>	<b>Date:</b> 01/11/2019
<b>Direction Photo Taken:</b>  North	
<b>Description:</b>  North facing view showing the potential leak location and abandoned field fence on background. Potential leak location is located at the intersection between Our Lady's Rd and James's Walk Street.

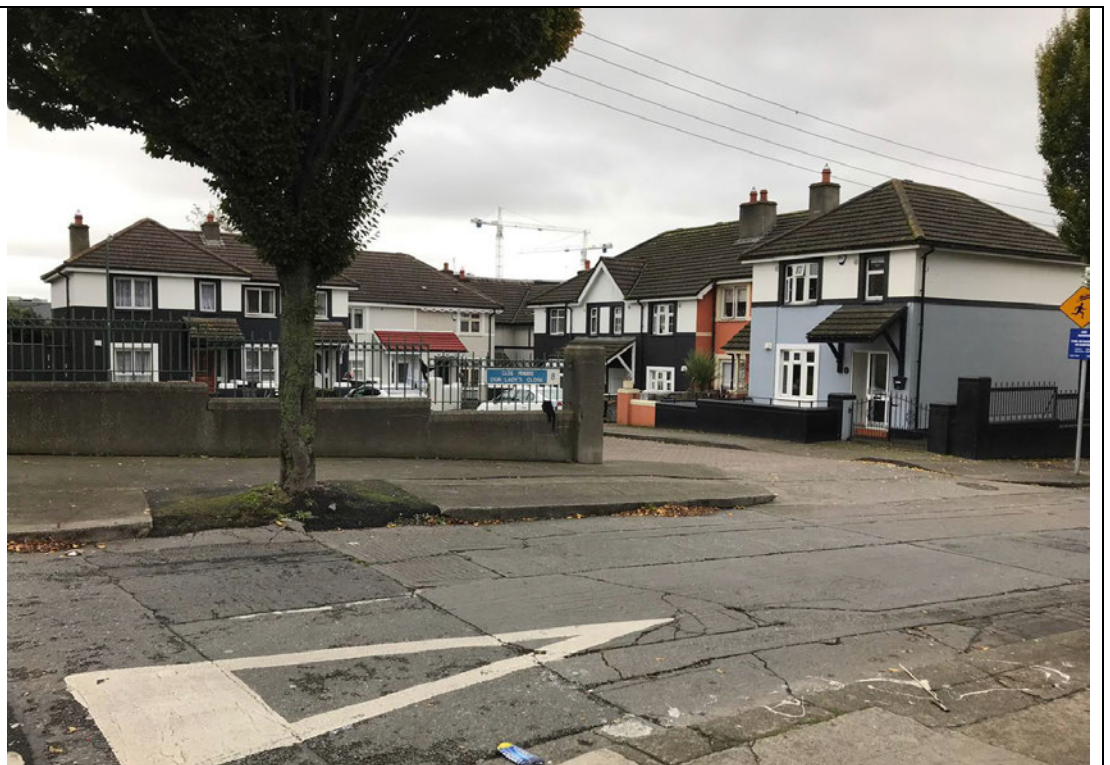
<b>Photo No.</b> <b>2</b>	<b>Date:</b> 01/11/2019
<b>Direction Photo Taken:</b>  East	
<b>Description:</b>  East facing view of residential houses adjacent to the potential leak location and cracked asphalt in the vicinity of the intersection.

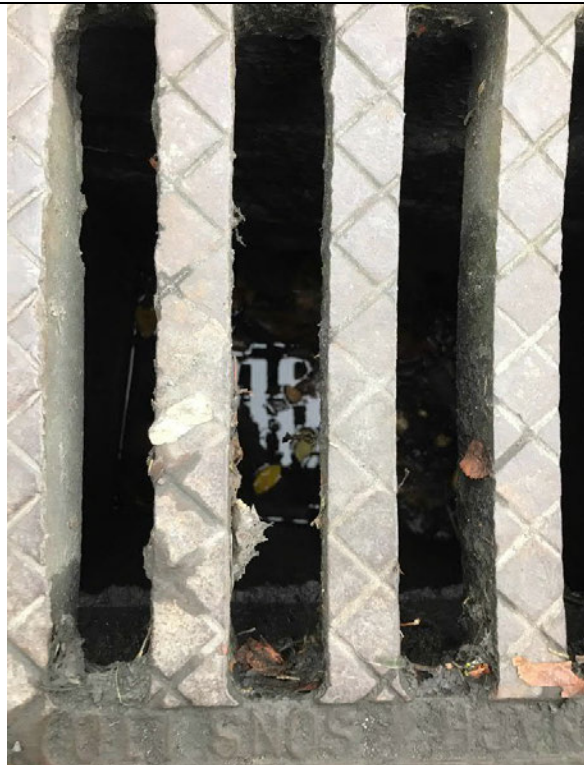
**Facility Name:**  
ESB Cable Assessment**Site Location:**  
James's Walk**Project No.**  
427640**Photo No.**  
**3****Date:**  
01/11/2019**Direction Photo Taken:****Description:**

Stormwater drain located immediately east of the potential leak location. No evidence of visual contamination was observed during the site visit.
