Site 37 Parkview to Ringsend 38 kV: Preliminary Site Assessment Report for Historic Fluid Filled Cable Loss

ESB Engineering and Major Projects

19126590.37.A.1

20 April 2020

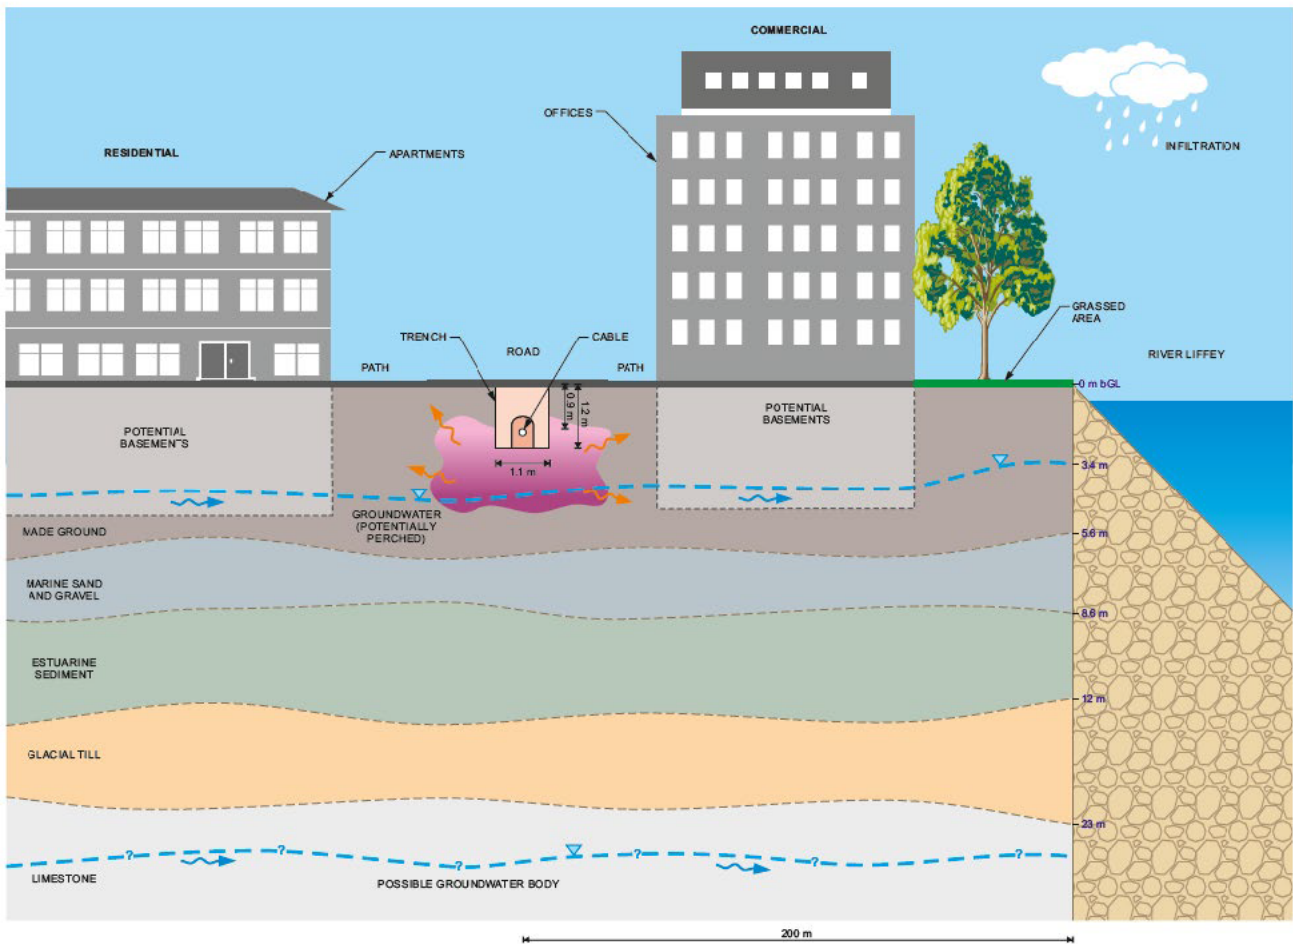
Figure 1: Preliminary CSM for Site 37 (Parkview to Ringsend).

All of the pollutant linkages assessed were classified as either low or very low risk. Golder do not recommend any follow up actions in relation to the 100 L cable fluid loss that occurred in 2008 (and was promptly repaired) at that site.

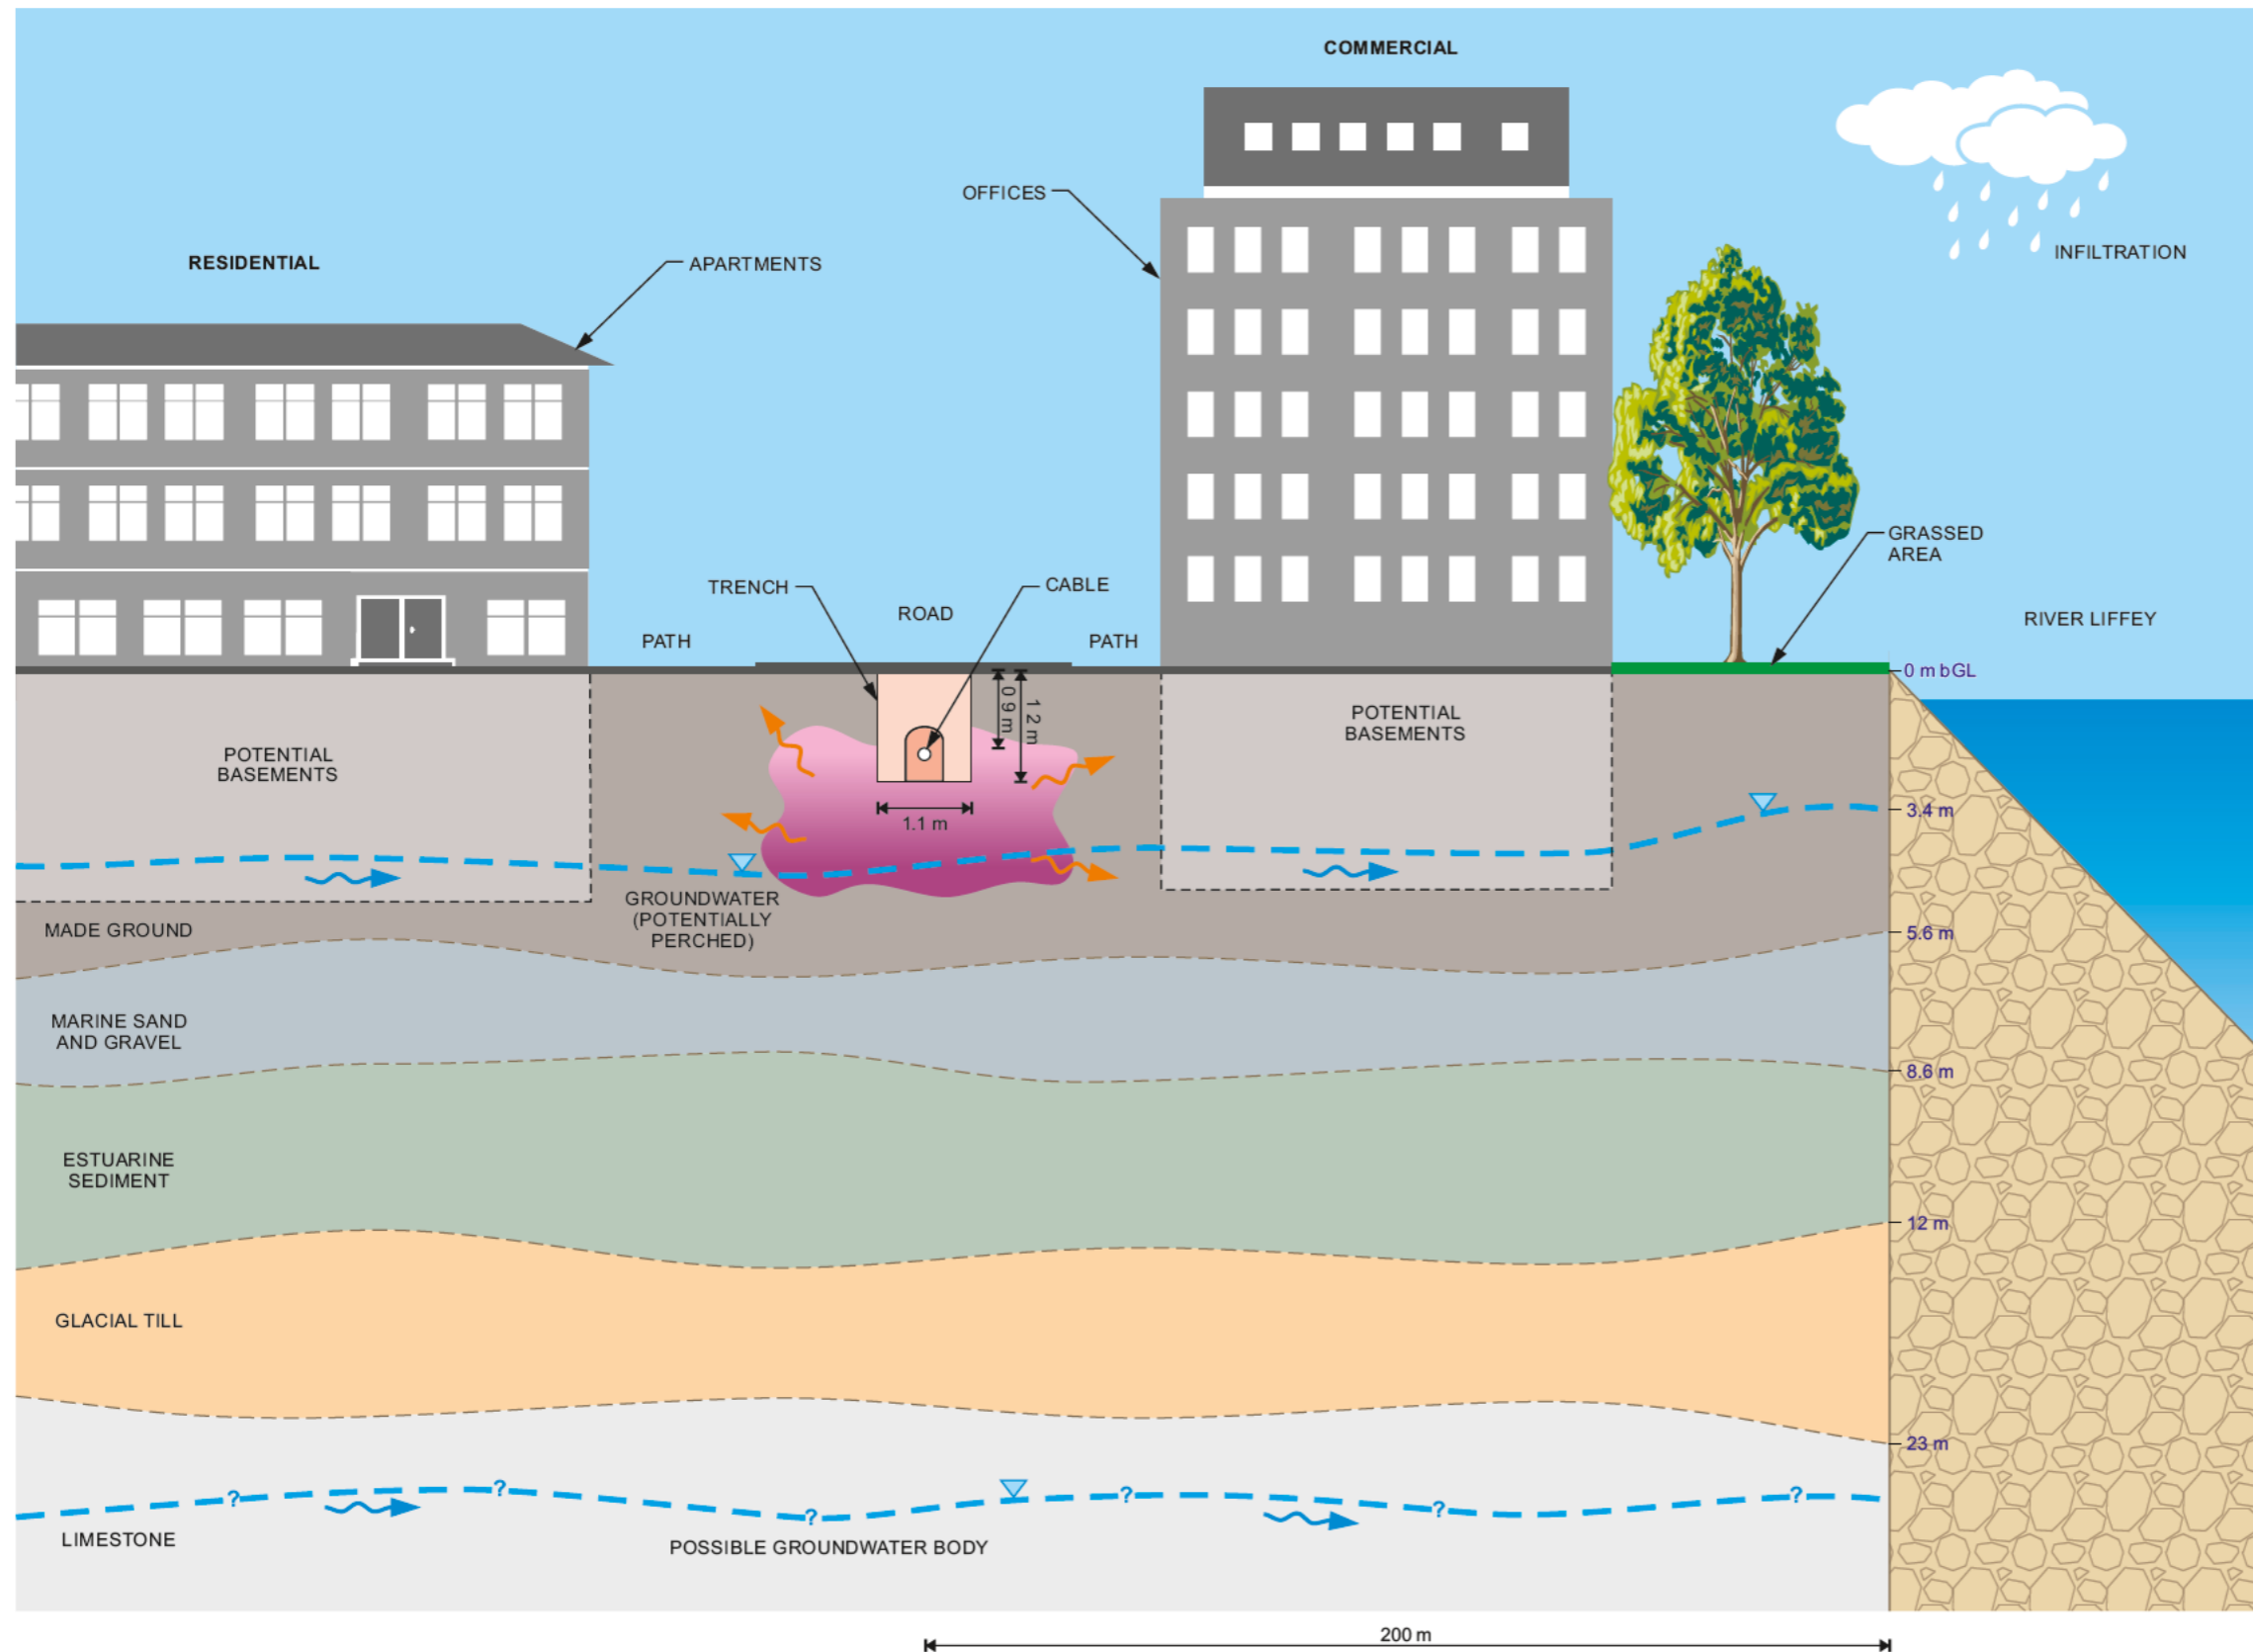
SHEET TITLE
PRELIMINARY CSM (IDENTIFYING POLLUTANT LEAKAGES)
PARKVIEW TO RINGSEND (SITE 37)

Potential pollutant linkages that could impact the identified receptors have been identified in the Preliminary CSM assessment. These linkages have been identified where the source, pathway, and receptor are all present and potentially viable, and the source is therefore considered to pose a theoretical risk to the identified receptors. However, we note that all the risks are classified as low or very low risk. This is primarily related to the small volume of cable fluid lost (100L) and the time elapsed since the loss (11 years) giving potential for LAB to degrade in the subsurface. Golder consider that only residual pockets of LAB, if any, will remain at this time from this loss.

At present Golder consider that the potential vertical migration of LAB through the Till to be low. A borehole in close proximity to the Site suggests the Till thickness is approximately 11 m at this location. Given this thickness of impermeable material and the relatively low volume of the leak (100 L), the bedrock groundwater aquifer is considered to be at a very low risk. Shallow groundwater, likely perched or associated with the nearby River Liffey, was noted in the Made Ground in a local borehole and is not considered to be protected from migration of LNAPL/dissolved phase LAB by the Till. However, given the relatively low volume of the leak and that LAB is not classified as hazardous in groundwater, this is also considered a very low risk.

The River Liffey is the nearest surface water receptor to the Site at 100 m north of the indicated leak location. Given the low volume of the leak and time elapsed since the leak the residual risk to the River Liffey is very low.

The availability of lateral preferential pathways along ducting routes is most likely to be the primary migration pathway for this Site due to the presence of industrial and residential properties within close proximity of the indicative leak location. However, the low volume of the leak means that it is unlikely to have migrated a significant distance from the indicated leak location and given the time since the loss occurred it has had significant time to degrade in the subsurface.

Due to the known leak of a small volume of cable fluid into the permeable cable trench material, the repair of the location within one month, and the unknown characteristics (e.g. permeability) of the Made Ground likely to be surrounding the trench, there potential risks identified to receptors are either low or very low. Golder does not recommend any follow up actions in relation to the loss of 100L of cable fluid in 2008 at this site.

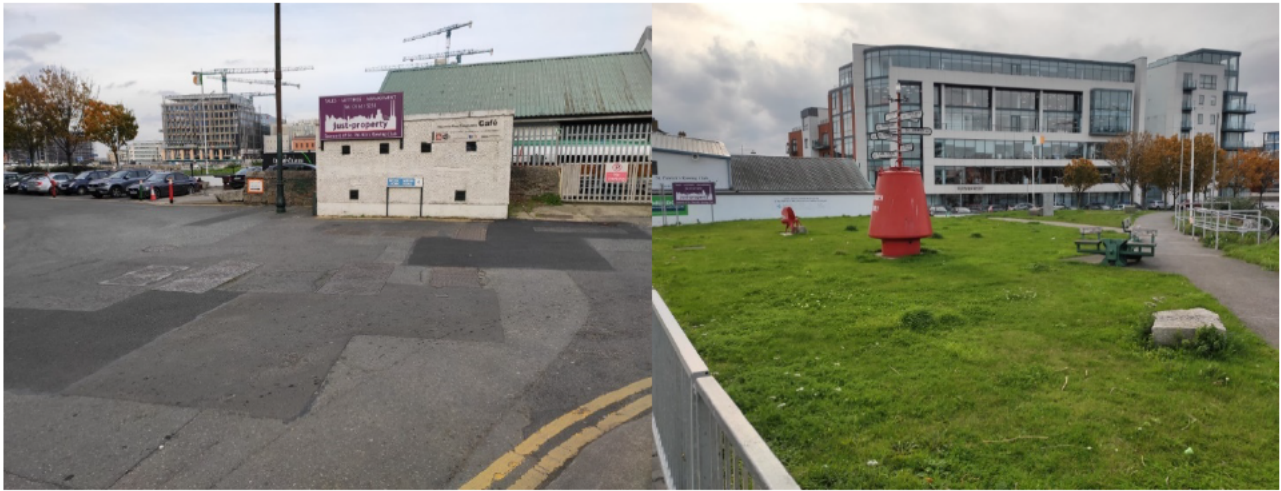
No evidence of potential contamination from cable fluid/oily substances was observed at the indicative leak location during the Site walkover. Selected photographs of potentially relevant observations made during the Site walkover are provided in APPENDIX A with commentary.

Photograph 1: Indicative leak location (Site 37) at junction of Thorncastle Street and York Road, looking north.

Photograph 2: Grassed area behind St. Patrick's Rowing Club, approx. 45 m north of Site, looking south.

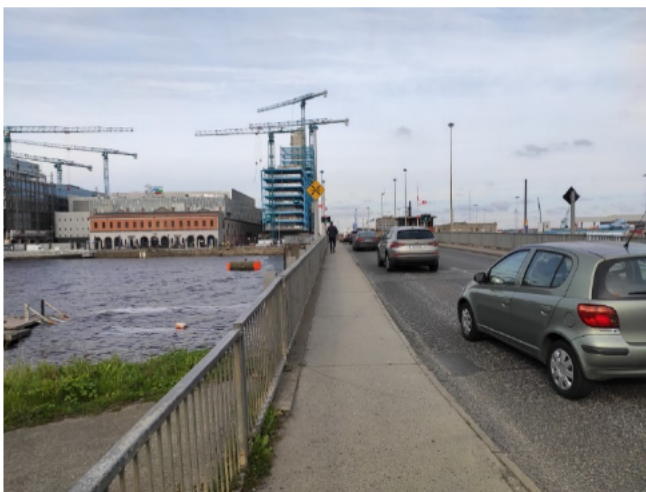
Photograph 3: East Link Toll Bridge/Tom Clarke Bridge, looking north.

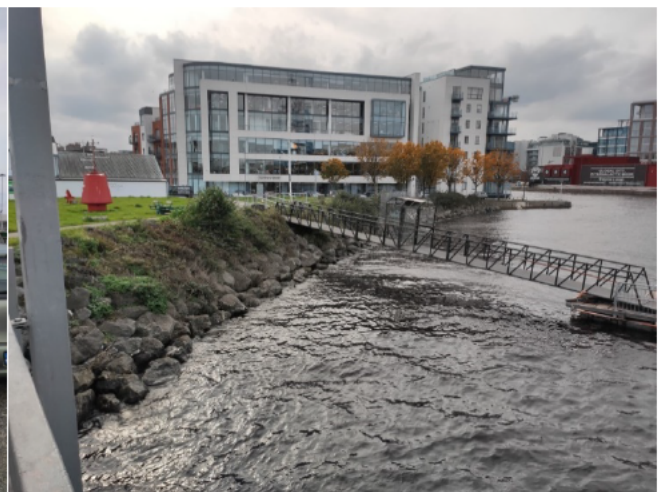
Photograph 4: Southwest bank of River Liffey behind St. Patrick's Rowing Club.

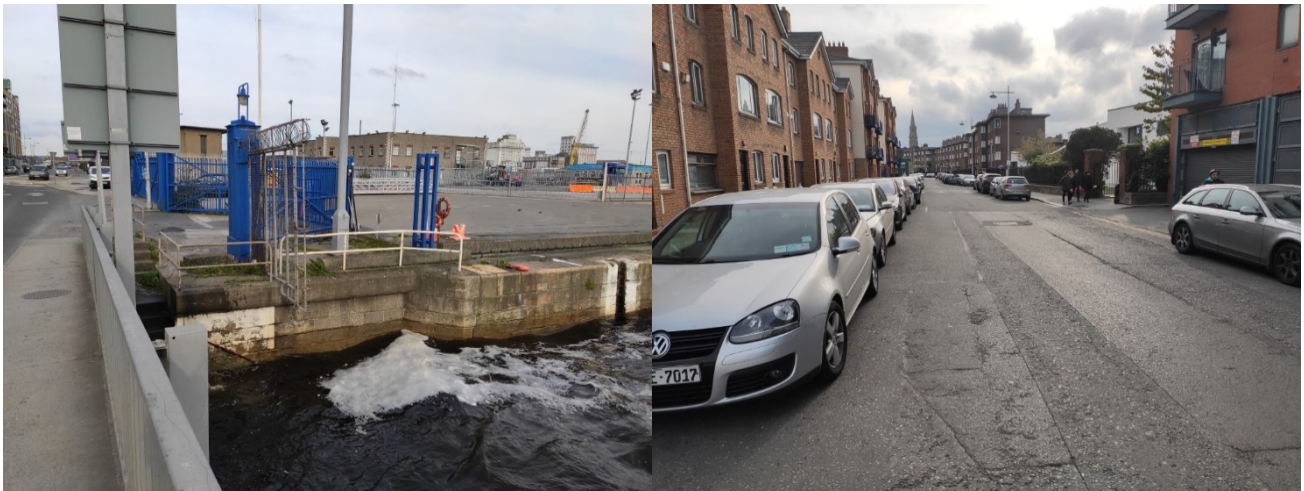
Photograph 5: Northeast bank of the River Liffey, adjacent to the East Link Toll Bridge.

Photograph 6: Looking south on Thorncastle Street from the indicative leak location.

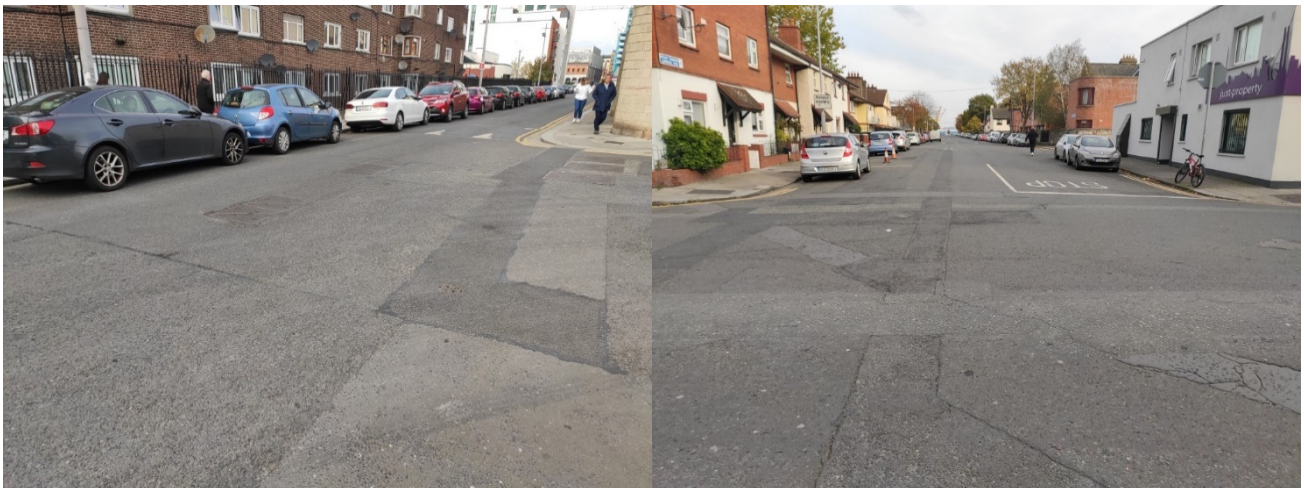
Photograph 7: Junction of Thorncastle Street and Cambridge Square, looking north.

Photograph 8: Junction of Thorncastle Street and Cambridge Road, looking east.
