ESB Engineering and Major Projects

Blackrock - Ringsend (Site ID 40)

Preliminary Environmental Site Assessment

602749 – R01 (01)

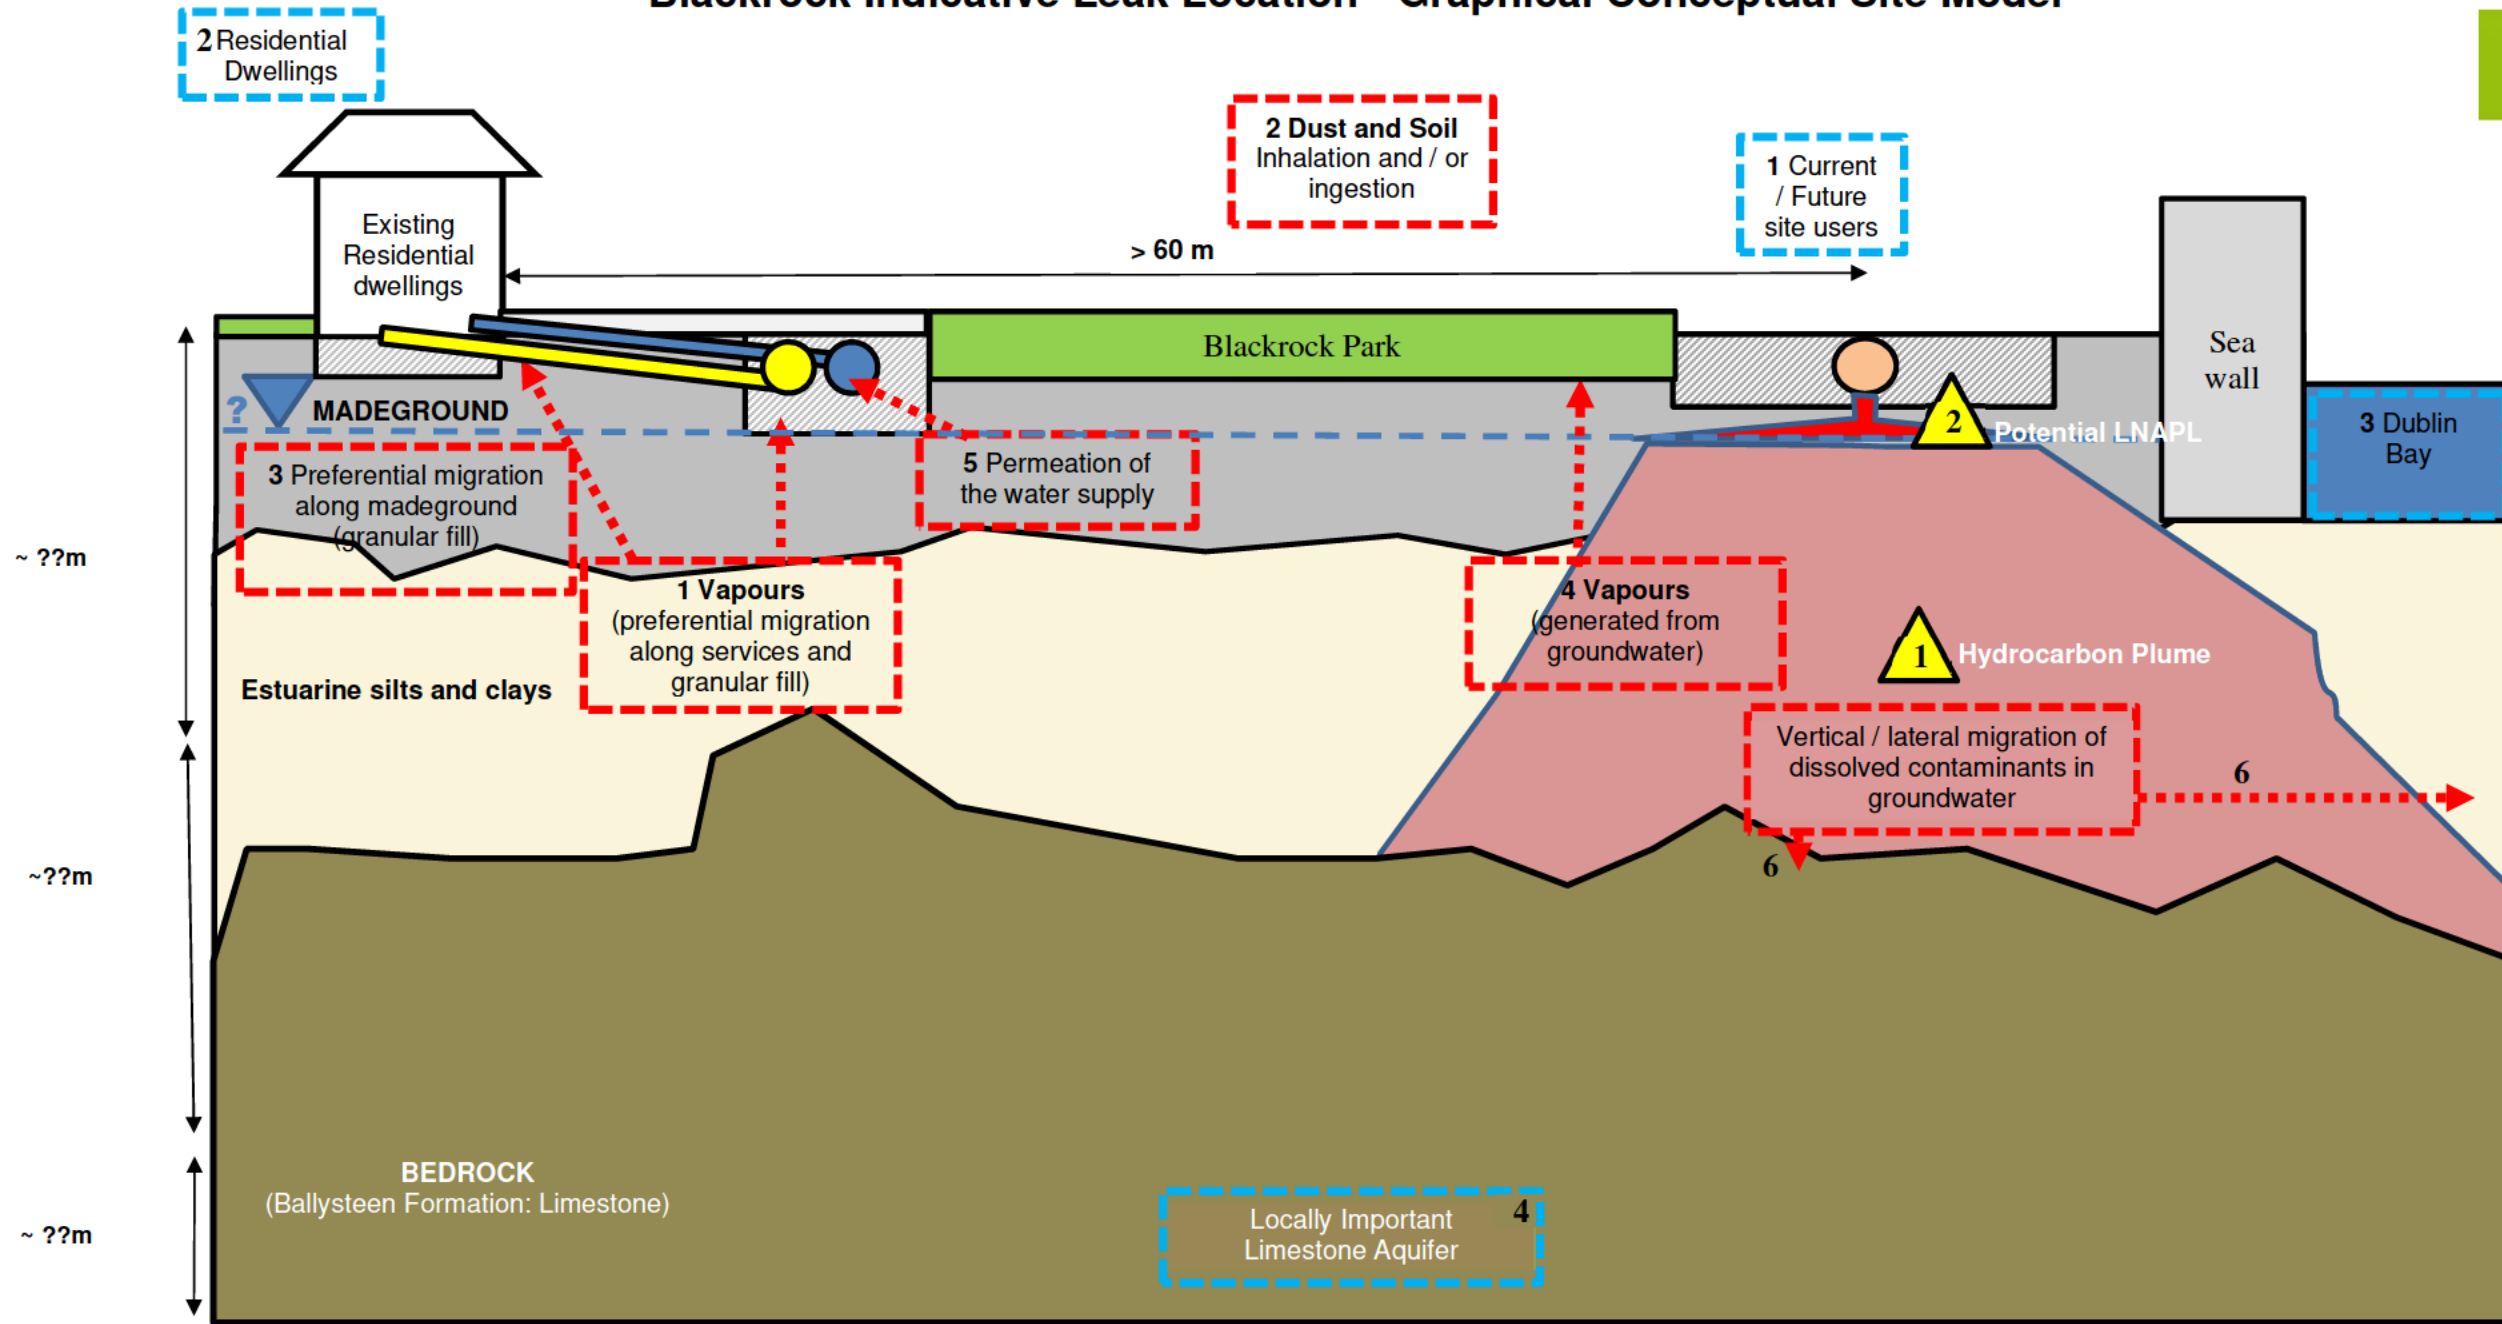
Blackrock Indicative Leak Location - Graphical Conceptual Site Model

Following the completion of a risk evaluation for the identified pollutant linkages, a potential pollutant linkage with a risk class of **MODERATE/LOW** for risks to Dublin Bay from lateral migration in groundwater has been identified. The initial CSM has identified potential pollutant linkages with a risk class of **LOW** for all other identified pollution linkages

RSK recommends further assessment to investigate and quantify potential risks to Dublin Bay from the historic spill.

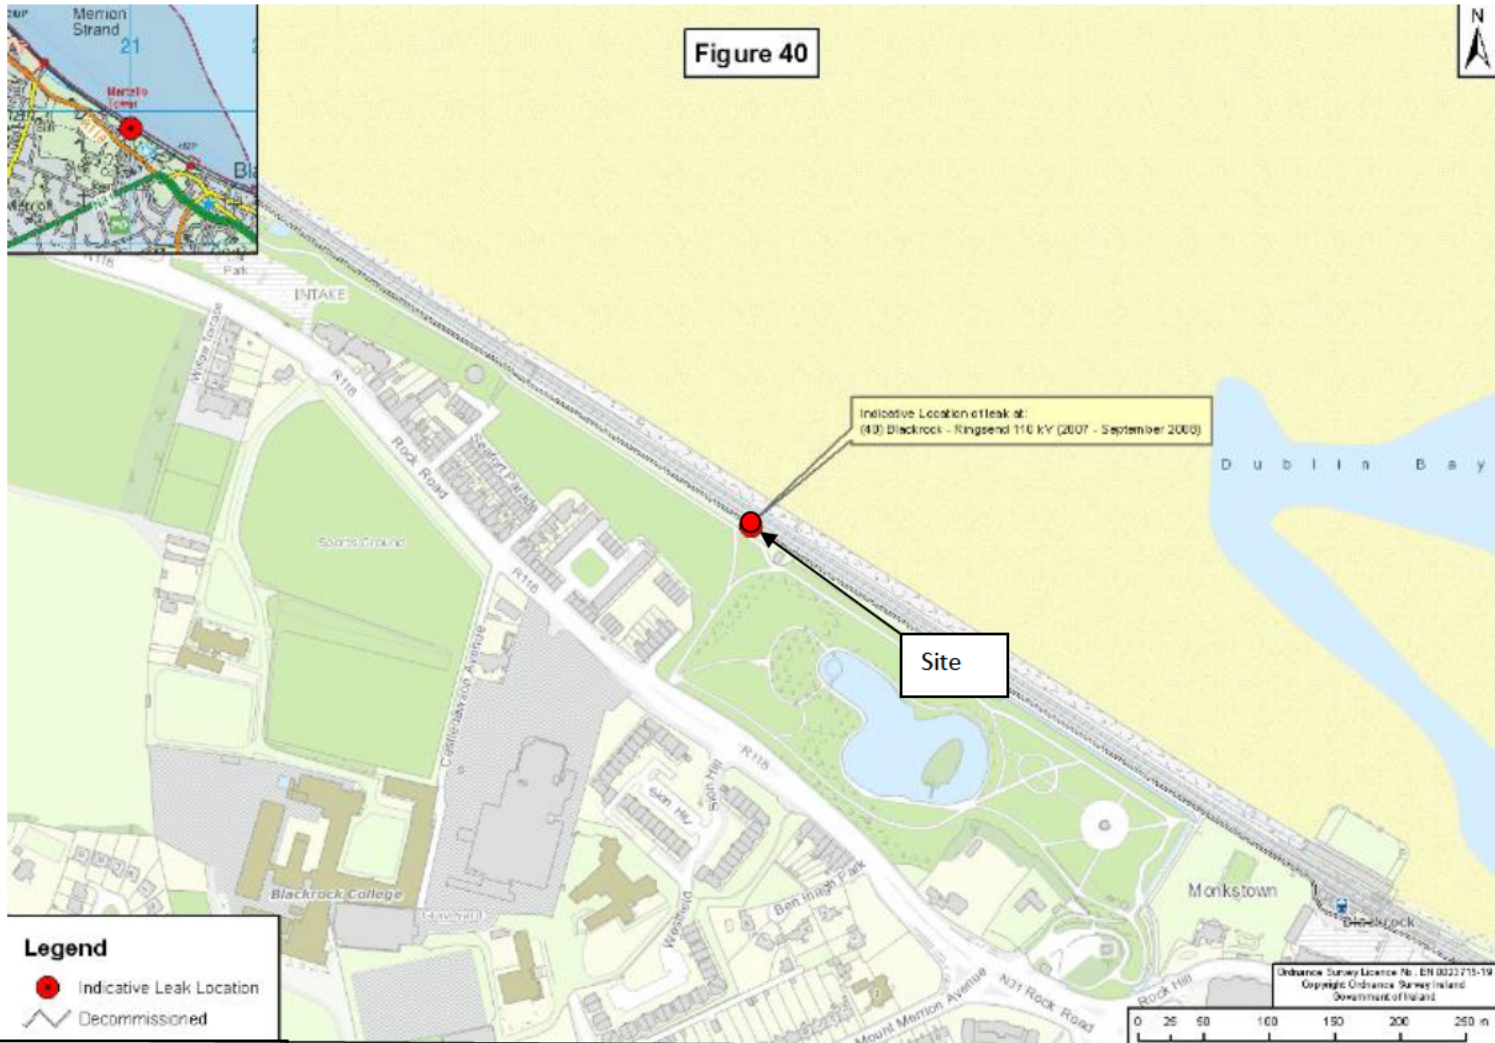
Figure 40

Indicative Location of leak at:
(40) Blackrock - Ringsend 110 KV (2007 - September 2008)

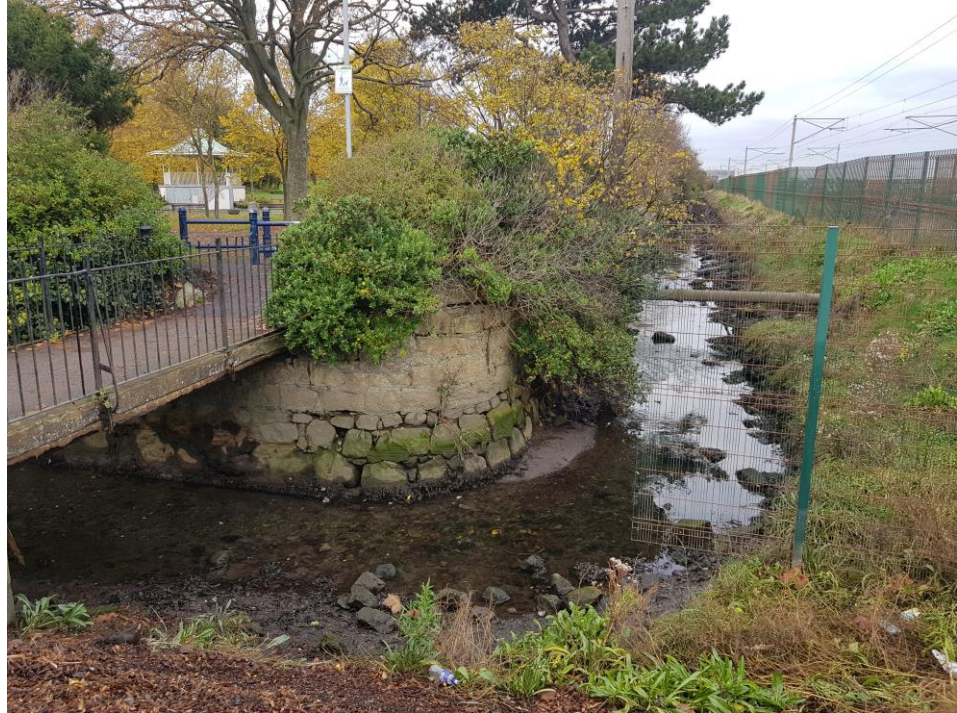
Priory Stream, at the southern extent of Blackrock Park. The stream is flowing from the left hand side of the photo, around a 90° bend, then flowing north away from the photographer. The stream is then culverted under the railway (right of photo) and into Dublin Bay.

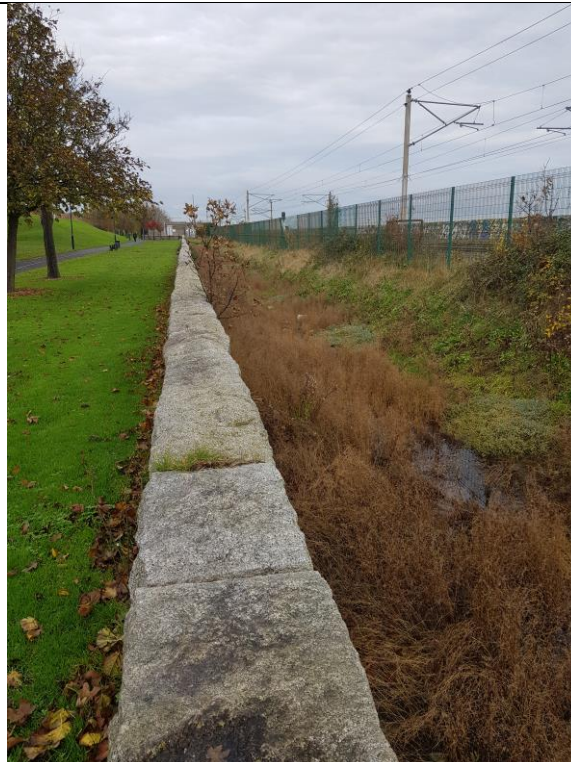
**Photo No.**
2**Date:**
November
2019**Direction Photo taken:**

View of Blackrock Park to the left of the photo, Priory Stream right of centre and the DART railway to the far right

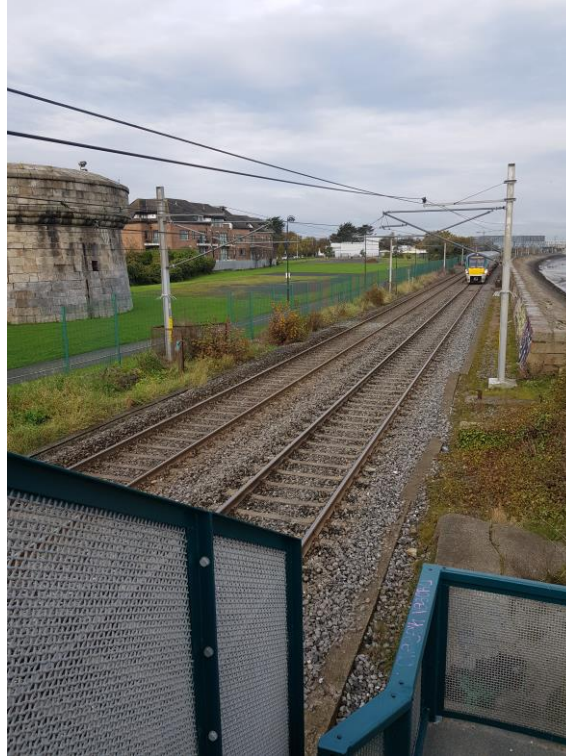
View of DART railway along which cable route is running.

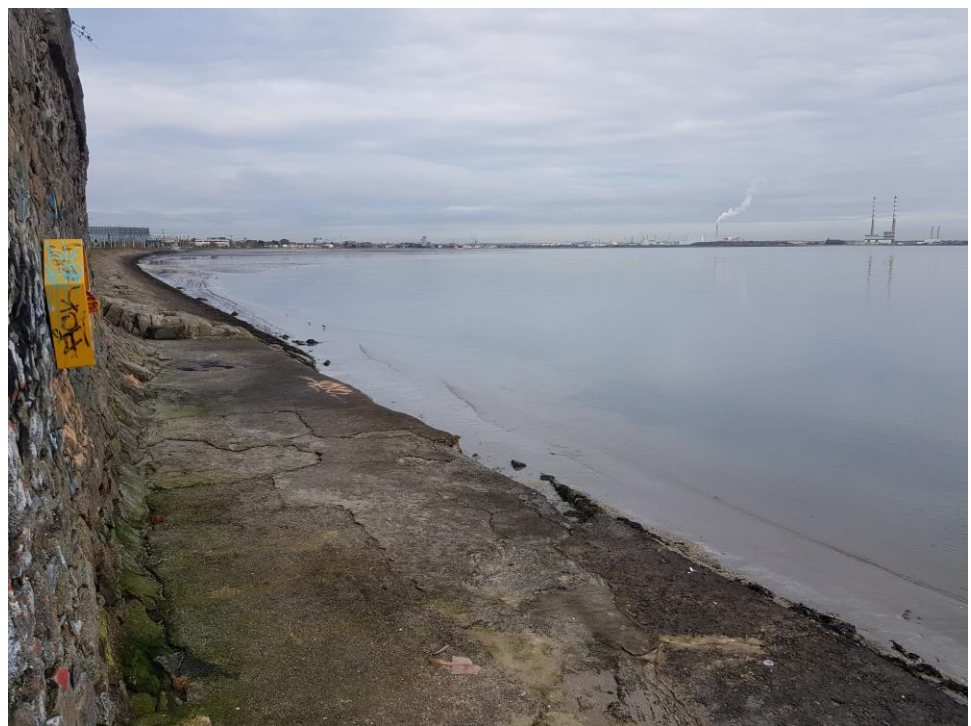
Photo No.
4

Dublin Bay, considered a sensitive receptor, located immediately adjacent to DART railway.

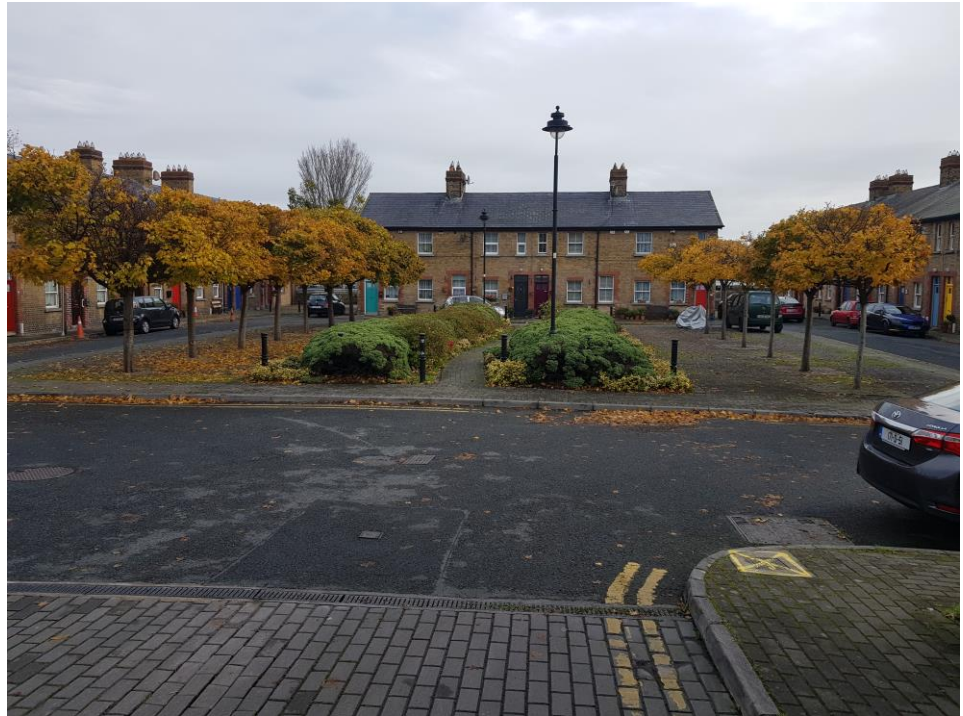
Residential properties approximately 60 m southwest of the cable leak location.

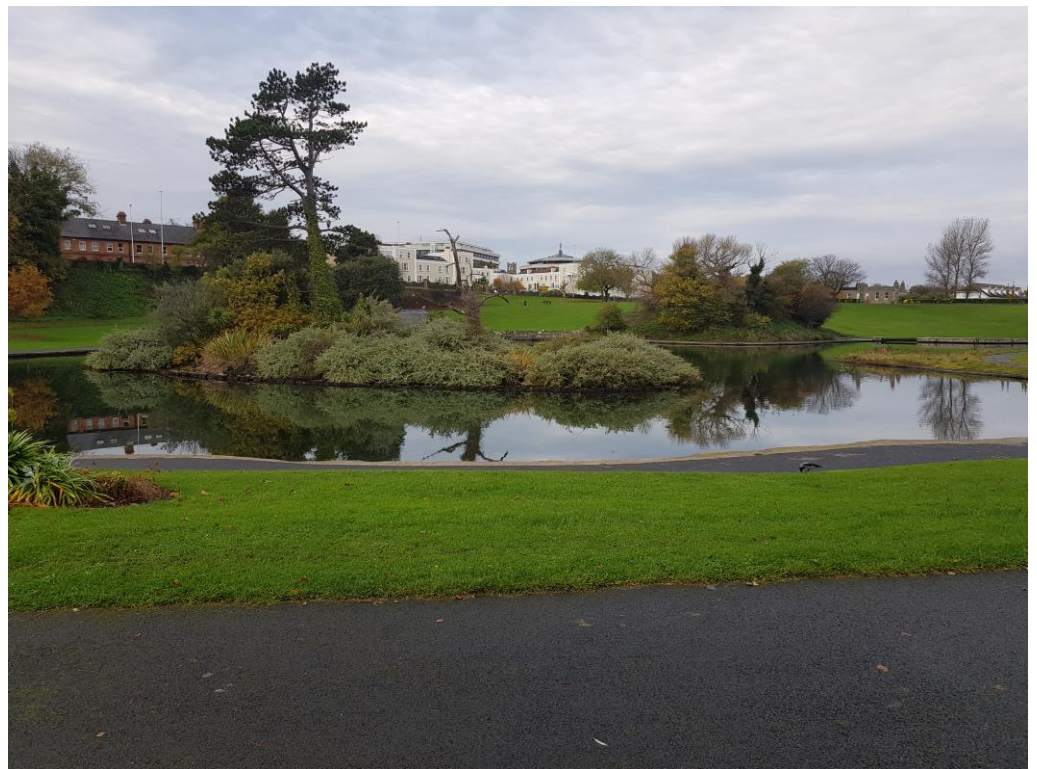
Photo No.
6

View of large pond in Blackrock Park
