ESB Engineering and Major Projects

Carrickmines - Poolbeg (Site ID 41)

Preliminary Environmental Site Assessment

602749 – R02 (01)

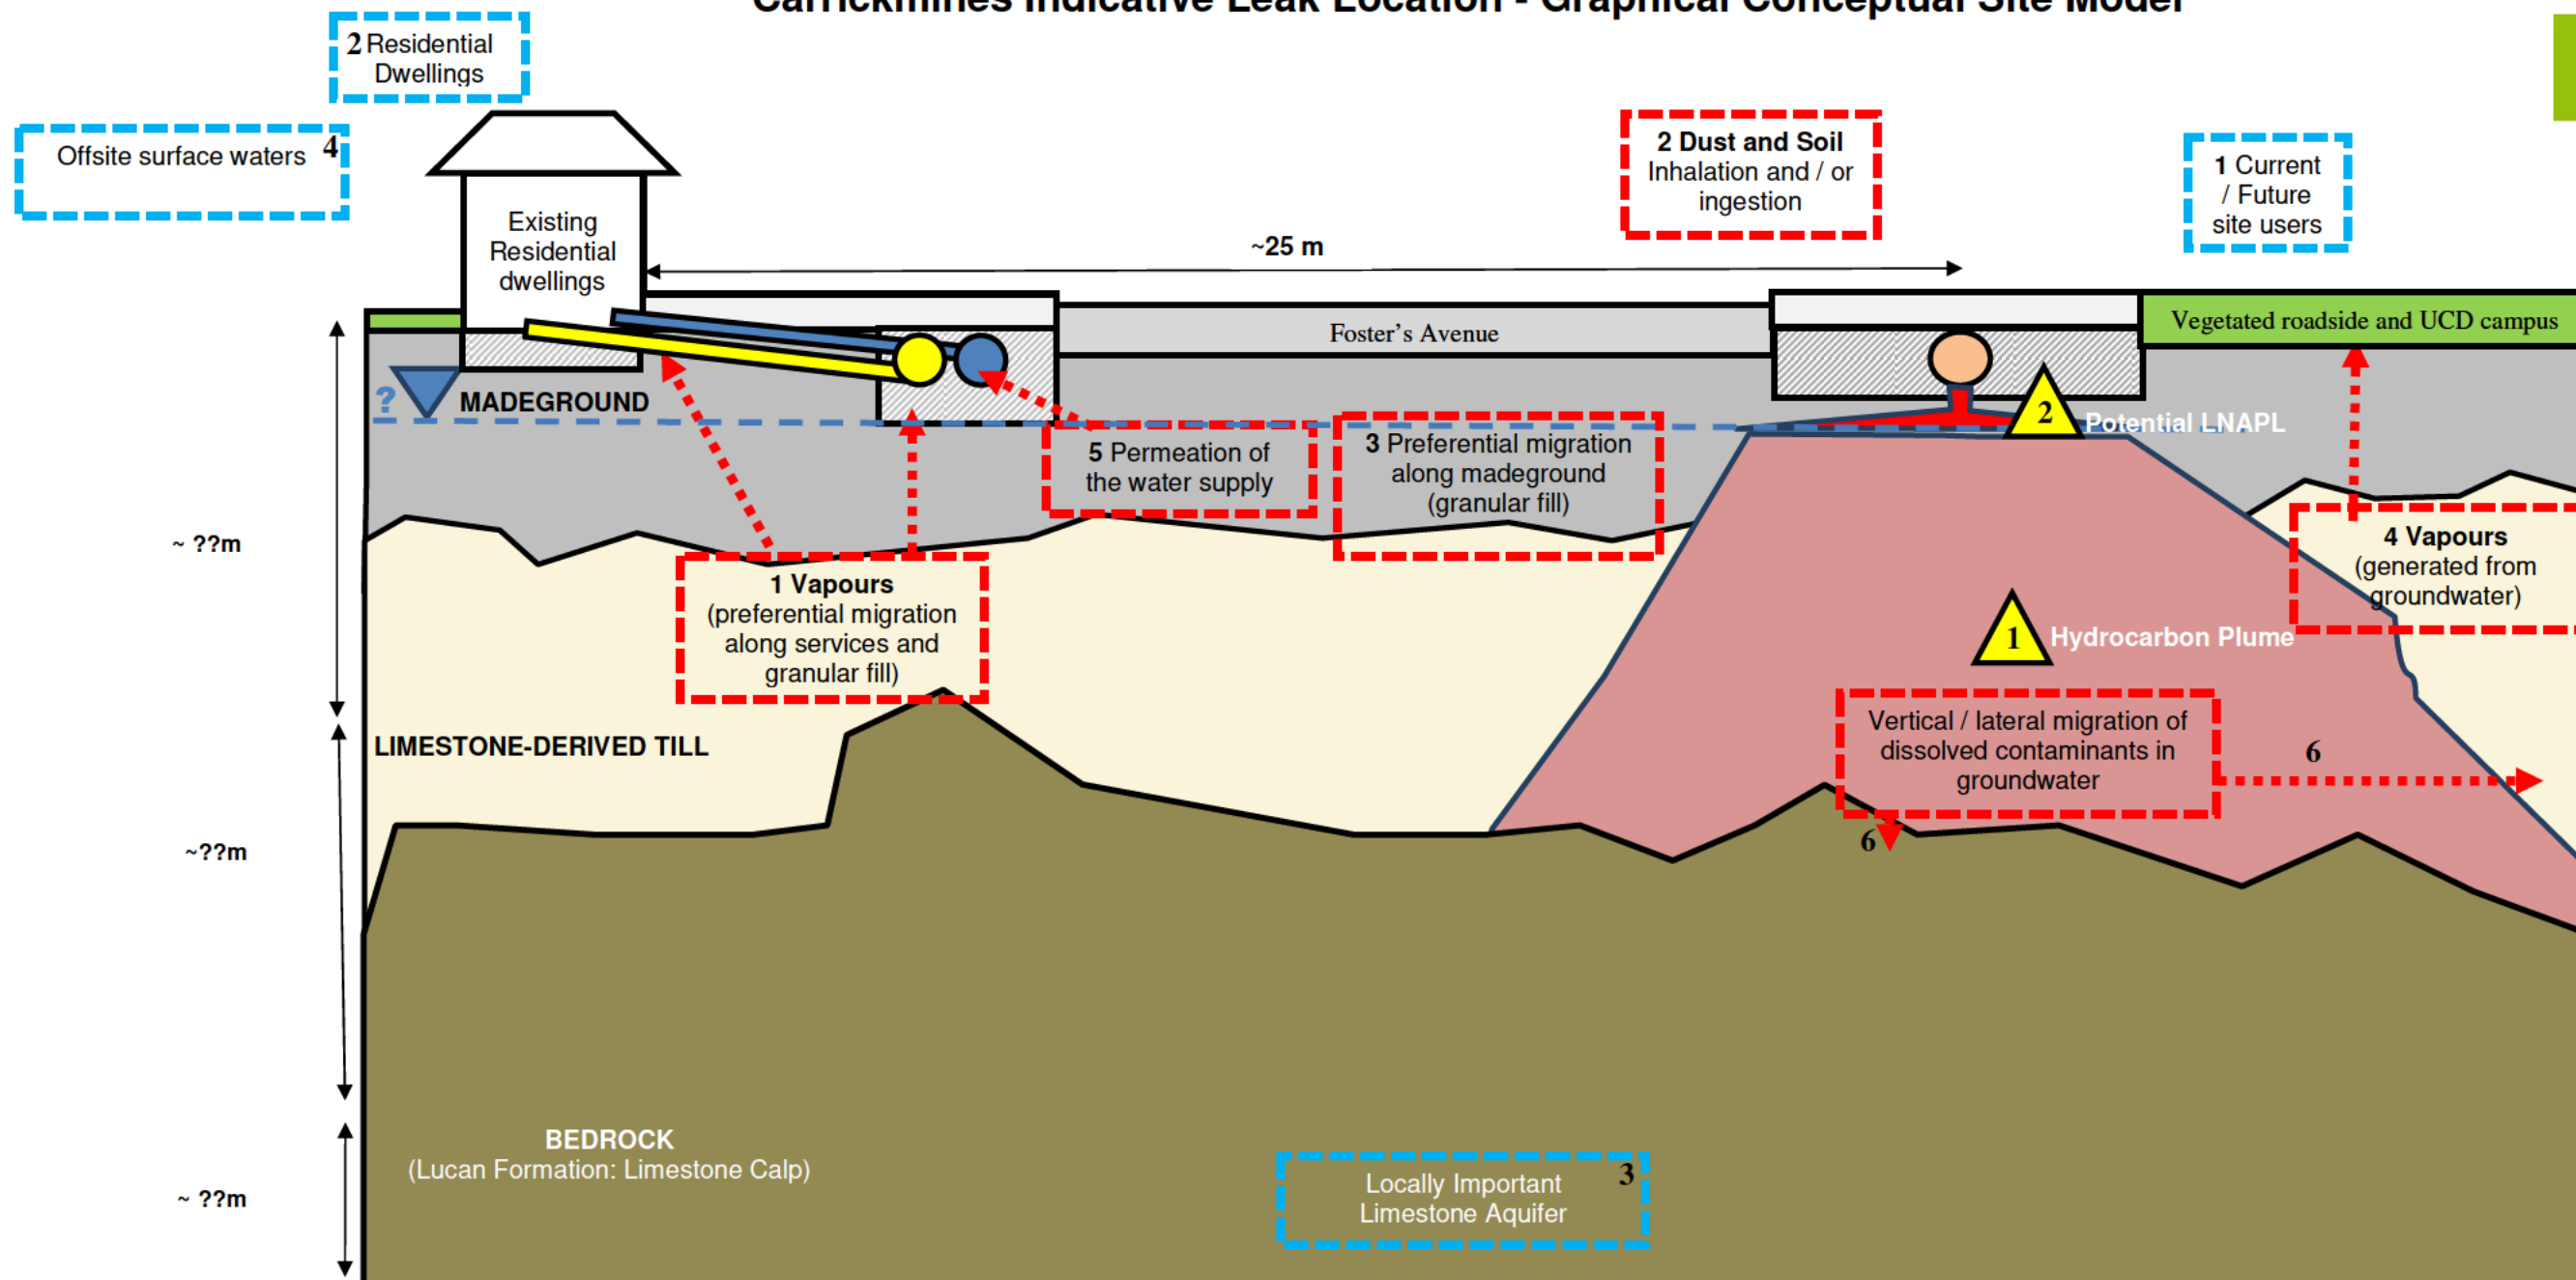
Carrickmines Indicative Leak Location - Graphical Conceptual Site Model

The initial CSM has identified potential pollutant linkages with a risk class of **LOW or VERY LOW** for all identified potential pollution linkages.

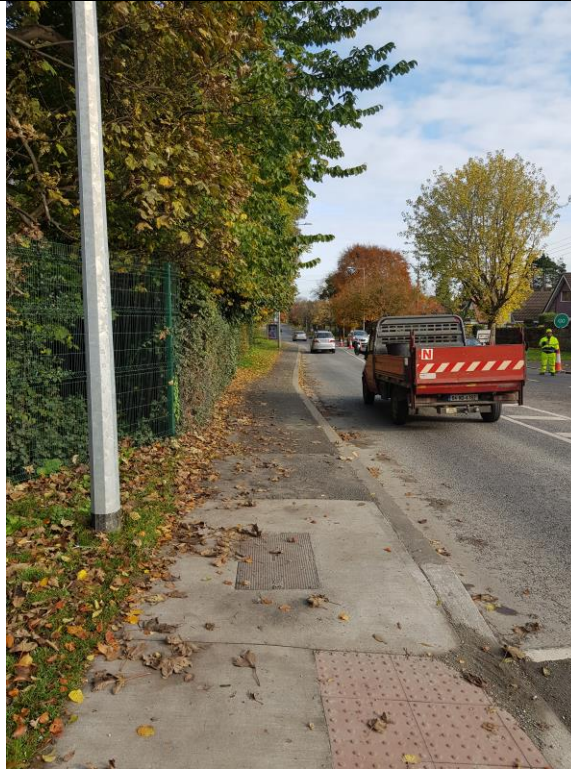
View of Fosters Avenue. A vegetated area at the edge of UCD campus can be seen on the left of the photo and residential properties can be seen in the background on the far right of the photo.

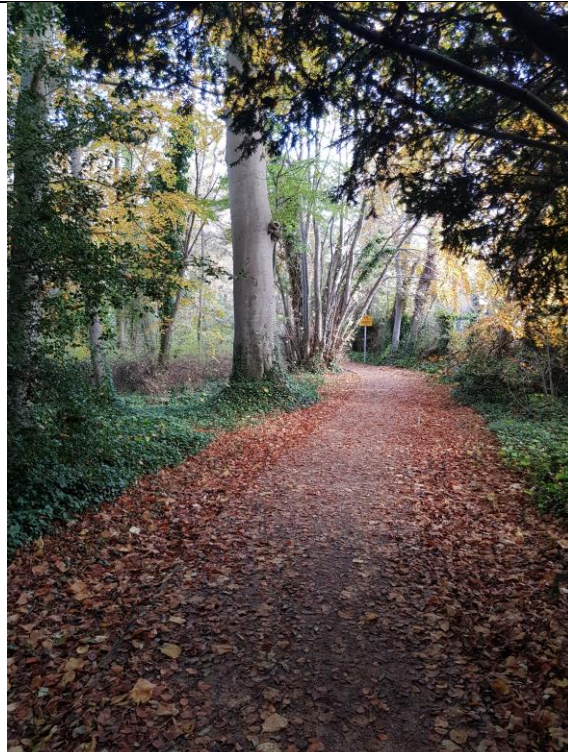
**Photo No.**
2**Date:**
November
2019**Direction Photo taken:**

View of the vegetated area immediately north of and adjacent to Fosters Avenue. From this point of view, Fosters Avenue is to the right (out of view) and UCD campus is to the left (out of view).

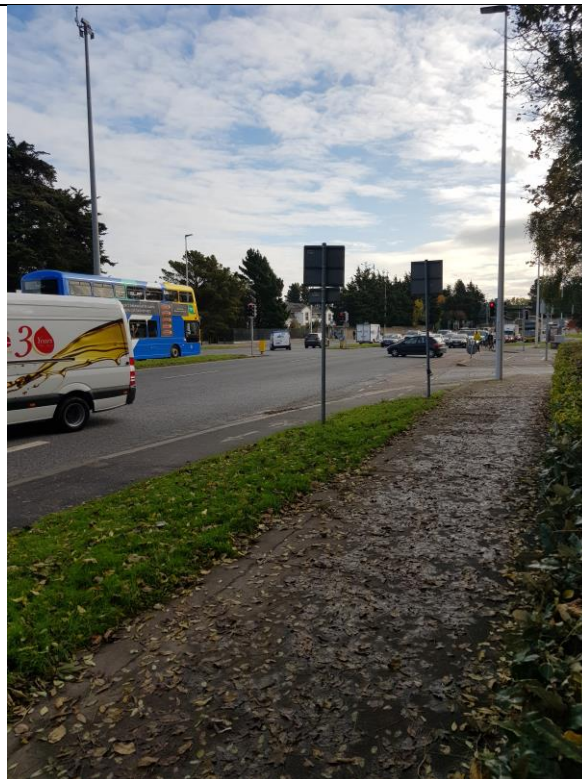
Photo No.
4

Description:
Junction of Fosters Avenue
and Stillorgan Road. This
forms the eastern extent of
the site

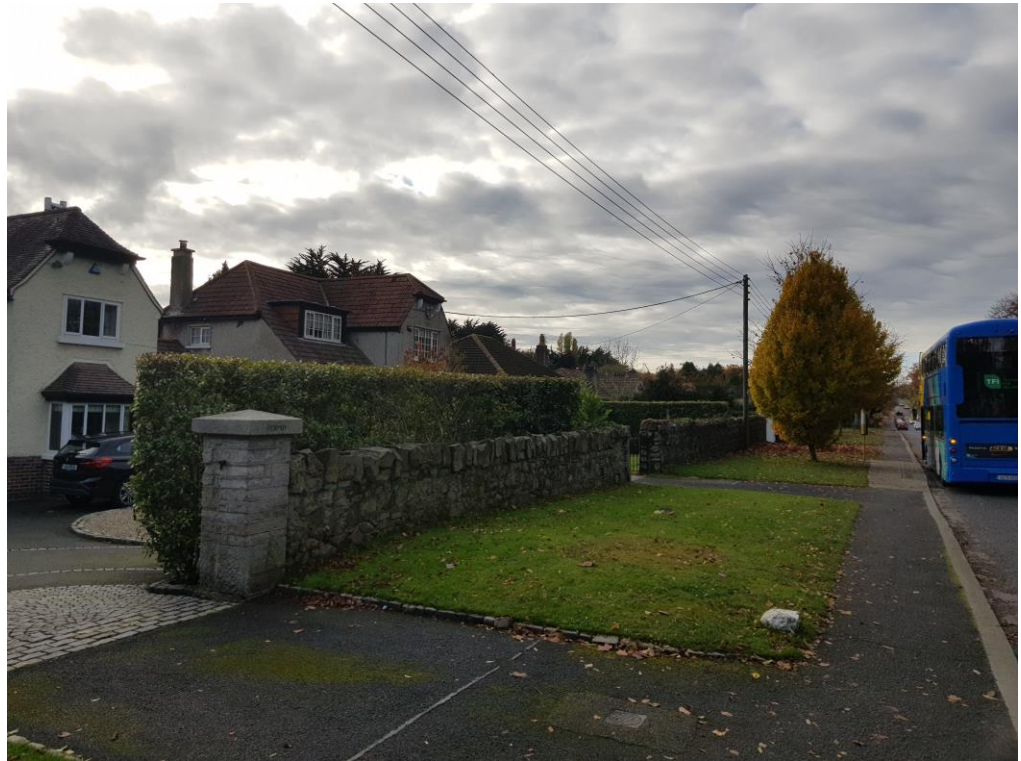
Description:Residential properties
south of Fosters Avenue

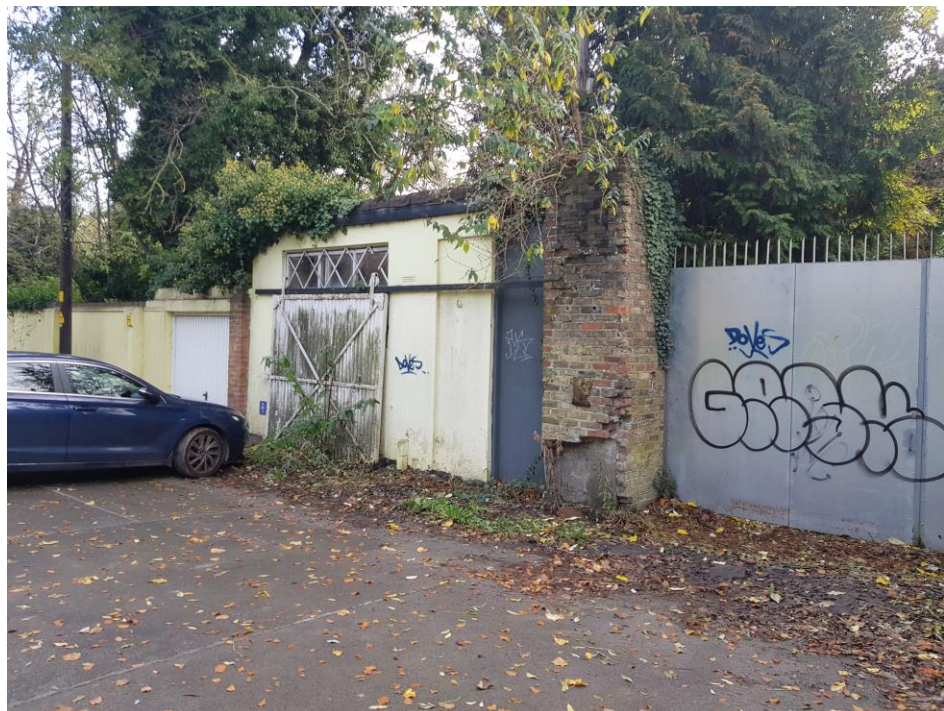
**Photo No.**
6**Date:**
October
2019**Direction Photo taken:**

Description:Entrance to one non-
residential property on
Fosters Avenue. Property
could not be identified but
from aerial photography
there appear to be
warehouses on the site.
