Site 47 East Wall Road to Ringsend 38 kV: Preliminary Site Assessment Report for Historic Fluid Filled Cable Loss

ESB Engineering and Major Projects

19126590.47.A.2

June 2020

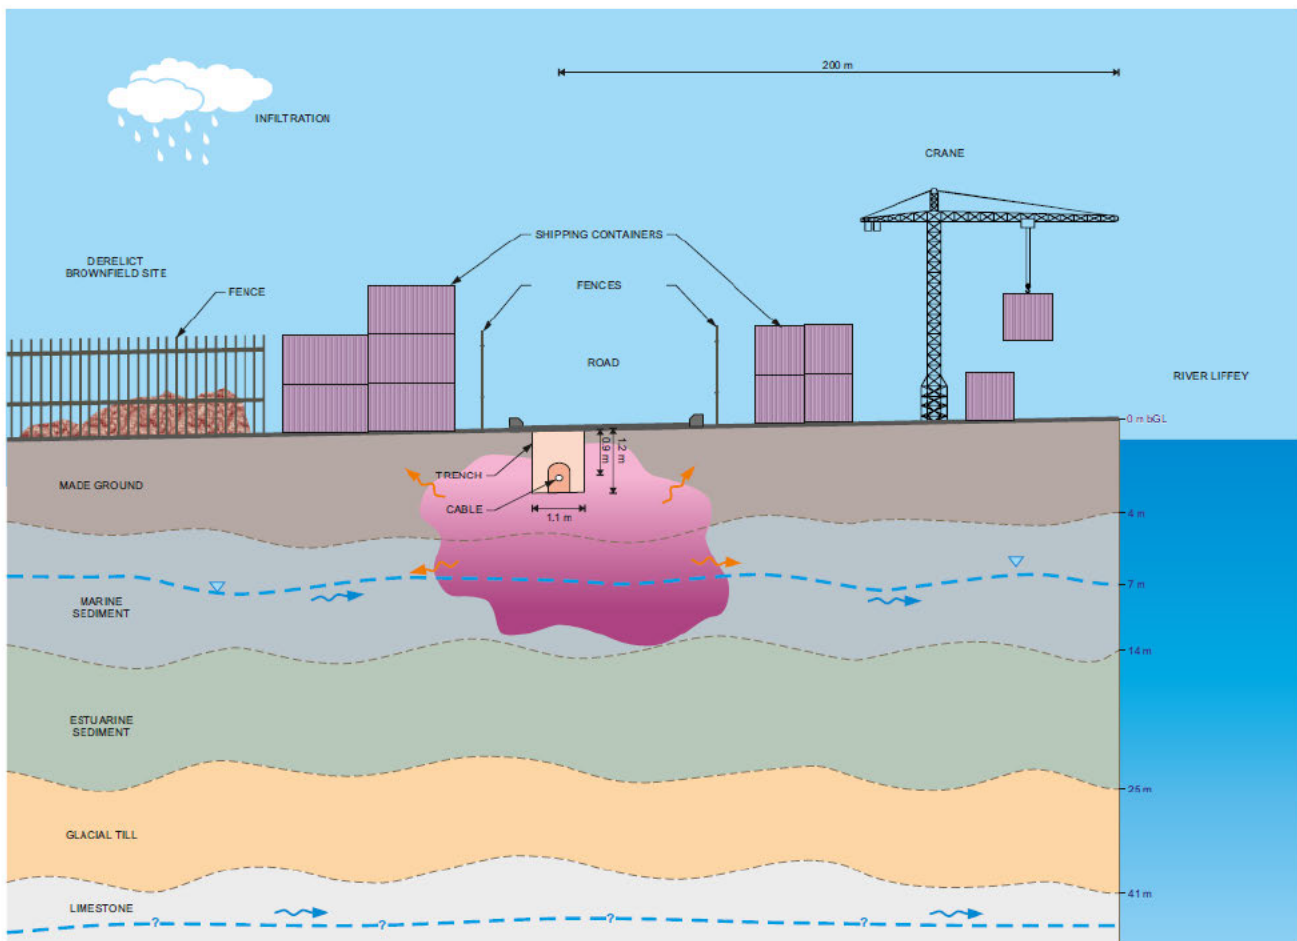
Figure 1: Preliminary CSM for Site 47 (East Wall Road to Ringsend).

All of the pollutant linkages assessed were classified as either low or very low risk. Golder do not recommend any follow up actions in relation to the 390 L cable fluid loss that occurred in 2007 (and was promptly repaired) at the site.

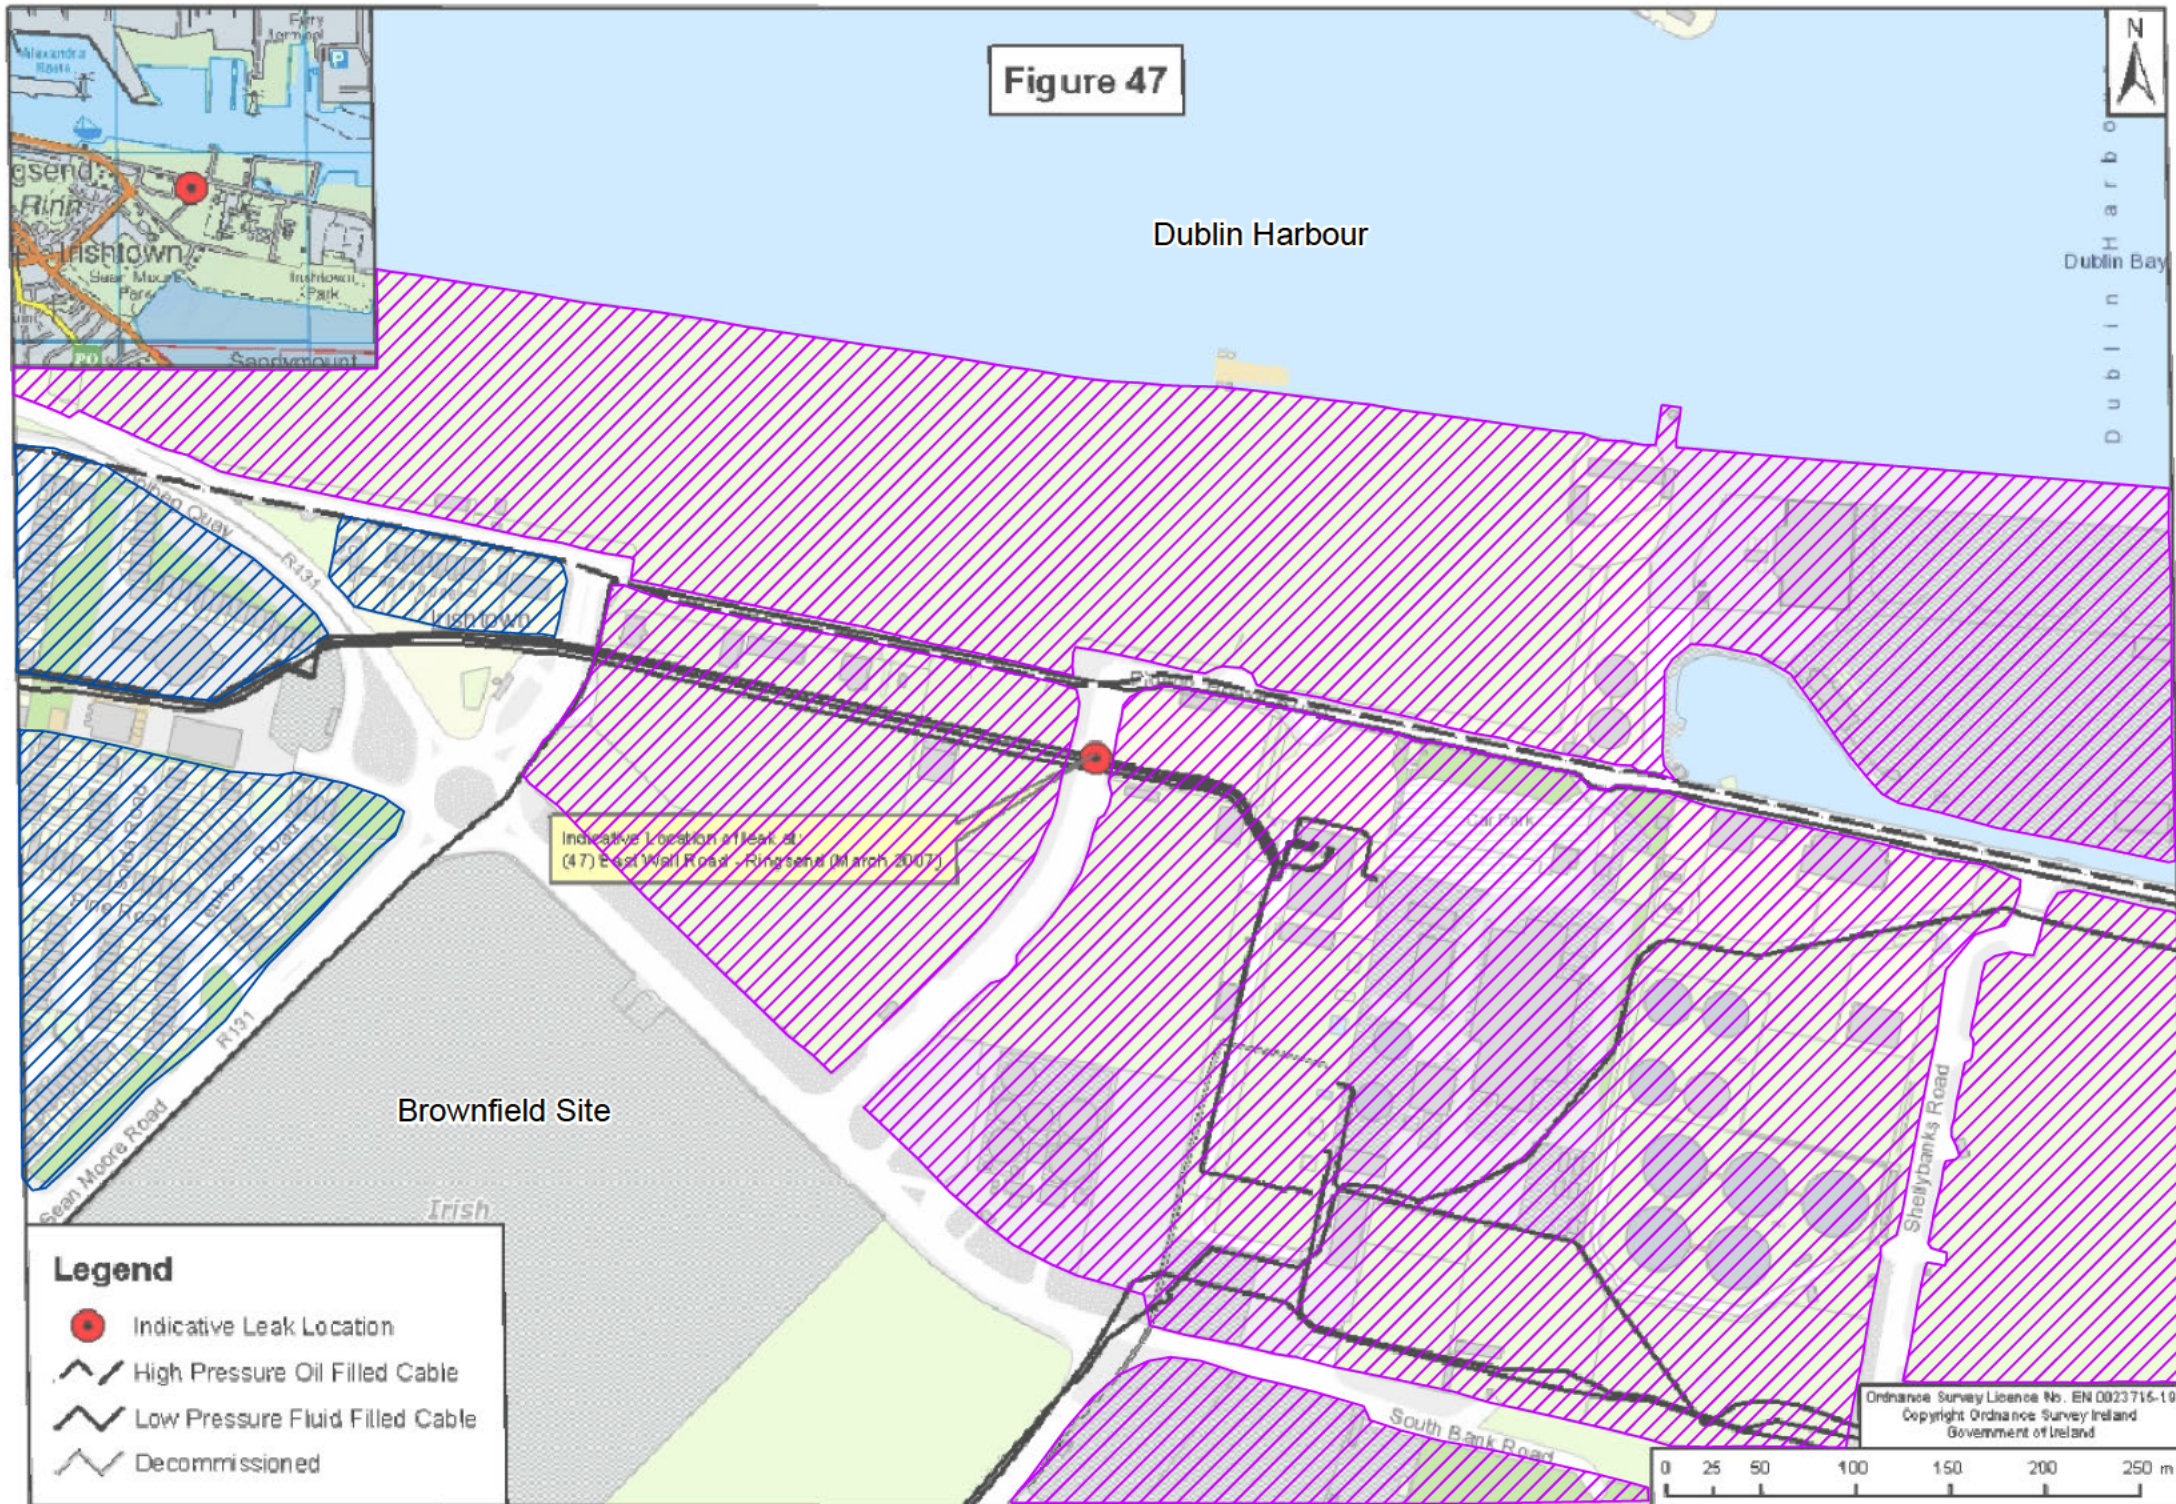
Figure 47

The source is the indicative leak location of the fluid filled cable (Eastings: 319384, Northing: 233803) (locations approximated from ESB provided drawing, Figure 47. An adapted version is provided in Drawing 1). ESB estimate the total loss of cable fluid over the leak period as approximately 390 L. The ESB has stated that the leak was repaired in March 2007.

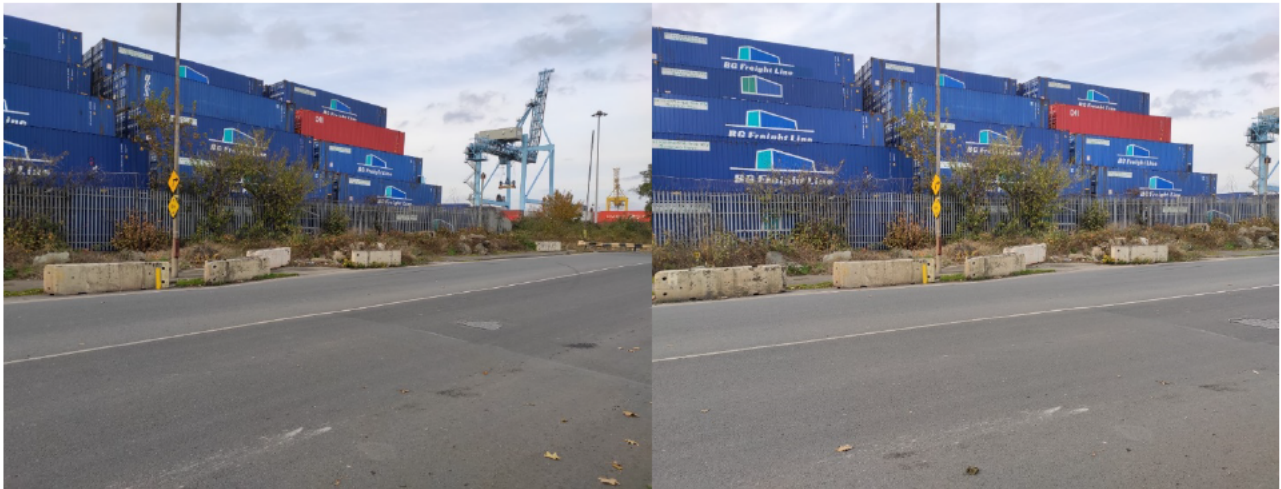
No evidence of potential contamination from cable fluid/oily substances was observed at the indicative leak location during the Site walkover. Selected photographs of potentially relevant observations made during the Site walkover are provided in APPENDIX A with commentary.

Photograph 1: Indicative leak location (Site 47) towards the north end of Whitebank Road, looking northwest.

Photograph 2: Indicative leak location, looking west.

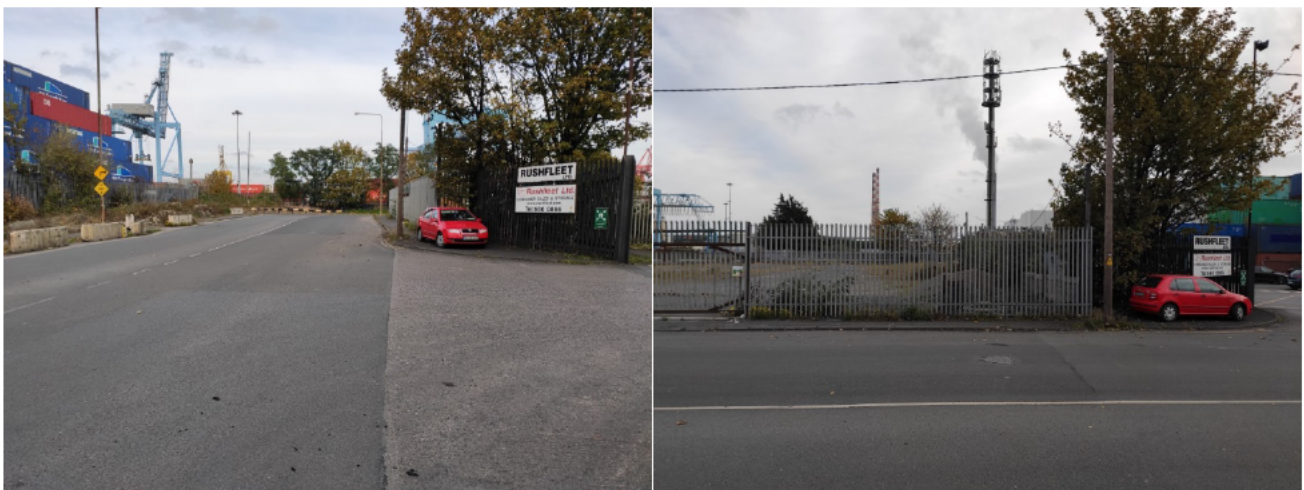
Photograph 3: South of indicative leak location, looking north.

Photograph 4: Indicative leak location, looking east.

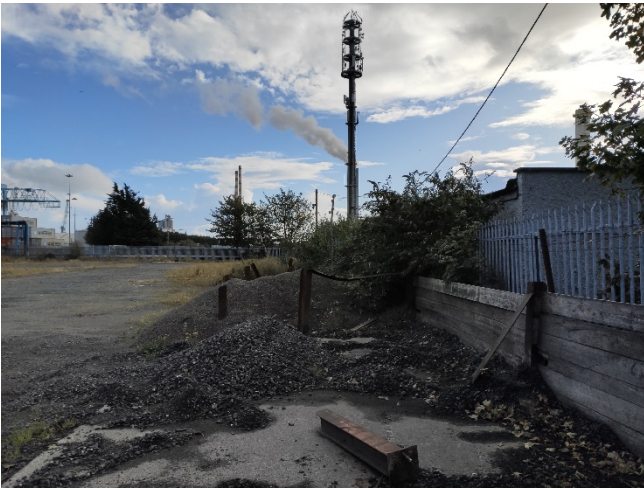
Photograph 5: Derelict land east of Site, looking east along boundary fence with Rushfleet.

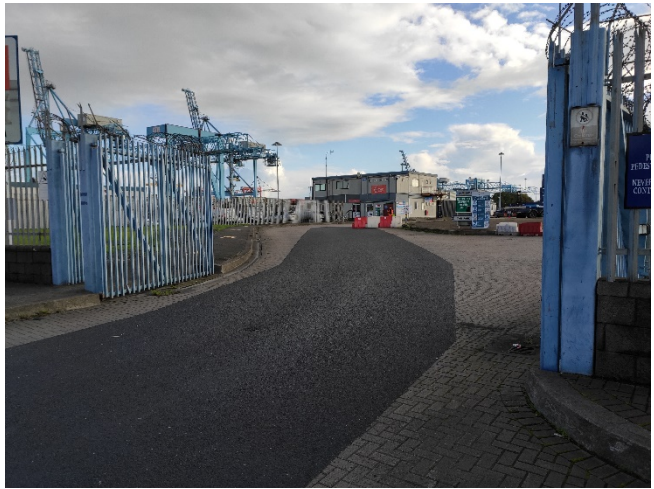
Photograph 6: Entrance to Peelports at the western extent of the Site limits.

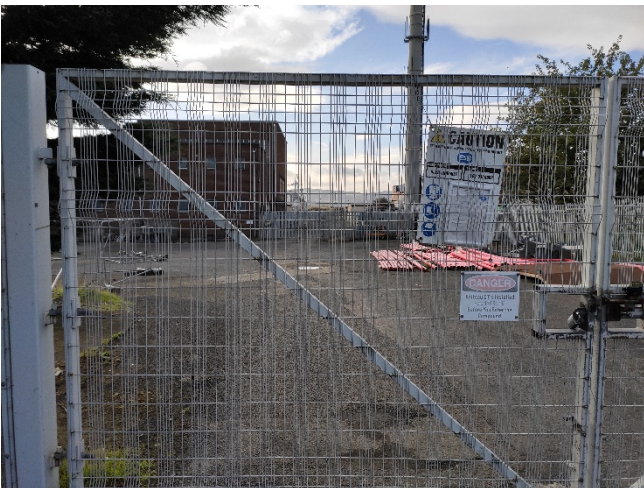
Photograph 7: Ringsend ESB Station from Pigeon House Road, near boundary with Rushfleet, looking south.
