Site 49 Poolbeg to Ringsend TF4 110 kV: Preliminary Site Assessment Report for Historic Fluid Filled Cable Loss

ESB Engineering and Major Projects

19126590/49.A.1

17 April 2020

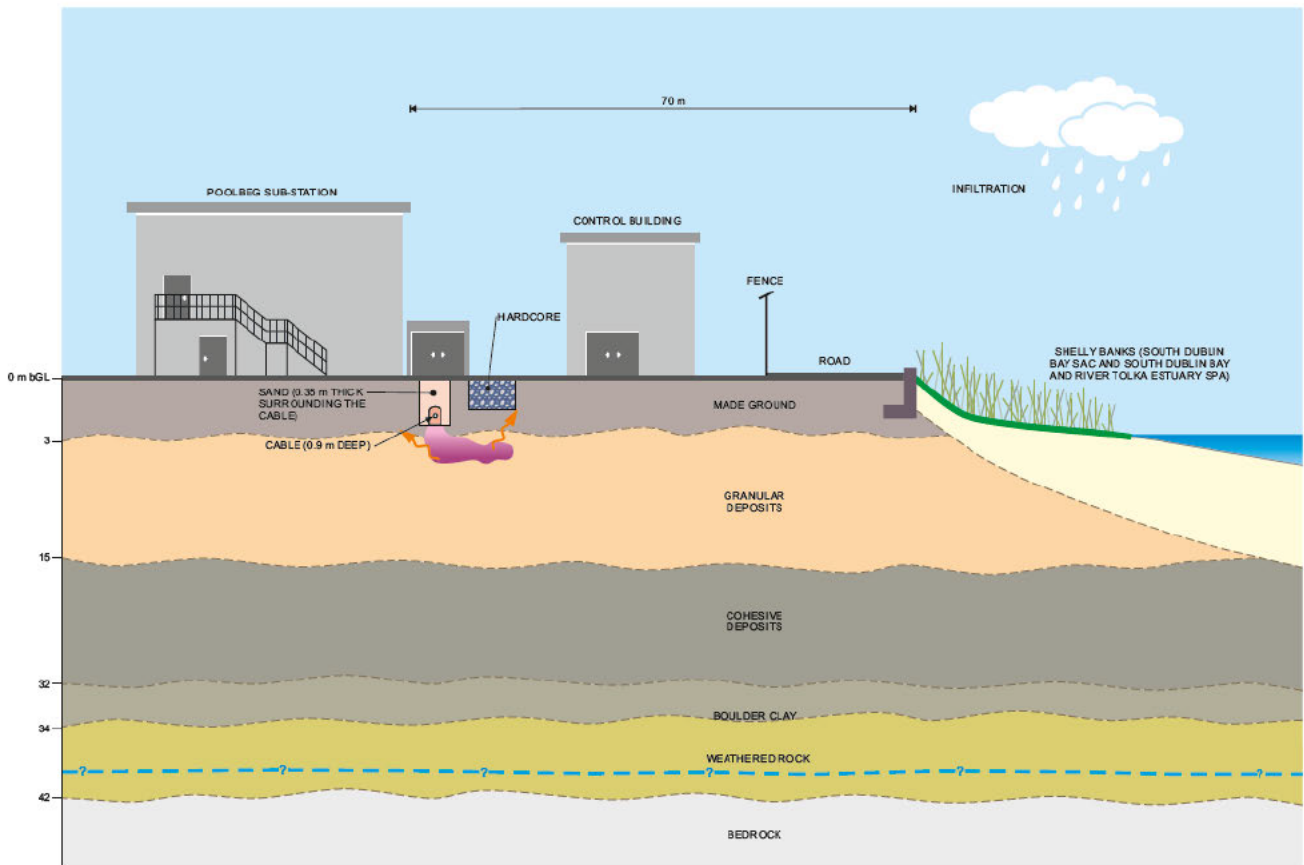
Figure 1: Preliminary CSM for Site 49 (Poolbeg to Ringsend TF4).

All of the pollutant linkages assessed were classified as very low risk. Golder do not recommend any follow up actions in relation to the 210 L cable fluid loss that occurred in August 2006 (and was promptly repaired) at the site.

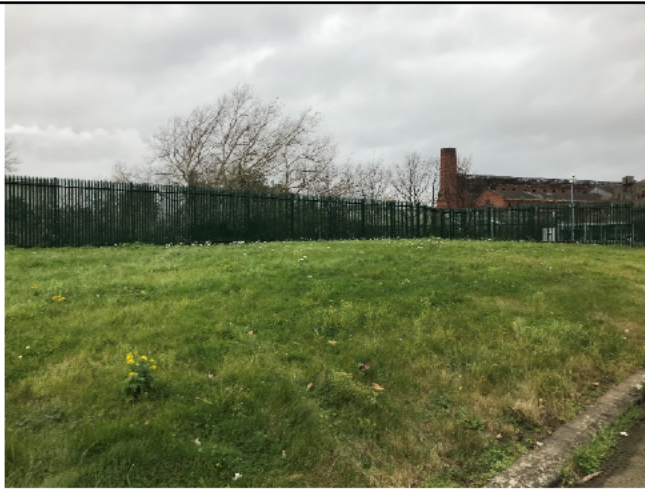
49-01 The cable travels under a green/grassy area at the western most side along the section of interest. No breakout was noted in this area or any other evidence of contamination, (e.g. vegetation die-back, staining, etc.)

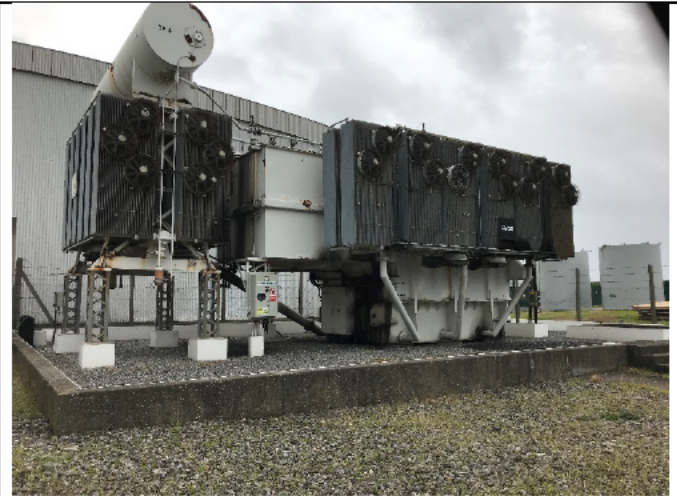
49-02 – the cable route progresses eastward and travels into the compound and to the TF4 transformers. These are positioned over a bund

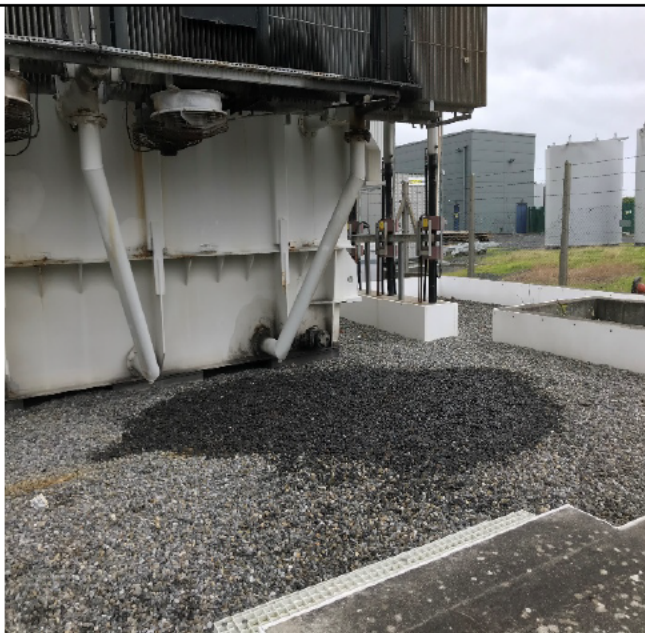
Staining was noted on the ground beneath the TF4 transformer, which is located within a bunded area. Apart from this, no evidence of potential contamination from cable fluid/oily substances was observed along the 400 m cable length (200 m each way from the leak location) that we examined during the Site walkover. Selected photographs of potentially relevant observations made during the Site walkover are provided in APPENDIX A with commentary.

49-03 Staining was noted under the TF4 unit in the bund.

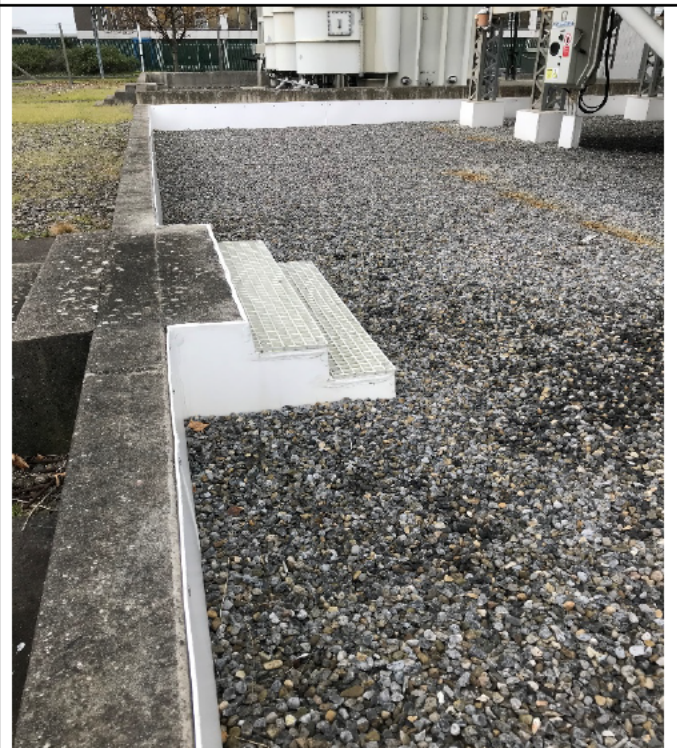
49-04 Recent integrity and relining repairs were evident in this bund

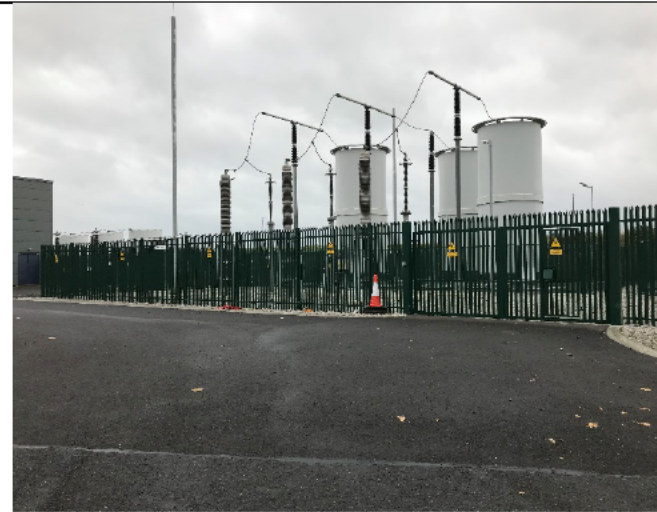
49-05 - No breakout noted along the section at the indicative leak location. However, recent groundworks were evident around the area (new hardcore surface and new tarmac access road). The site representative noted that these works were conducted about 3 years previously.

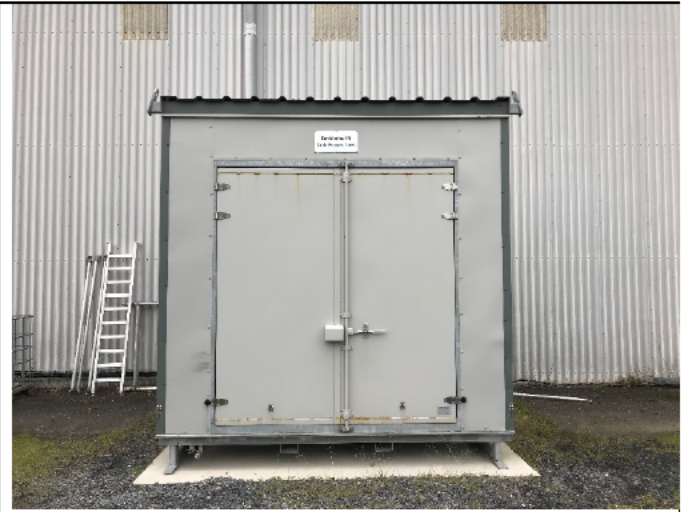
A cabin was positioned over the indicative leak location, however no evidence of potential contamination from cable fluid/oily substances was observed at this location during the Site walkover. Selected photographs of potentially relevant observations made during the Site walkover are provided in APPENDIX A with commentary.

49-06 – A cabin is positioned over the indicative leak location. The cabin was locked but a plate on it's exterior noted 'Carrickmines HV Cable Pressure Tanks'. It is assumed that this may have been built around the time of the other surface works due to the unweather appearance of the concrete under the cabin. There was no staining evident on or around the cabin's base.

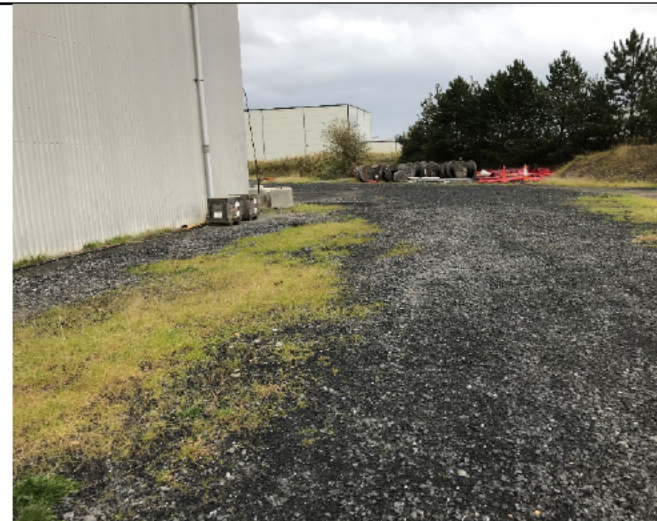
49-07 – The cable travels east under a hardcore surface. As noted, the site representative indicated that the cable under this particular route was removed previously (exact date unknown)

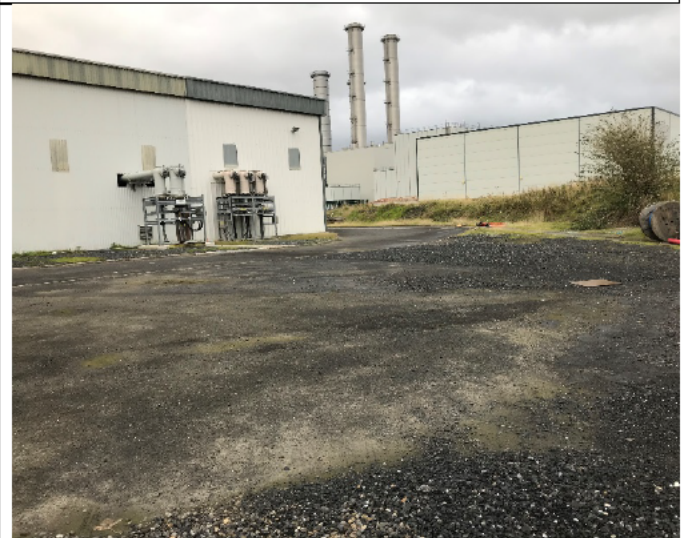
49-08 – One cable (likely removed) travels east and then north and entered the '220 GIS Building'. No overlying evidence of contamination was noted along this route. Break/repairs in the tarmac were noted prior to the cables entering the building

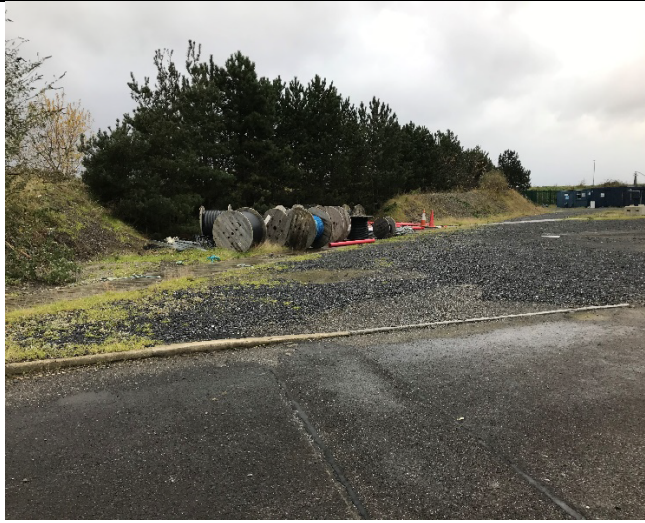
49 -09 – Another route travels southwards and along the southern perimeter of the site. No overlying evidence of contamination was noted along this route.

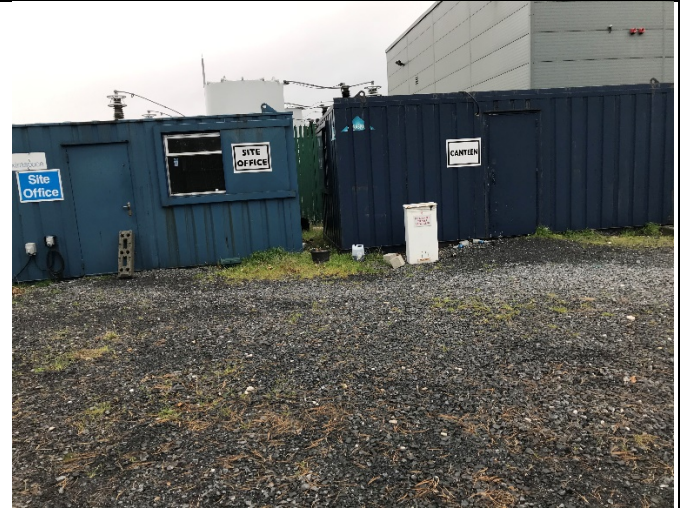
49 –10 A portacabin site office, toilets and septic tank was identified to be overlying this route.
