Site 52 Parkview to Ringsend 38 kV: Preliminary Site Assessment Report for Historic Fluid Filled Cable Loss

ESB Engineering and Major Projects

19126590.52.A.2

9 June 2020

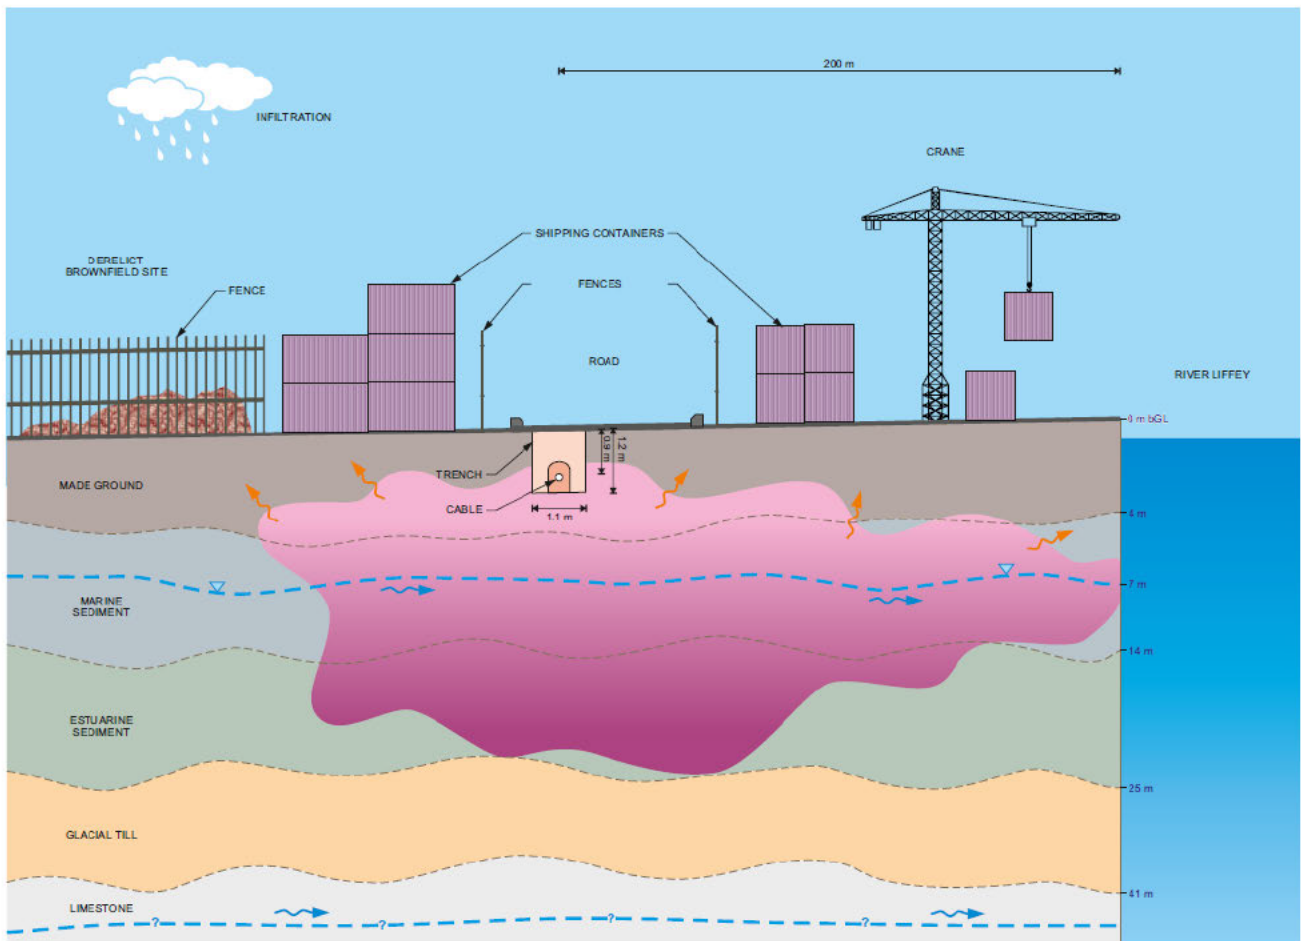
Figure 1: Preliminary CSM for Site 52 (Parkview to Ringsend).

Due to the known leak of cable fluid into the permeable cable trench material, and the unknown characteristics (e.g. permeability) of the Made Ground likely to be surrounding the trench, there is the potential for lateral migration of contaminants along ducting routes and laterally towards nearby service ducts/tunnels and vertically towards shallow groundwater. These are considered to be the primary viable pollutant linkages and risk drivers for this Site at present. However, the risk classification for these are medium/low. Considering the location of the spill i.e. an industrial area with commercial receptors, the time elapsed since the spill occurred and the low vulnerability of the underlying aquifer Golder do not recommend any follow up actions in relation to the identified spill at this site as presented herein.

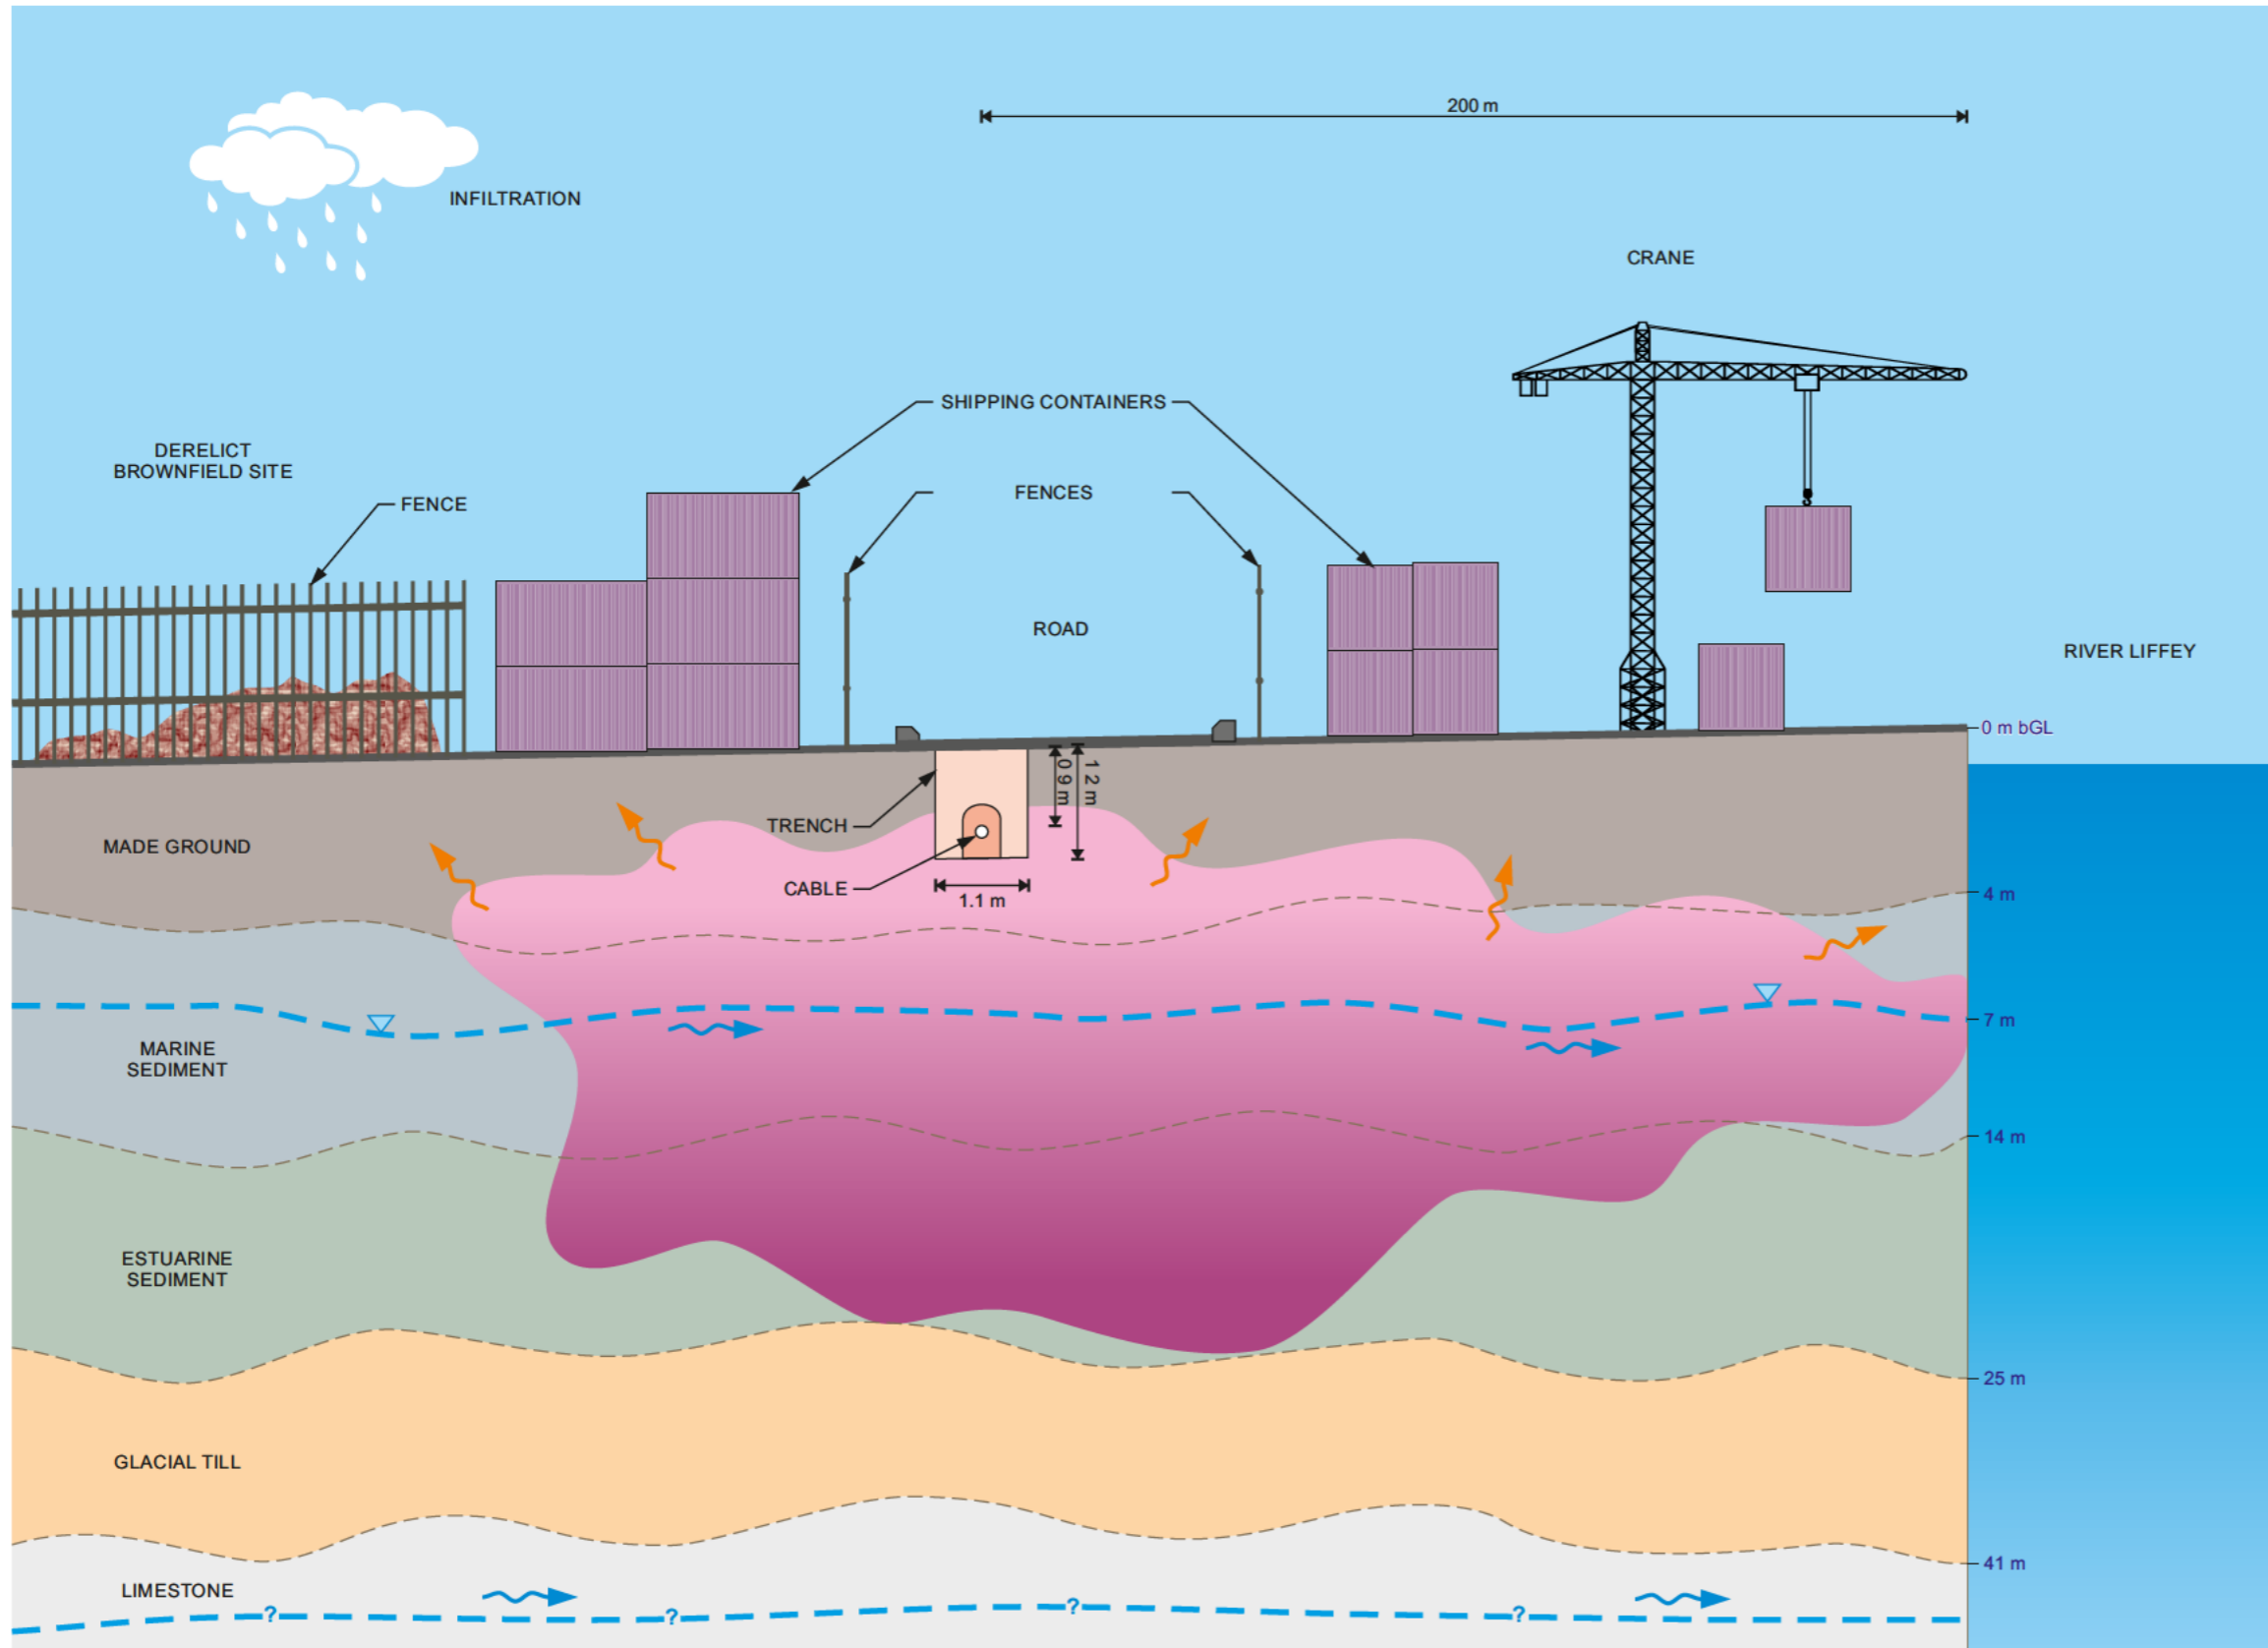
SHEET TITLE
PRELIMINARY CSM (IDENTIFYING POLLUTANT LEAKAGES)
PARKVIEW TO RINGSEND (SITE 52)

The availability of lateral preferential pathways along ducting routes is most likely to be the primary migration pathway for this Site due to the presence of industrial properties within close proximity of the indicative leak location.

Due to the known leak of cable fluid into the permeable cable trench material, and the unknown characteristics (e.g. permeability) of the Made Ground likely to be surrounding the trench, there is the potential for lateral migration of contaminants along ducting routes and laterally towards nearby service ducts/tunnels and vertically towards shallow groundwater. These are considered to be the primary viable pollutant linkages and risk drivers for this Site at present. However, the risk classification for these are medium/low. Considering the location of the spill i.e. an industrial area with commercial receptors, the time elapsed since the spill occurred and the low vulnerability of the underlying aquifer Golder do not recommend any follow up actions in relation to the identified spill at this site as presented herein.

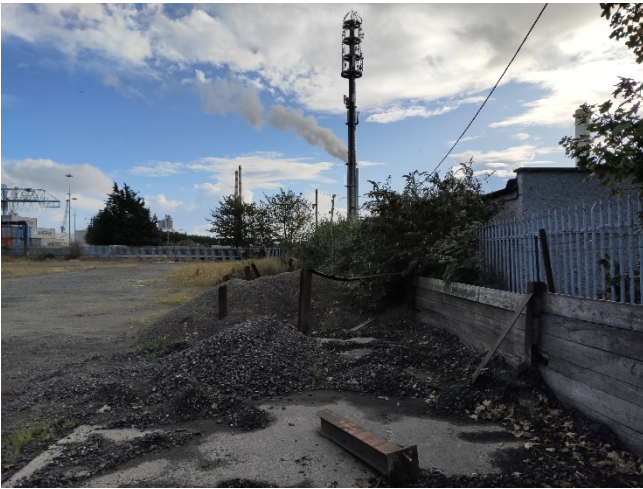
Photograph 5: Derelict land east of Site, looking east along boundary fence with Rushfleet.

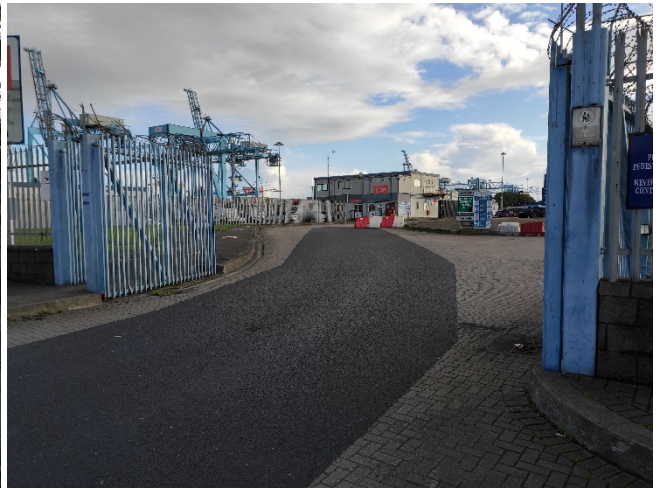
Photograph 6: Entrance to Peelports at the western extent of the Site limits.

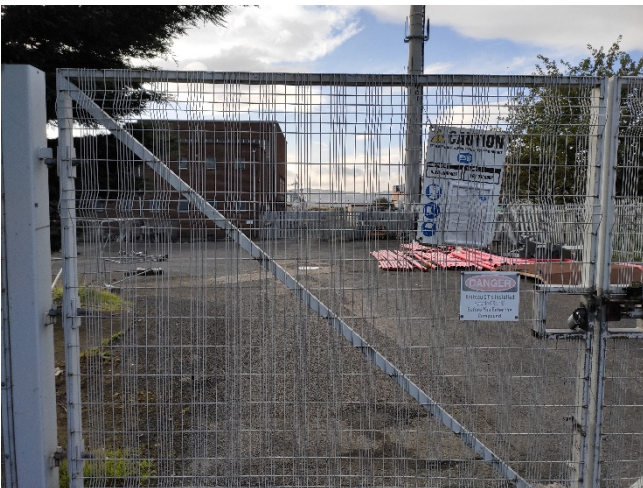
Photograph 7: Ringsend ESB Station from Pigeon House Road, near boundary with Rushfleet, looking south.
