Preliminary Site Assessment

Site 57 Inchicore – Poolbeg 220 kV

Electricity Supply Board

Project number: PR-427640_ACM_RP_ENV_059_0

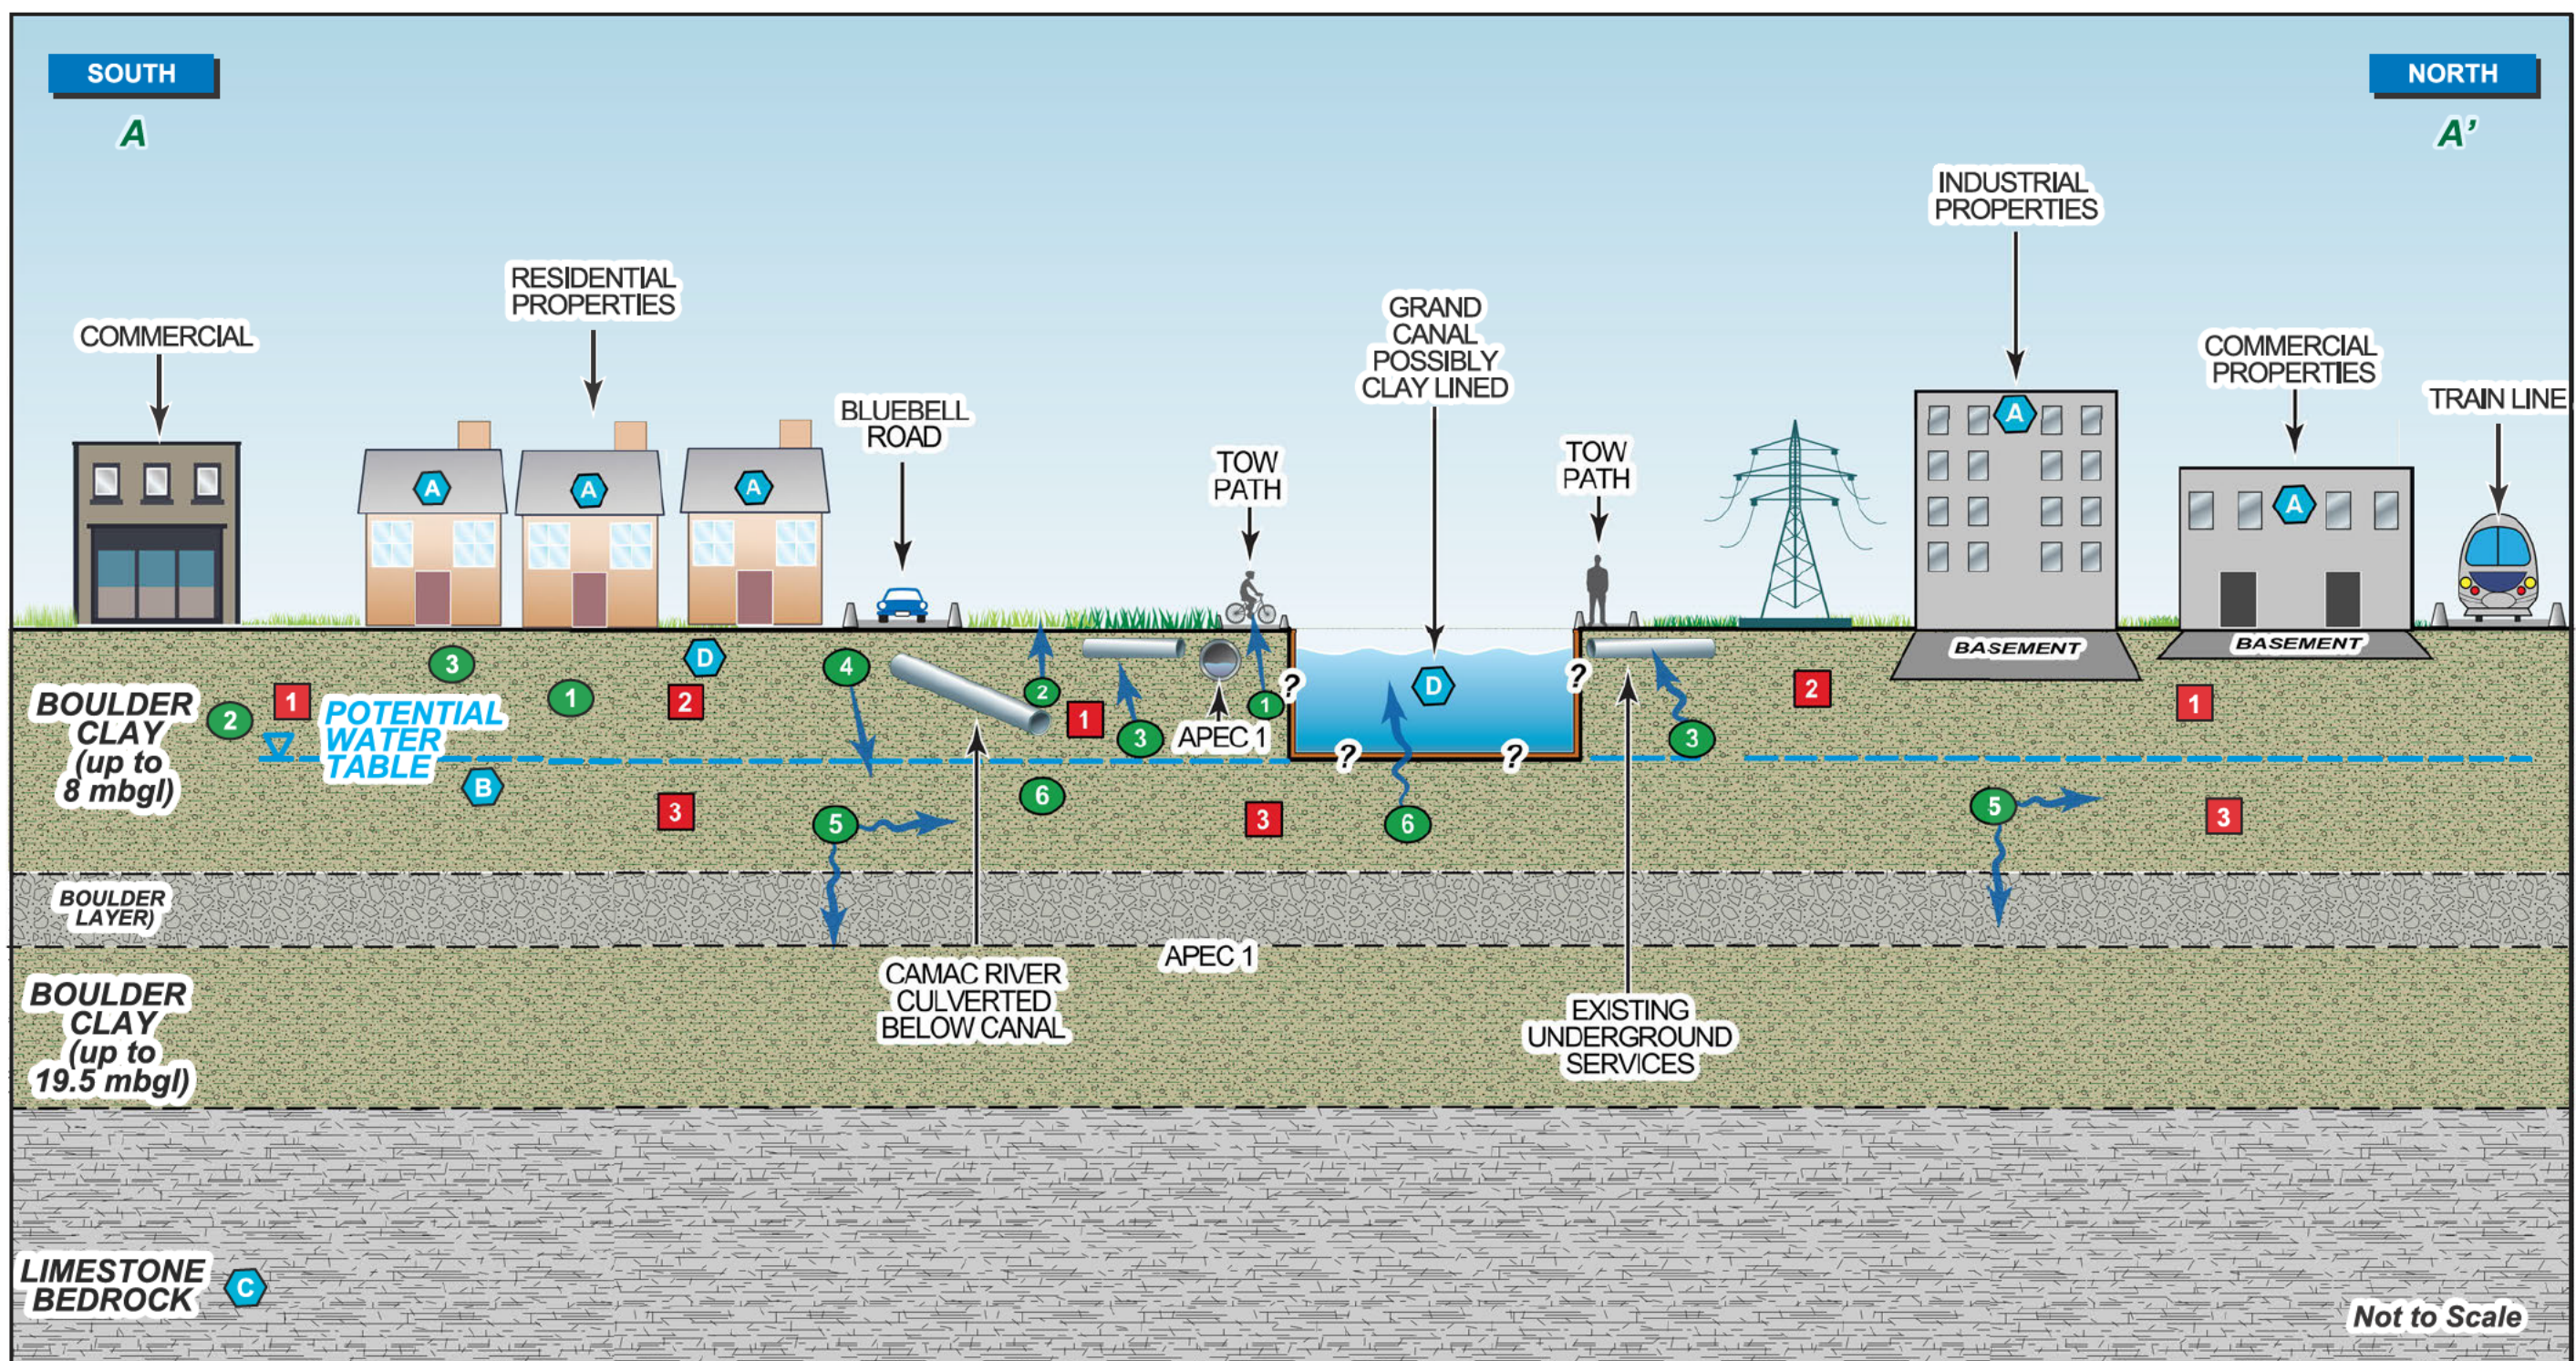
Figure 3. Conceptual Site Model

SOURCES	
1	GROUND GAS
2	NON-VOLATILE CONTAMINANTS IN SOIL
3	CONTAMINANTS IN GROUNDWATER

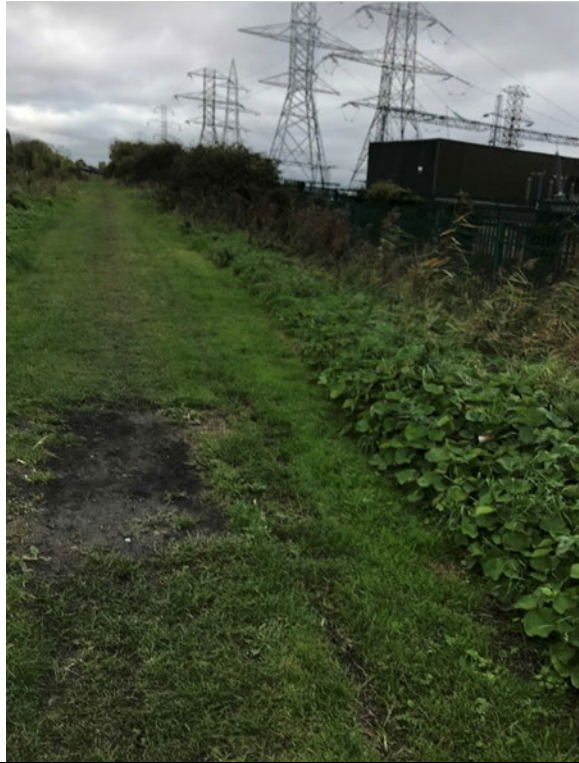
Photo No.: 7	Date: 01/11/19	 
Direction Photo Taken: South		
Description: Substation located approximately 50 m east of leak location, adjacent to LUAS stop.
