Site 60 Pembroke to Ringsend 38kv: Preliminary Site Assessment Report for Historic Fluid Filled Cable Loss

ESB Engineering and Major Projects

19126590.60.A.2

24 April 2020

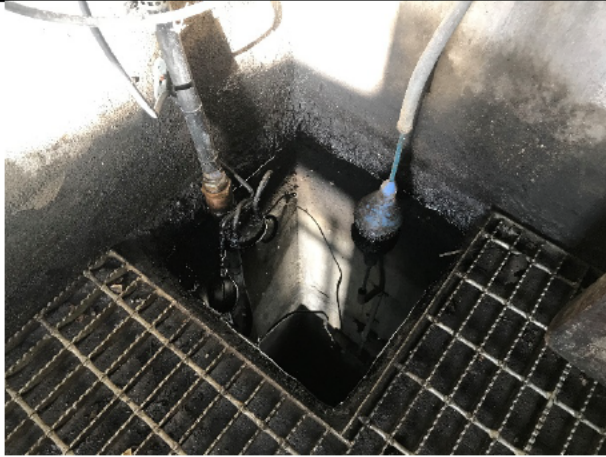
60-01 – A sump was noted on the steps down to the basement level. The site representative noted that this sump drains liquids which may build up within the basement of the substation. Oily material was noted in the sump, with staining around the sump.

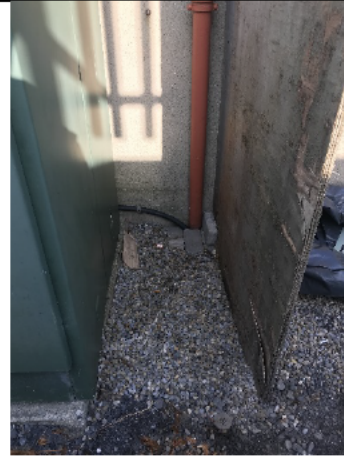
60-02 – The outflow from the pump was found to lead to a surface water drain. It was not fully determined during the walkover whether an interceptor is linked to the site's surface water drainage system.

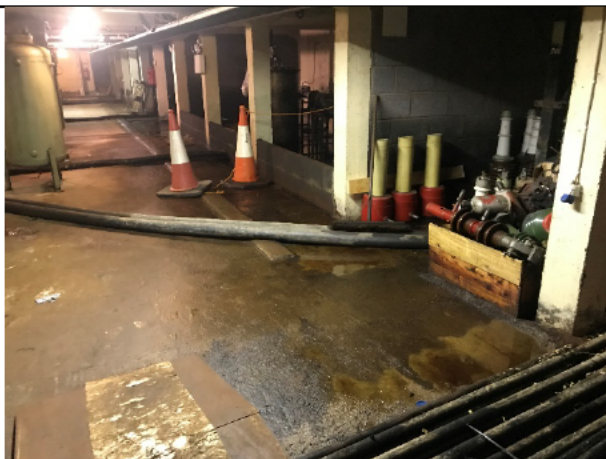
60-03 - The basement contains two bunds. The first bund on the left (closest to entrance door) contains a cable and two steel tanks. There were notable amounts of liquid in the bund and on the floor in front of the bund. Given the clear appearance of LAB it is difficult to differentiate from water pooling from a visual inspection, however due to the infrastructure within the bund and staining in that area it is highly likely that the majority of the liquid is oily material associated with the line and not water.

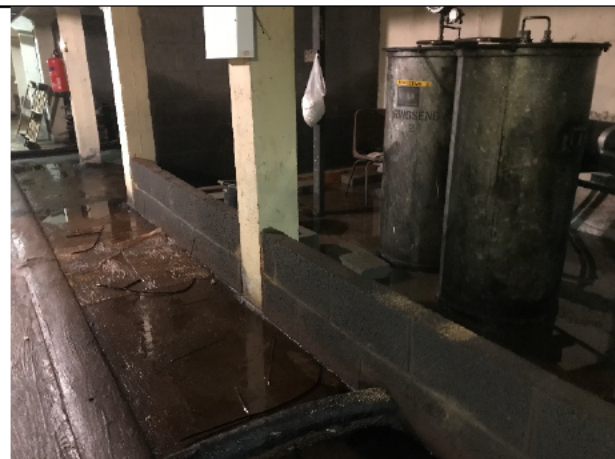
60-04 - Additional staining and liquid in one of the basement bunds.

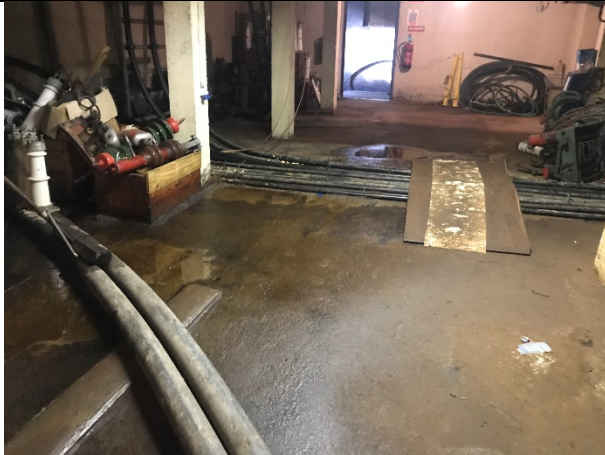
60-05 - Additional staining and liquid in one of the basement bunds.

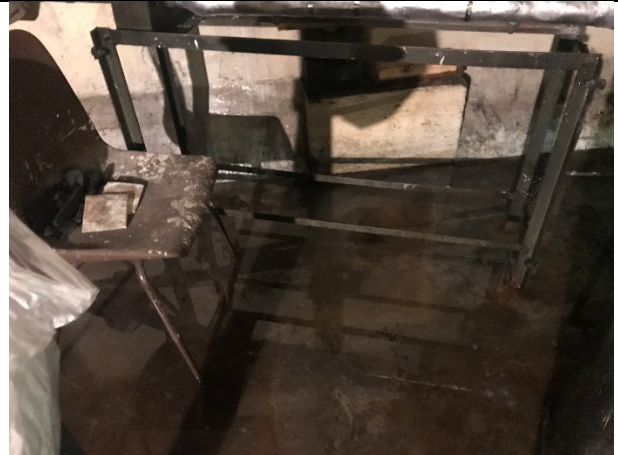
60-06 - Additional staining and liquid in one of the basement bunds.

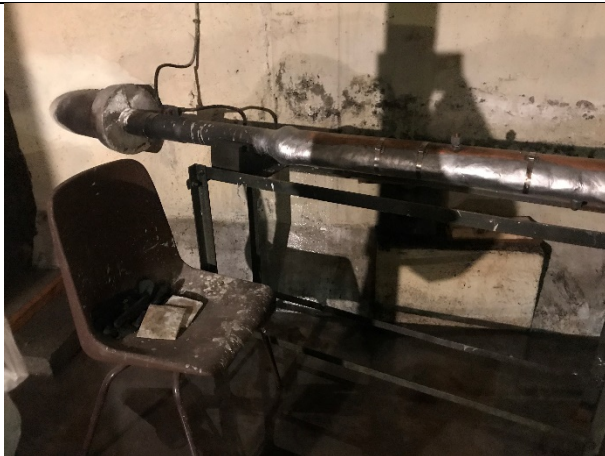
60-07 – Oily staining was noted on the wall to the rear of the first bund.

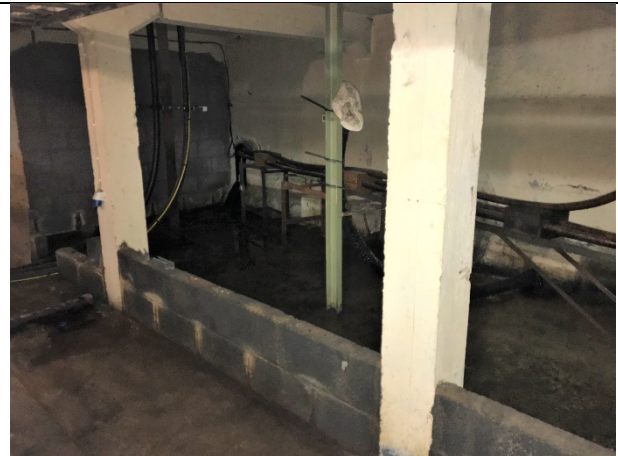
60-08 – A second bund contained a similar amount of liquid build up as the first bund in its base and outside the bund.

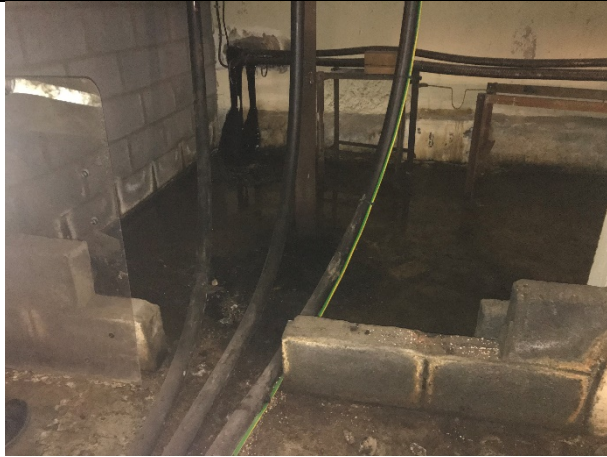
60 -09 – The perimeter blocks of this bund had been removed in one area to accommodate three cable lines.

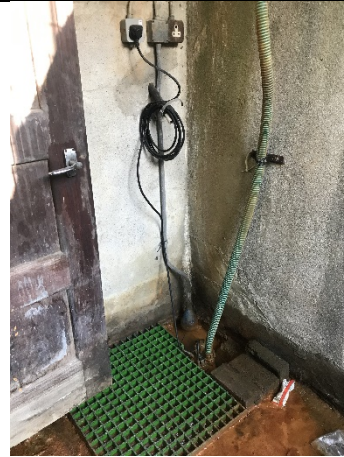
60 -10 – A further sump and pump were noted in another stairwell into the basement (northern side of the building). The sump contained a red rusty residue

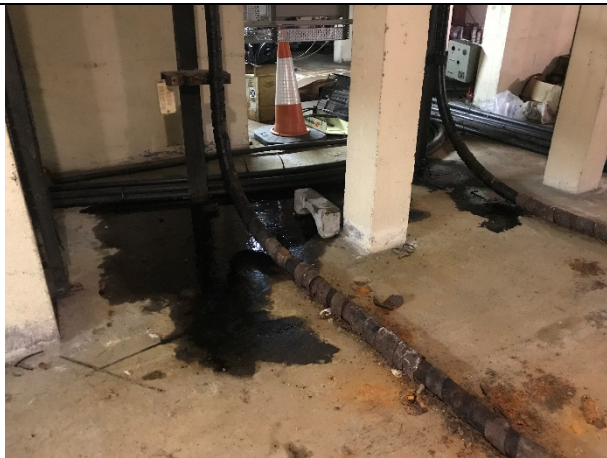
60 -11 – Oily staining was noted in several other areas within the substation basement. Some staining was noted by the site representative to be bitumen, which was previously used as a type of insulation.

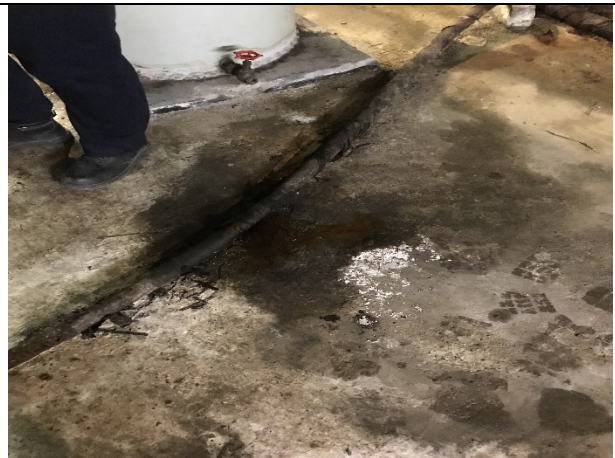
60 -12 – Additional oily staining within the substation basement.

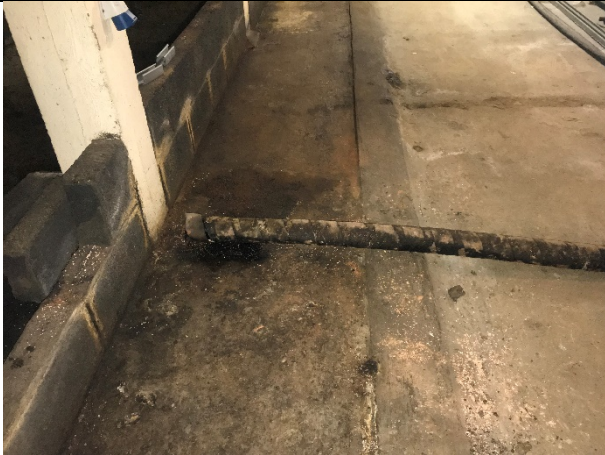
60 –13 – Additional oily staining within the substation basement.

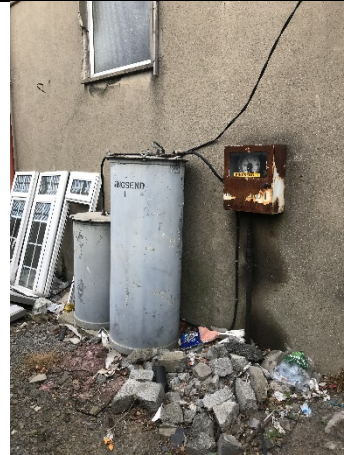
60 –14 – A fill point similar to the tanks in the first basement bund was found externally on the northeast corner of the substation building. Staining was not noted on the external sides of the tanks or on the hardcore surface, however staining was evident on the pipework and the wall behind the pressure valves.

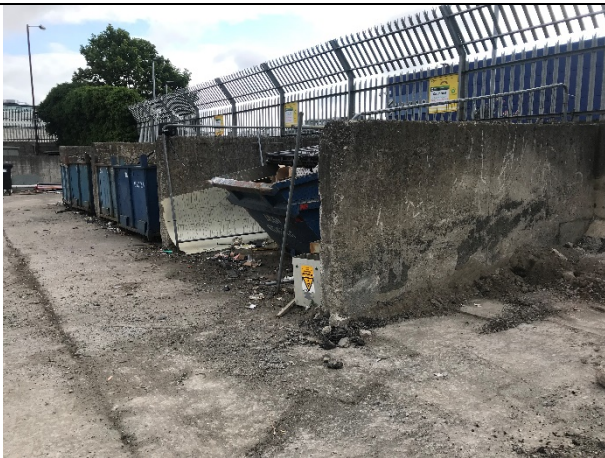
60–15 – From the mapping it appears that the section of interest runs northwards within the ESB networks property, under a waste storage area. This area has a patched concrete base.

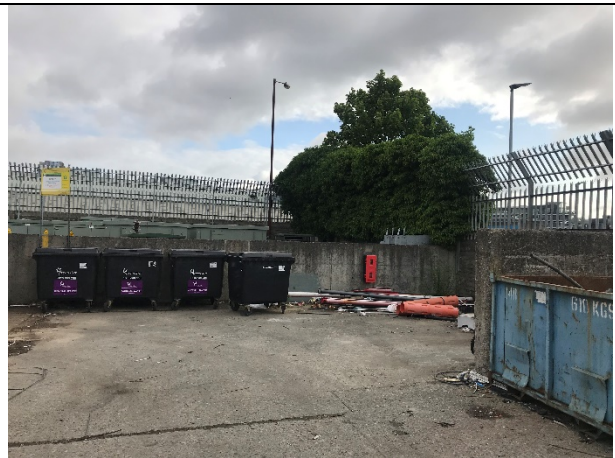
60 –16 – Additional patched concrete base under a waste storage area.

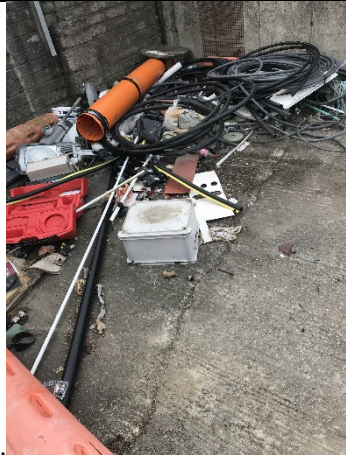
60 –17 – Additional patched concrete base under a waste storage area.

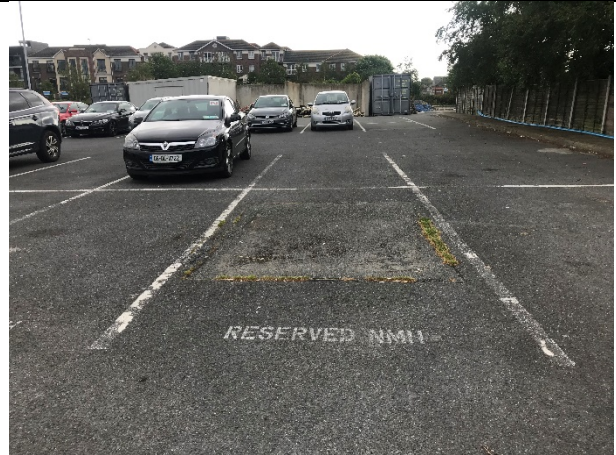
60 –18 – From the mapping it appears that the section of interest turns east after it leaves the ESB networks property. This turn is under the Sportsco access road. The section of interest then runs under a tarmac carpark east towards the River Dodder. The carpark surface was noted to generally be in good condition with only one patch noted in the general vicinity of the cable route.

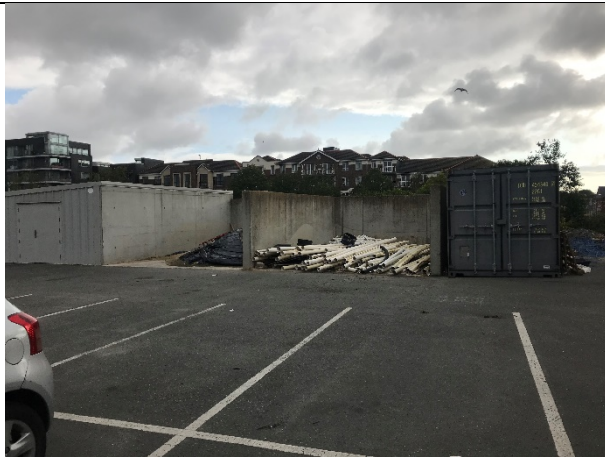
60 –19 – Concrete storage bays and a shipping container are located above the section of interest prior to the end of this section at the River Dodder.
