# **Preliminary Site Assessment Report for Dennehy's Cross, Cork City**

ESB Site Ref: 61  
Dennehy's Cross – Liberty Street 38 kV

**Project Title:** ESB Networks Historic Fluid Filled Cable Loss  
Environmental Assessment

**Report Ref:** Stage 1 Preliminary Site Assessment Report for Dennehy's Cross, Cork City. ESB Ref: 61 Dennehy's Cross – Liberty Street 38 kV

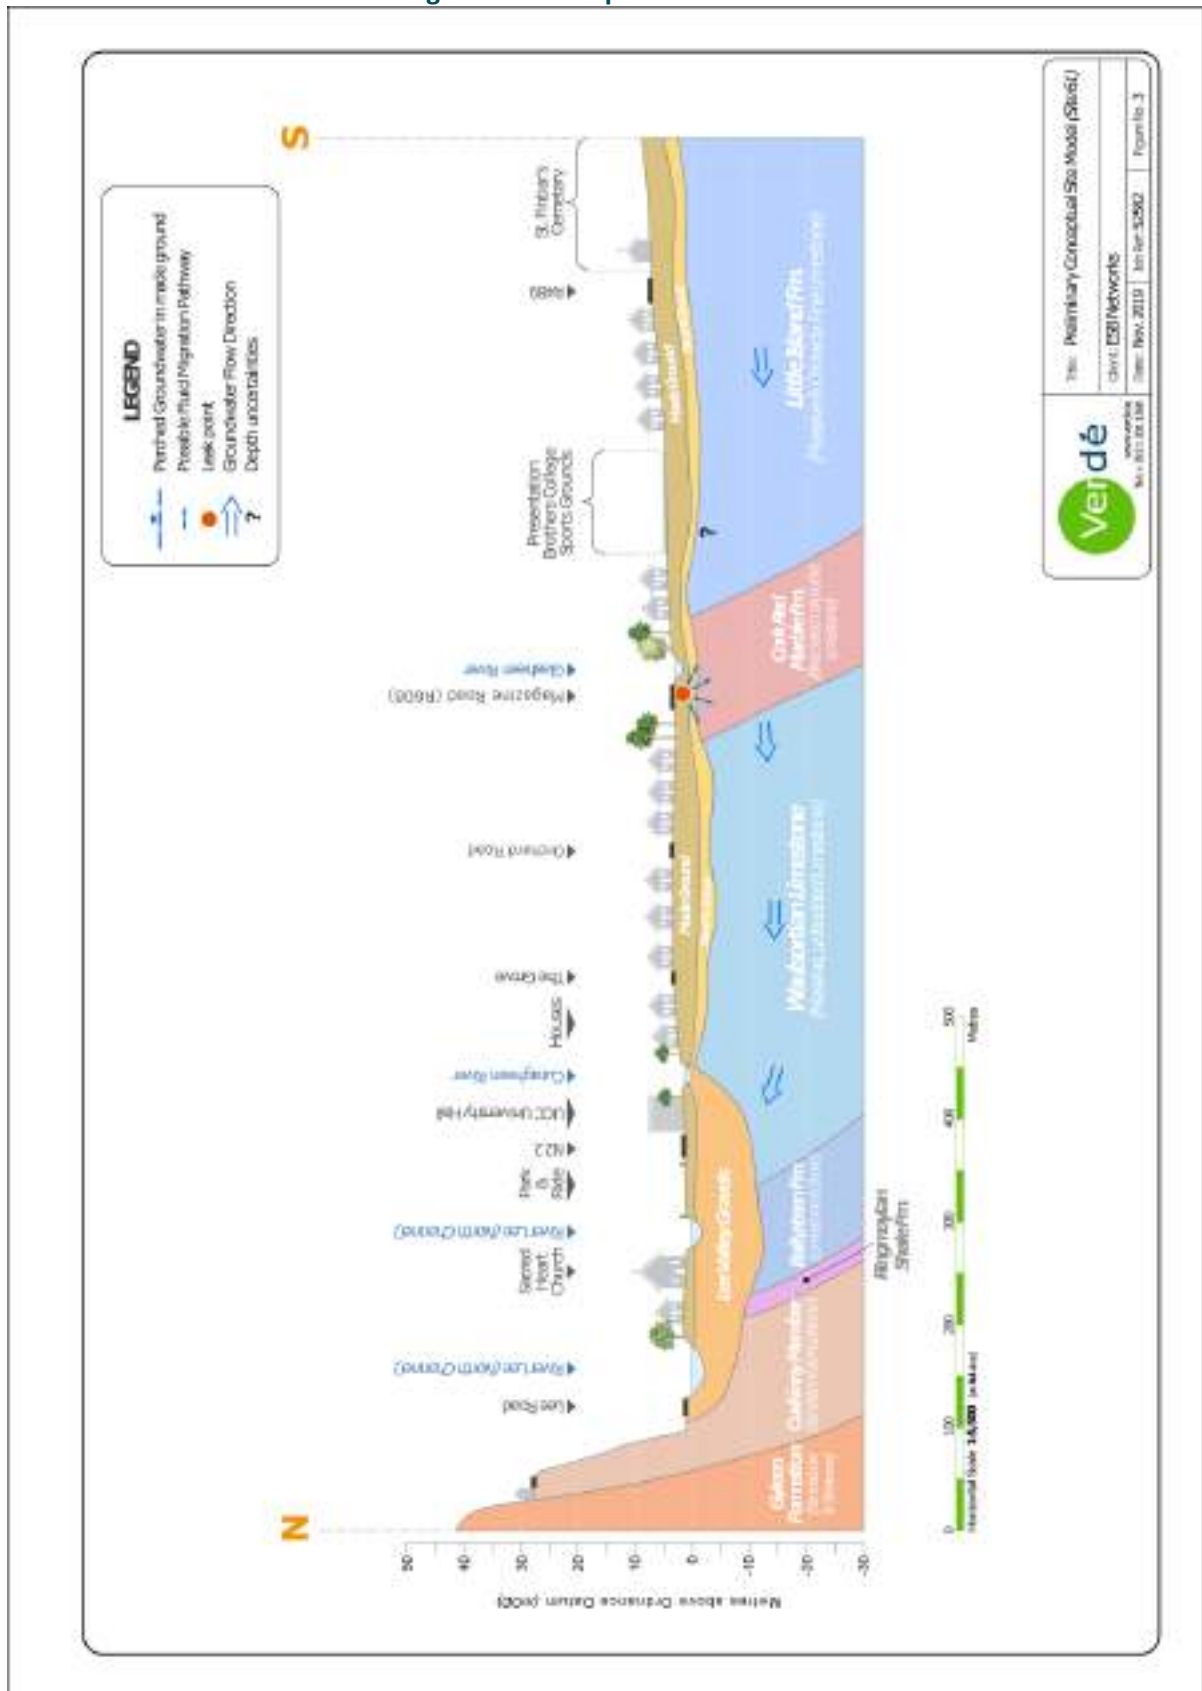
Figure 3 – Conceptual Site Model

- hydrocarbon migration into the adjacent watercourse and the downstream Curragheen River and Upper Lee Estuary given the short distance to the culverted Glasheen River which poses a potential pollutant linkage between the leak site and the surface water receptors.
- hydrocarbon migration to the underlying aquifer given the possible connection to shallow groundwater, or directly to bedrock, through shallow rock in the area indicated by the high to Extreme vulnerability.

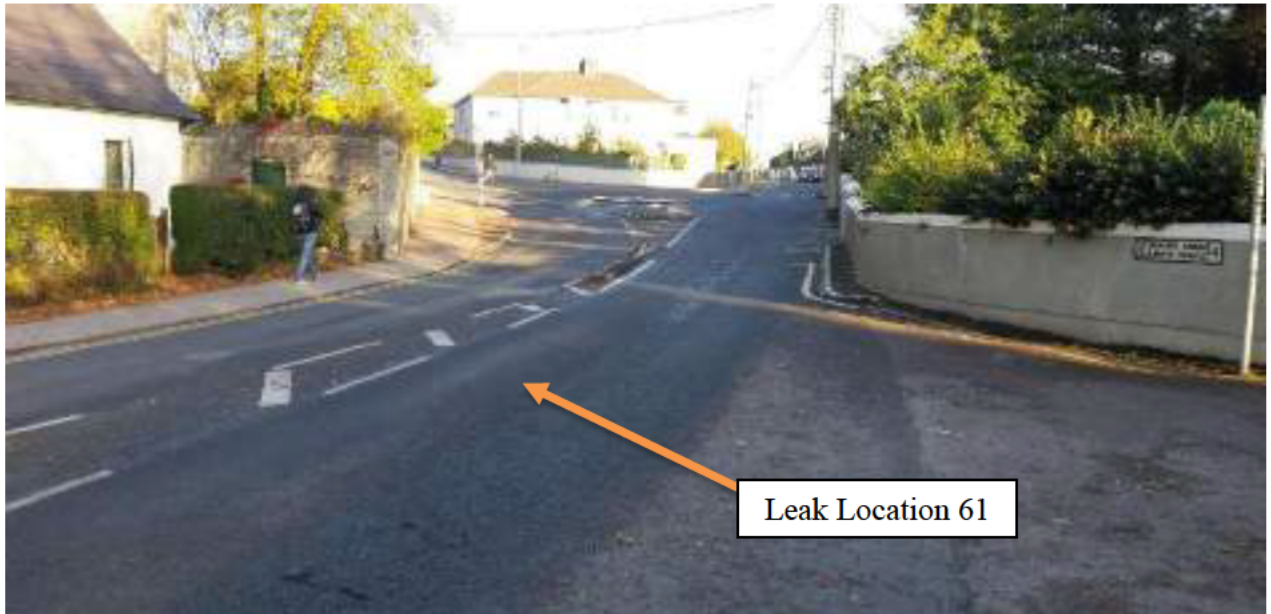
The leak point was located on the eastern side of the road as presented in Photograph 1 in Appendix C. On initial site walkover in November 2019, there was no physical evidence of hydrocarbon contamination on the surface in terms of oil odours/staining or impact to vegetation with healthy looking trees and hedges.

Photo 1. Photo looking east of indicated location of known leak point (ESB Ref: 61) located on eastern side of Glasheen Bridge and River. It is thought that the leak point coincides with the east side of Glasheen Bridge.

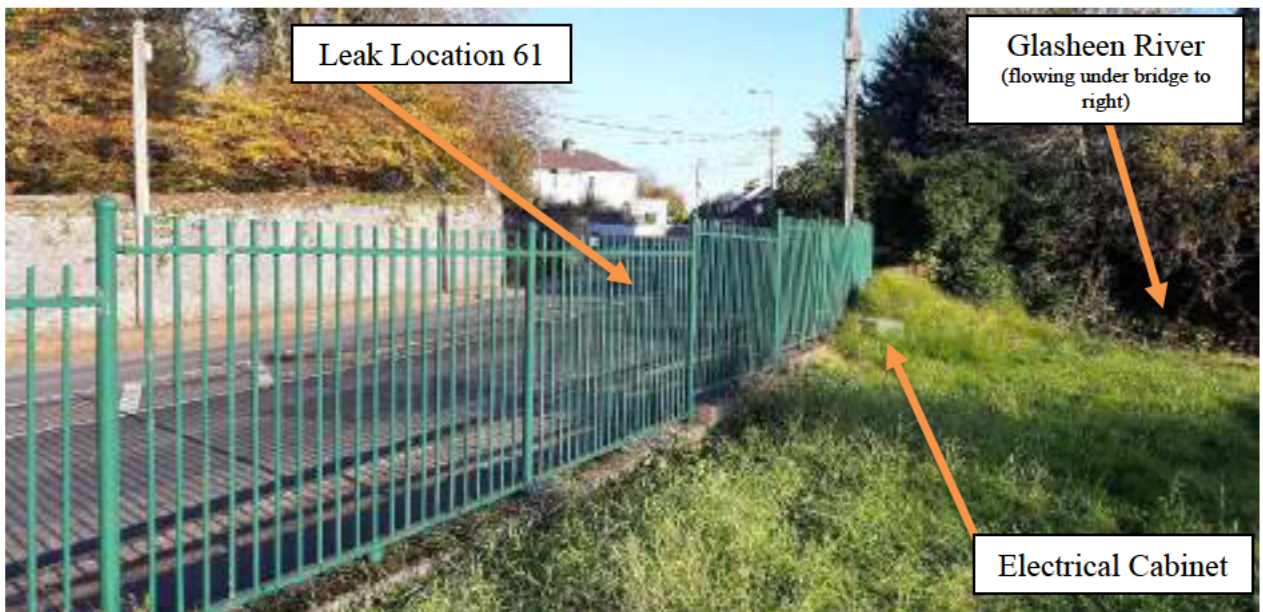
Photo 2. Photo looking east towards indicated location of known leak point (ESB Ref: 61). Note the position of the leak point (background on road); a small electrical cabinet and Glasheen River.

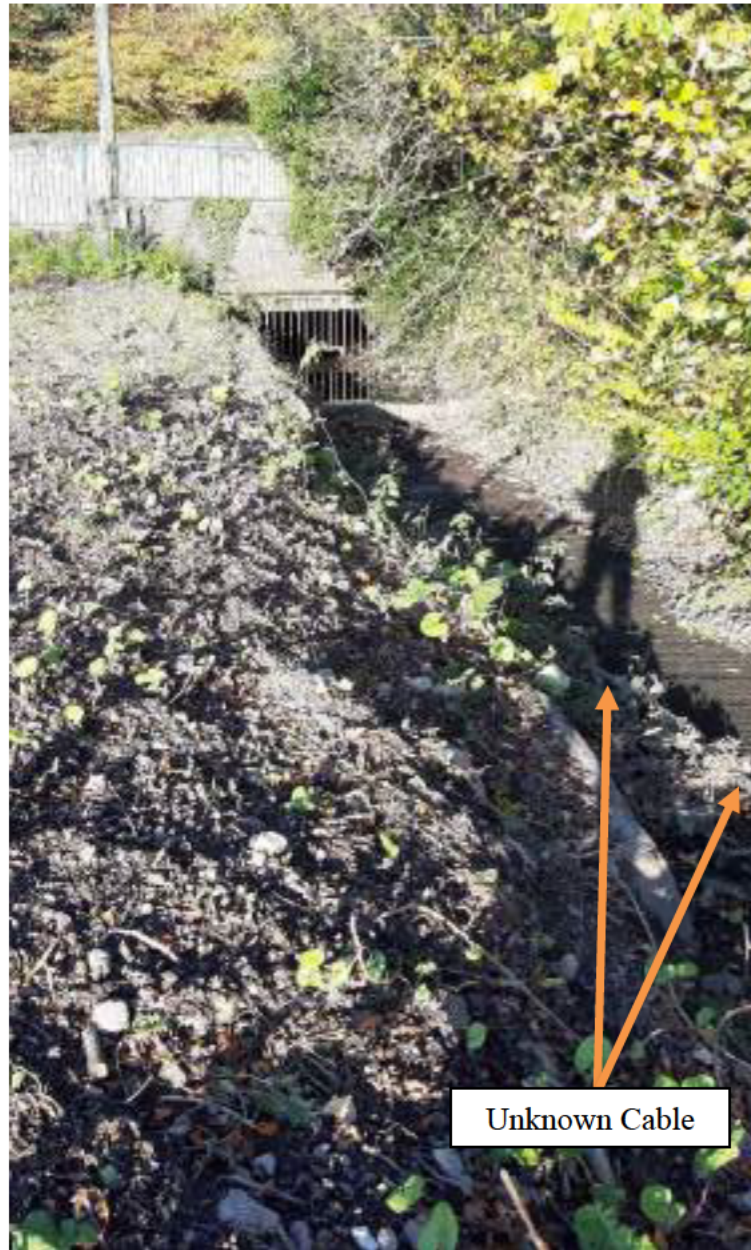
Photo 3. Photo looking north from Glasheen River park area, towards Glasheen Bridge and cable leak point. Note the small concrete weir (dry) and debris at entrance to bridge. Near-stagnant flow. A 2-3" diameter pipe/cable of unknown purpose was seen to follow River and pass under the bridge.

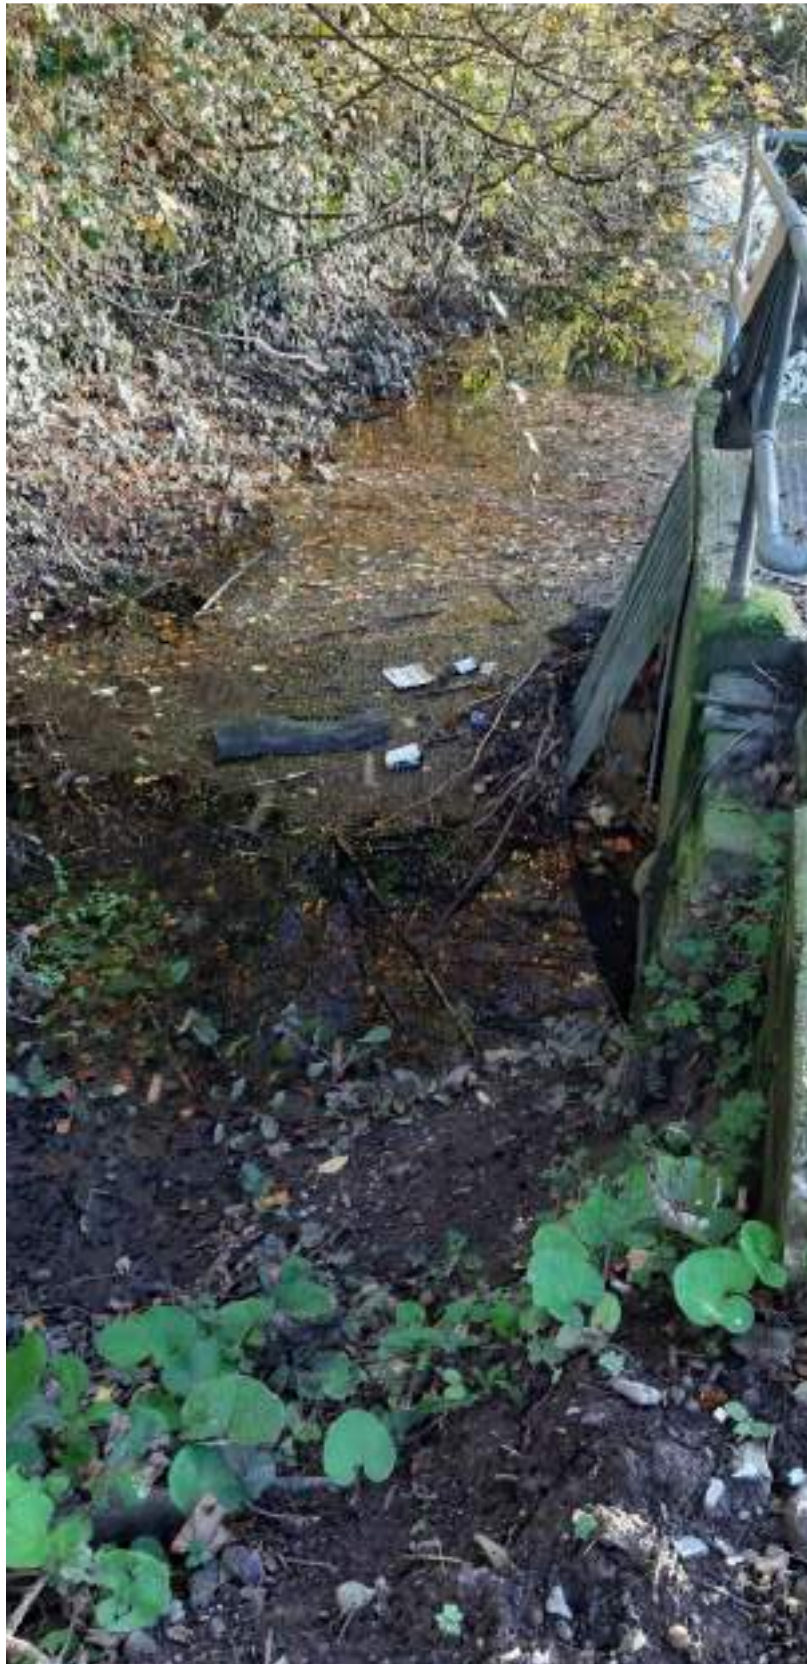
The Glasheen River bridge is located immediately to the east (<5m) of the leak point; where the river passes from south to north underneath Magazine Road (Photo 4 in Appendix C). At the time of the site walkover in November 2019, the river passing under the bridge was seen to be of low flow and somewhat stagnant. It was observed that some sort of culverted diversion of the river approximately 30m south of the bridge. This grated diversion channel was seen to be taking the majority of the river's flow along an unknown path to the north. It is likely that this channel re-joins the river to the immediate east of Orchard Garden's.

Photo 4. View, looking south, of Glasheen River (35m from leak point) showing the location of the diverted channel of the River and associated diversion/treatment/pumping channel and grate. Note that the bulk of flow on the river was flowing into this grate.

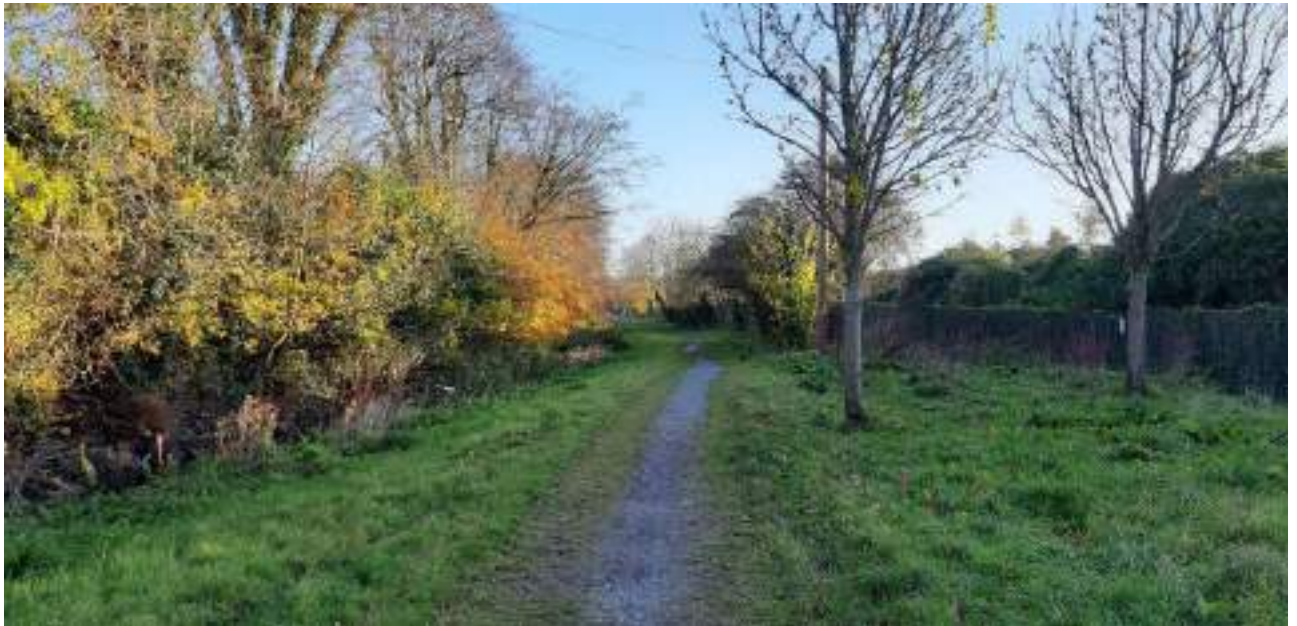
Photo 5. Photo, looking south, from the route of the Glasheen River (left) showing it's route from the south and associated green area.

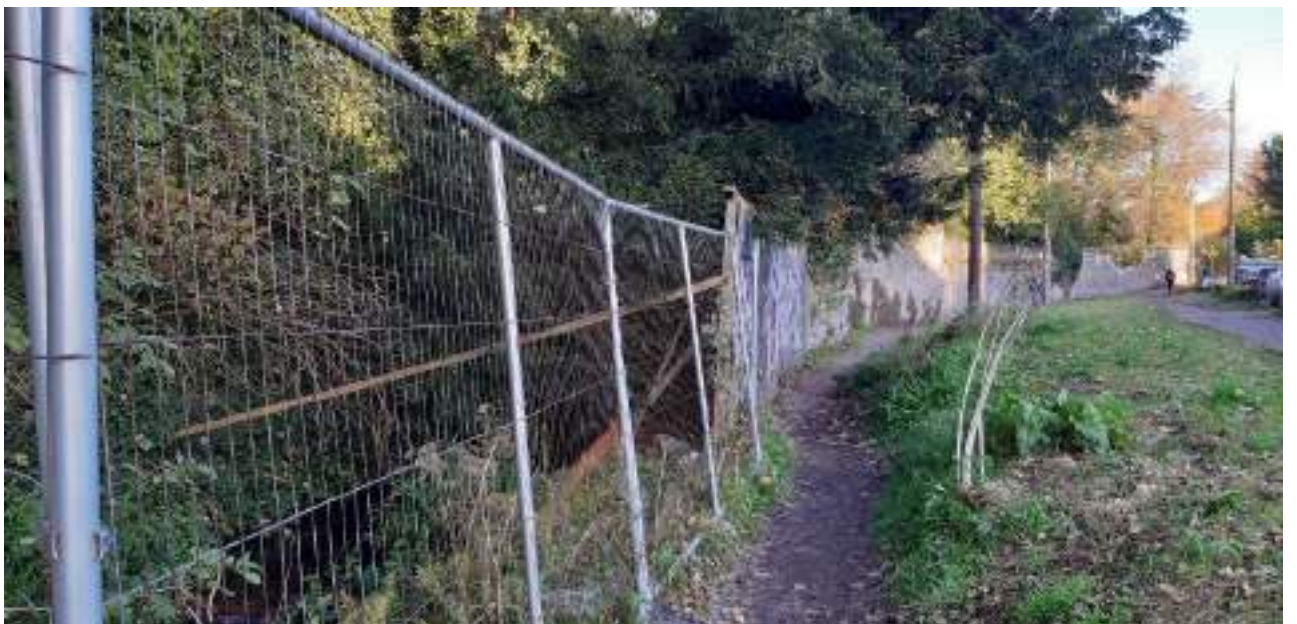
Photo 7. Image showing the route of the Glasheen River to the north side of Magazine Road, at the boundary of the large private estate. The leak point is towards the roundabout in the rear-right background.

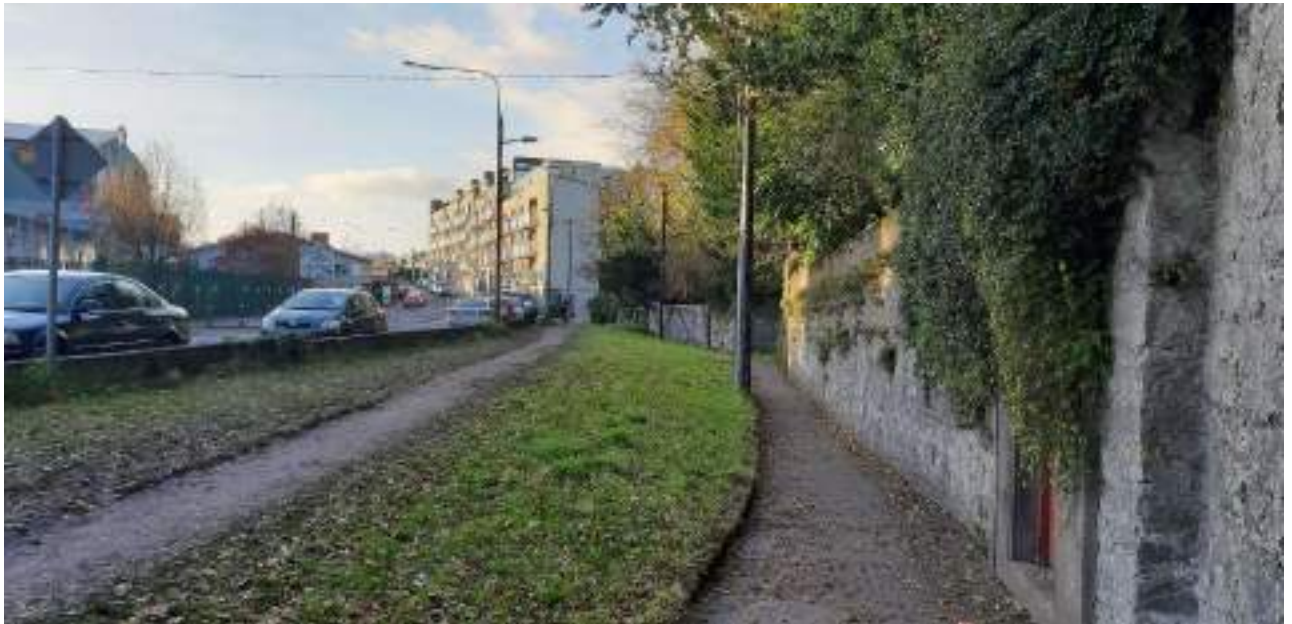
Photo 8. Image, looking west from the area of the leak point, showing the location of the Orchard Gardens apartment complex. Note that the open section of the Glasheen River flows on the north side of the wall seen in the right of this image.
