ESB Networks Historic Cable Fluid Losses: Preliminary Site Assessment

**Location 67: Finglas - North Wall - 220 kV
November 1998 - December 1998**

Project Number: GCU0257001

March 2020

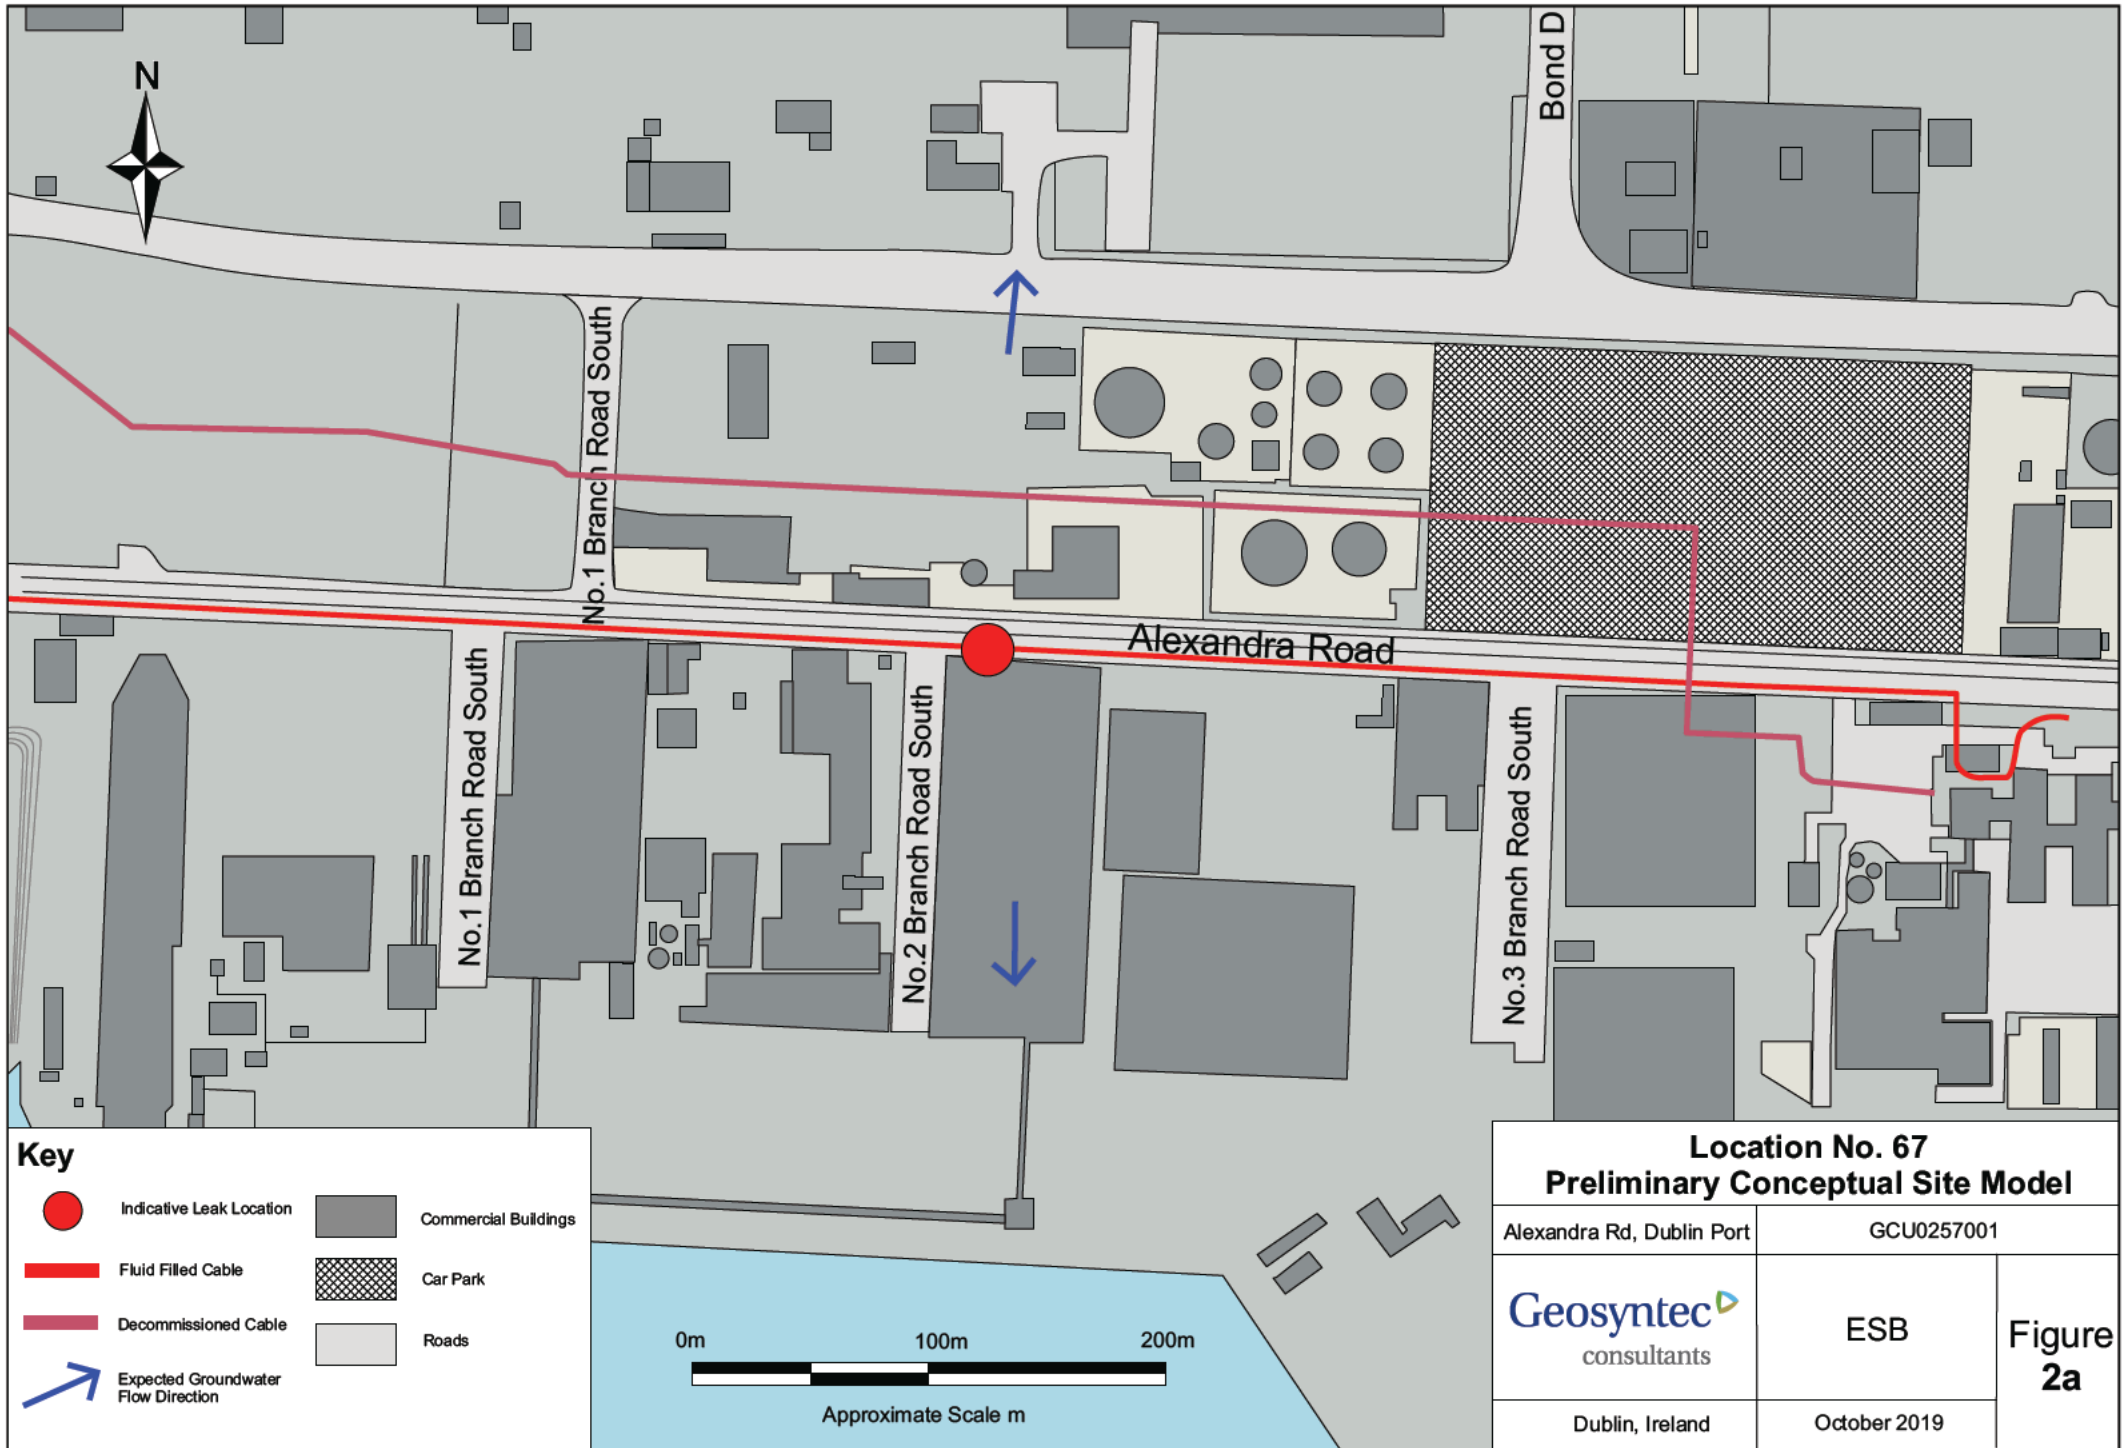
**Location No. 67
Preliminary Conceptual Site Model**

Based on the expected nature of overburden material and/or fill material in the vicinity of the leak location, cable fluid lost to ground in this case can be expected to have spread laterally within the permeable sand bedding within the cable trench, and also potentially radially into the surrounding fill material or natural soil, assuming this material is predominantly granular in nature.

With the above migration pathways in mind, the River Liffey and River Tolka estuaries (the latter of which forms part of a SPA), ecosystems dependent on these water bodies, and the underlying bedrock aquifer, appear to be the key environmental receptors potentially at risk of impact from the leak of cable fluid from this location.

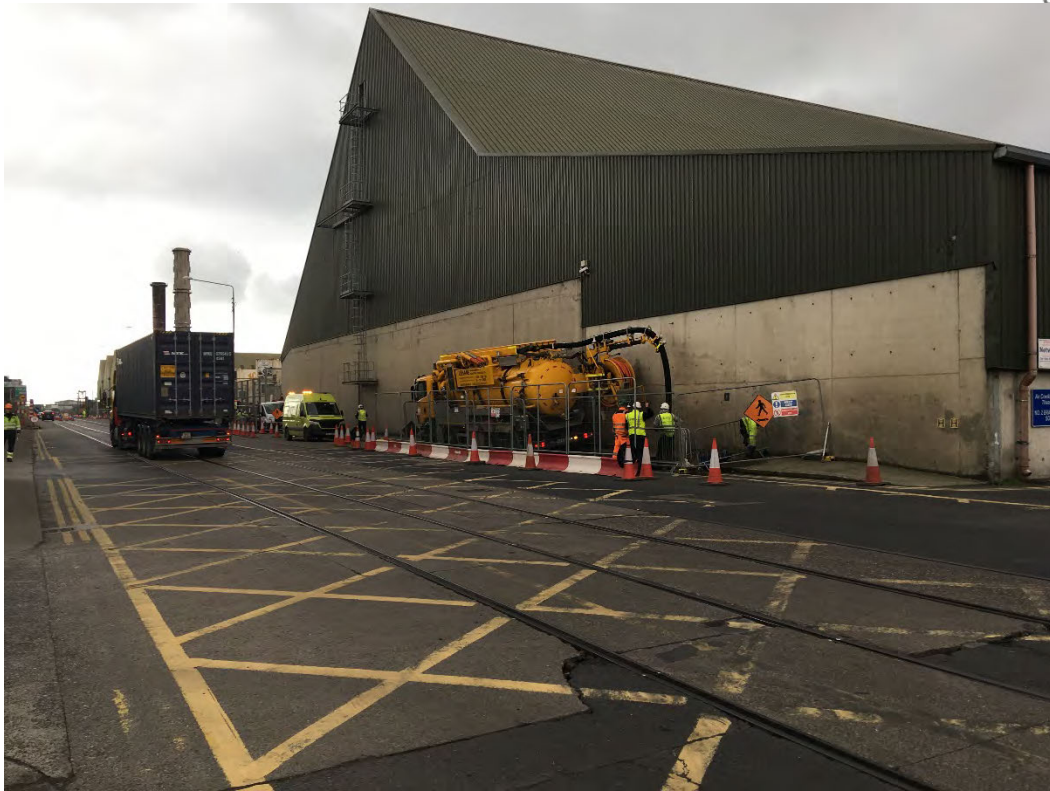
- The leak location is situated on the southern edge of Alexandra Road, close to the intersection with No.2 Branch Road South in North Dock, Dublin Port;

- Land use in the vicinity of the leak location is industrial and commercial associated with Dublin Port operations. The closest building to the leak location is a warehouse, which extends up to the edge of the footpath adjacent to the leak location;

Photograph 1 – Leak location
