Site 7 Inchicore to Poolbeg One 220kV: Preliminary Site Assessment Report for Historic Fluid Filled Cable Loss

ESB Engineering and Major Projects

19126590.07.A.7

25 June 2020

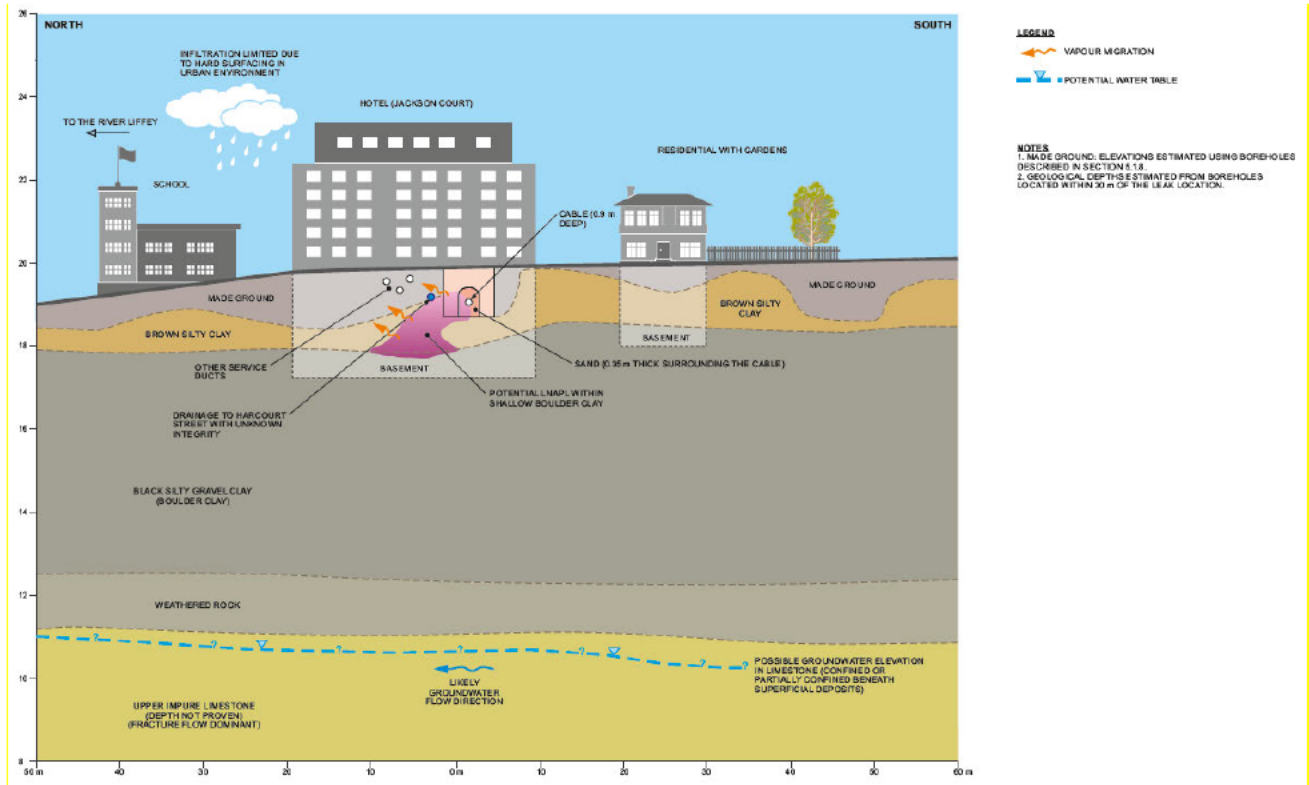
- There is a moderate potential risk that residents in basement apartments or workers in basement offices or cellars close to the spill location could be exposed to vapours.

Figure 1: Preliminary CSM for Site 7 (Inchicore to Poolbeg One).

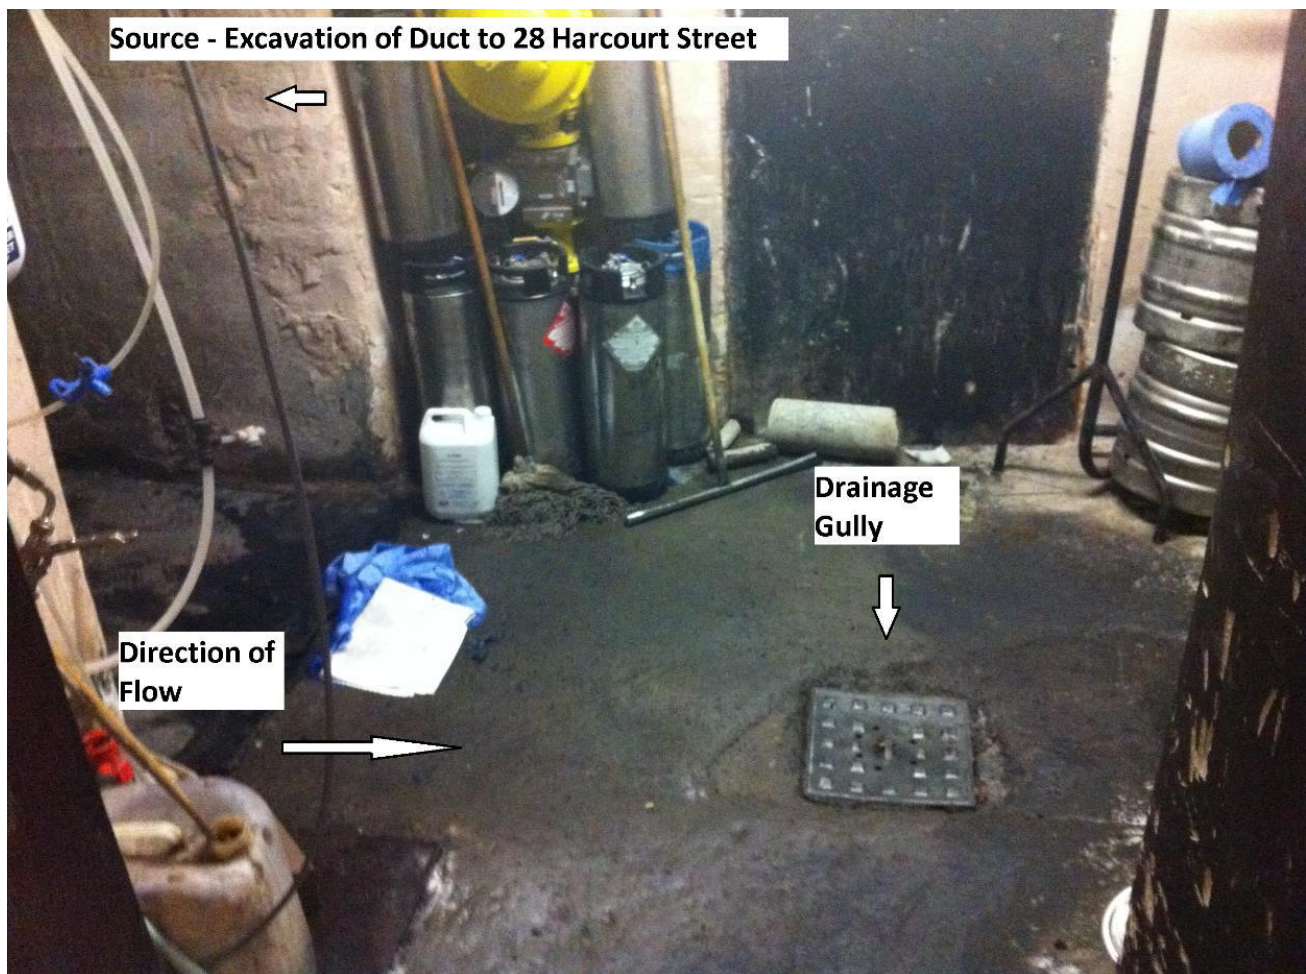
ESB confirmed that the leak occurred in the basement of Jackson Court Hotel, located at 29/30 Harcourt Street, Dublin, in early March 2015. A contractor struck the 220 kV un-energised cable whilst drilling an opening for a duct, causing the oily cable fluid, approximately 4,412 L, to leak from the cable into the duct opening and onto the basement floor. It is understood that the majority of the fluid flowed into a partially confined area of the basement used as a beer keg store and cloakroom. This section of the basement had a gully that the cable fluid collected in before flowing directly to the connected surface water drainage system. ESB noted in their report on the incident that the drainage gully is linked to the Irish Water combined sewer system on Harcourt Street, which ultimately discharges to Ringsend Wastewater Treatment Plant. ESB confirmed that the vast majority of the liquid was discharged to drain which flowed to the treatment plant in Ringsend.

It is noted that the entire leak volume calculated by the ESB is 4,412 L. The vast majority of this active fluid flowed to the drainage system and the residual spill was treated with sorbent pads and cleaned down. Therefore, the residual volumes remaining after this spill are considered to be low by ESB.

Figure 2: Photograph of the basement in Jackson Court following the leak incident. Photograph taken after the majority of the fluid had drained into the drainage system, but prior to ESB remediation contractor attending the location (photograph provided by ESB, dated 7 March 2015).

ESB has confirmed that Rilta Ltd were engaged by ESB Networks to clean up this cable fluid spill. ESB state that Rilta used absorbent pads to clean the residual cable fluid spill and in total removed a 180 kg drum of waste from the Site to an appropriate disposal facility using a licenced waste contractor.

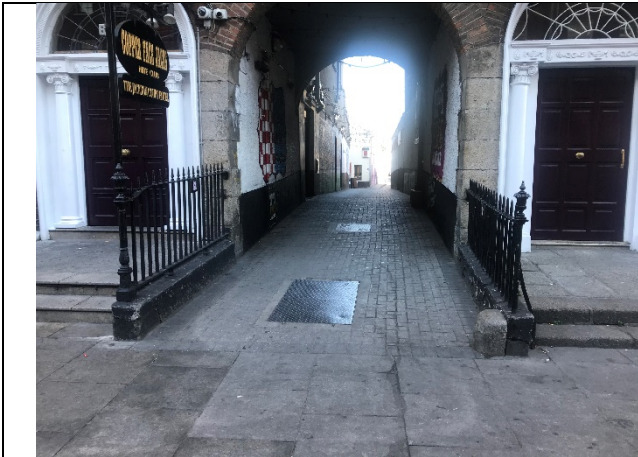
7-01 – Manhole covers present at indicative leak location, at arch to Camden Place.

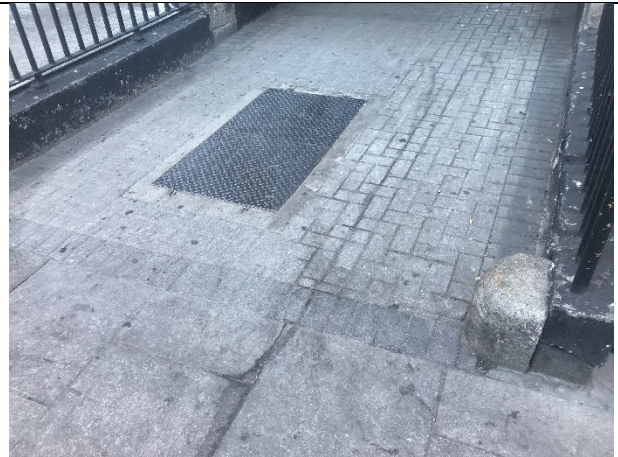
7-02 – Staining noted on footpath surface at indicative leak location. Consistent with surrounding staining, likely resulting from activities associated with the adjacent nightclub.

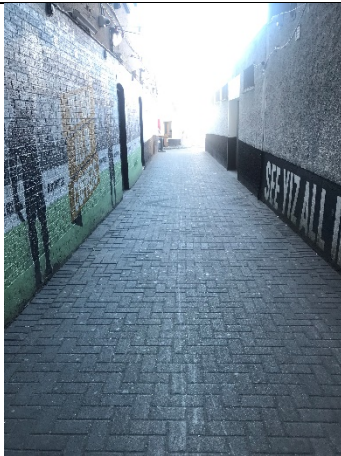
7-03 – Paving under Camden Place in good visible condition.

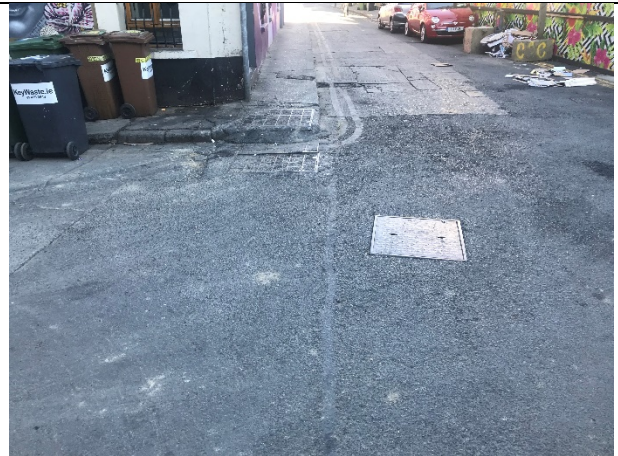
7-04 – Camden Road surfacing is a mixture of concrete and asphalt. The concrete surface was noted to be damaged in several areas and HGV movements were noted on Camden Place.

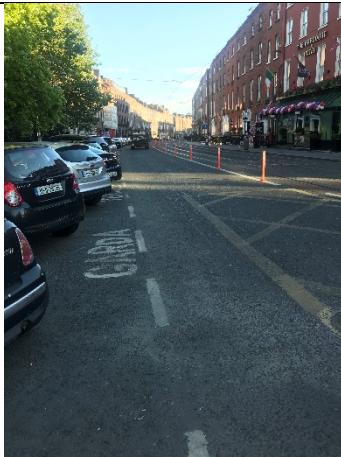
7-05 - Road surfacing in good condition on Harcourt Street.

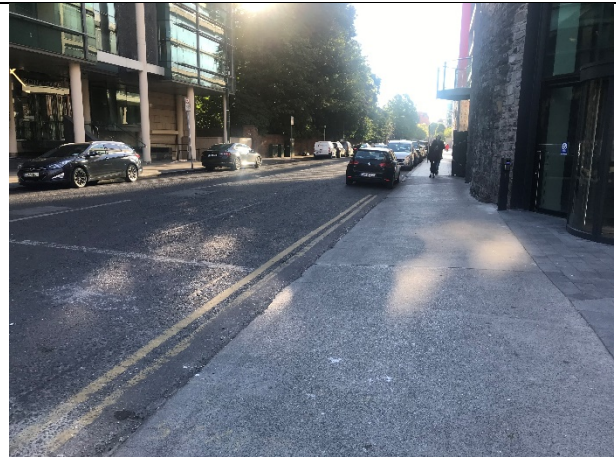
7-06 – Road surfacing in good condition on Hatch Street Upper. Staining noted on surface, typical of minor losses from parked cars.

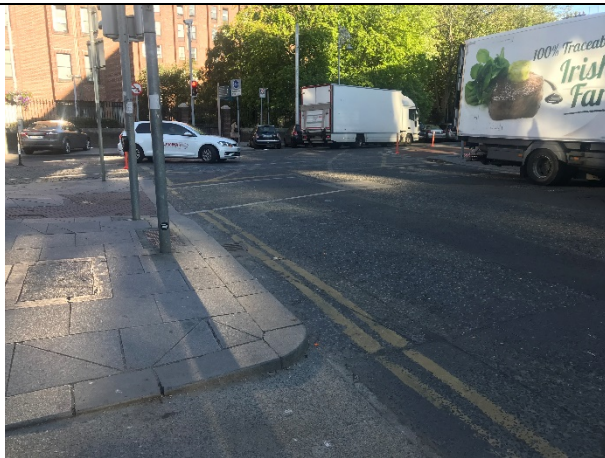
7-07 – Some surface repairs evident on Harcourt Street Upper.

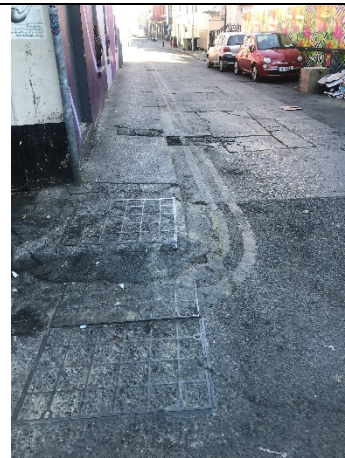
7-08 – Staining noted along section of interest (approx. 25 m west of indicative leak location, on Camden Place); however, appears consistent with bins stored locally.

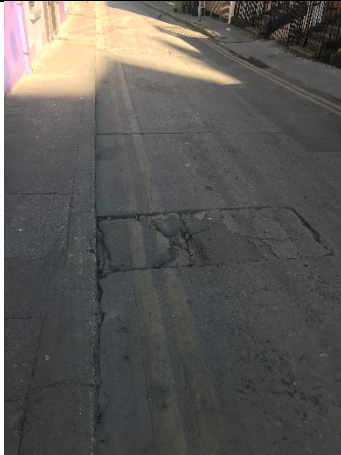
7-09 – Numerous sections cut from concrete on Camden Place. Indicative of repairs or access to subsurface utilities.

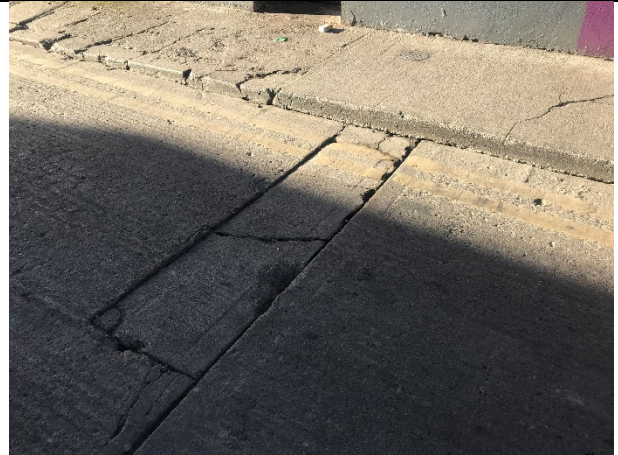
7-10 - Numerous sections cut from concrete on Camden Place. Indicative of repairs or access to subsurface utilities.

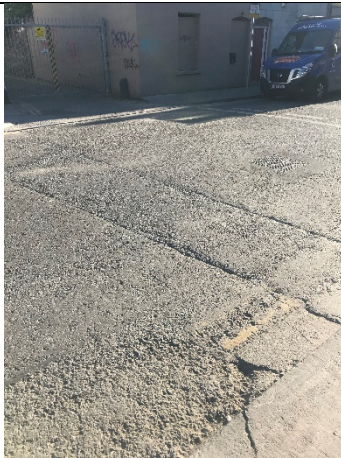
7-11 – Road surfacing in good condition on Pleasants Street. Some sections of previous works evident, indicative of repairs or access to subsurface infrastructures.

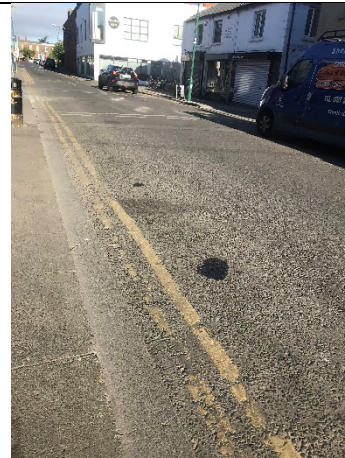
7-12 – Staining noted on road surface of Pleasants Street, typical of a parked vehicle.

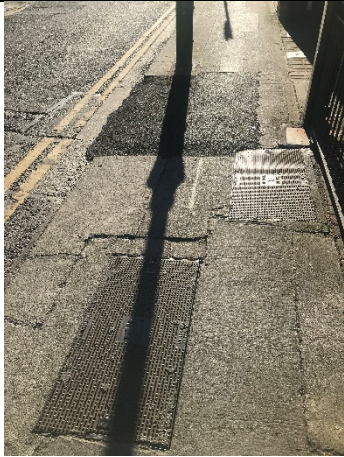
7-13 – Numerous telecommunications conduits noted along the section of interest (Pleasants Street).

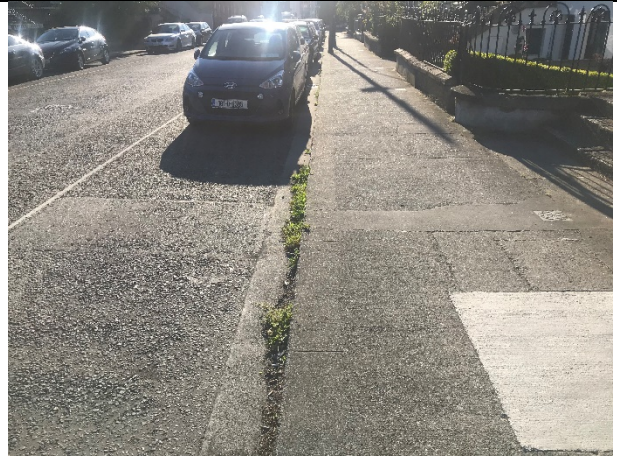
7-14 – Numerous water connections perpendicularly crossing the section of interest on Pleasants Street. Repaired sections lead to water meter covers.
