# Storm Éowyn Review

Issue date: October 2025

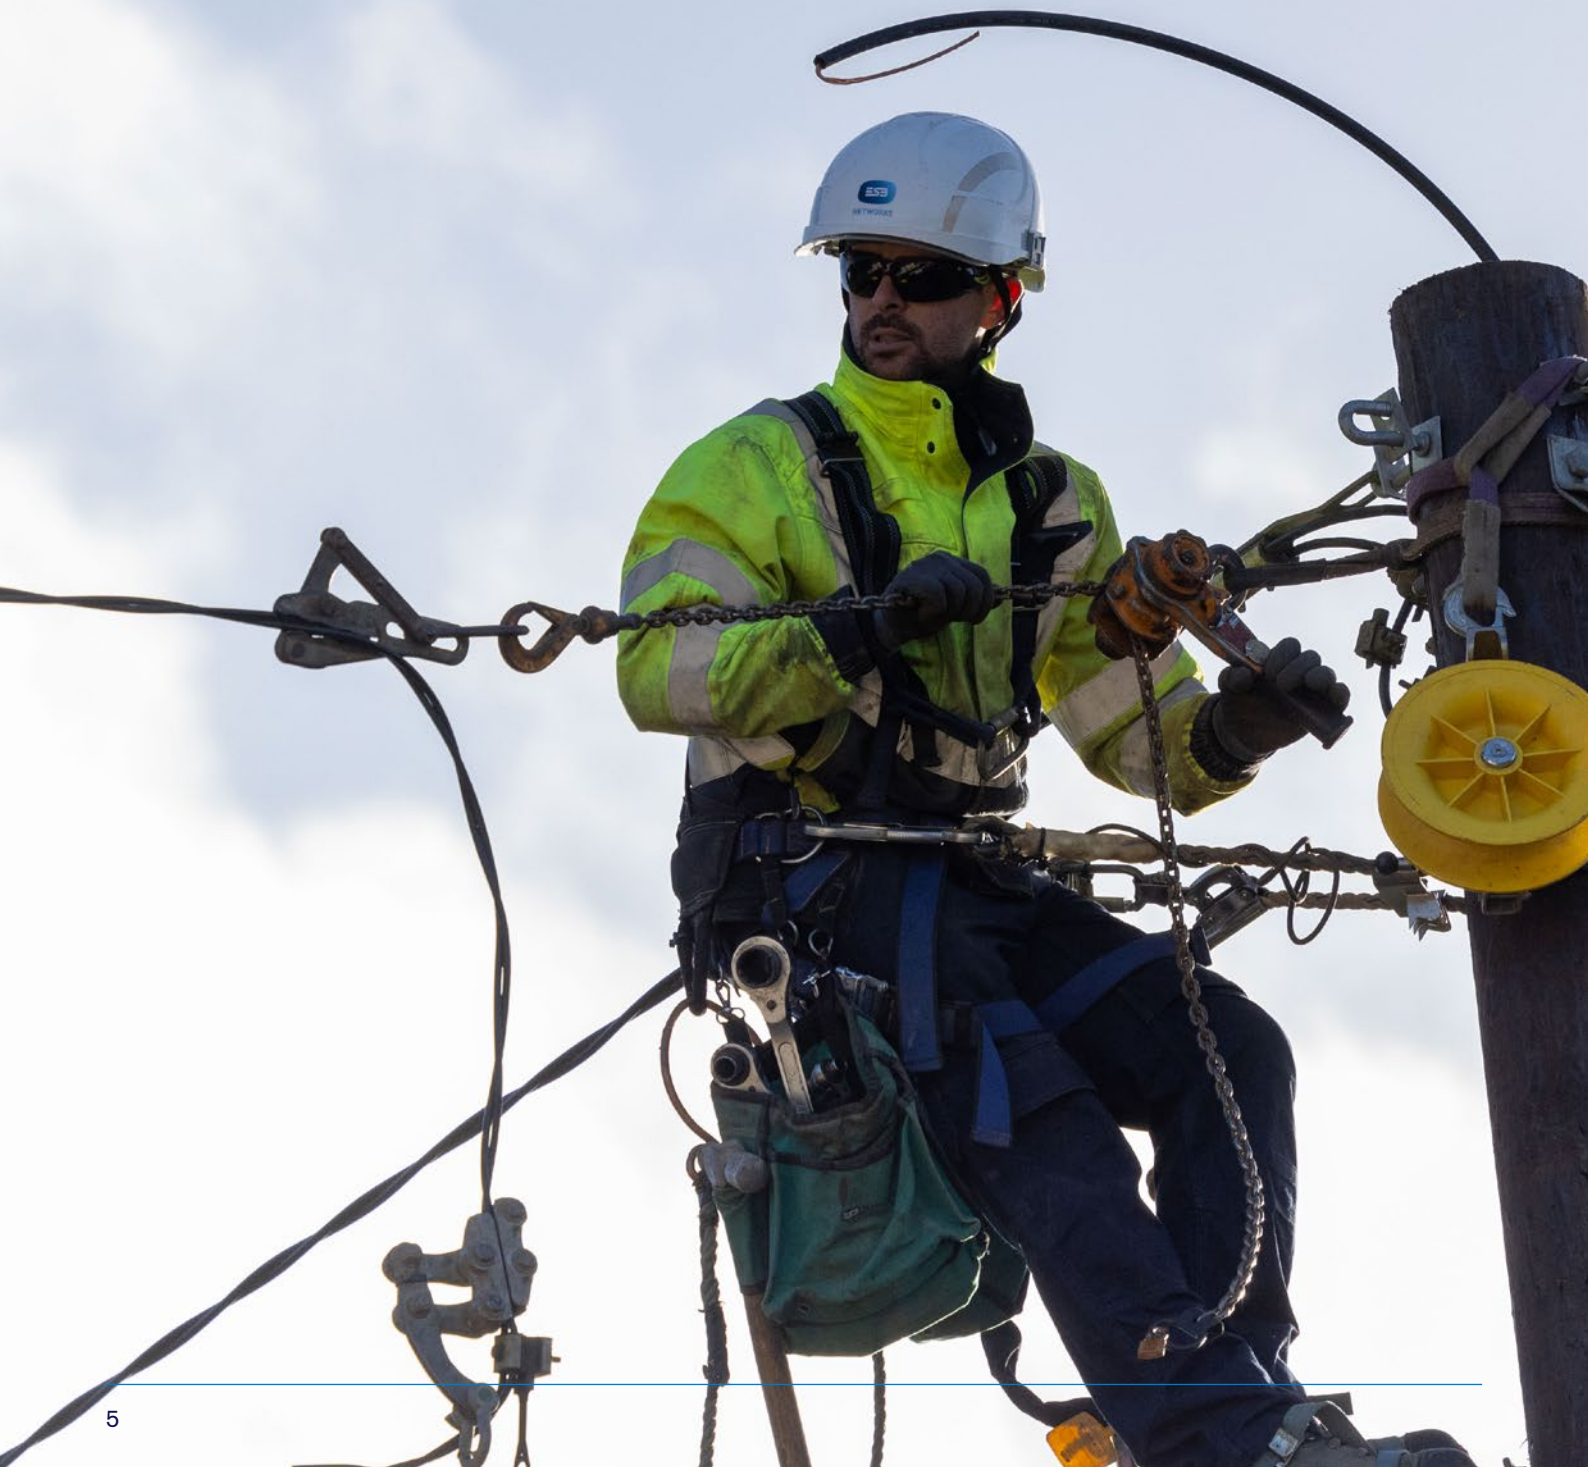
## Unprecedented Impact to Communities and Businesses

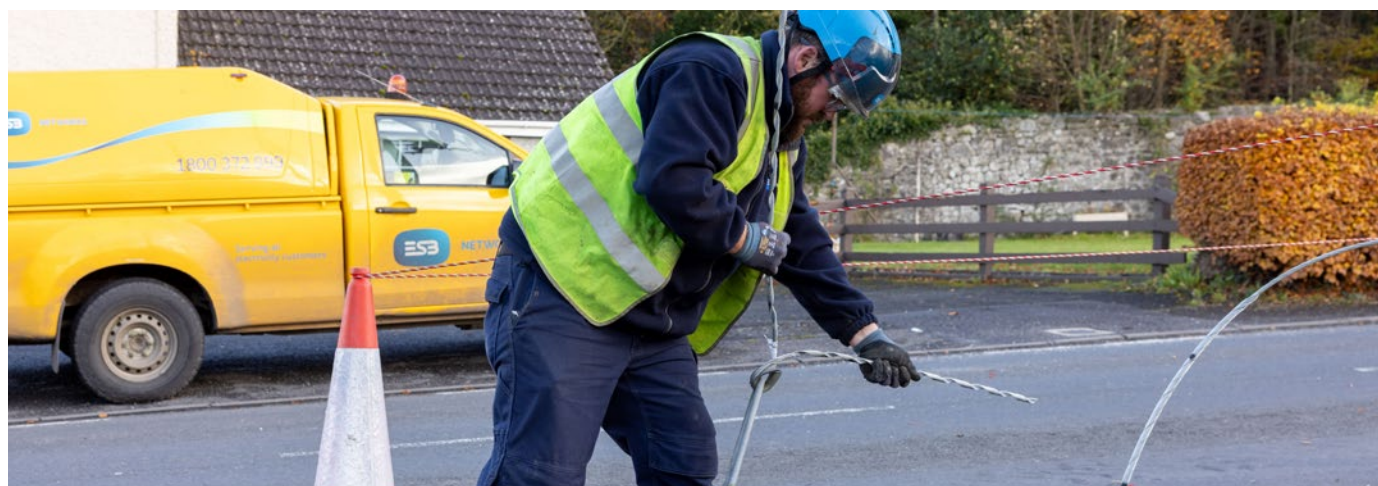
Formalise Safety Assurance roles within emergency storm plans to include dedicated auditors for real-time observation and post-storm safety auditing, aligned with day-to-day safety practices. Standardise safety protocols for visiting utilities through NEWSAC and E.DSO collaboration, including the development of Storm Safety Toolboxes to support consistent safety practices. Ensure employee wellbeing by applying oversight to the scheduling rest days during and after storm events, to safeguard recovery and performance.

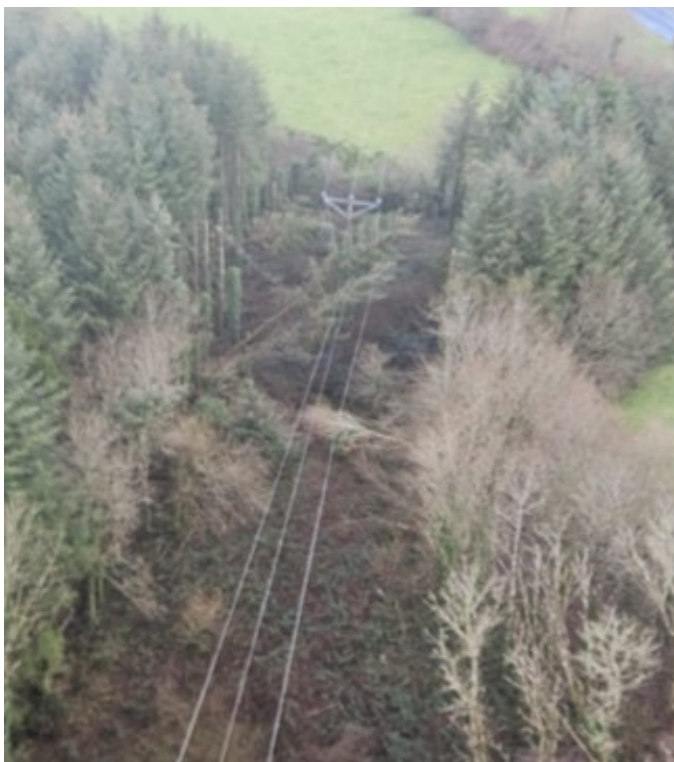
**Figure 6: Arva – Carrick On Shannon 110kV  
network, Co. Leitrim**

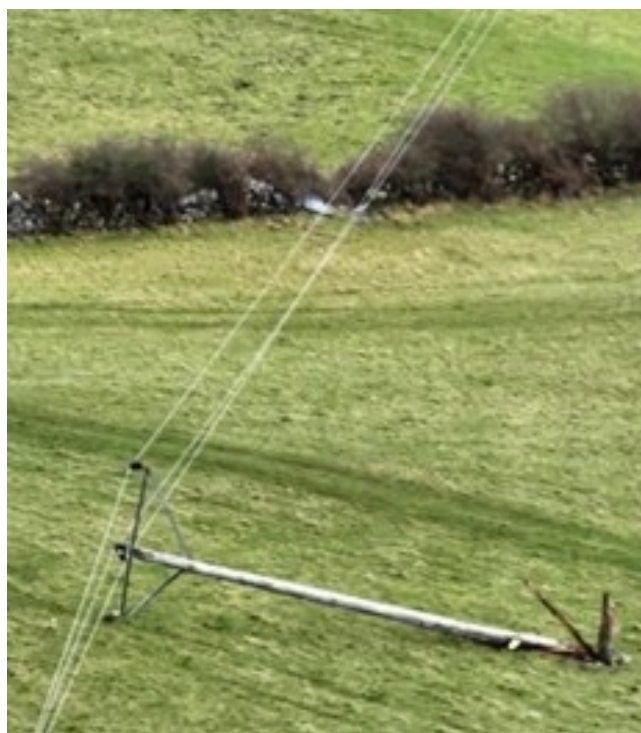
**1.1.4 Overview of damage caused across the country**

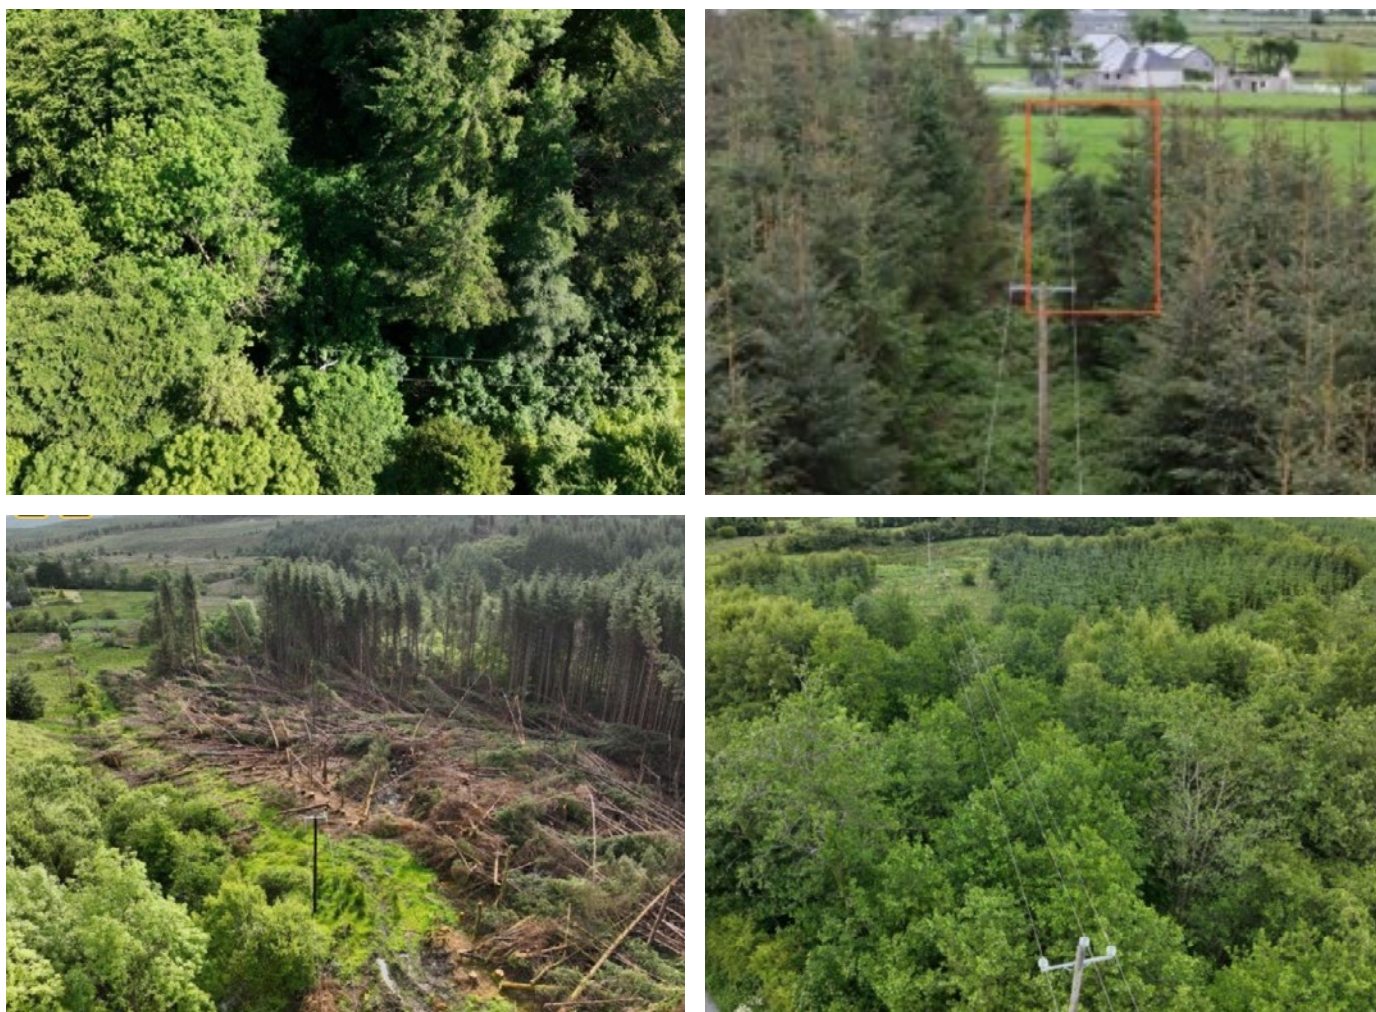
## 1.2 ESB Networks Emergency Planning for Storms

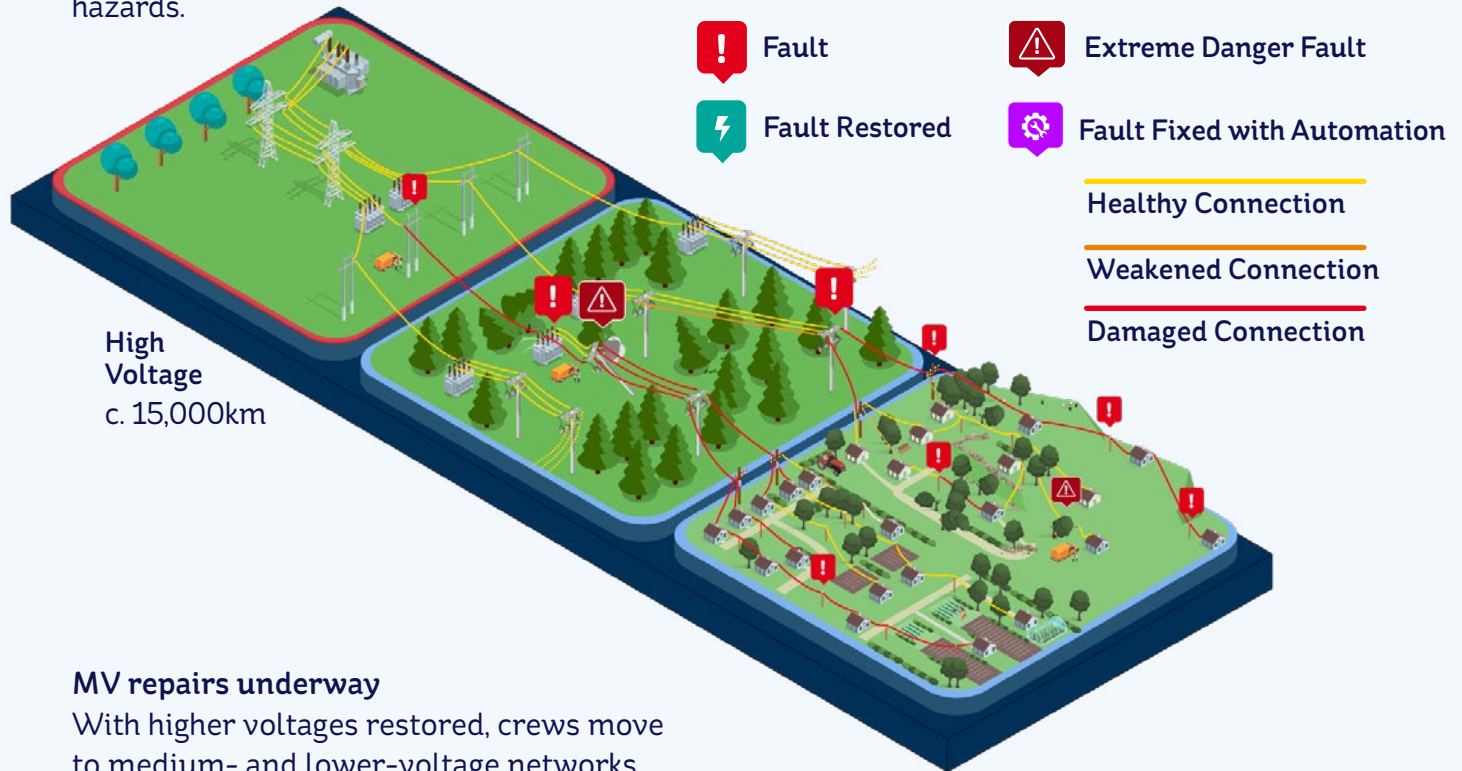
### MV repairs underway

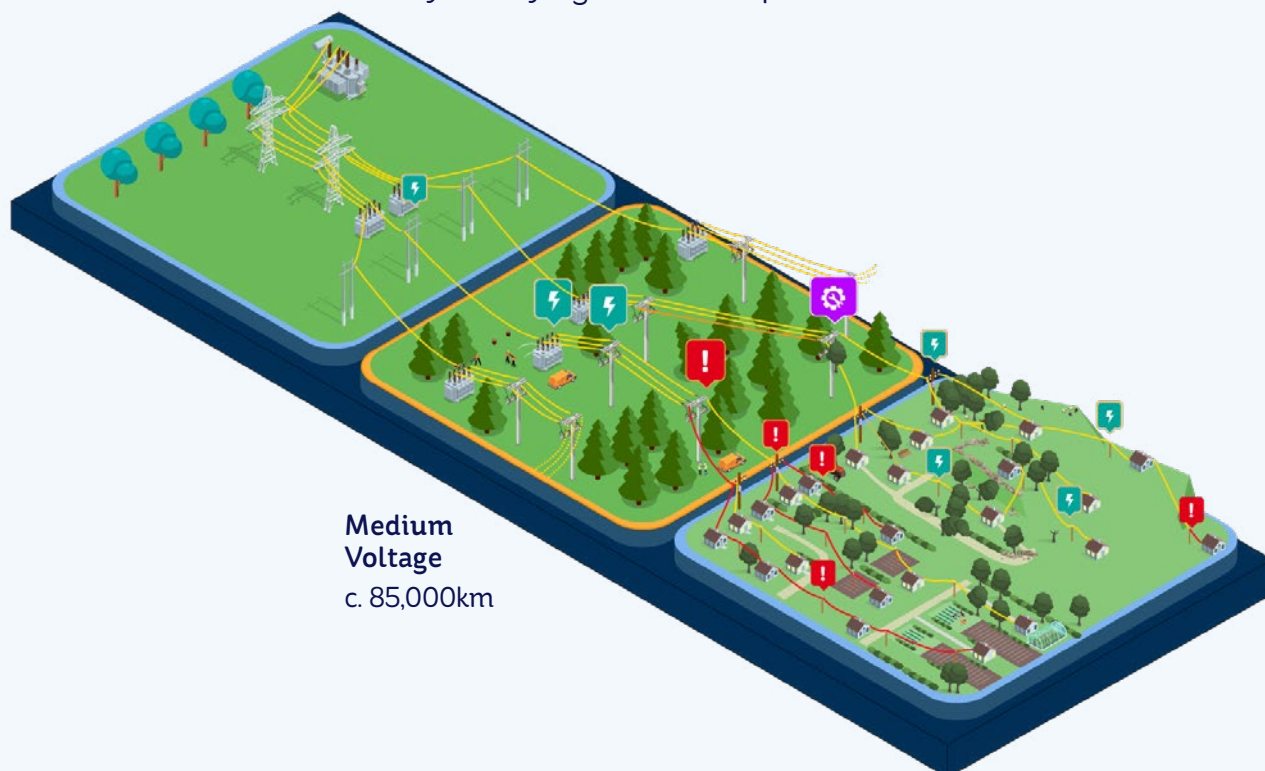
## LV repairs underway

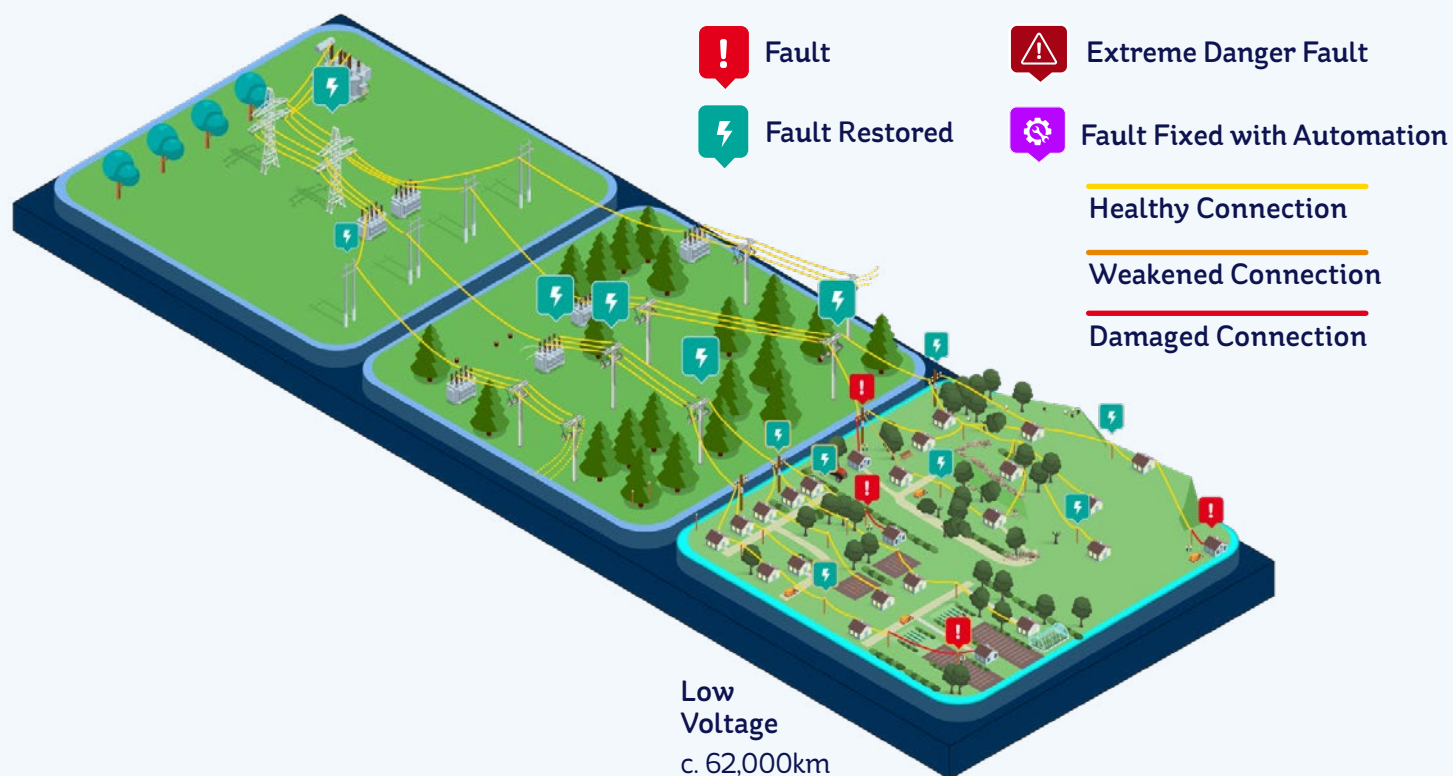
## 2.2 Timeline of Restoration

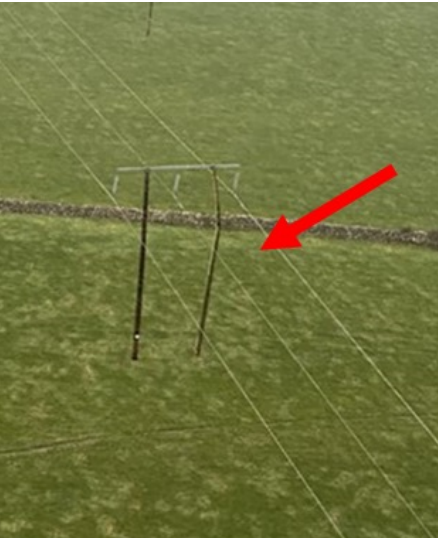
**Figure 18: Forestry Fault, Cavan (Rathrussan - Shankil 110kV line)**

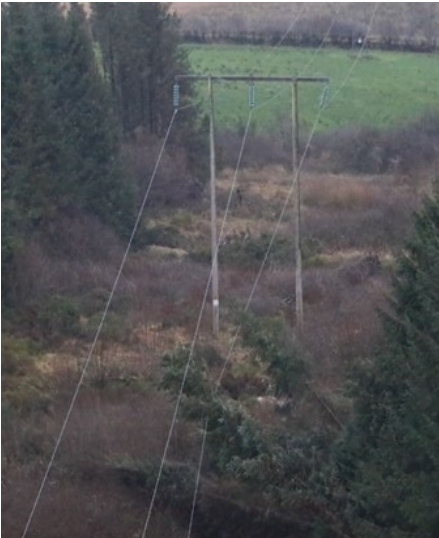
In order to return the transmission network to normal operation, there was ongoing engagement with EirGrid’s teams to assess the faults and agree the prioritisation of fault repair, while balancing the need for repair and restoration of the distribution network. ESB Networks deployed its transmission crews to repair the identified faults, and as an additional precaution, given the importance of the transmission system, almost 5,000km of the transmission network was flown by helicopter to identify any residual hazards that needed to be addressed.

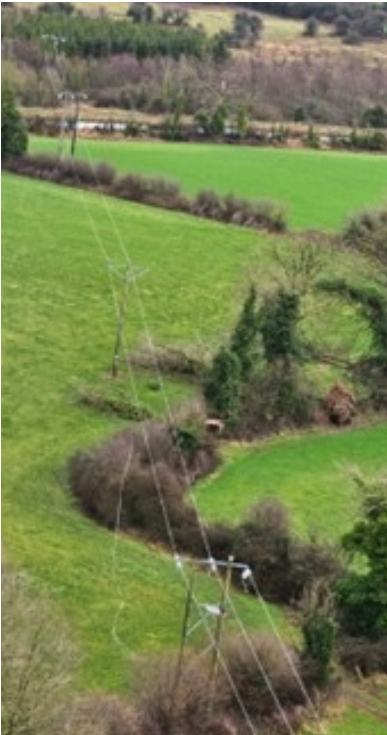
**Figure 21: Leaning pole on 38kV network (Cathleen Falls 38kV)**

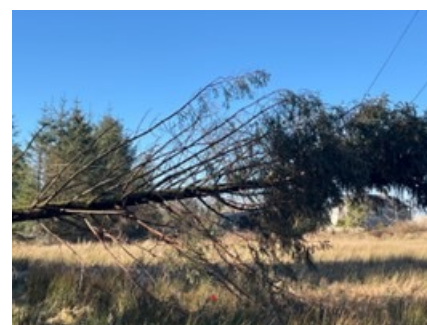
#### Example #2: Hedgerow Timber Fault Repair at Medium and Low Voltage network

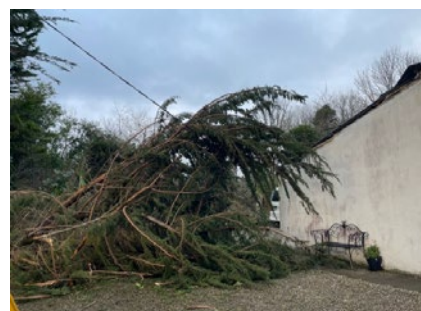
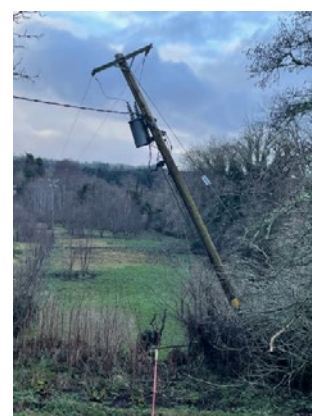
**Example #3: Hedgerow Timber Fault Repair at Medium Voltage network**

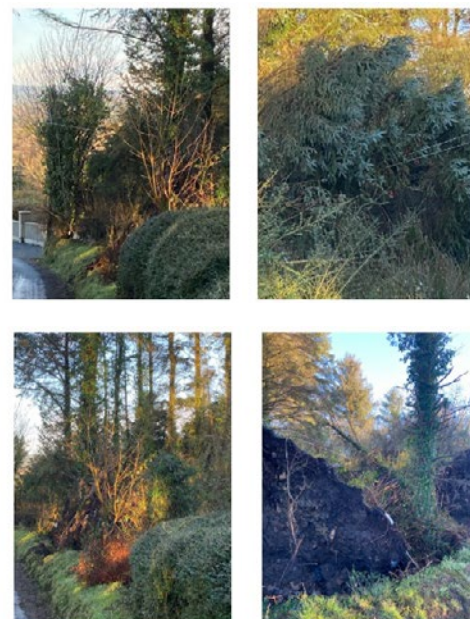
**3.1.4.3 Damage Assessment Data for Forestry Related Faults**

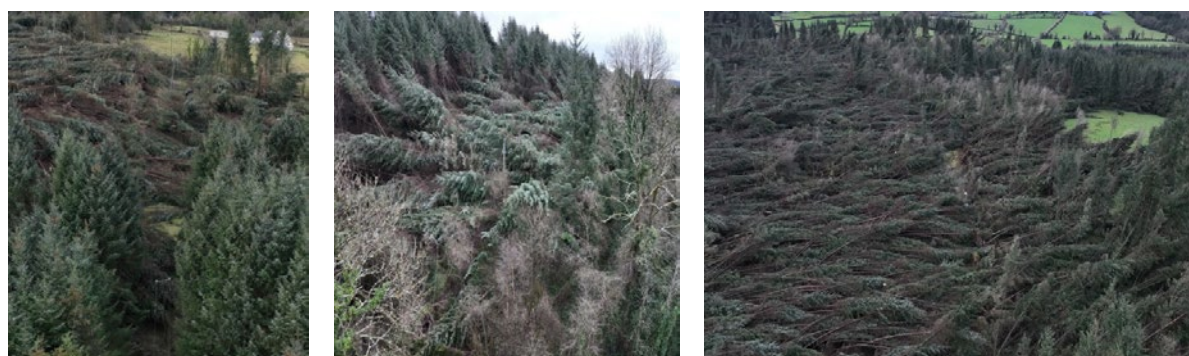
#### Example #1: Forestry Fault Repair at Medium Voltage network

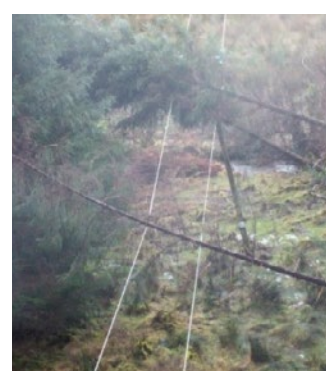
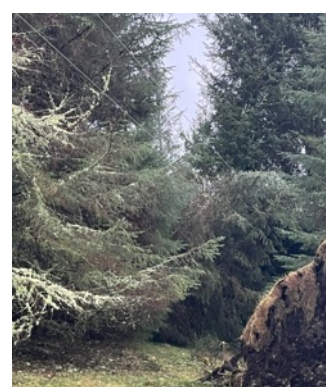
**Example #2: Forestry Fault Repair at Medium Voltage network**

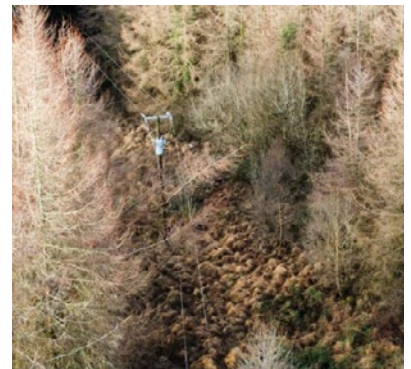
**Example #3: Forestry Fault Repair at Medium Voltage network**

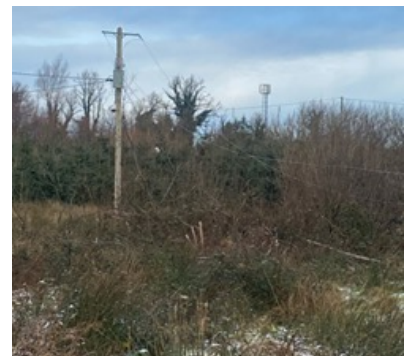
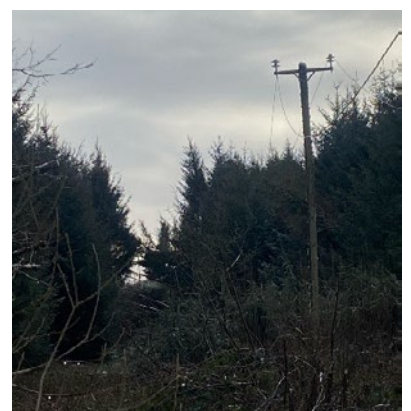
#### **3.1.4.5 Estimated Effort to Repair Fault Types involving Timber Cutting and Forestry Harvesting**

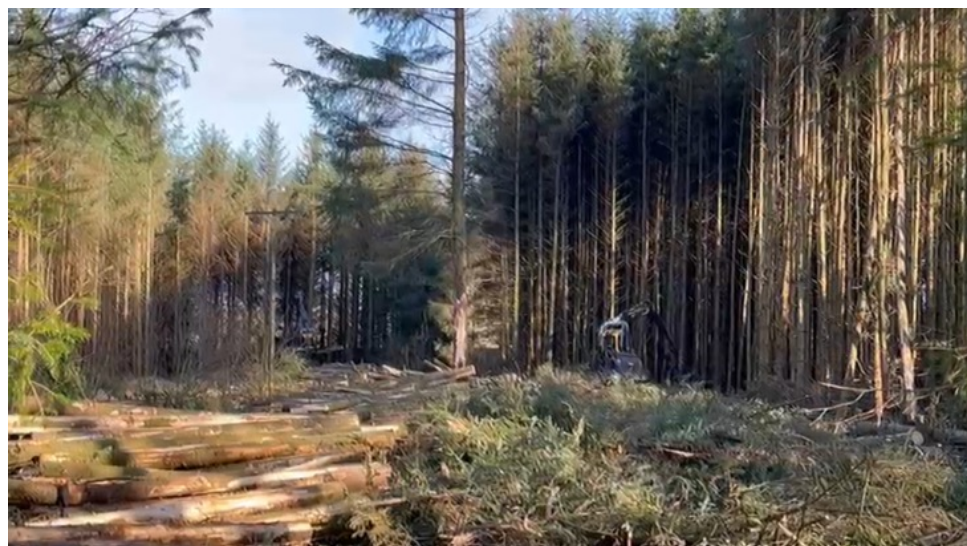
#### **3.1.5 ESB'S Statutory Powers for addressing forestry and hedgerow timber along the network**

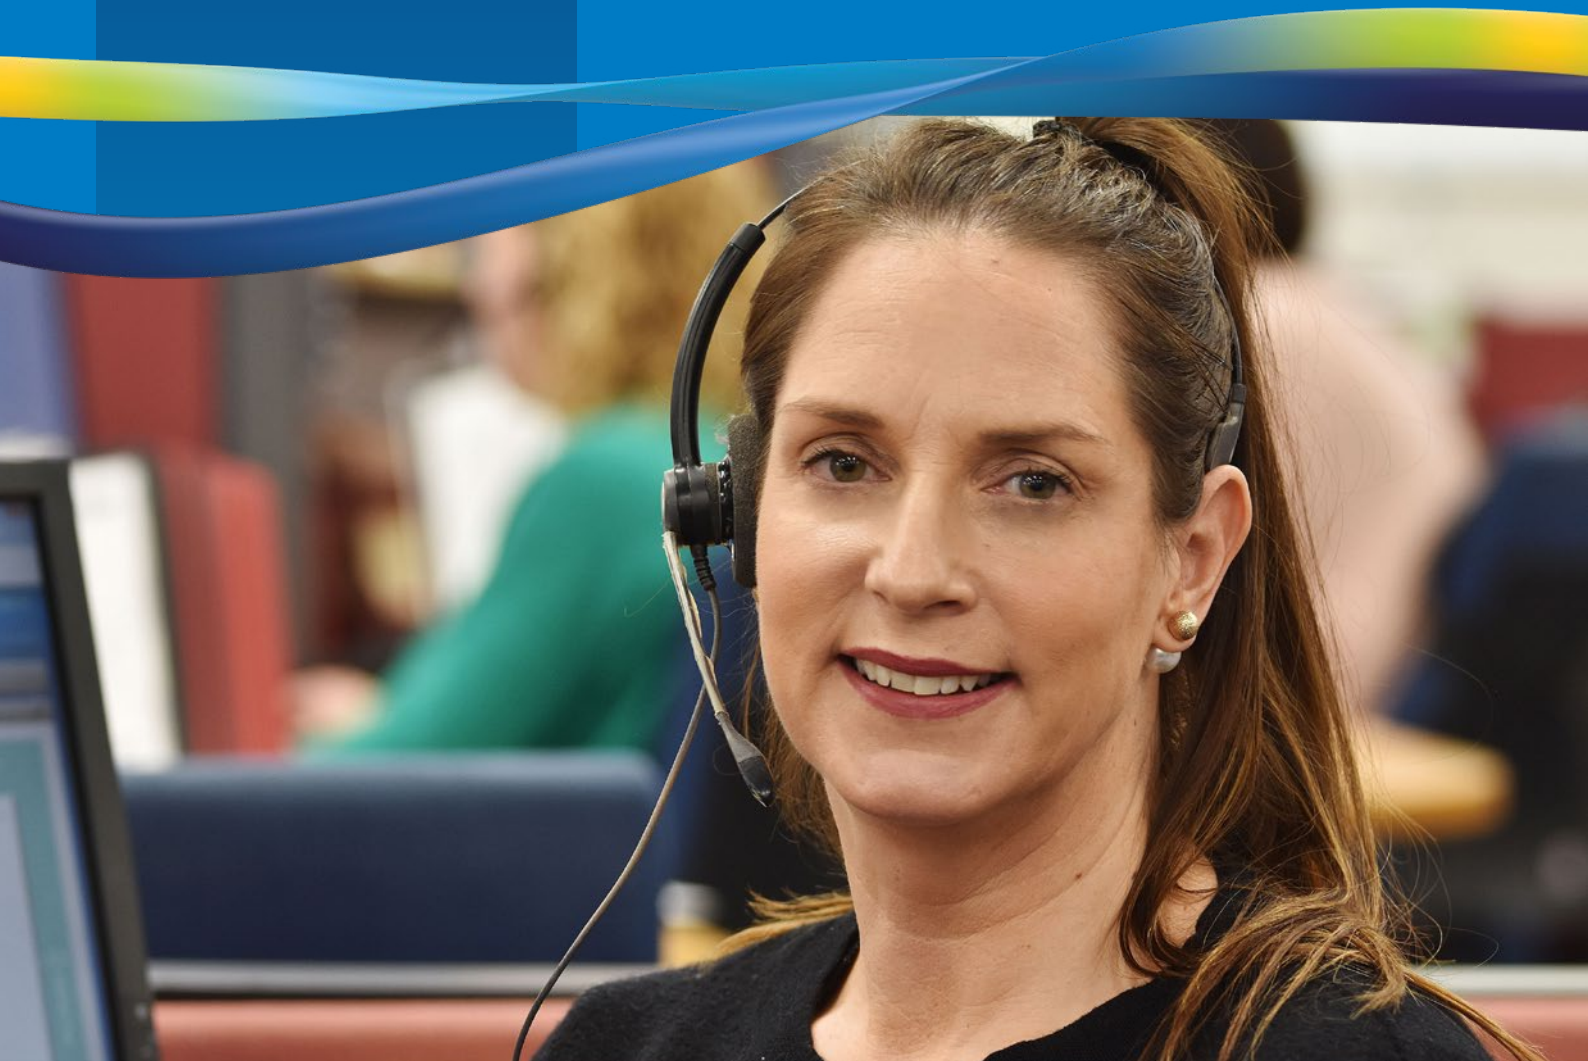
## 5 Customer and Communications

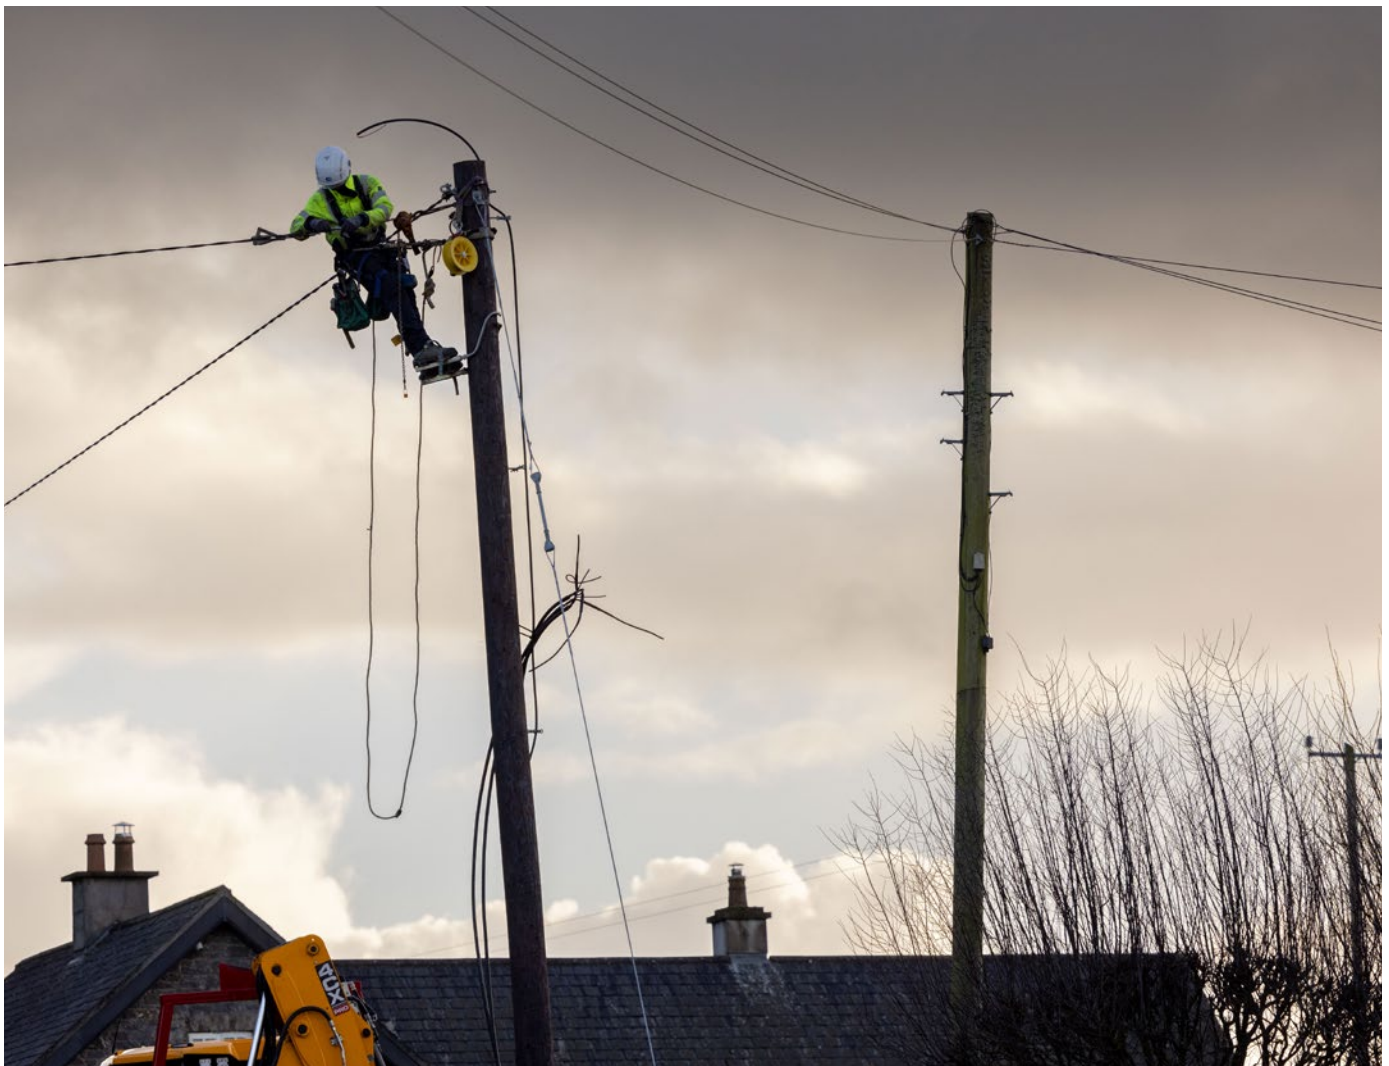
### 5.1.5 Large Critical Infrastructure owners

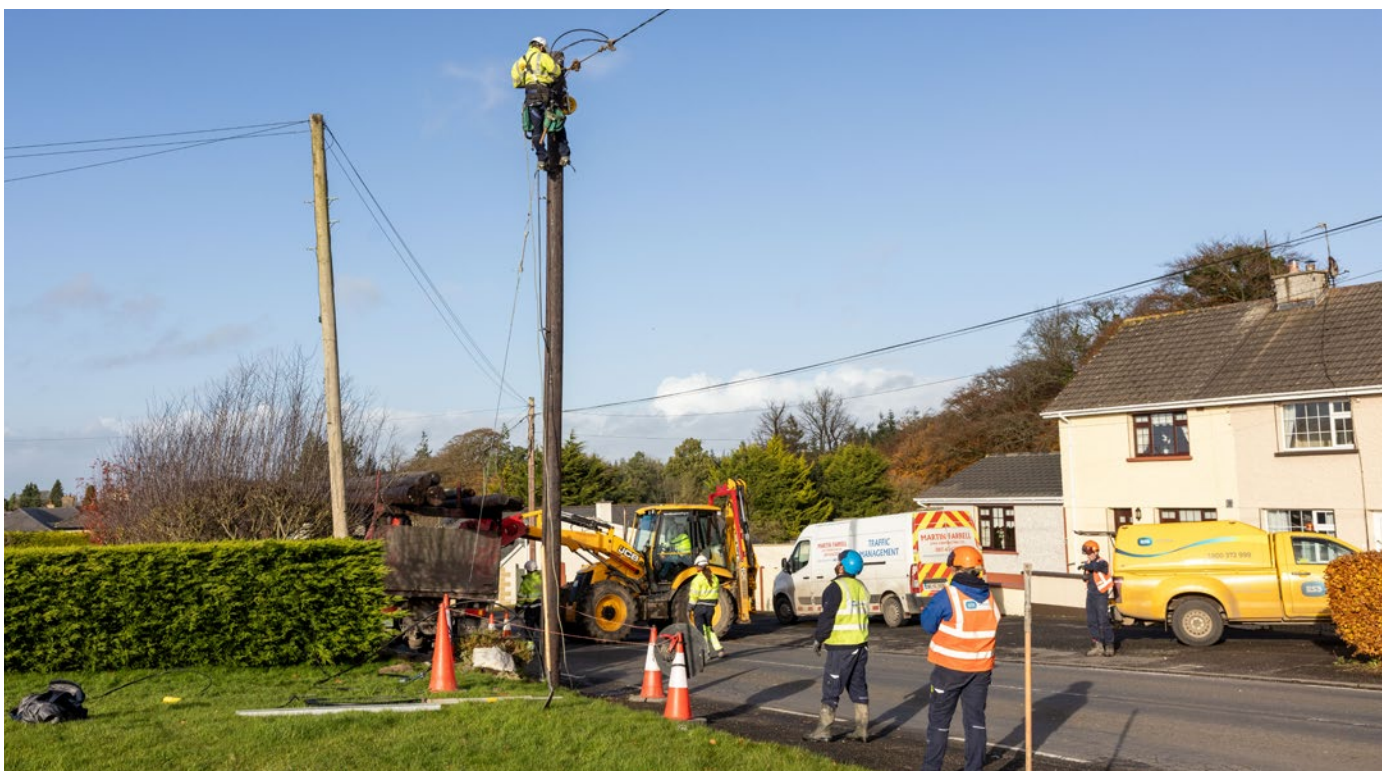
Unfortunately, during Storm Éowyn, ESB Networks had to contract third-party security firms following incidents where vehicles were broken into, and equipment was stolen. This was mainly at hotels where vehicles were parked overnight and at staff accommodation. This should be considered as a requirement for future storms, where large groups of staff and contractors are working and staying, with the utility vehicles being very visible to opportunist criminals.

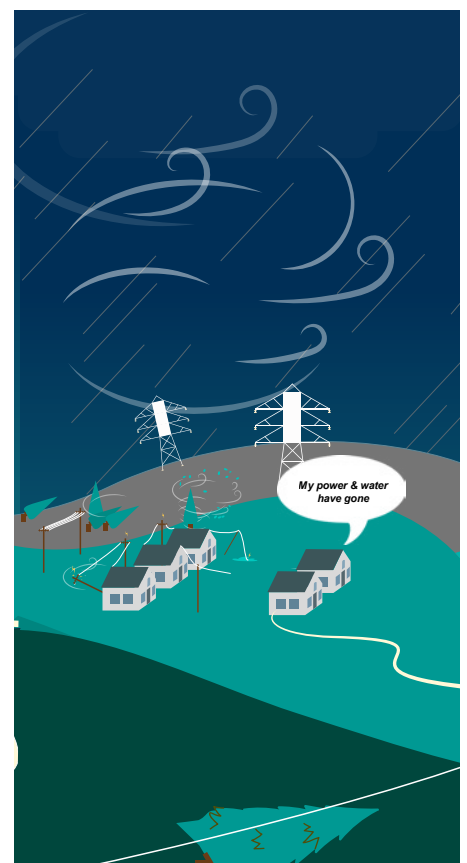
## Restoration timeline

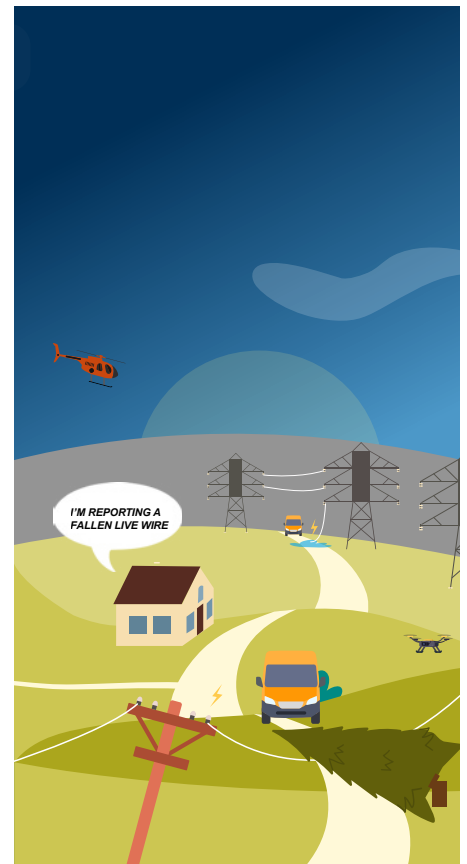
### Phase 2: after 7 days
