# ESB Networks Historic Cable Fluid Losses: Preliminary Site Assessment

## Location 13: Dodder Rd - Templeogue 38 kV - April 2015

Project Number: GCU0257001

February 2020

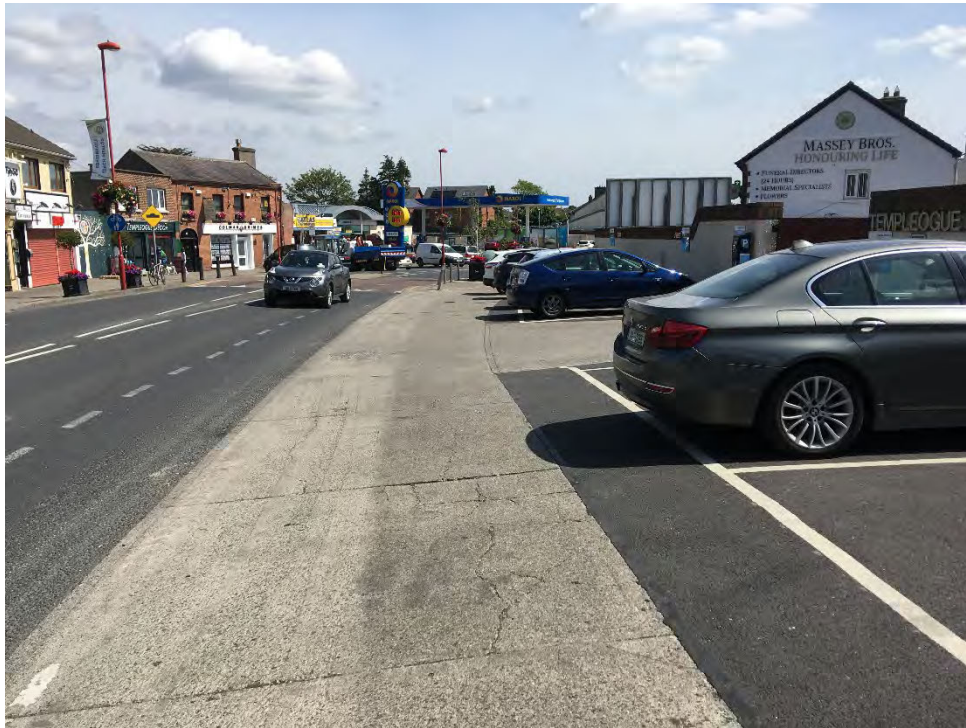
**Photograph 1 – View north-east along Templeogue Road close to leak location**

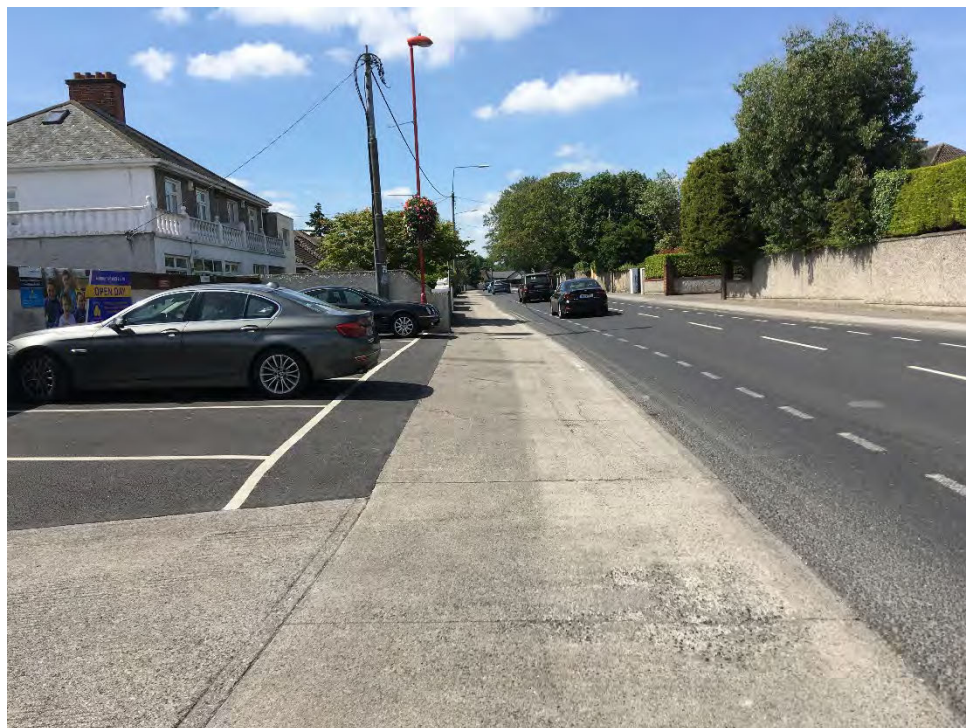
**Photograph 2 – View south-west along Templeogue Road close to leak location**

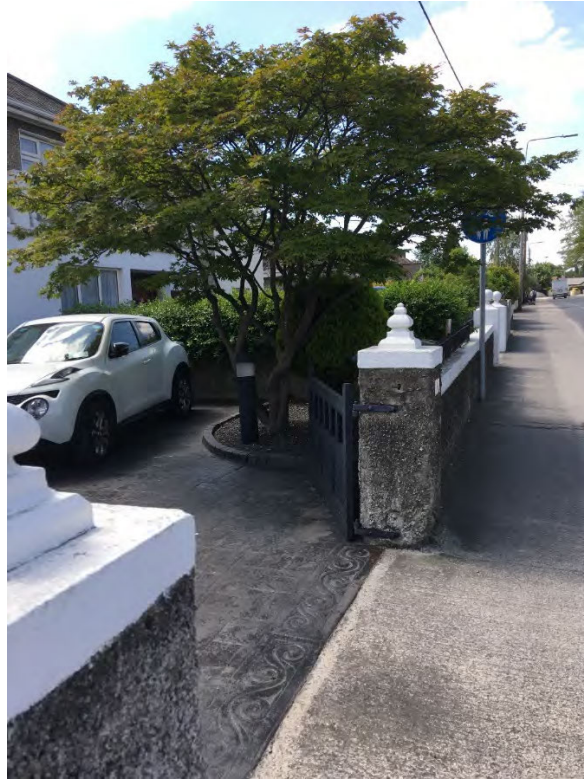
**5. Front garden of residence close to leak location  
(note: mature tree in garden appeared healthy)**

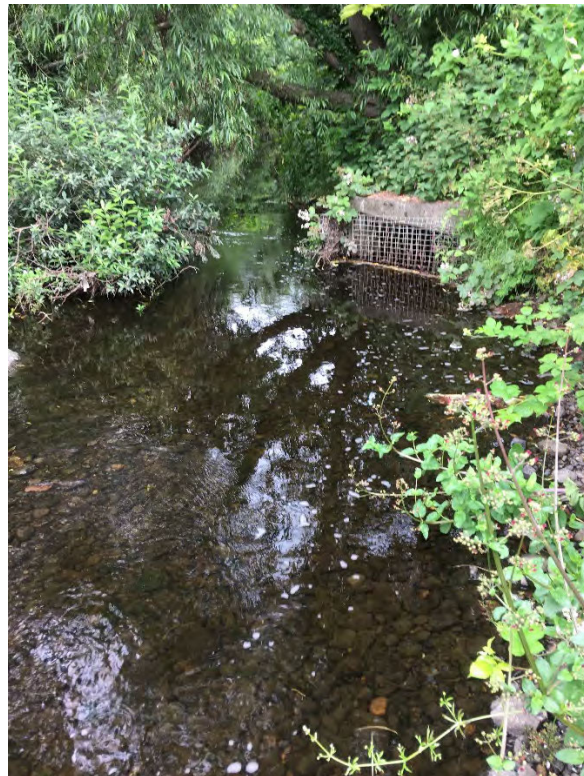
**Photograph 6 – River Dodder down-gradient of leak location  
(close to Riverside Cottages)**

The nearest surface water body to the leak location is the River Dodder which is located approximately 100 metres south of the leak location and generally flows in an east-north-easterly direction. It discharges into the River Liffey adjacent to the East Link bridge in central Dublin, approximately 8 km from the leak location. The status of the River Dodder under the WFD classification system is currently “at risk” of not meeting current WFD objectives and is listed as being under significant pressure due to urban run-off. For the period 2010 - 2015, the EPA classified water quality in the River Dodder as “moderate.”
