ESB Engineering and Major Projects

Francis Street – South King Street (Site ID 34)

Preliminary Environmental Site Assessment

602620 – R02 (02)

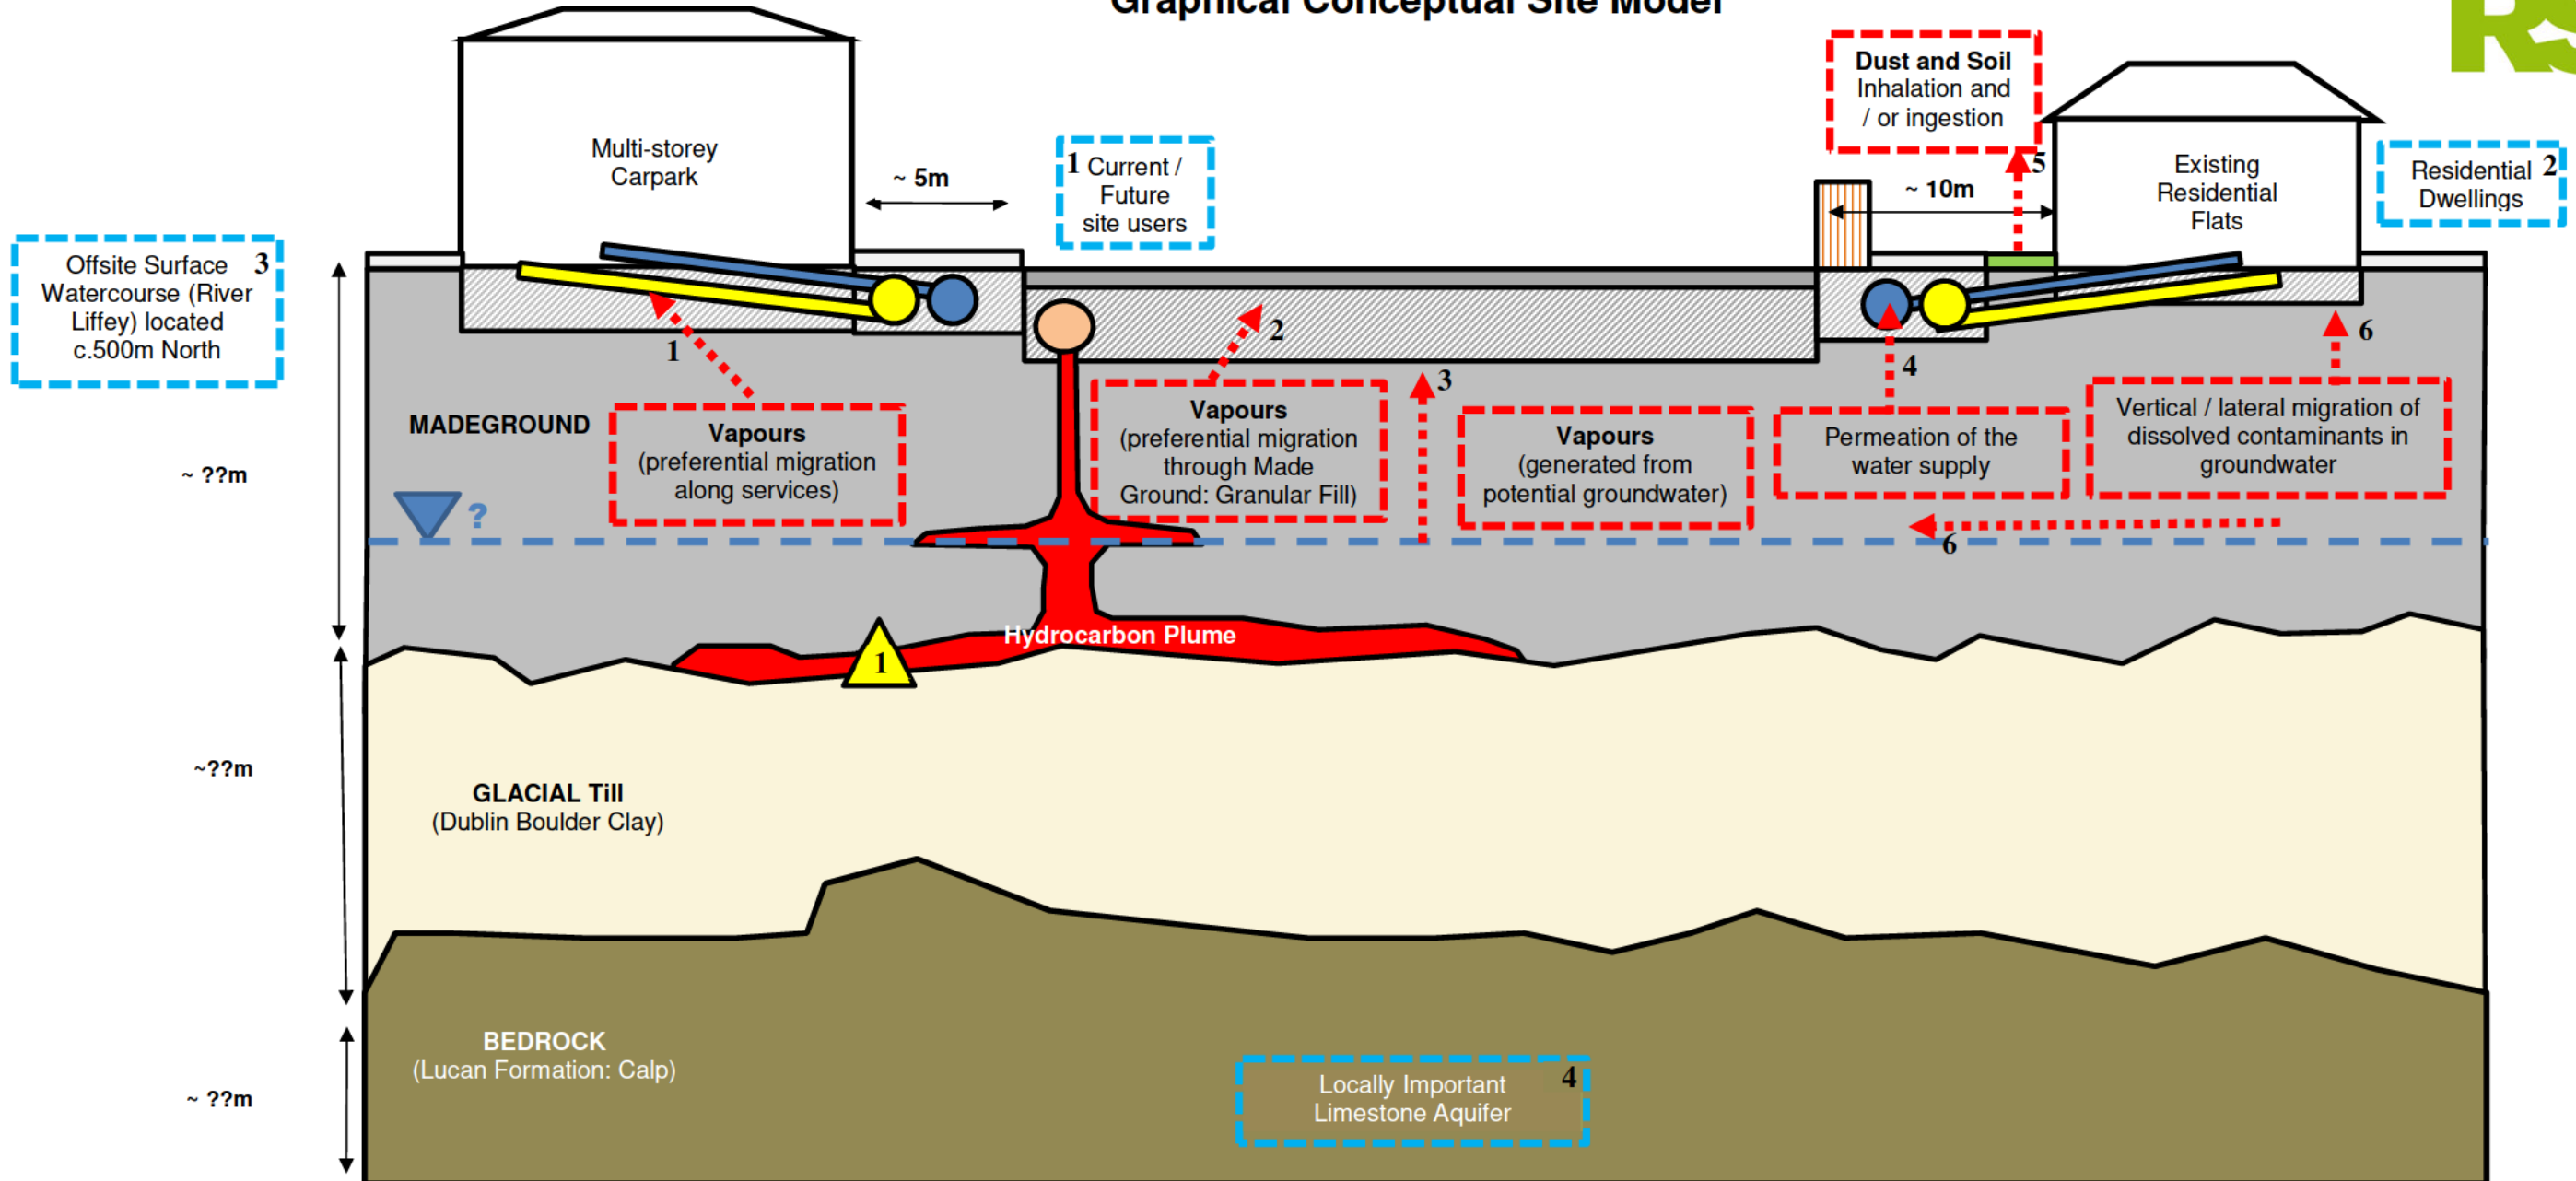
(34) Francis Street – South King Street Indicative Leak Location - Graphical Conceptual Site Model

Potential Sources	Potential Pathways	Potential Receptors
Hydrocarbon Plume	Preferential migration along services	Current / Future site users
	Preferential migration through made ground (granular fill)	Residential dwellings
	Vapour migration in potential groundwater	River Liffey (c.500m north; offsite)
	Permeation of the water supply	Locally Important Limestone Aquifer
	Dust and/or soil inhalation and/or ingestion	
	Vertical / lateral migration of dissolved contaminants in groundwater

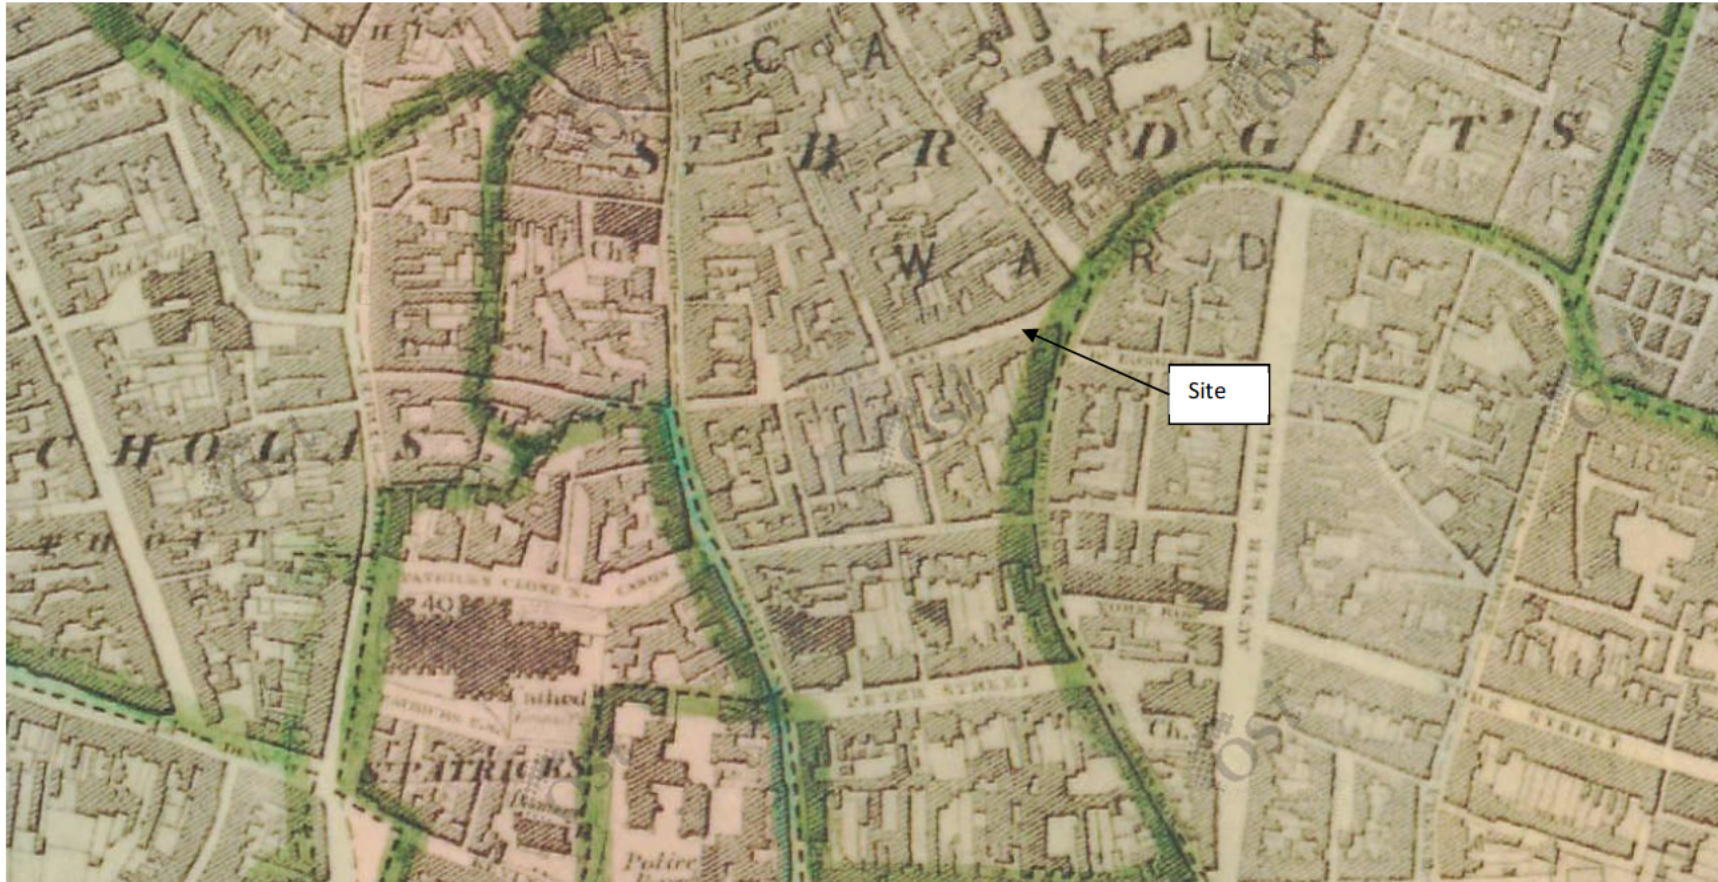
Drawing Title: Figure 4 OSI Historical Map 1837-1842

The earliest available online OSI map dating from 1837-1842 (Figure 4) shows that the site and the surrounding land as being part of a built, urban environment. However, it is not possible to identify individual buildings/premises or land use. A map from 1843 was examined in TCD which identified a graveyard approximately 100m to the north west and Castle Barracks approximately 80m to the north east. The surrounding area is predominantly residential. TCD maps from 1864 and 1892 show little change at the site and surrounding area.

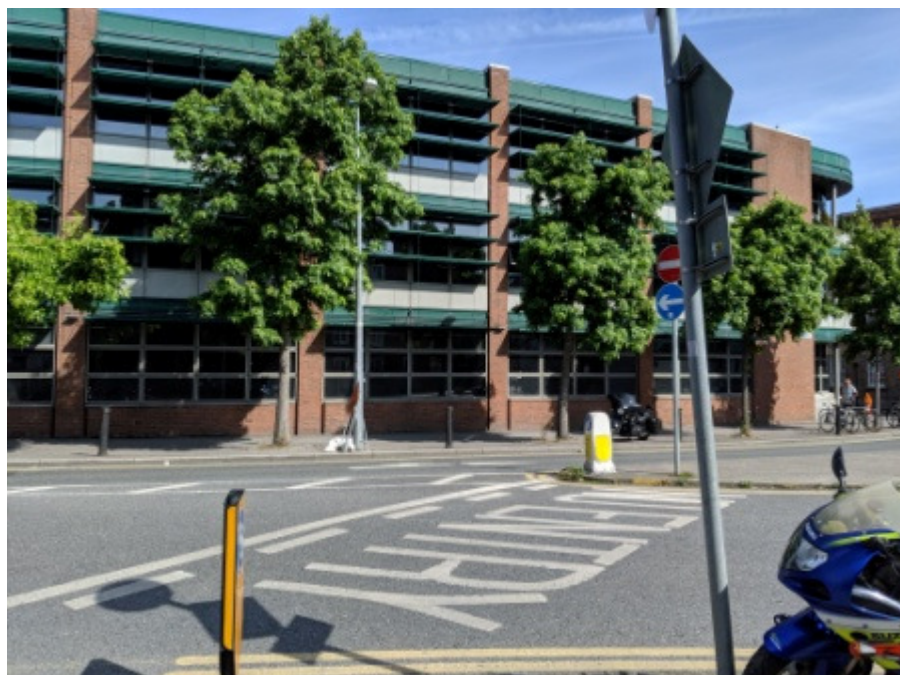
View of the indicative leak location. Multi-storey car park located to the immediate north. Residential apartment with communal landscaped area located to the immediate south. Mature trees located along the footpath to the north and south of leak.

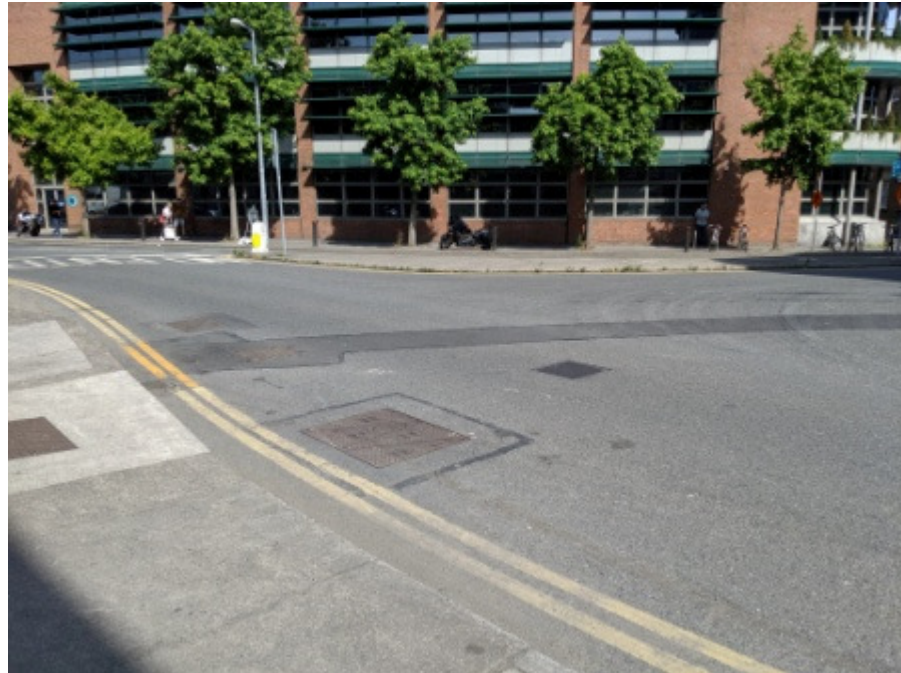
View of the indicative leak location.
Significant road scarring and service manhole covers in the area.
Junction is busy due to the temporary traffic lights on the one-way Stephen Street Upper.

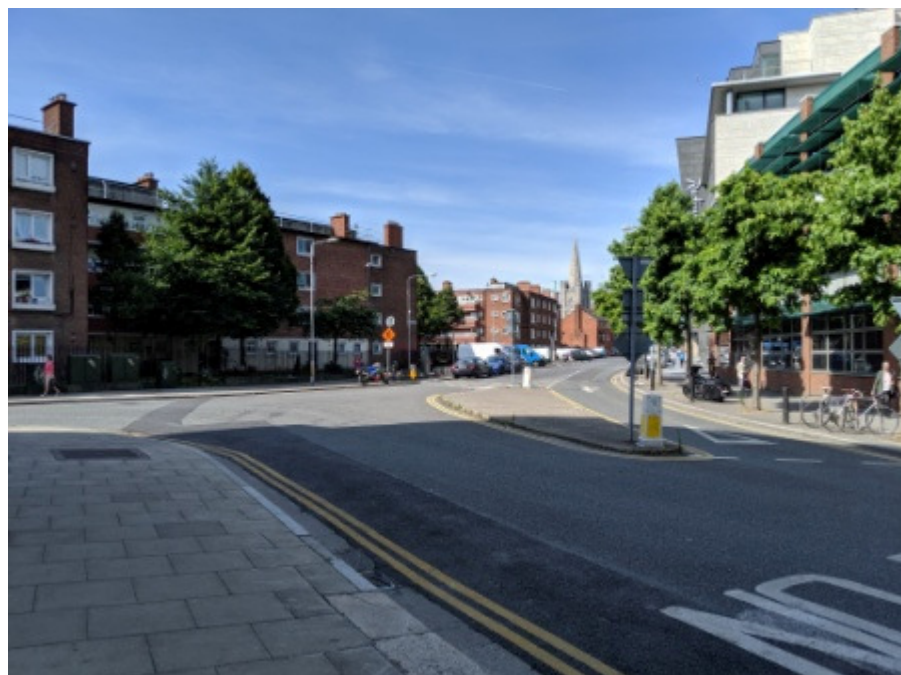
View of the indicative leak location.
Multi-storey car park located to the north of the leak and residential apartments with communal landscaped area to the south.
Bicycle park also located to the immediate south of the leak location.
