ESB Networks Historic Cable Fluid Losses: Preliminary Site Assessment

Location 35: Blackrock – Ringsend 110 kV – March 2009

Project Number: GCU0257001

February 2020

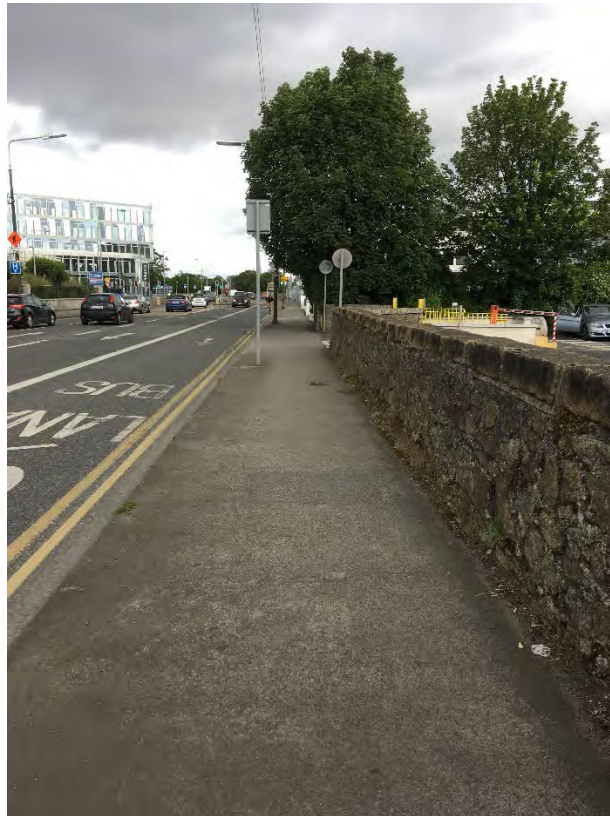
Photograph 1 – View north from leak location

No evidence of stressed vegetation or die-back was observed in the vicinity of the leak location, along the cable route, or in the vicinity of the above-mentioned open drain at the time of the walk-over survey.

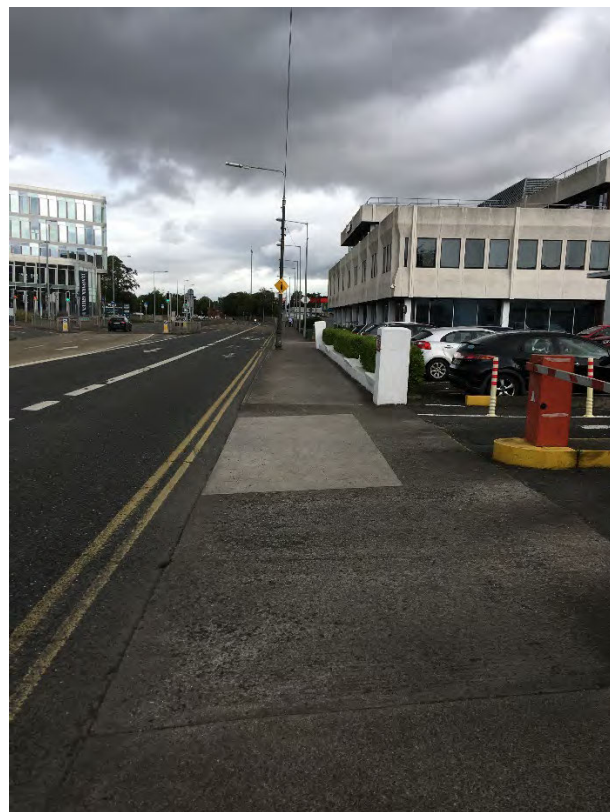
Photograph 2 – View north past Merrion House

Between the above-mentioned car park and Booterstown Marsh there is an area of disused ground, which is vegetated with a mix of grasses, small bushes and trees. To the north of the leak location is a vacant single-storey commercial building (possibly a former car sales business), beyond which is “Merrion House”, which is a three-storey office building.

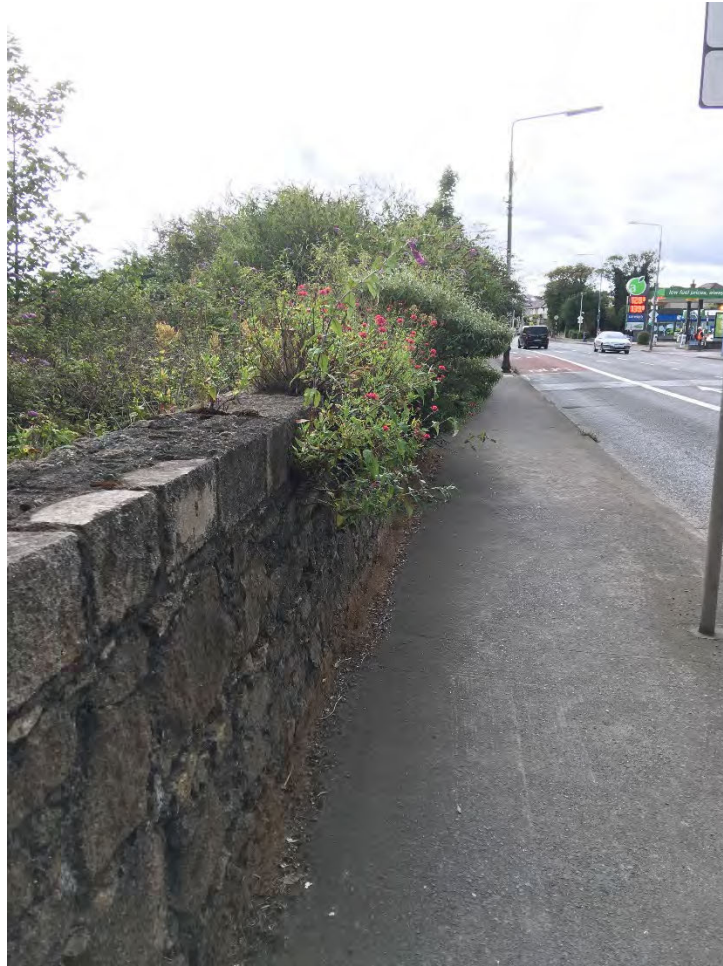
Photograph 3 – View south from leak location

Merrion Road, a four-lane arterial route, lies adjacent to the leak location to the south-west. Beyond Merrion Road is a terrace of residential houses that is set back from Merrion Road; the closest house is approximately 40m from the leak location. The extensive Elm Park development, which comprises a mix of multi-storey office buildings and residential apartment buildings, is located to the rear of this terrace of houses.
