Preliminary Site Assessment

Site 39 Francis Street - Inchicore 110 kV

Electricity Supply Board

Project number: PR-427640_ACM_RP_ENV_055_0

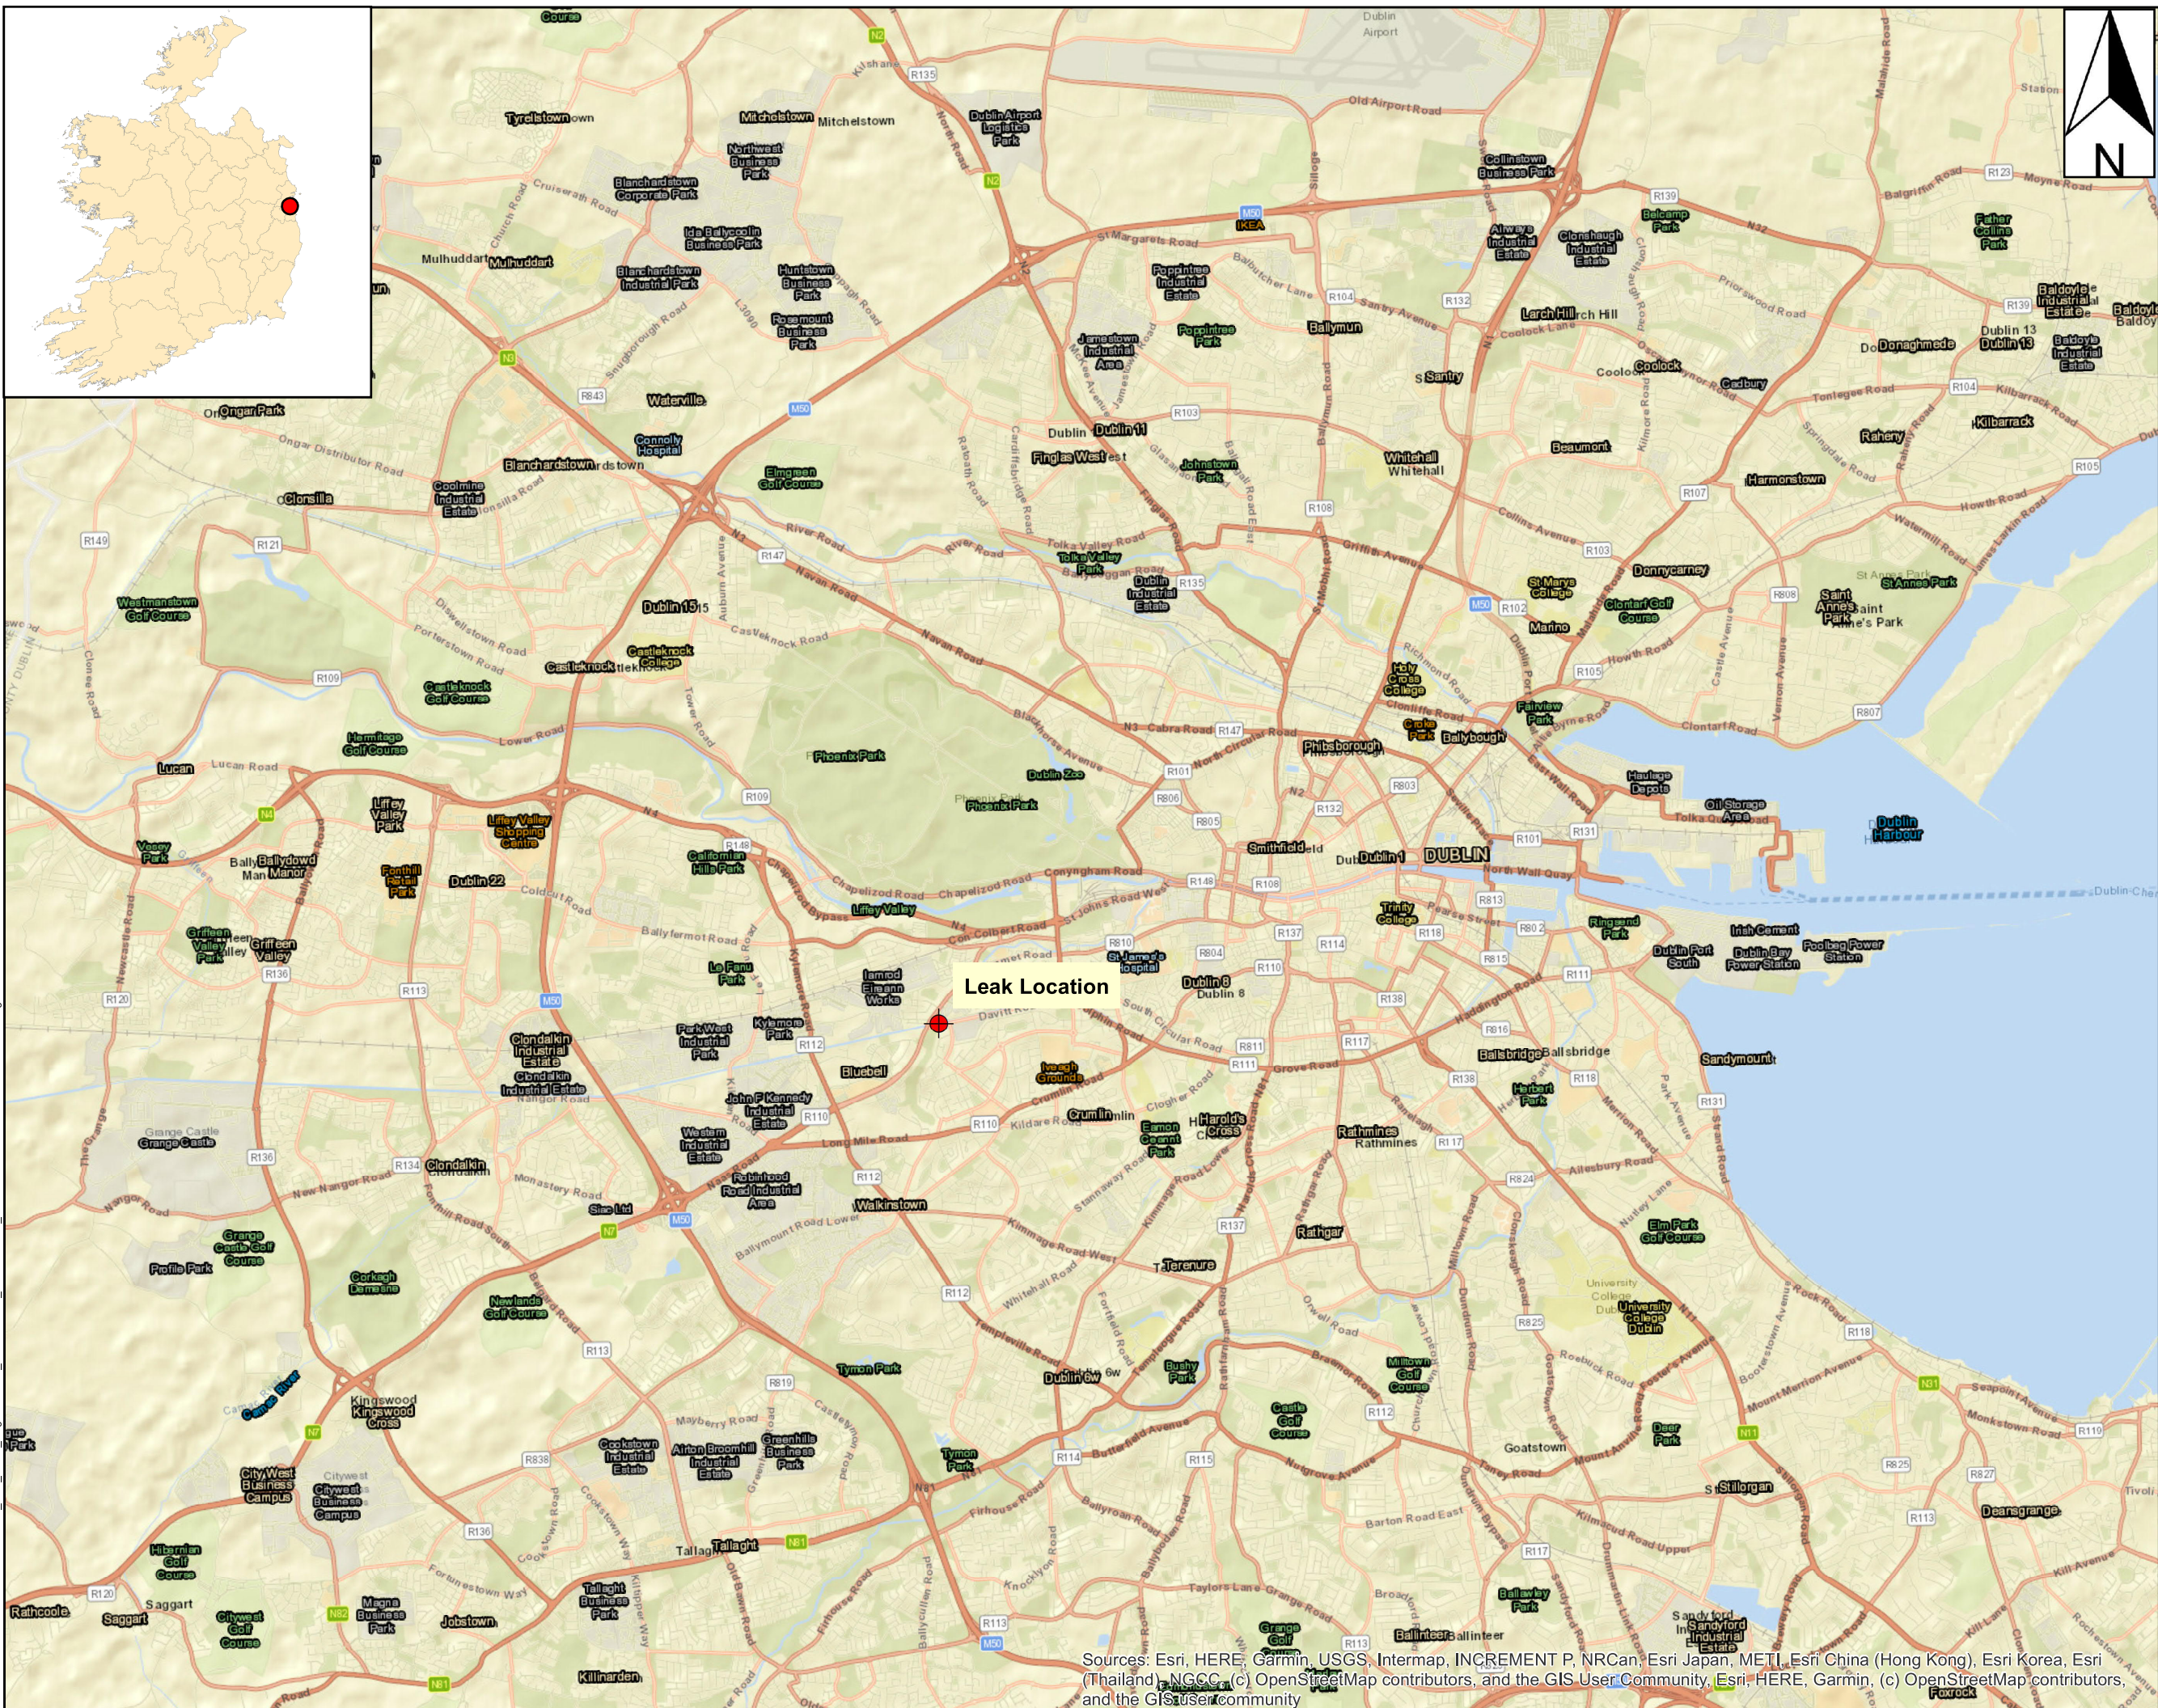
Figure 2. Areas of Potential Environmental Concern

Based on the assessment works completed, the primary APEC for this site comprises the leak location identified by ESB. This is presented in Figure 2 and a description is provided in Table 10.

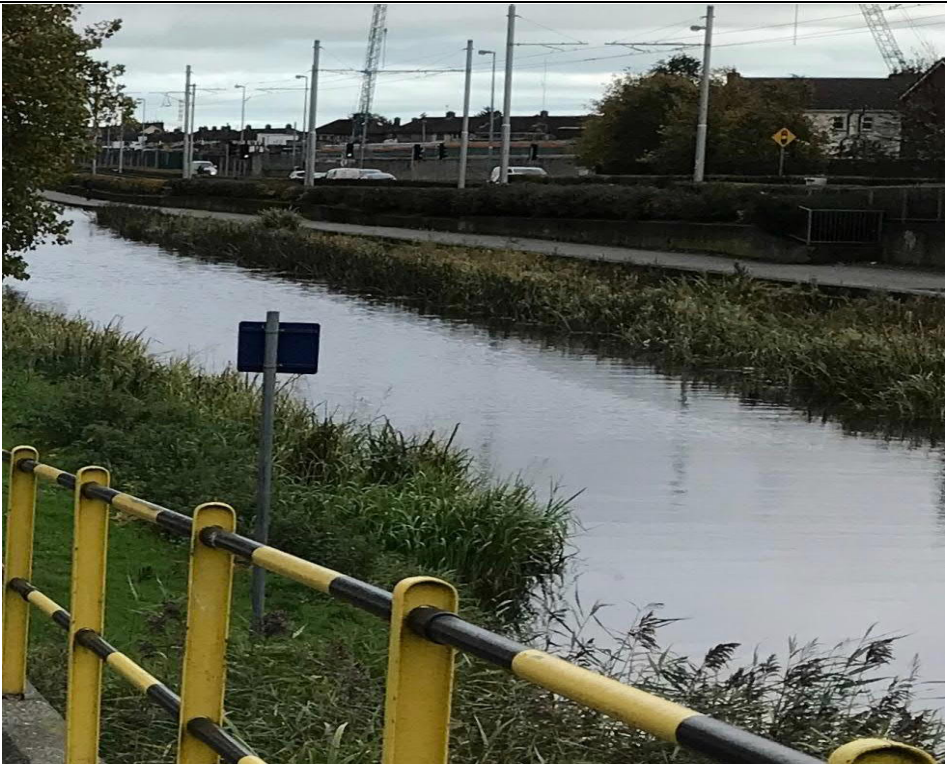
Photo No.: 1	Date: 01/11/2019

Direction Photo Taken: Southeast		
Description: Southeast facing view showing the potential leak location. Potential leak location is located in a pedestrian walkway adjacent to the canal. No evidence of visual contamination was observed in the adjacent canal water.

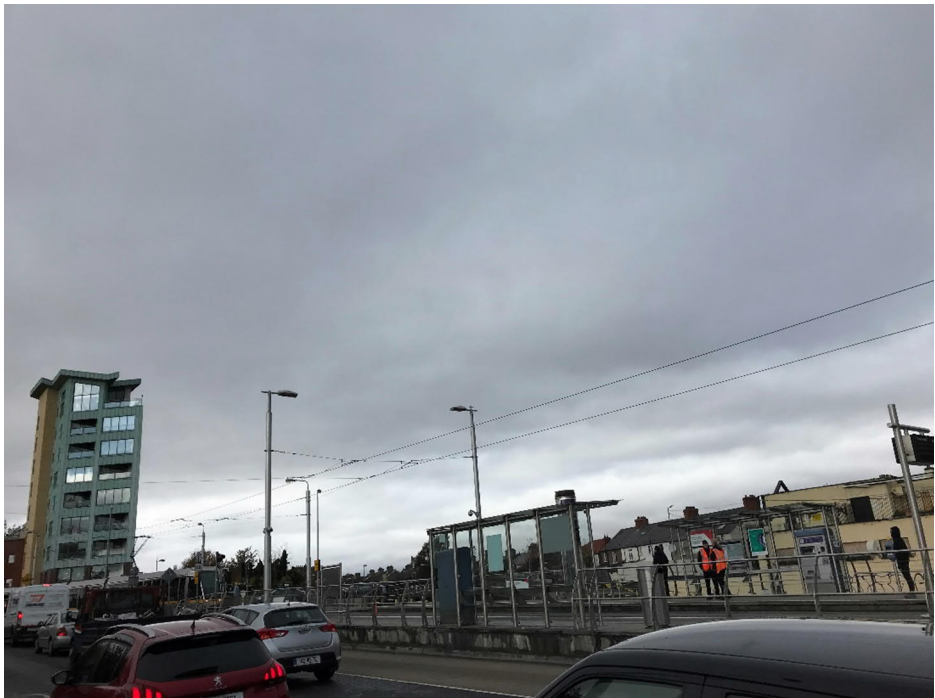
Photo No.: 2	Date: 01/11/2019

Direction Photo Taken: West		
Description: LUAS stop situated about 65 m away from the potential leak location.

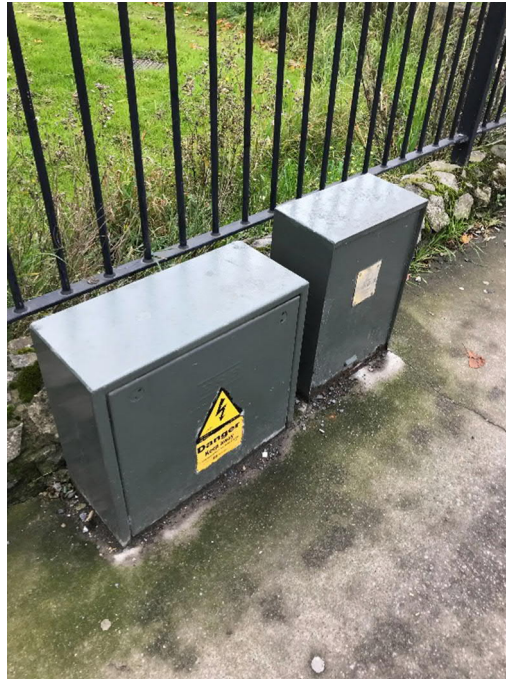
Facility Name:
ESB Cable Assessment**Site Location:**
Site 39 – Davitt Road**Project No.**
427640**Photo No.**
3**Date:**
01/11/2019**Direction Photo Taken:****Description:**

Small substations close to the intersection between Landsdowne Valley Park street and Davitt Road.
