# ESB Networks Historic Cable Fluid Losses: Preliminary Site Assessment

## Location 4: Dodder Road - Templeogue 38 kV - November 2018

Project Number: GCU0257001

Report Ref: GCU0257001/004

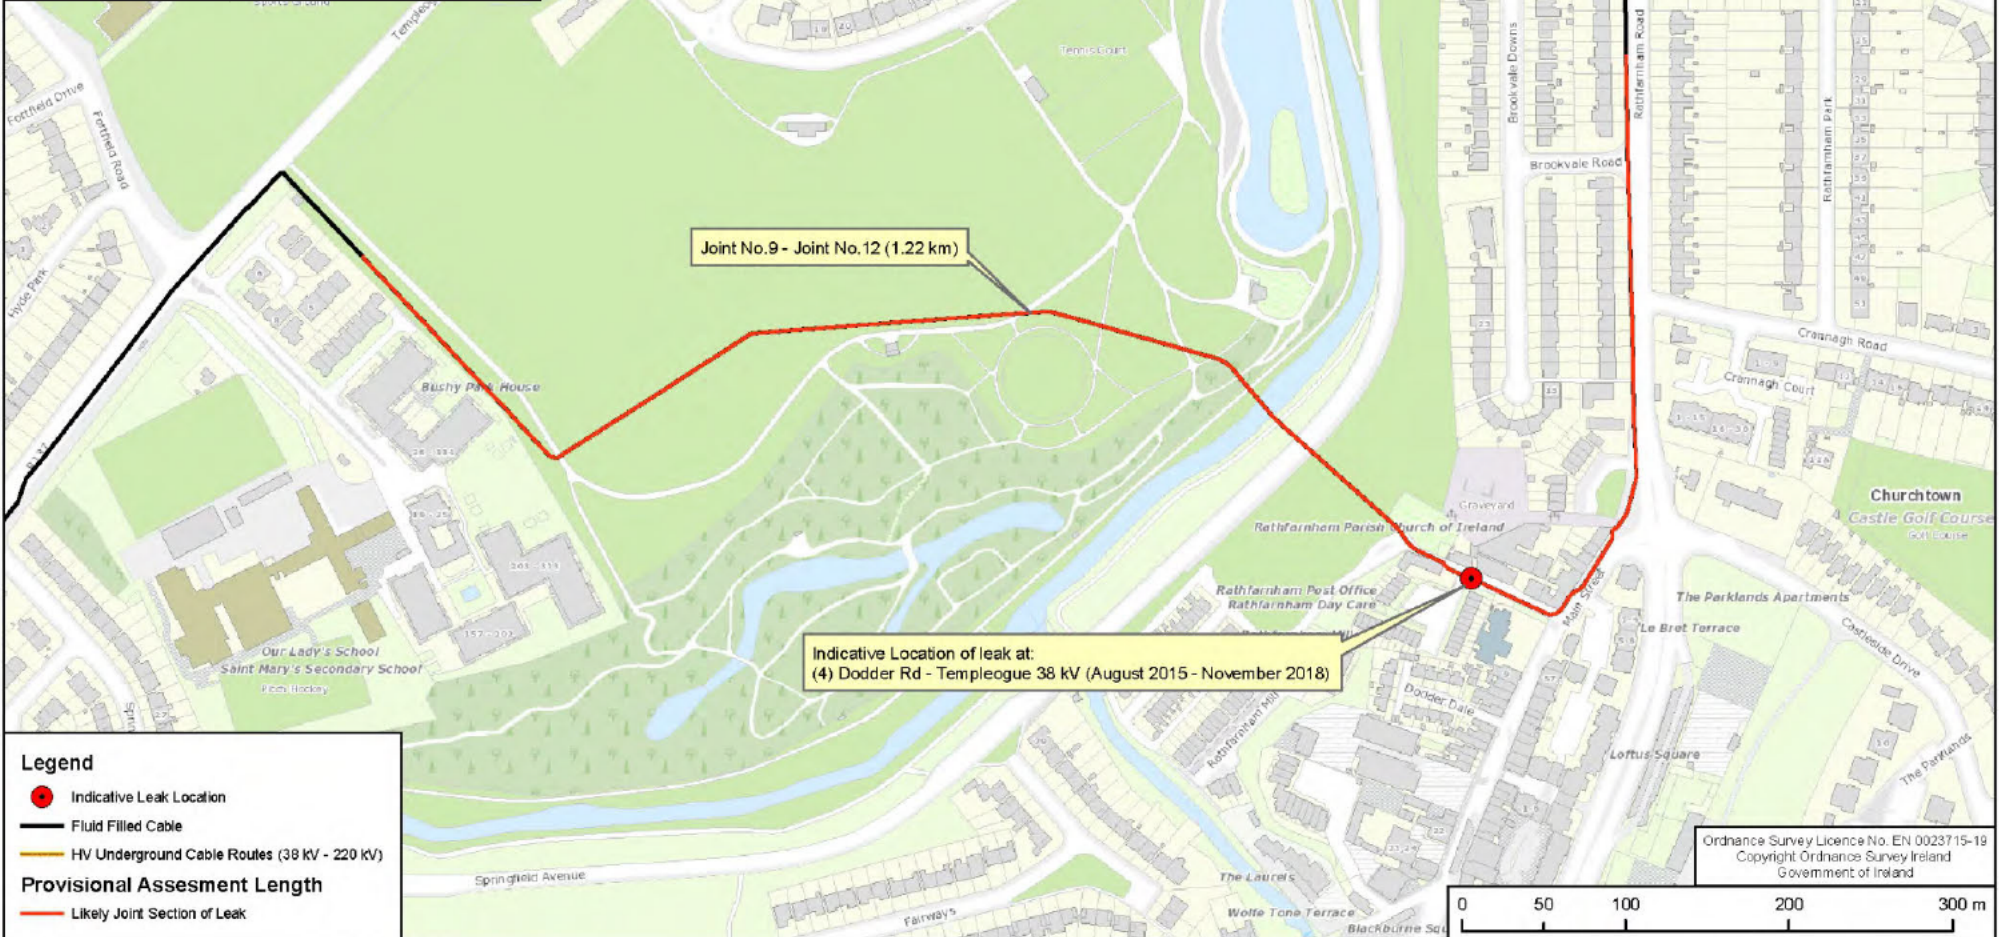
**Figure 1 - Location No. 4**

PRODUCTION UNIT:	<b>Civil &amp; Environmental Engineering</b>
DRAWING TITLE:	<b>Indicative Cable Fluid Leakage Locations &amp; Cable Sections (4) Dodder Rd - Templeogue 38 kV (August 2015 - November 2018)</b>

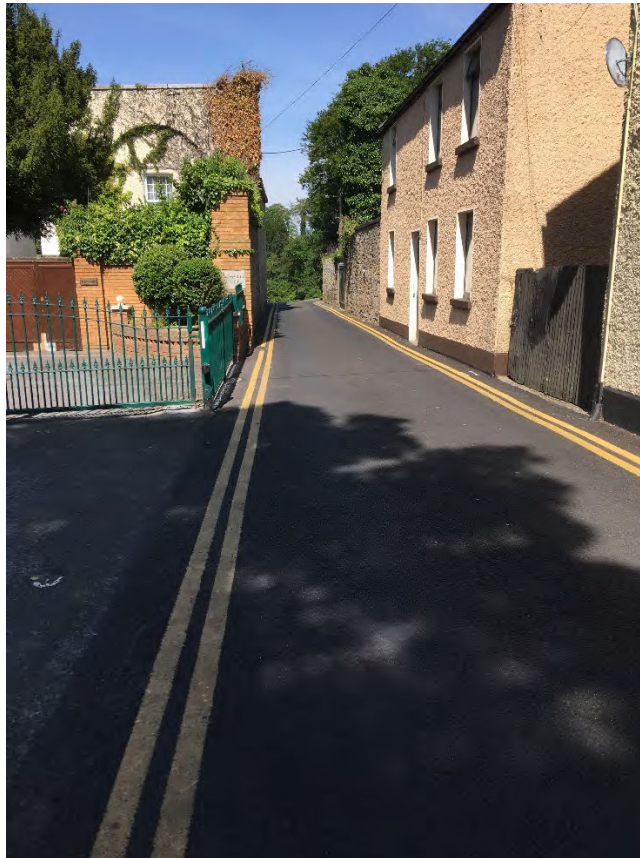
**Photograph 1 – View north-west along Church Lane**

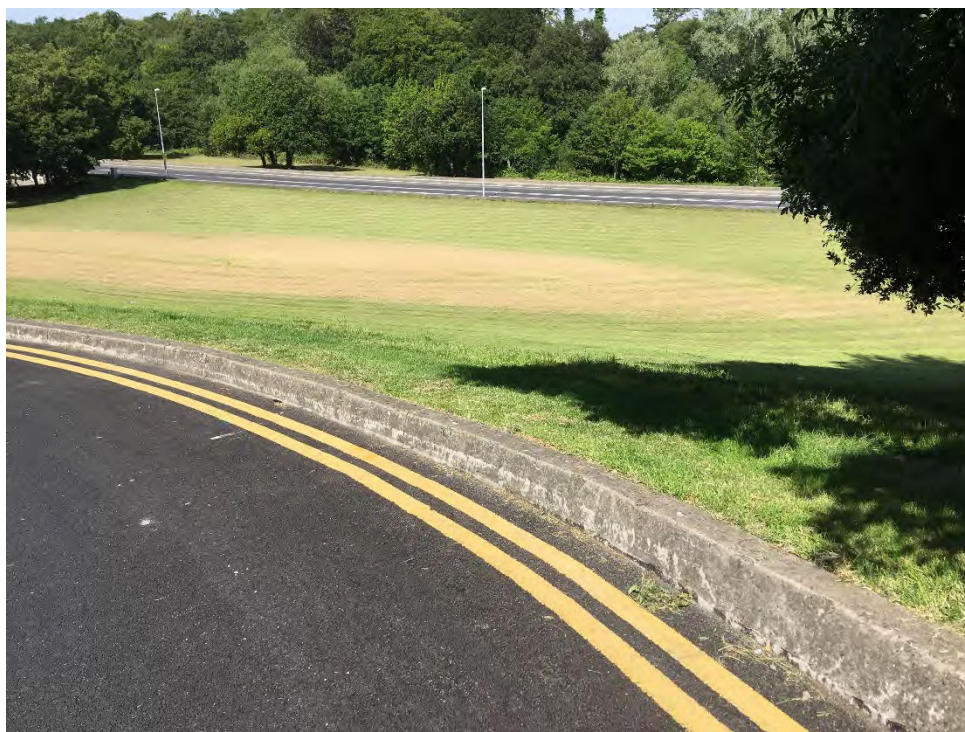
**Photograph 2 – View north-west towards River Dodder from Church Lane**

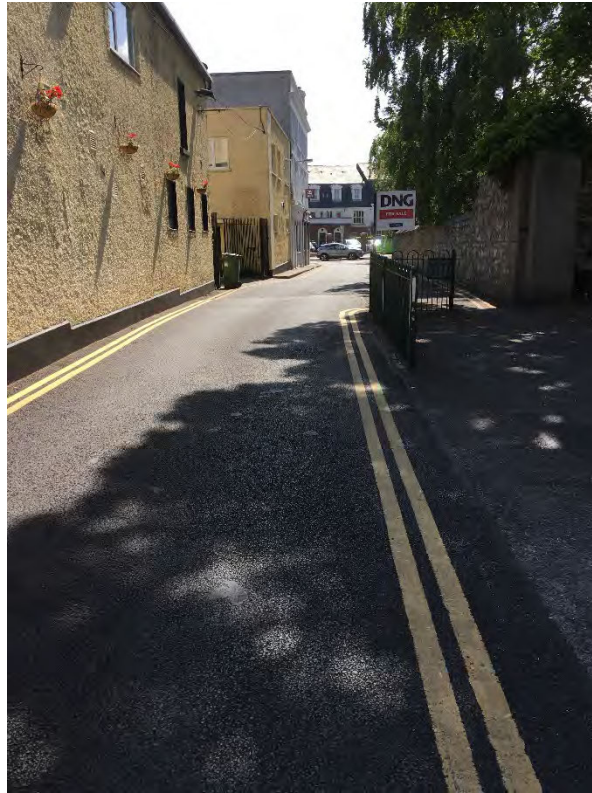
**Photograph 3 – View south-east along Church Lane**

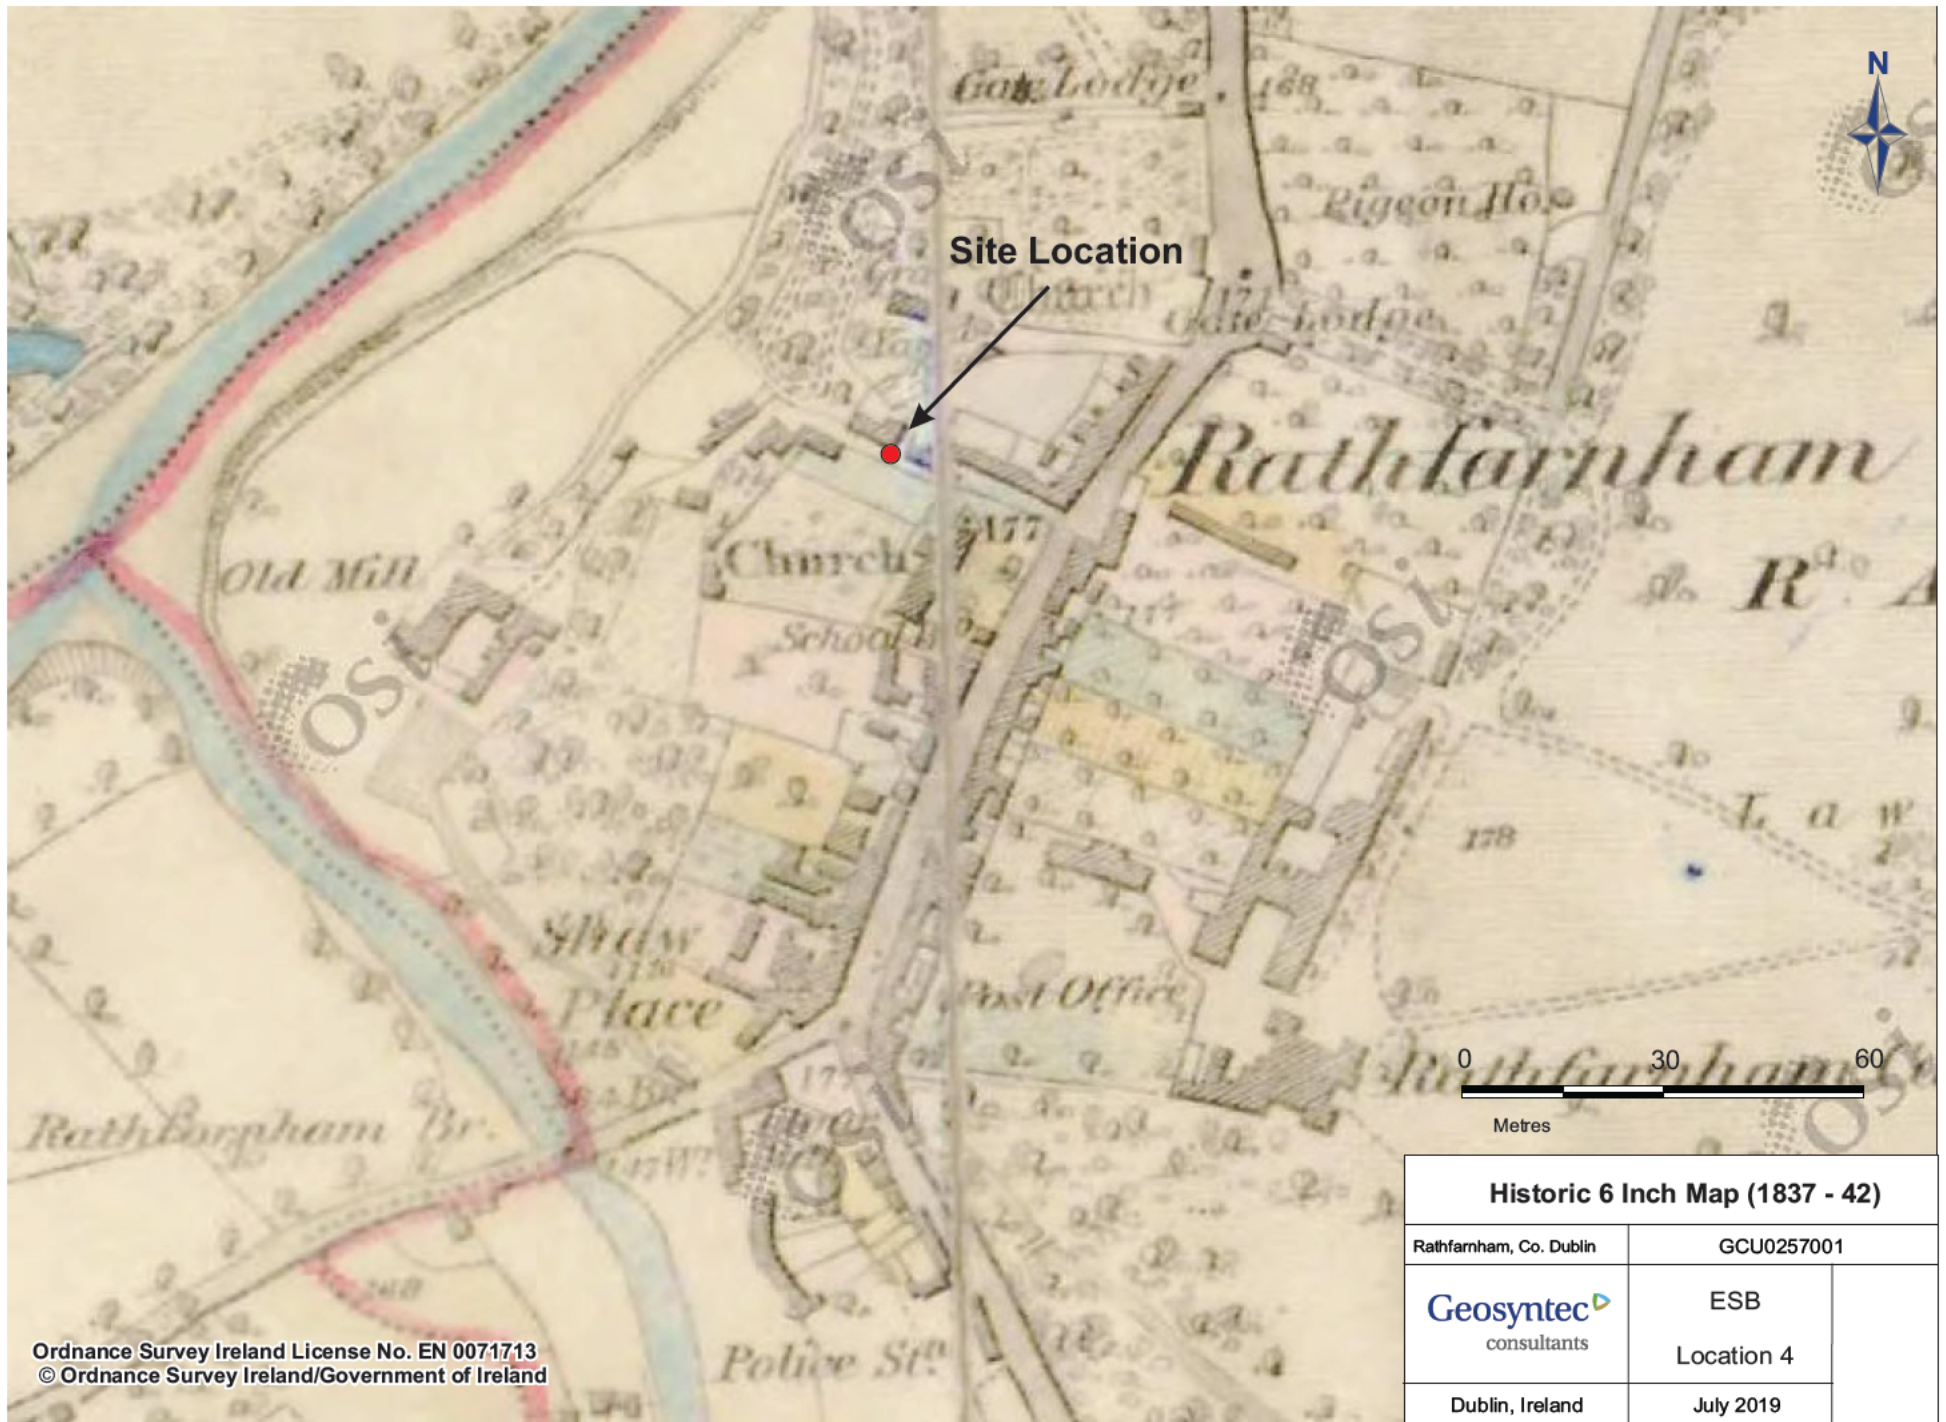
Historic 6 Inch Map (1837 - 42)	
Rathfarnham, Co. Dublin	GCU0257001
Geosyntec consultants	ESB Location 4
Dublin, Ireland	July 2019

The earliest historic map available from the OSI's website is dated 1837 - 1842 (Appendix B) and shows the above-mentioned buildings north-east, north-west and south-west of the leak location. The historic map dated 1888 - 1913 indicates no further significant development in the immediate vicinity of the leak location took place over that period.

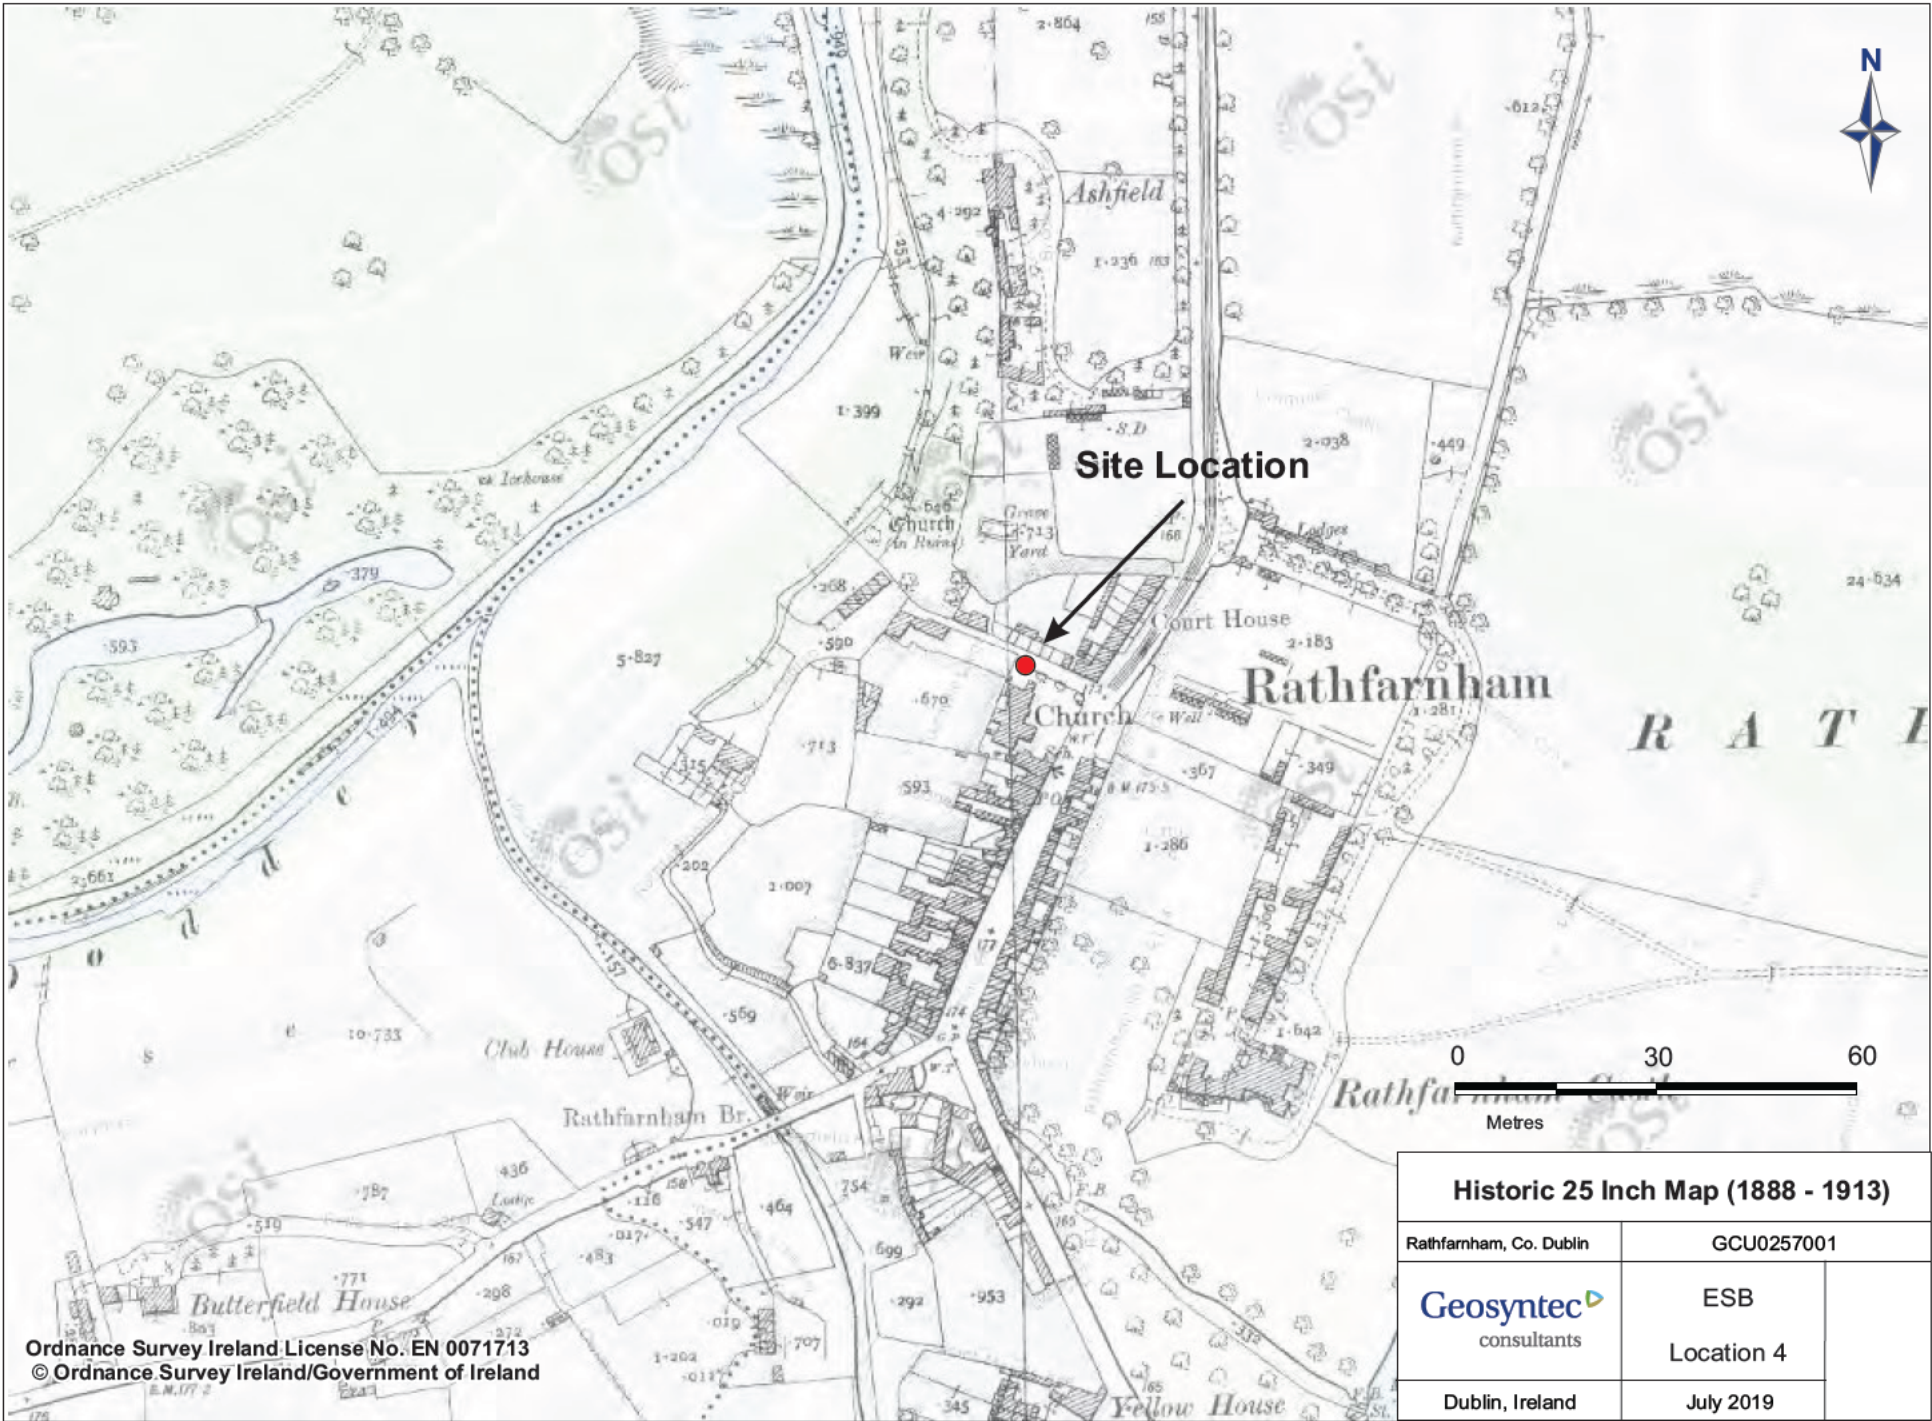
Historic 25 Inch Map (1888 - 1913)	
Rathfarnham, Co. Dublin	GCU0257001
Geosyntec consultants	ESB Location 4
Dublin, Ireland	July 2019
