ESB Engineering and Major Projects

Donnybrook - Pembroke (Site ID 42)

Preliminary Environmental Site Assessment

602749 – R03 (01)

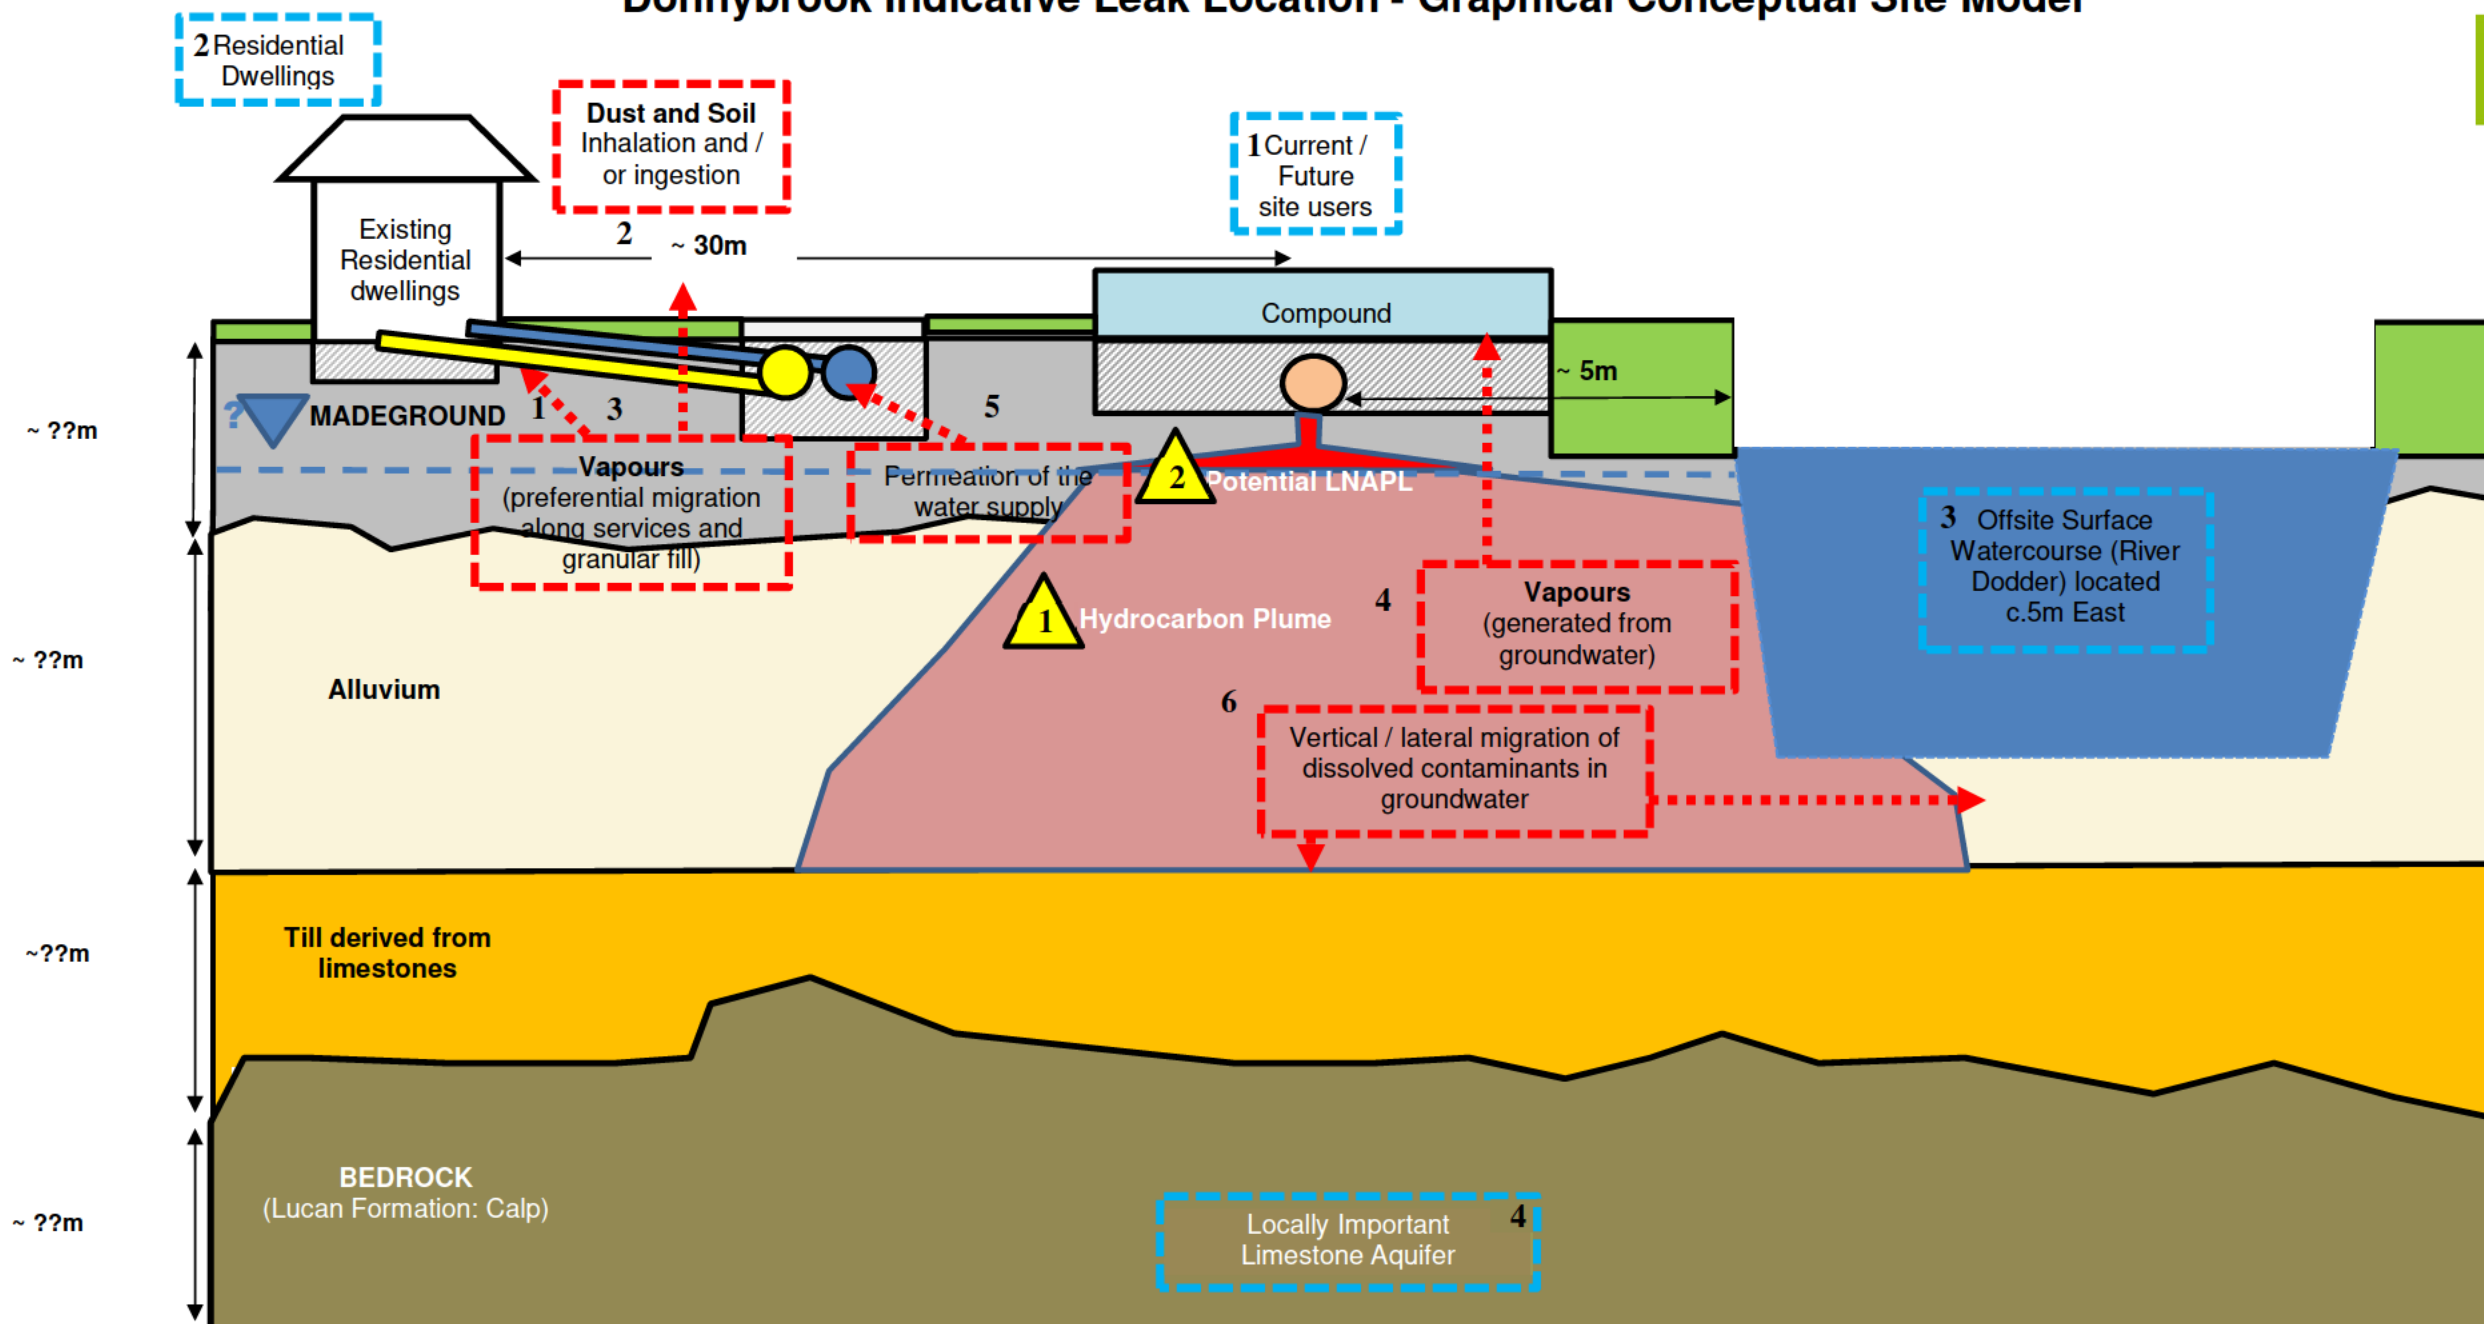
Donnybrook Indicative Leak Location - Graphical Conceptual Site Model

Following the completion of a risk evaluation for the identified pollutant linkages, a potential pollutant linkage with a risk class of **MODERATE** for risks to the River Dodder from lateral migration in groundwater has been identified. The initial CSM has identified potential pollutant linkages with a risk class of **LOW or VERY LOW** for all other identified potential pollution linkages

Potential Sources	Potential Pathways	Potential Receptors
Hydrocarbon Plume	Preferential migration along services	Current / Future site users
Potential LNAPL	Dust and/or soil inhalation and/or ingestion	Residential dwellings
	Preferential migration through made ground (granular fill)	Bachelors Stream (<5m). River Dodder (c. 1.8km south)
	Vapour migration in groundwater	Locally Important Limestone Aquifer
	Permeation of the water supply	
	Vertical / lateral migration of dissolved contaminants in groundwater

RSK recommends further assessment to investigate and quantify potential risks to the River Dodder from the historic spill.

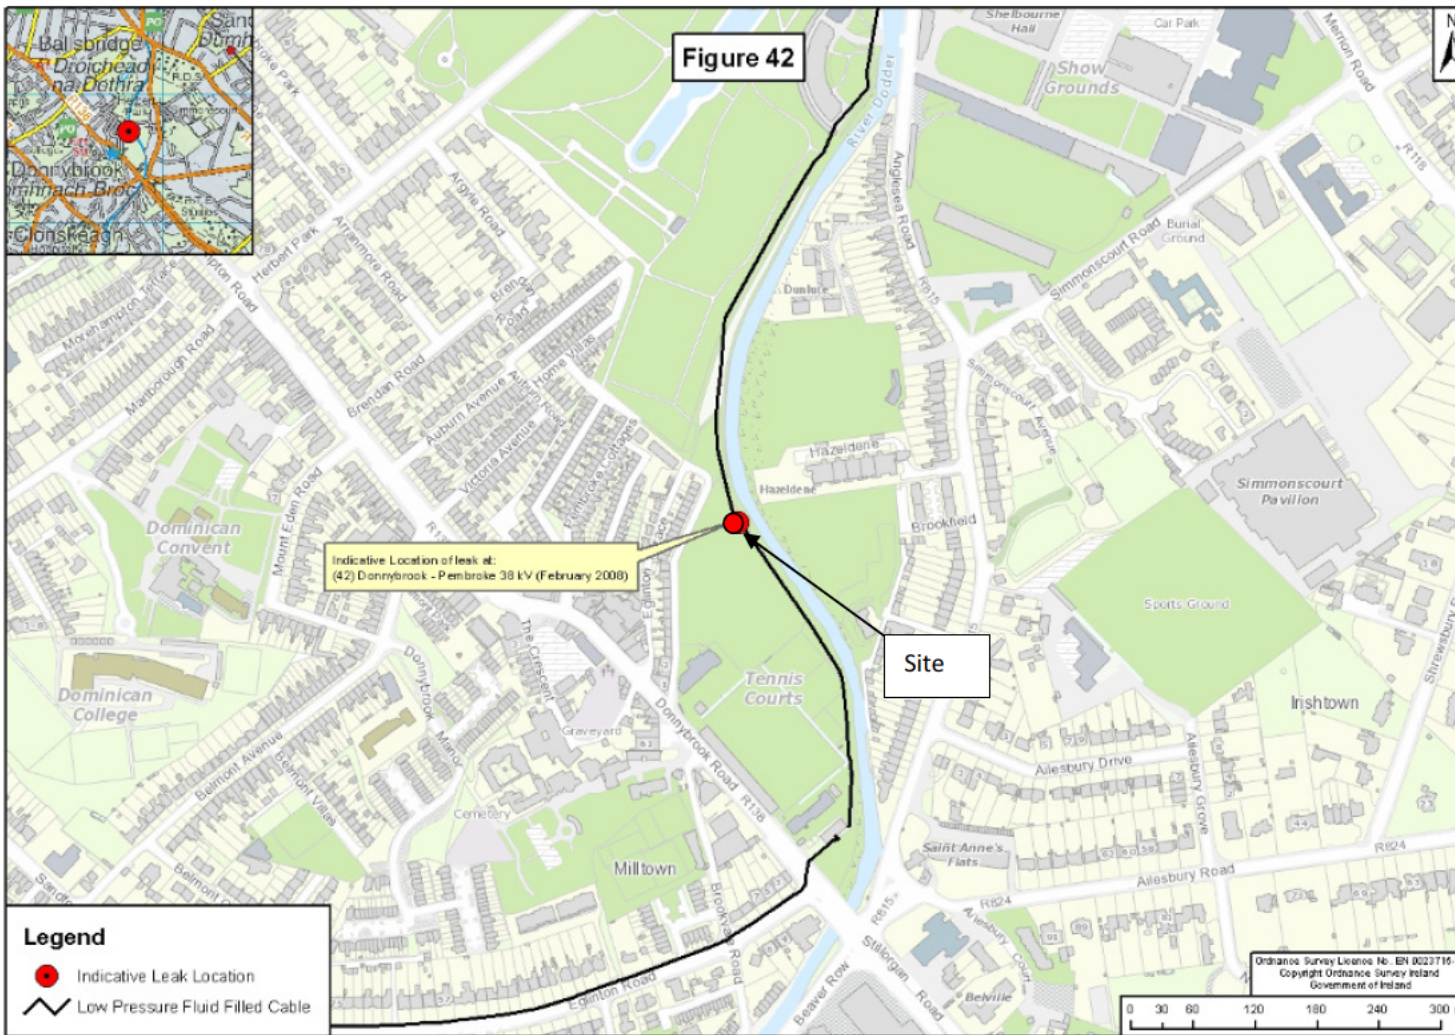
Drawing Title: Figure 2 Site Layout Plan

The site layout is shown on Figure 2. The area around the site is comprised primarily of parkland, sports grounds and residential land uses.

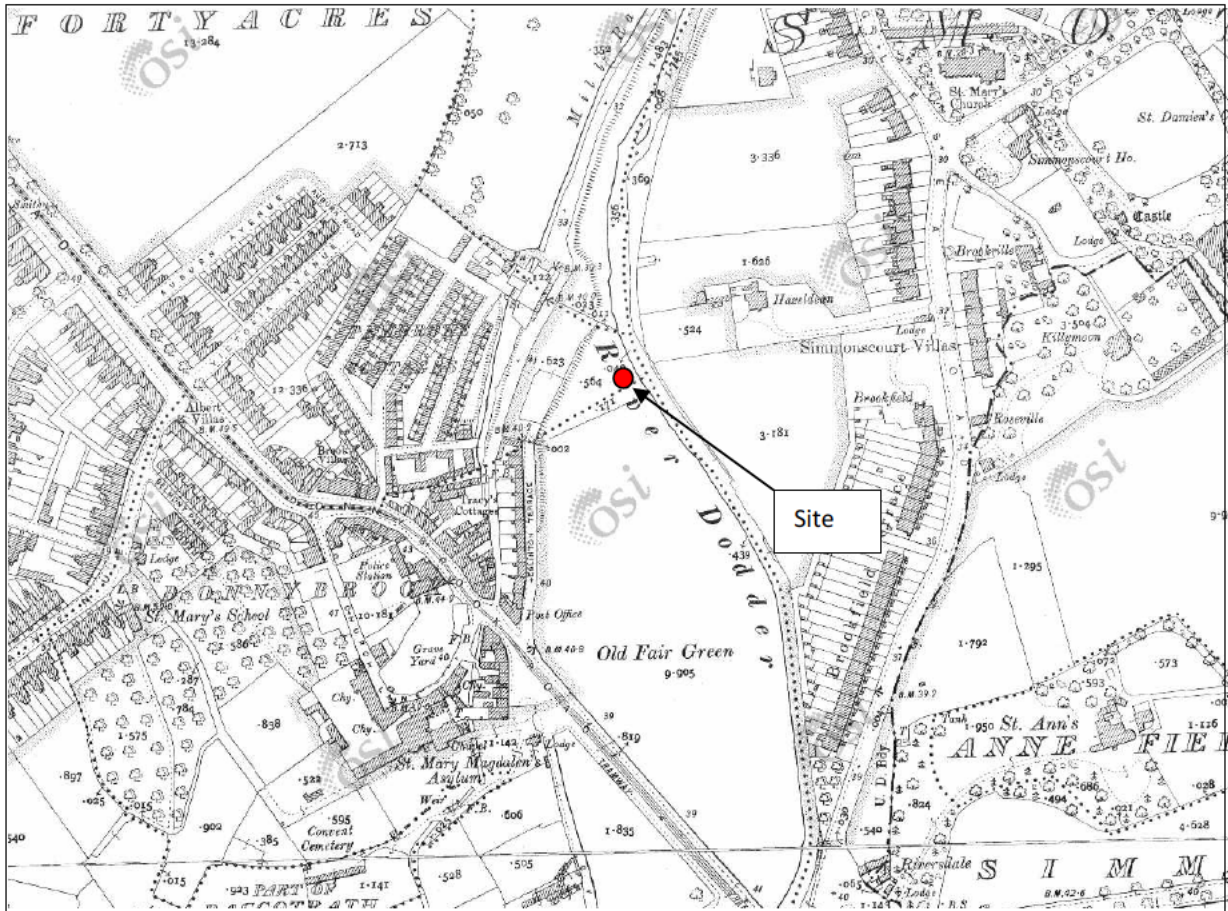
Drawing Title: Figure 4 OSI Historic Map 1888-1913

The OSI online map from 1888-1913 (Figure 4) shows that the site is in an increasingly urbanised setting. Donnybrook has expanded and is now located approximately 100m to the south west of the site. The gravel pit to the south is no longer present and the Fair Green is now immediately to the south of the site. The mill, windmill and surface water feature, previously identified to the west and north west, are no longer present. A tramway is present approximately 200m to the south west.

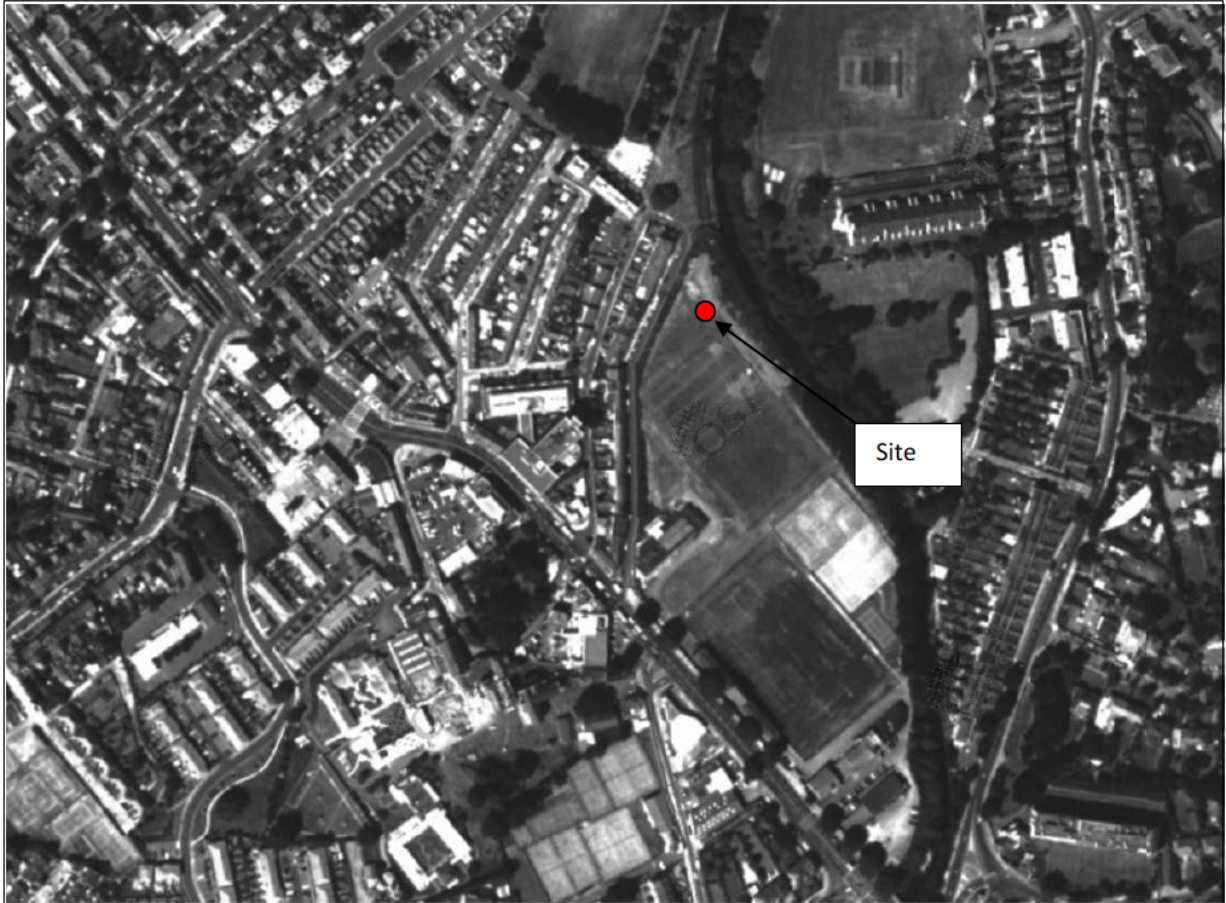
The OSI aerial photos from 1995 to 2012 have also been reviewed. The resolution of the photography is poor, and it is not possible to identify building or property use. The surrounding land use appears to be predominantly residential. In general, little change is noted during this period in the site and surrounding area. The 1995 aerial photo (Figure 5) shows the site in the northern corner of a field, possibly used for sports. Eglinton Terrace is present 30m to the west. Sports pitches are noted approximately 150m to the south. There is little change noted between 1995 and 2012.

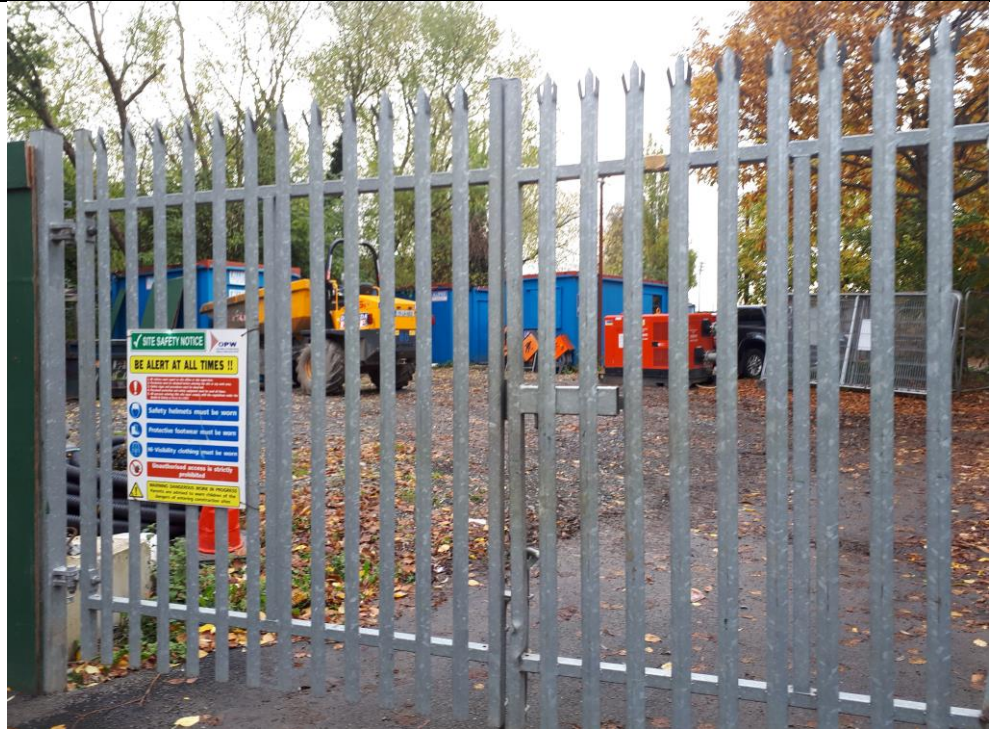
Works compound adjacent (west) to the River Dodder restricting access to the site, c.50m marker from the site.

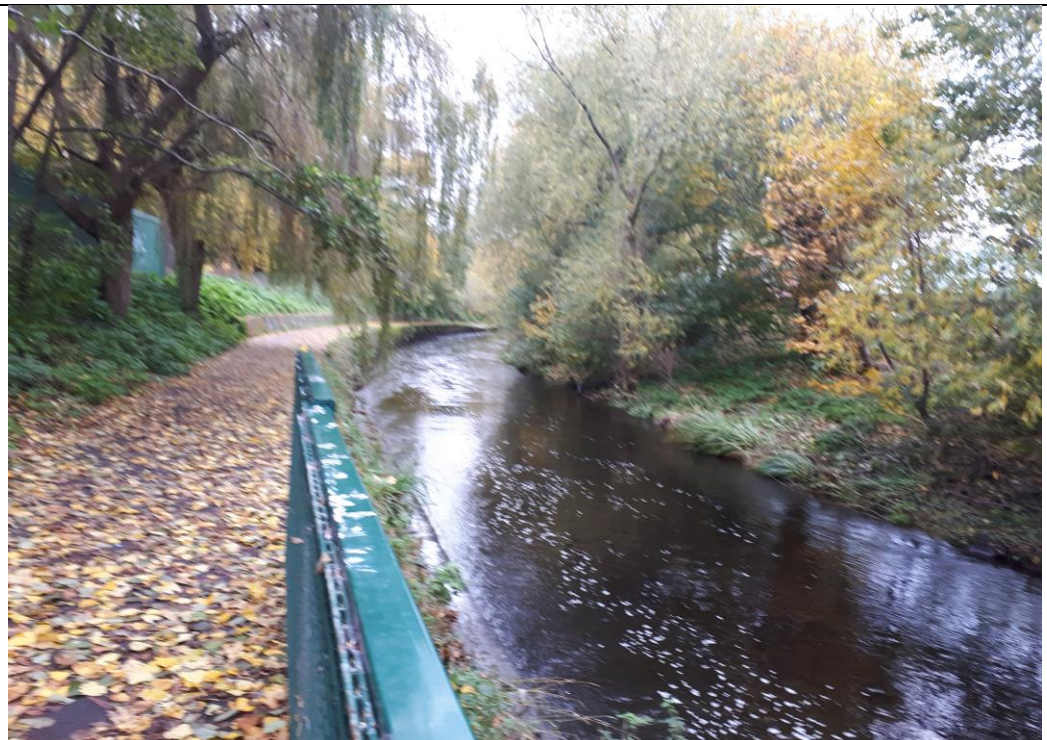
Photo No.
4

The River Dodder flowing in a northern direction, c.150m marker from the site.
