Preliminary Site Assessment

Site 45 Francis Street - Inchicore 110 kV

Project number: PR-427640_ACM_RP_ENV_057_0

AECOM Ireland Limited (AECOM) completed a Preliminary Site Assessment (PSA) of a cable fluid leak location on the Grand Canal southern tow path adjacent to Blackhorse Bridge, Inchicore, Dublin 8 (the site).

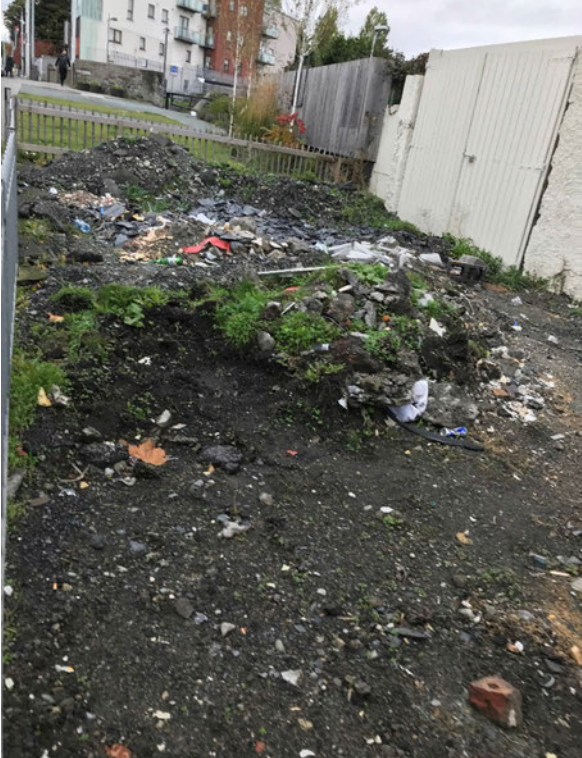
Photo No.: 5	Date: 01/11/19

Direction Photo Taken: North		
Description: Waste of unknown composition disposed on a small yard 35 north of leak location.

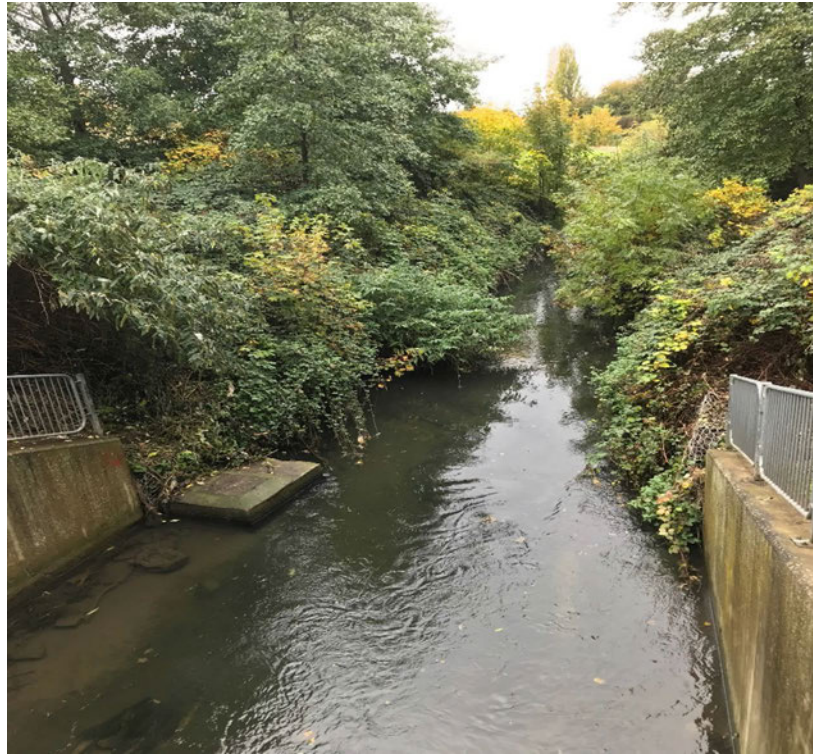
Secondary stream discharging into the Canal and flowing towards north. Flow is high and no evidence of contamination both downstream and upstream of leak location was observed during the site visit. Vegetation appears to be in very good condition.

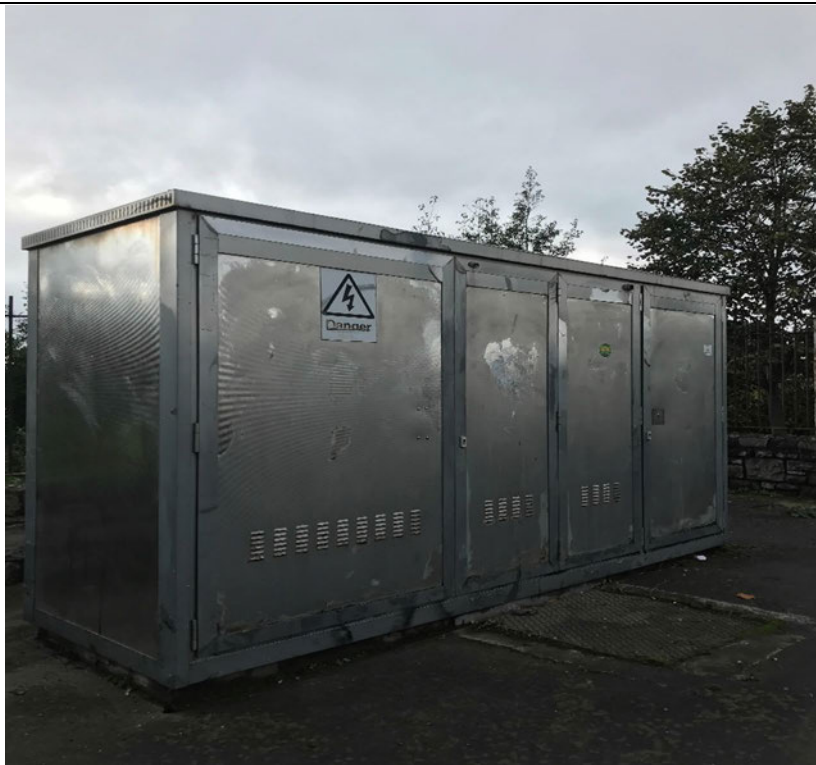
Facility Name:
ESB Cable Assessment**Site Location:**
Site 45 – Blackhorse Bridge**Project No.**
427640**Photo No.**
8**Date:**
01/11/19**Direction Photo Taken:**

Substation located approximately 50 m east of leak location, adjacent to LUAS stop.
