ESB Engineering and Major Projects

Marrowbone Lane - Newmarket (Site ID 53)

Preliminary Environmental Site Assessment

602749 – R05 (01)

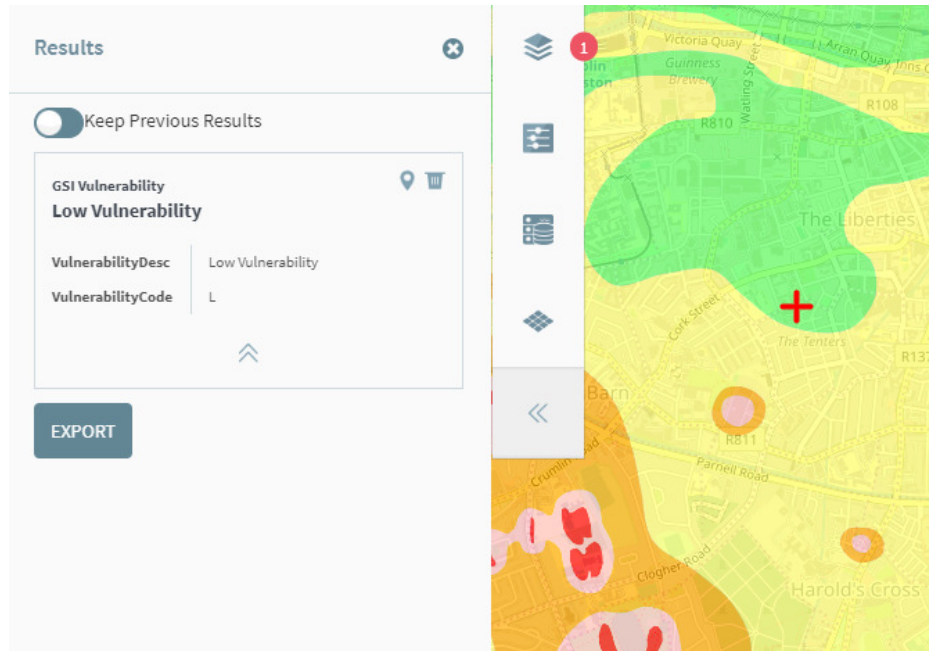
Figure 3.2 Groundwater Vulnerability

Information from the GSI Groundwater public viewer website <http://spatial.dcenr.gov.ie/imf/imf.jsp?site=Groundwater> indicates that the underlying bedrock is categorised as a locally important aquifer, that is an aquifer which is productive only in local zones. It is anticipated that perched groundwater may be encountered in more permeable horizons within any made ground and superficial deposits.

Groundwater vulnerability is classified as Low at the site (see Figure 3.2 above). The EPA categorise the groundwater body as not at risk and water framework directive (WFD) monitoring (2010-2015) ranks the water quality status as good.

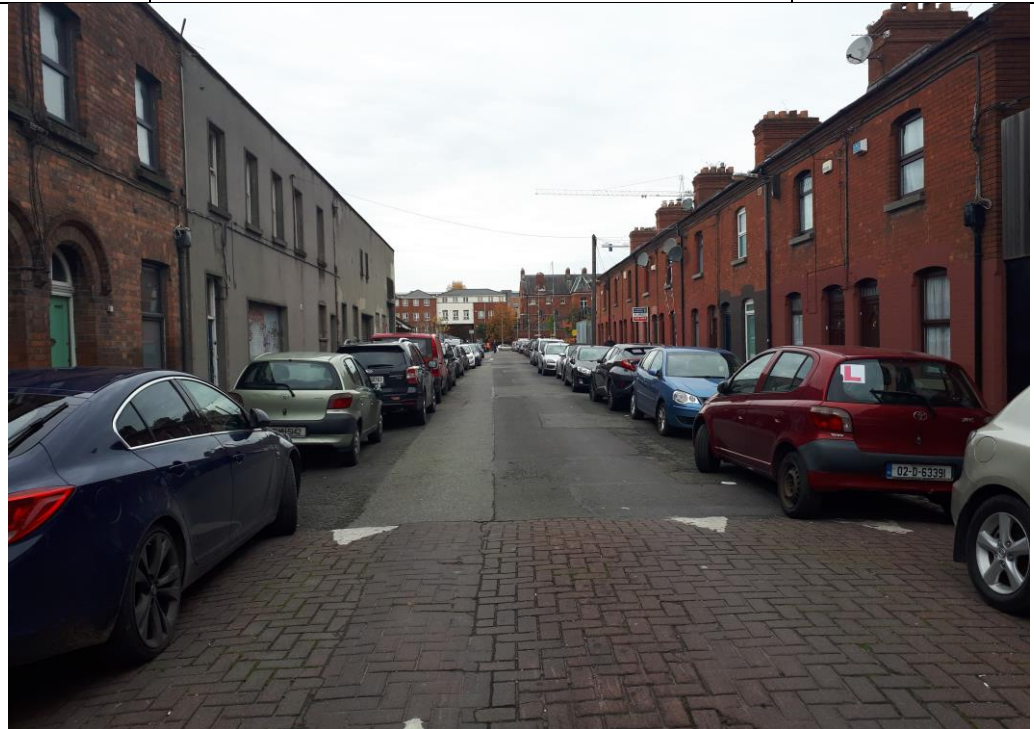
View of Chamber Street c.250m marker from indicative leak location. Bounded by attached residential housing with rear gardens and footpaths on both sides.

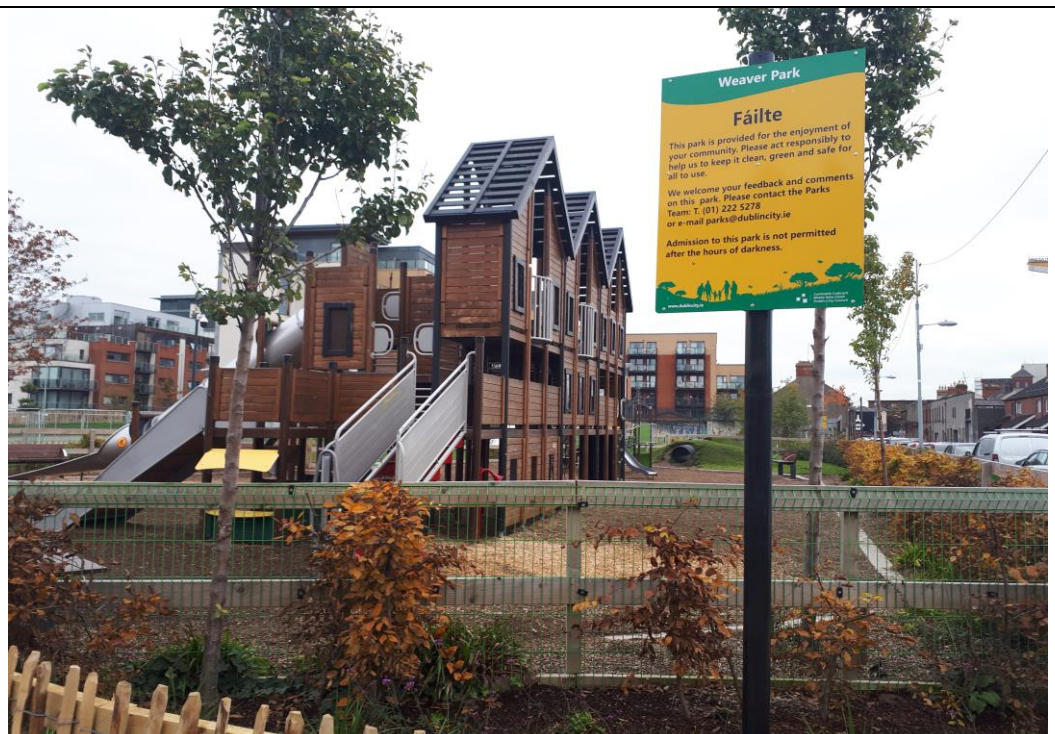
Photo No.
2

An entrance to Weaver Park off Chamber Street c. 155m marker from indicative leak location. View of the playground and communal landscape within the park.

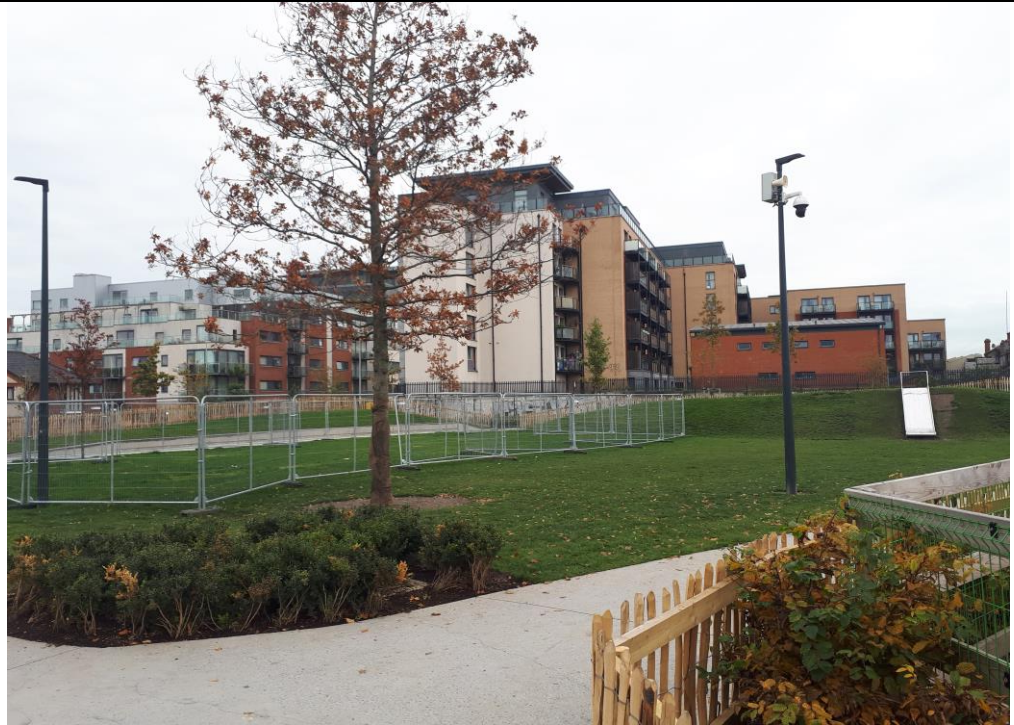
170m marker from indicative leak location. View from inside Weaver Park. The land use is an access path to and from both Chamber Street and the R110.

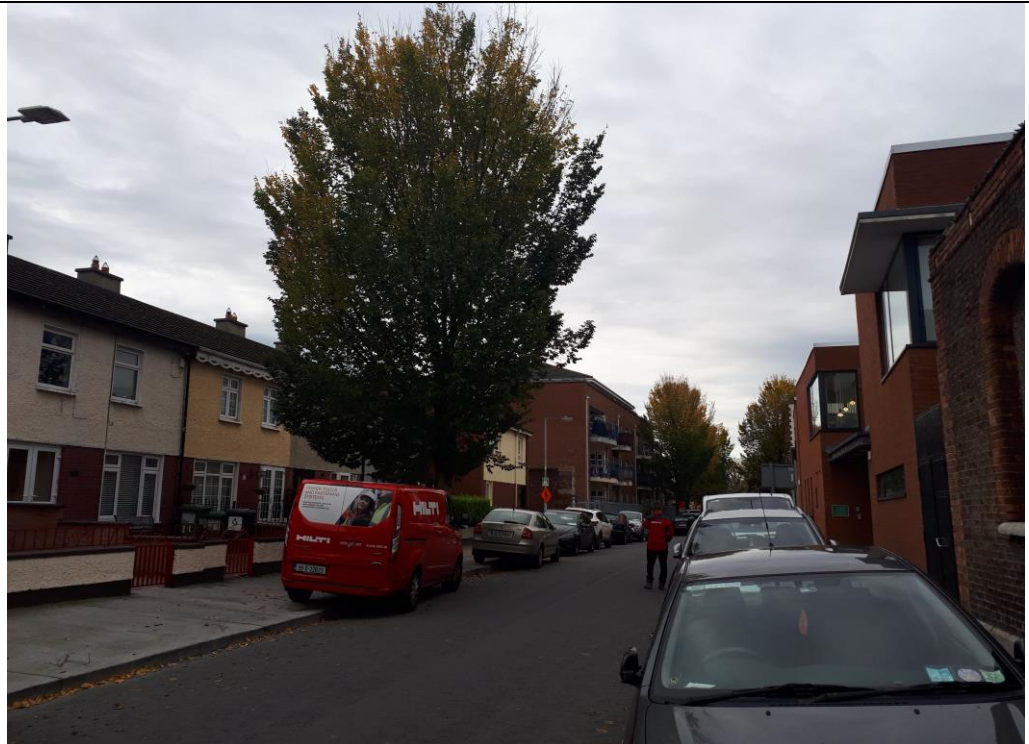
Photo No.
4

View from the indicative source leak (Brown Street South). The site is predominantly bounded by attached residential dwellings on both sides of the road. Trees and footpaths also bound both sides of the road.

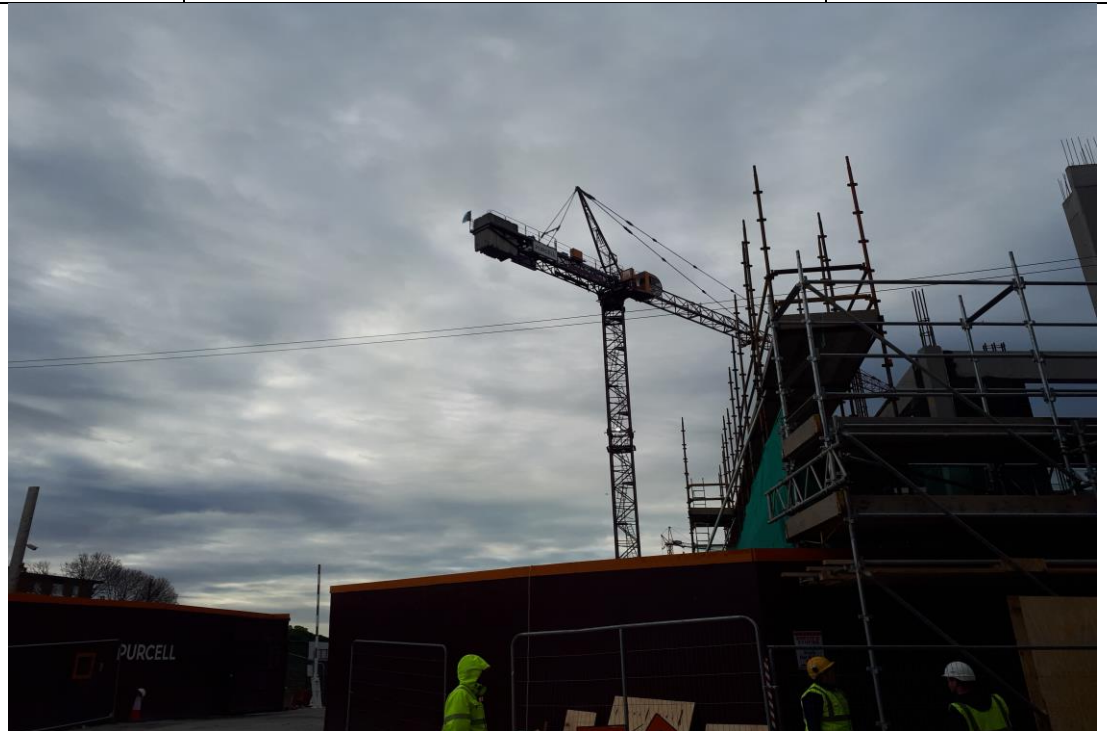
View of the construction site to the west of the site on Brown Street South c. 160m from the site. The area is surfaced by hard standing concrete and surrounded scaffolding and hoarding.

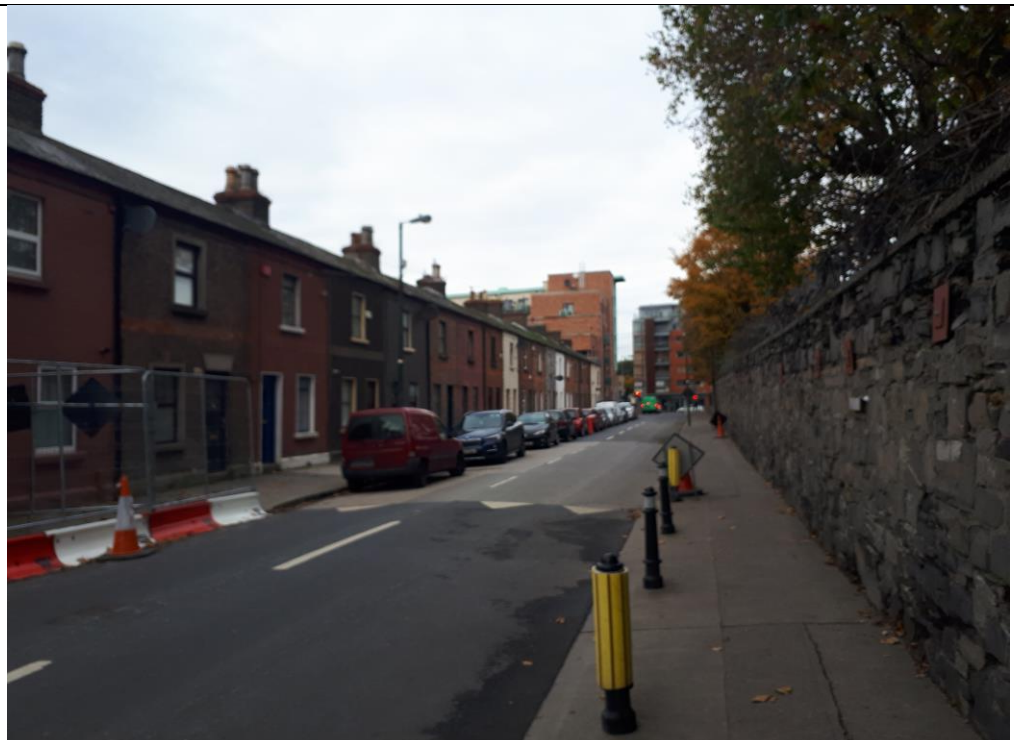
**Photo No.**

View of Donore Avenue bounded by attached residential dwellings (west) and a concrete wall (east) which is the boundary of Brú Chaoimhín Hospital. This marker is c. 180m from the site.

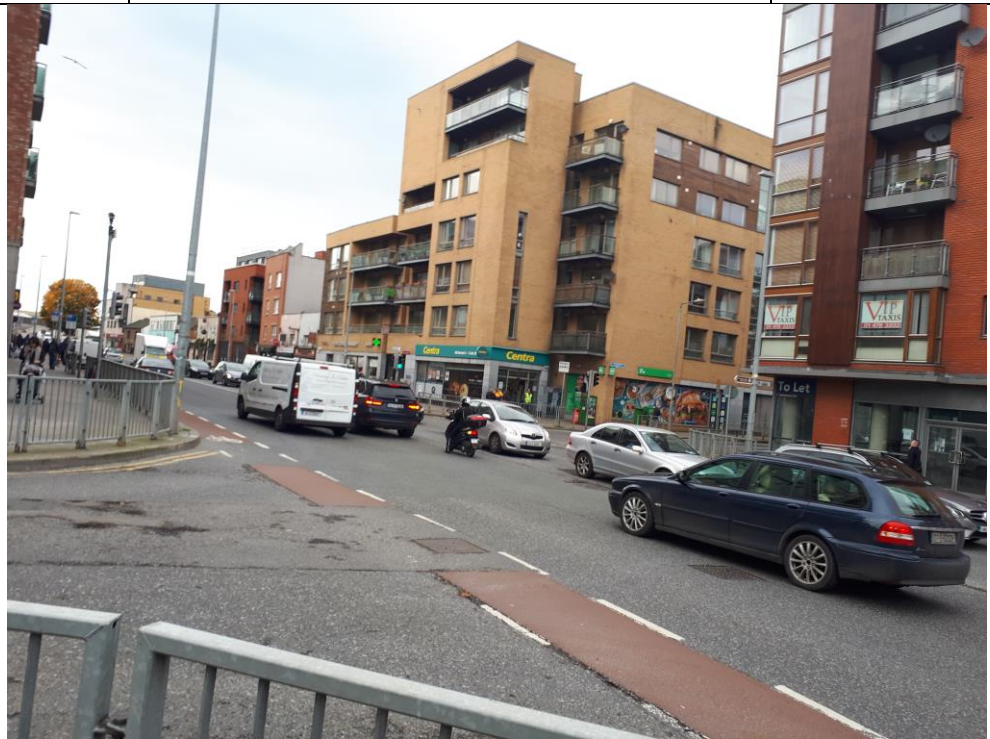
View of the nearest main road, the R110 which is an access point to both Ormond Street and Donore Avenue.

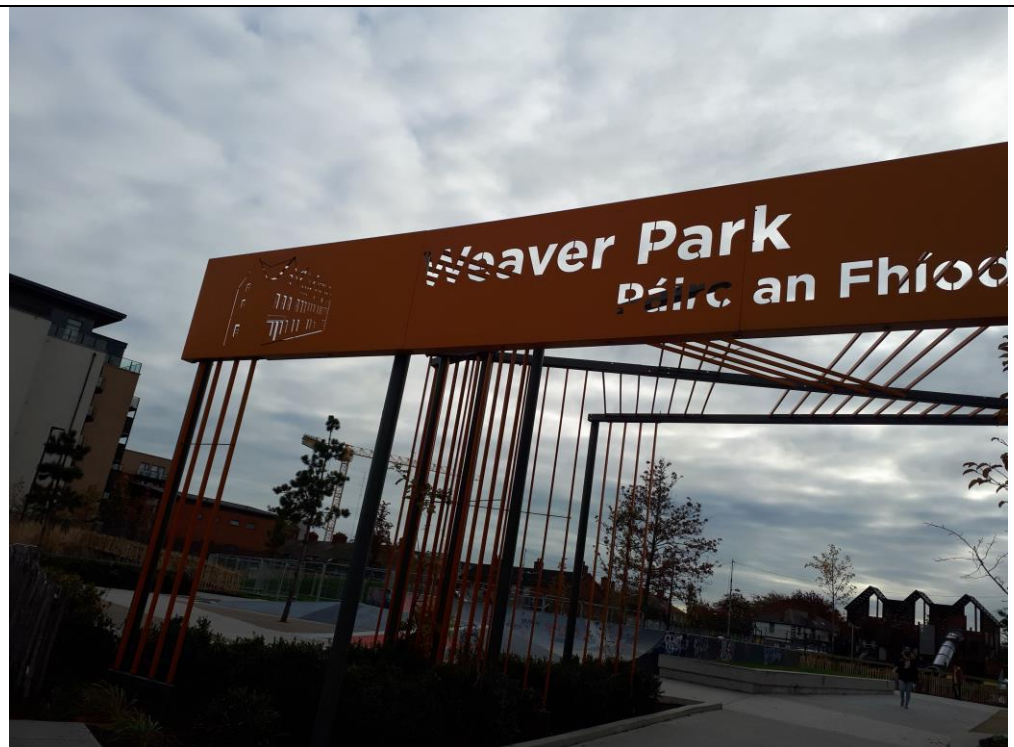
Photo No.
8

View of Weaver Park from the R110. A south facing access point to the park and is a c.160m marker from the site.
