Preliminary Site Assessment

Site 55 Francis Street - Inchicore 110 kV

Electricity Supply Board

Project number: PR-427640_ACM_RP_ENV_065_0

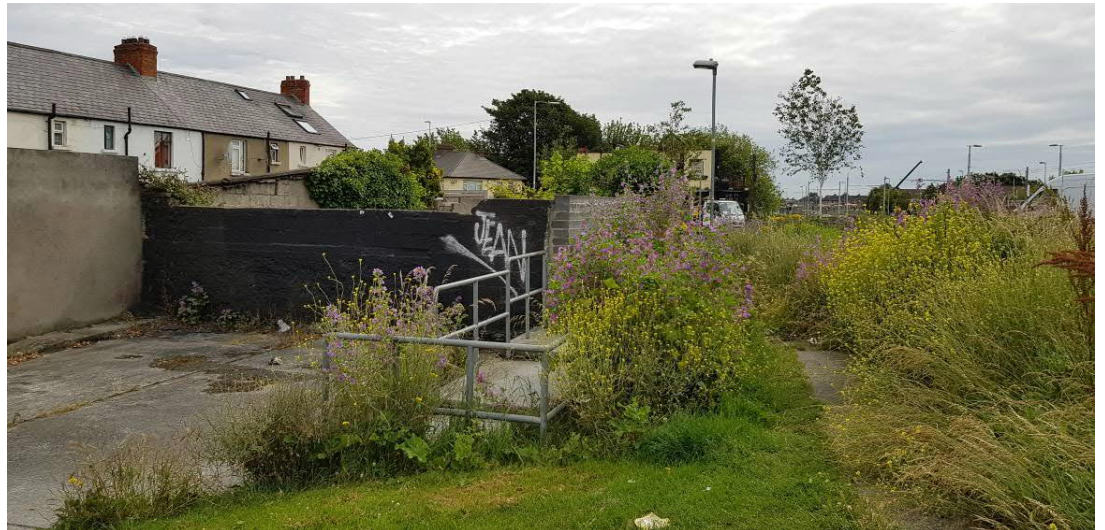
**Date:**
09 July 2019**Description:**
Residential properties on Jamestown Road at the eastern end of Site 27. Drainage ditch running along left hand side of photograph below line of trees.

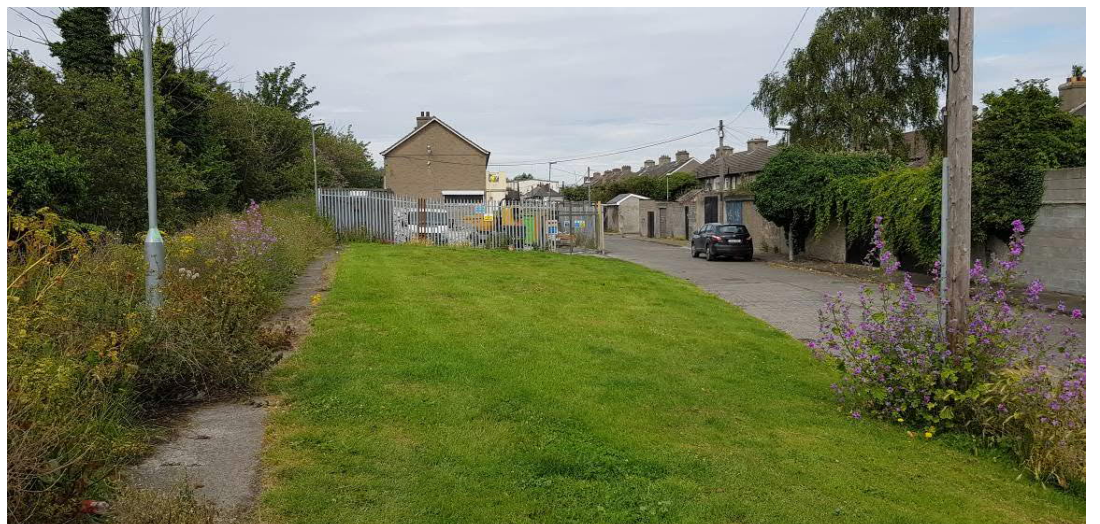
Client Name: ESB	Site Location: Site 55: Francis Street - Inchicore	Project No. PR-427640
Date: 09 July 2019	 	
Description Tow path looking west from eastern end of Site 27. Cables beneath tow path. Grand Canal to the left and drainage ditch to right hand side of tow path in photograph.

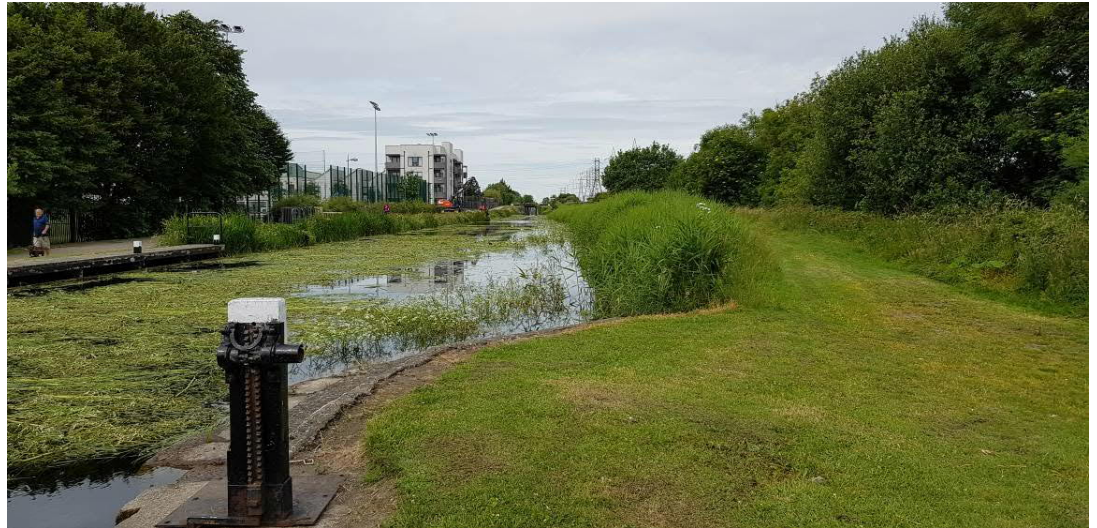
Description:
View North along Grand Canal from middle lock on Site 27. APEC location on right hand side of Photograph in the far distance (opposite the playing fields shown on left of photograph).

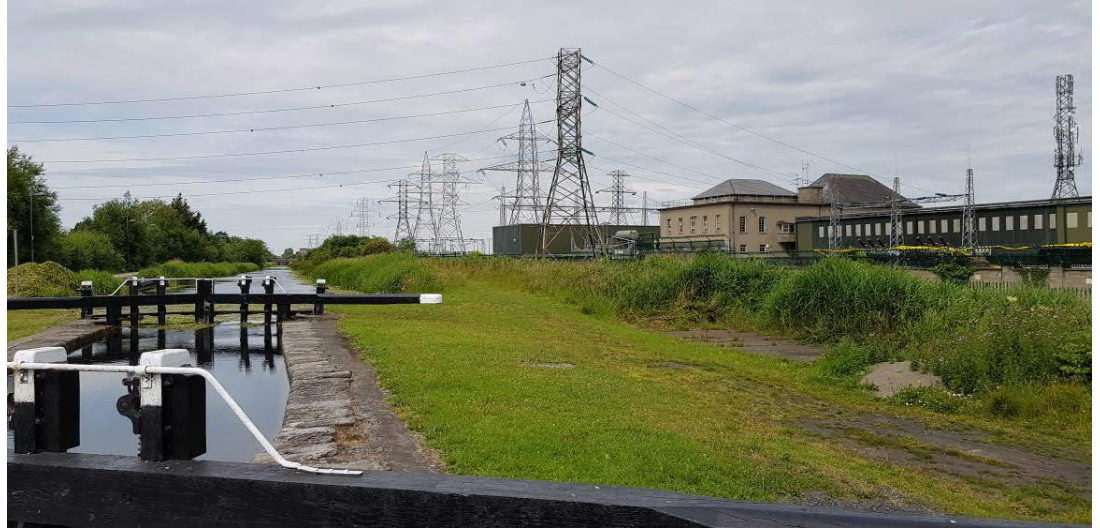
Date: 09 July 2019	 	
Description: Discharge culvert from Grand Canal to drainage stream upstream of APEC location. (Drainage Stream Side)

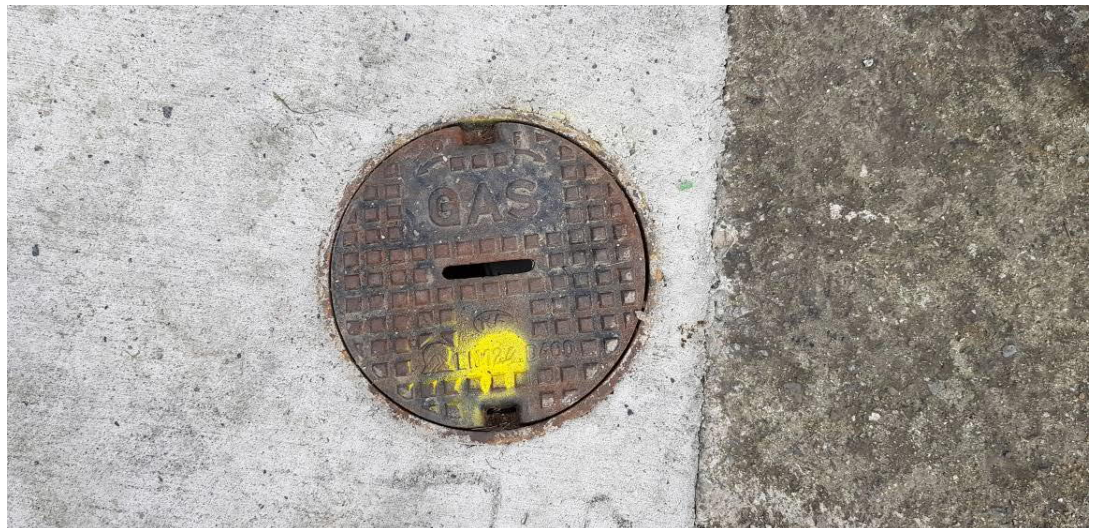
Description:
Evidence of underground
Gas utilities located on
southern side of upper
lock opposite ESB
Inchicore Station.
