ESB Networks Historic Cable Fluid Losses: Preliminary Site Assessment

Location 62: Blackrock - Ringsend 110 kV - November 2003

Project Title: ESB Networks Historic Cable Fluid Losses: Preliminary Site Assessment. Location 62: Blackrock - Ringsend 110 kV - November 2003

Report Ref: GCU0257001/009

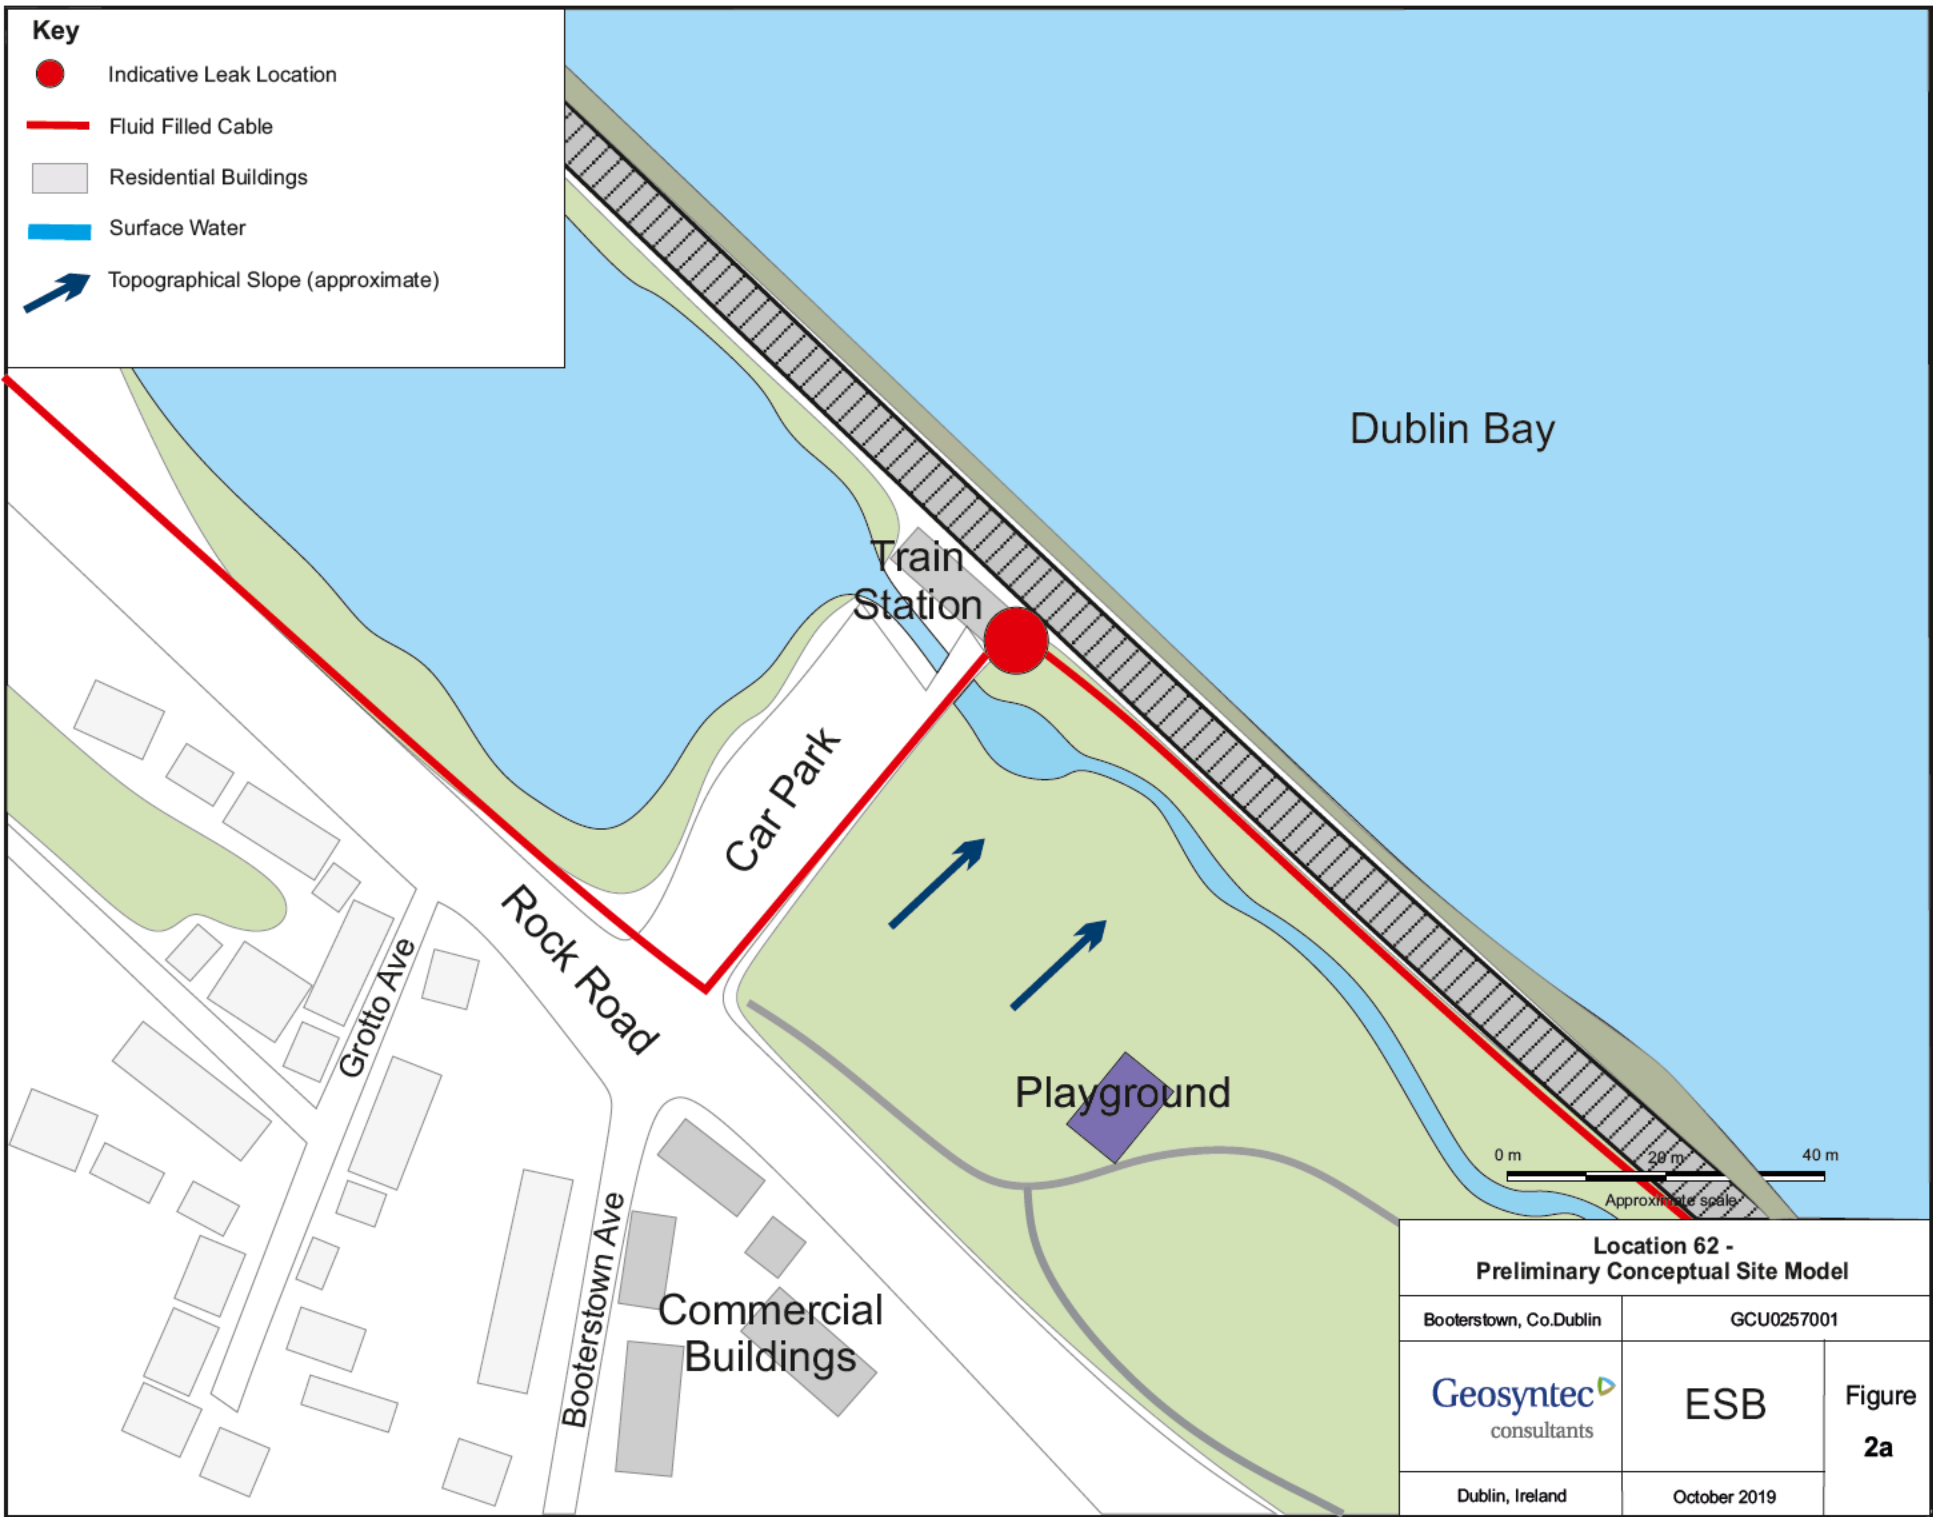
PRODUCTION UNIT:	Civil & Environmental Engineering
DRAWING TITLE:	Indicative Cable Fluid Leakage Locations & Cable Sections (33) Blackrock - Ringsend 110 kV (October 2003 - November 2003)

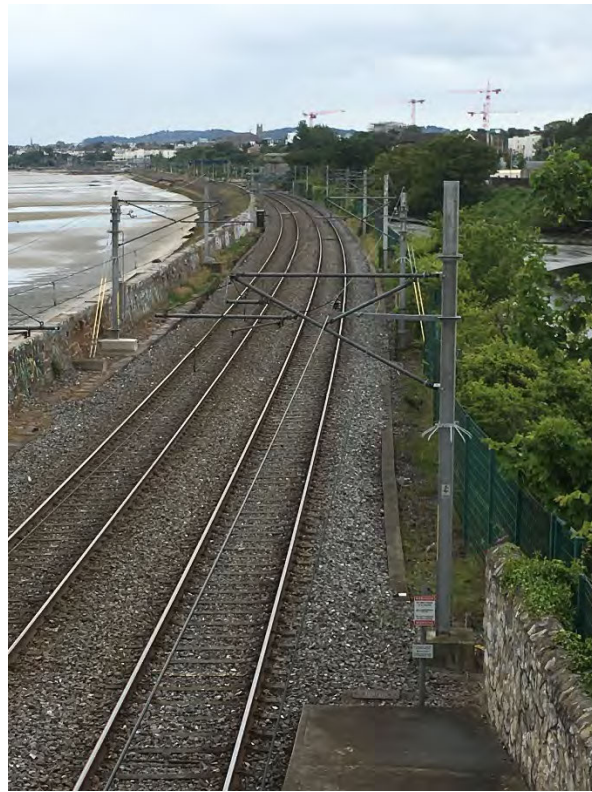
Photograph 2 – View south along cable route

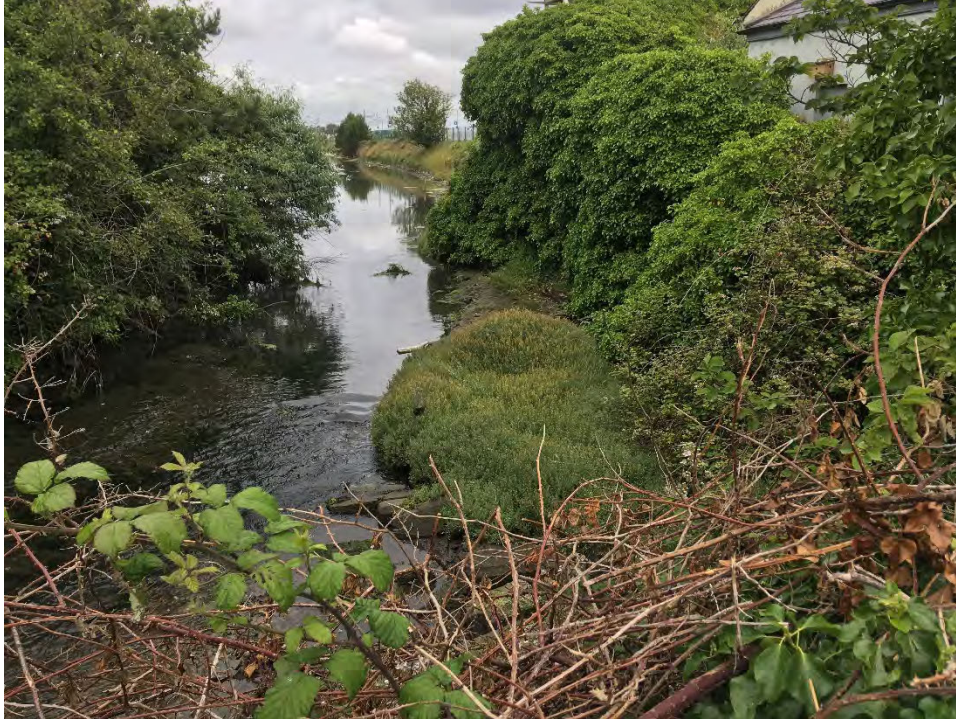
No evidence of distressed vegetation was noted along the banks of Booterstown Marsh in the vicinity of the leak location at the time of the walkover survey.

**Photograph 3 – Water course north-west of leak location
(no evident dieback of vegetation)**

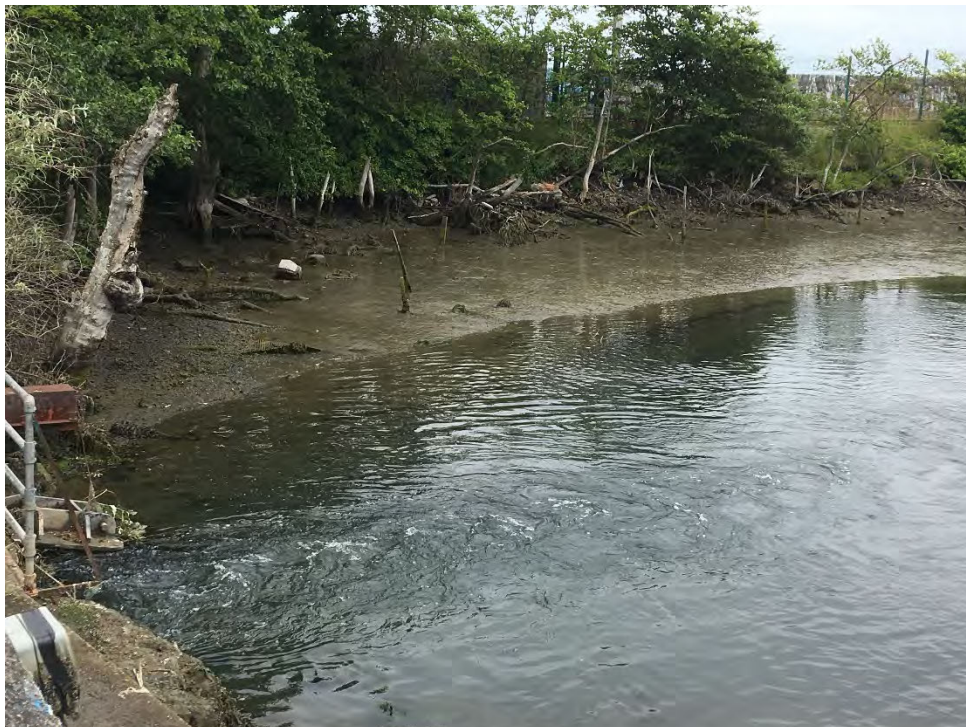
**Photograph 4 – Area south-west of leak location
(no evident dieback of vegetation)**

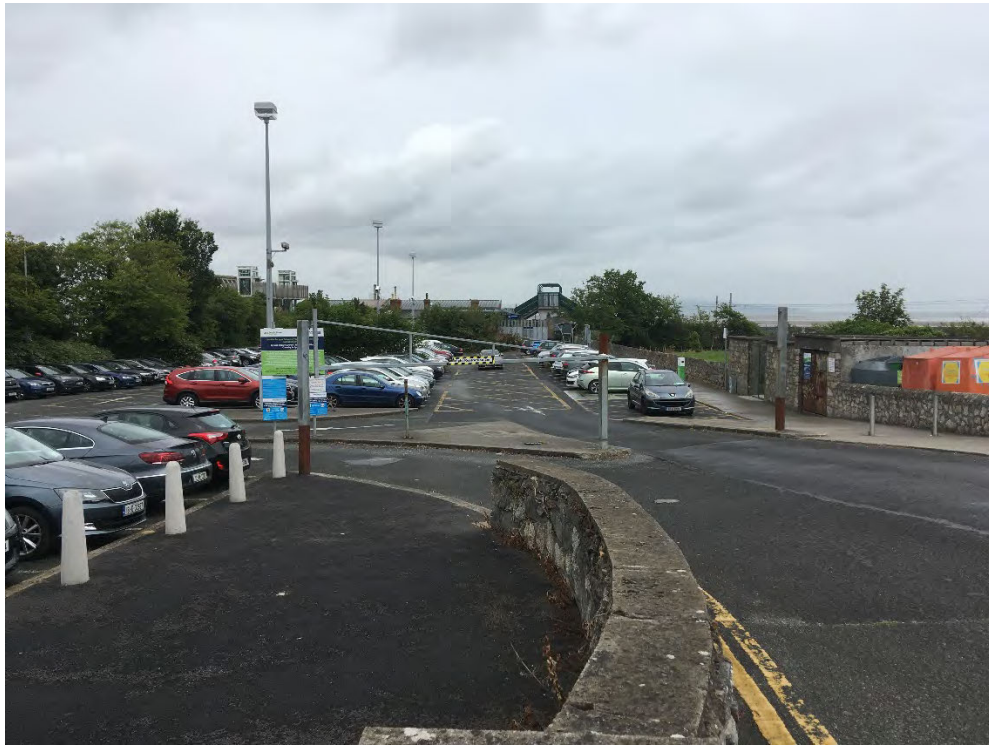
Photograph 5 - View towards Booterstown Station from Rock Road

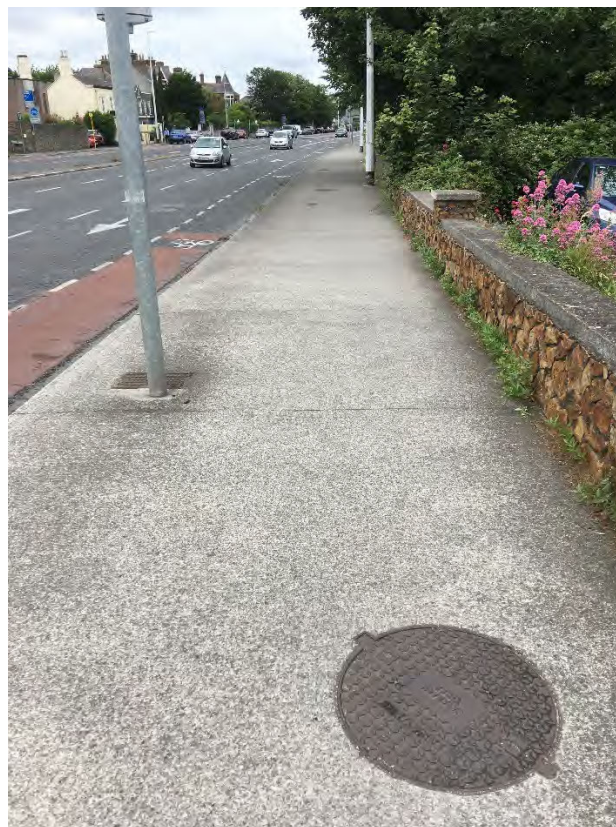
Photograph 6 – View north along Rock Road

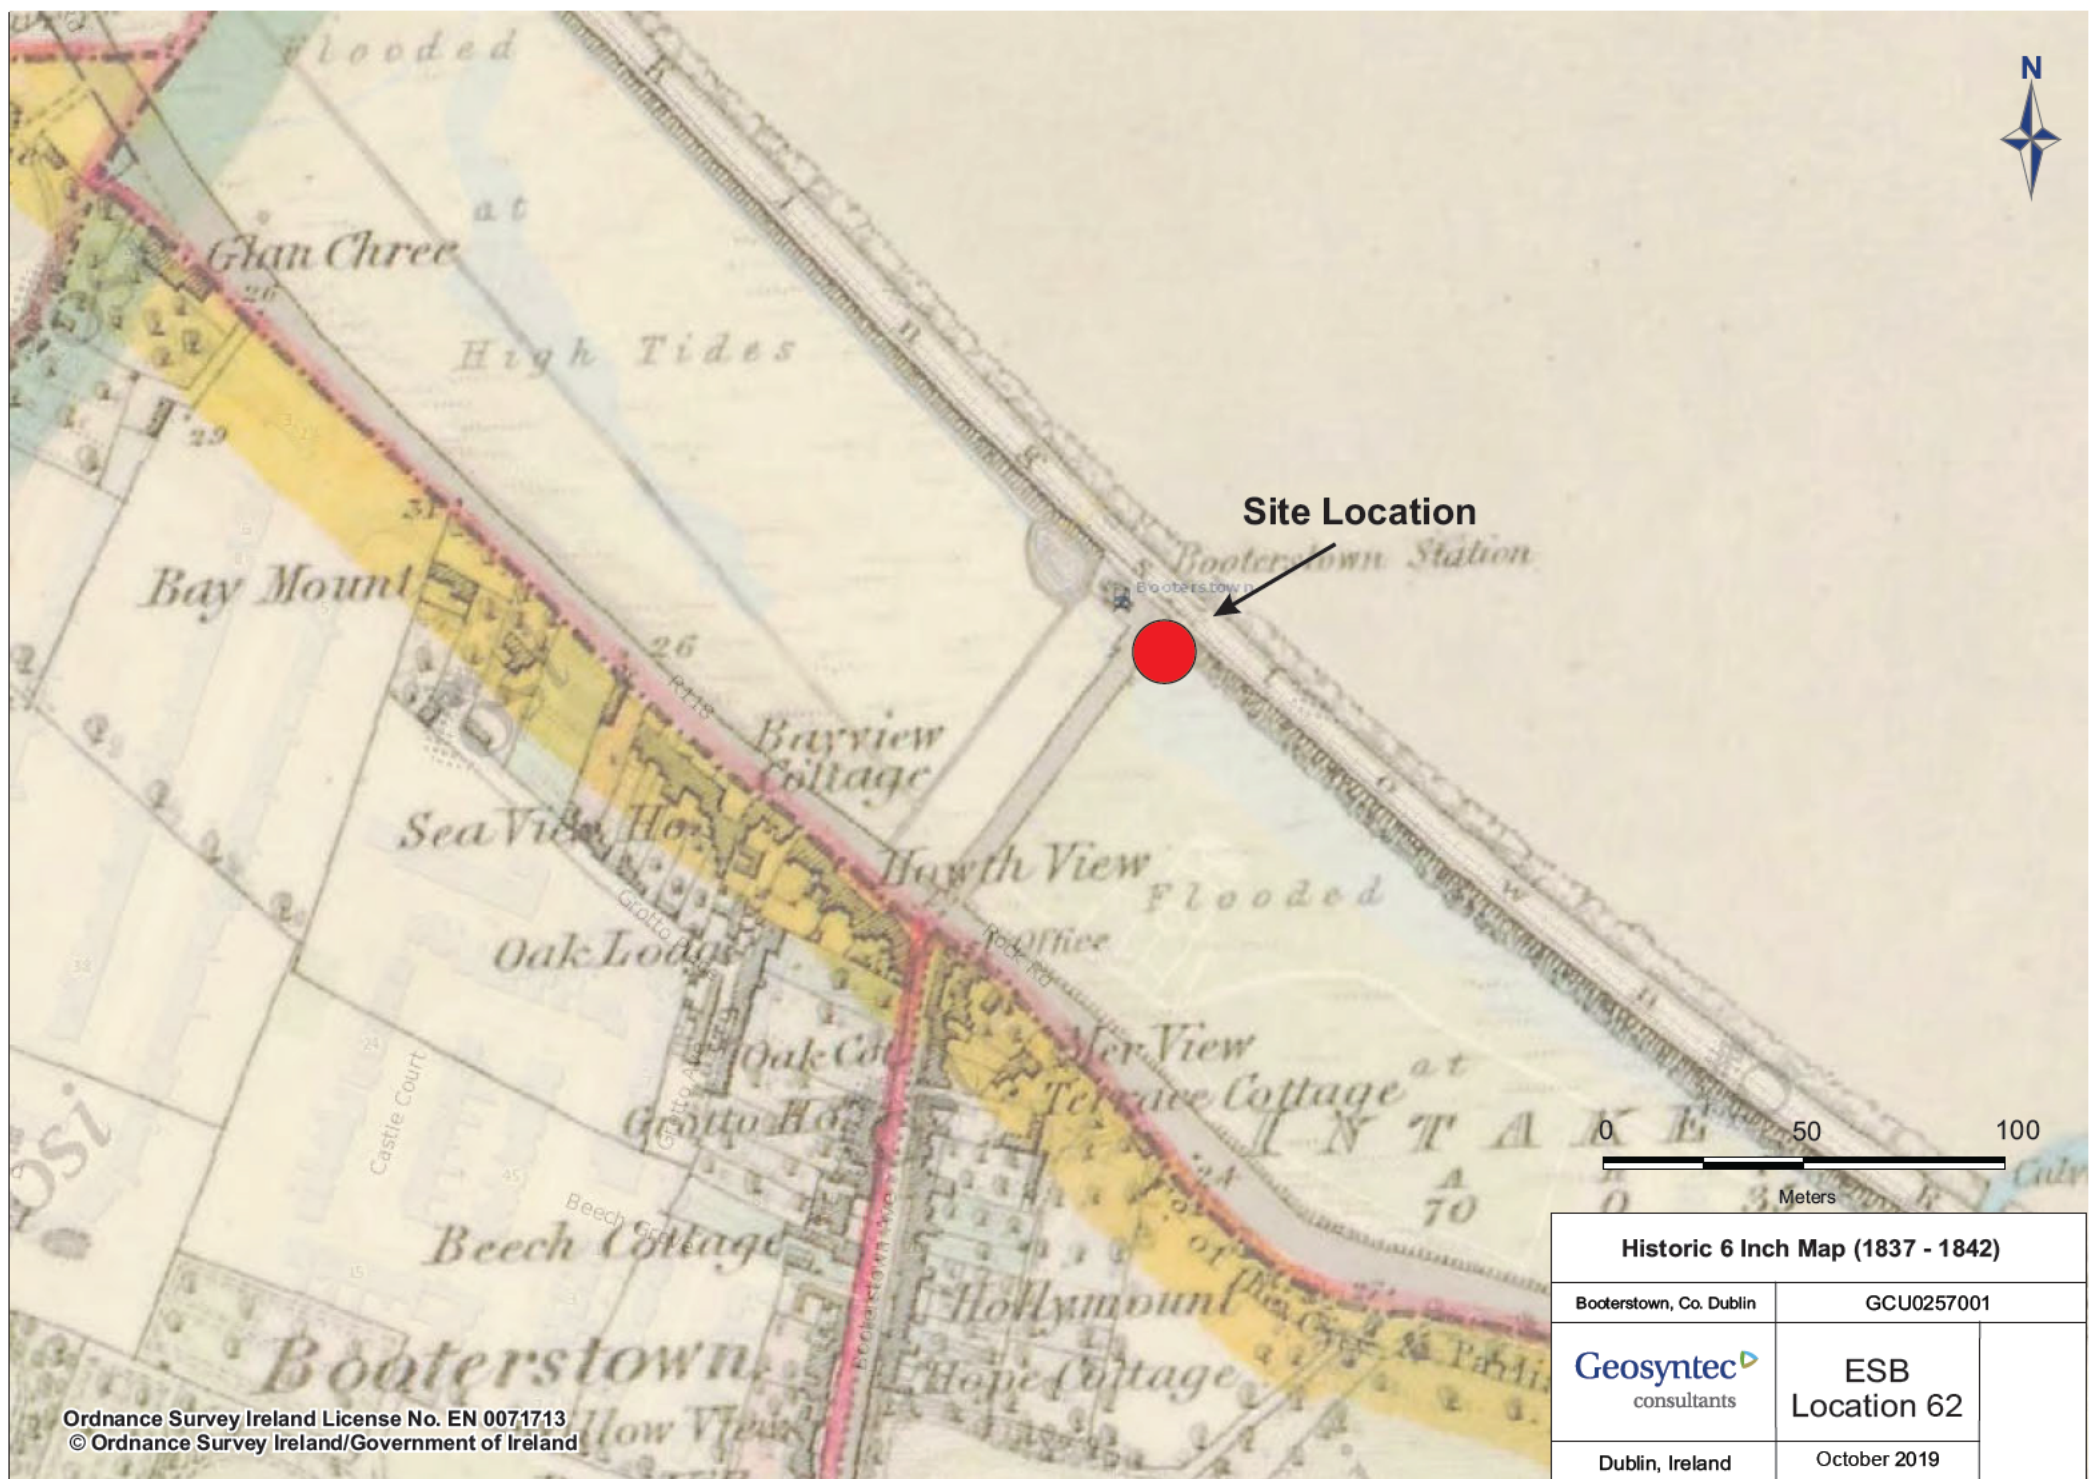
The earliest historic map available from the OSI's website is dated 1837 – 1842. Booterstown Station and the railway line are present in this map as well as an access causeway into the station off Rock Road. Booterstown Marsh is shown as an area that floods at high tide. The area along Booterstown Avenue and along Rock Road close to Booterstown Avenue are developed with what appear to be mostly residential housing.

Historic 6 Inch Map (1837 - 1842)	
Booterstown, Co. Dublin	GCU0257001
Geosyntec consultants	ESB Location 62
Dublin, Ireland	October 2019

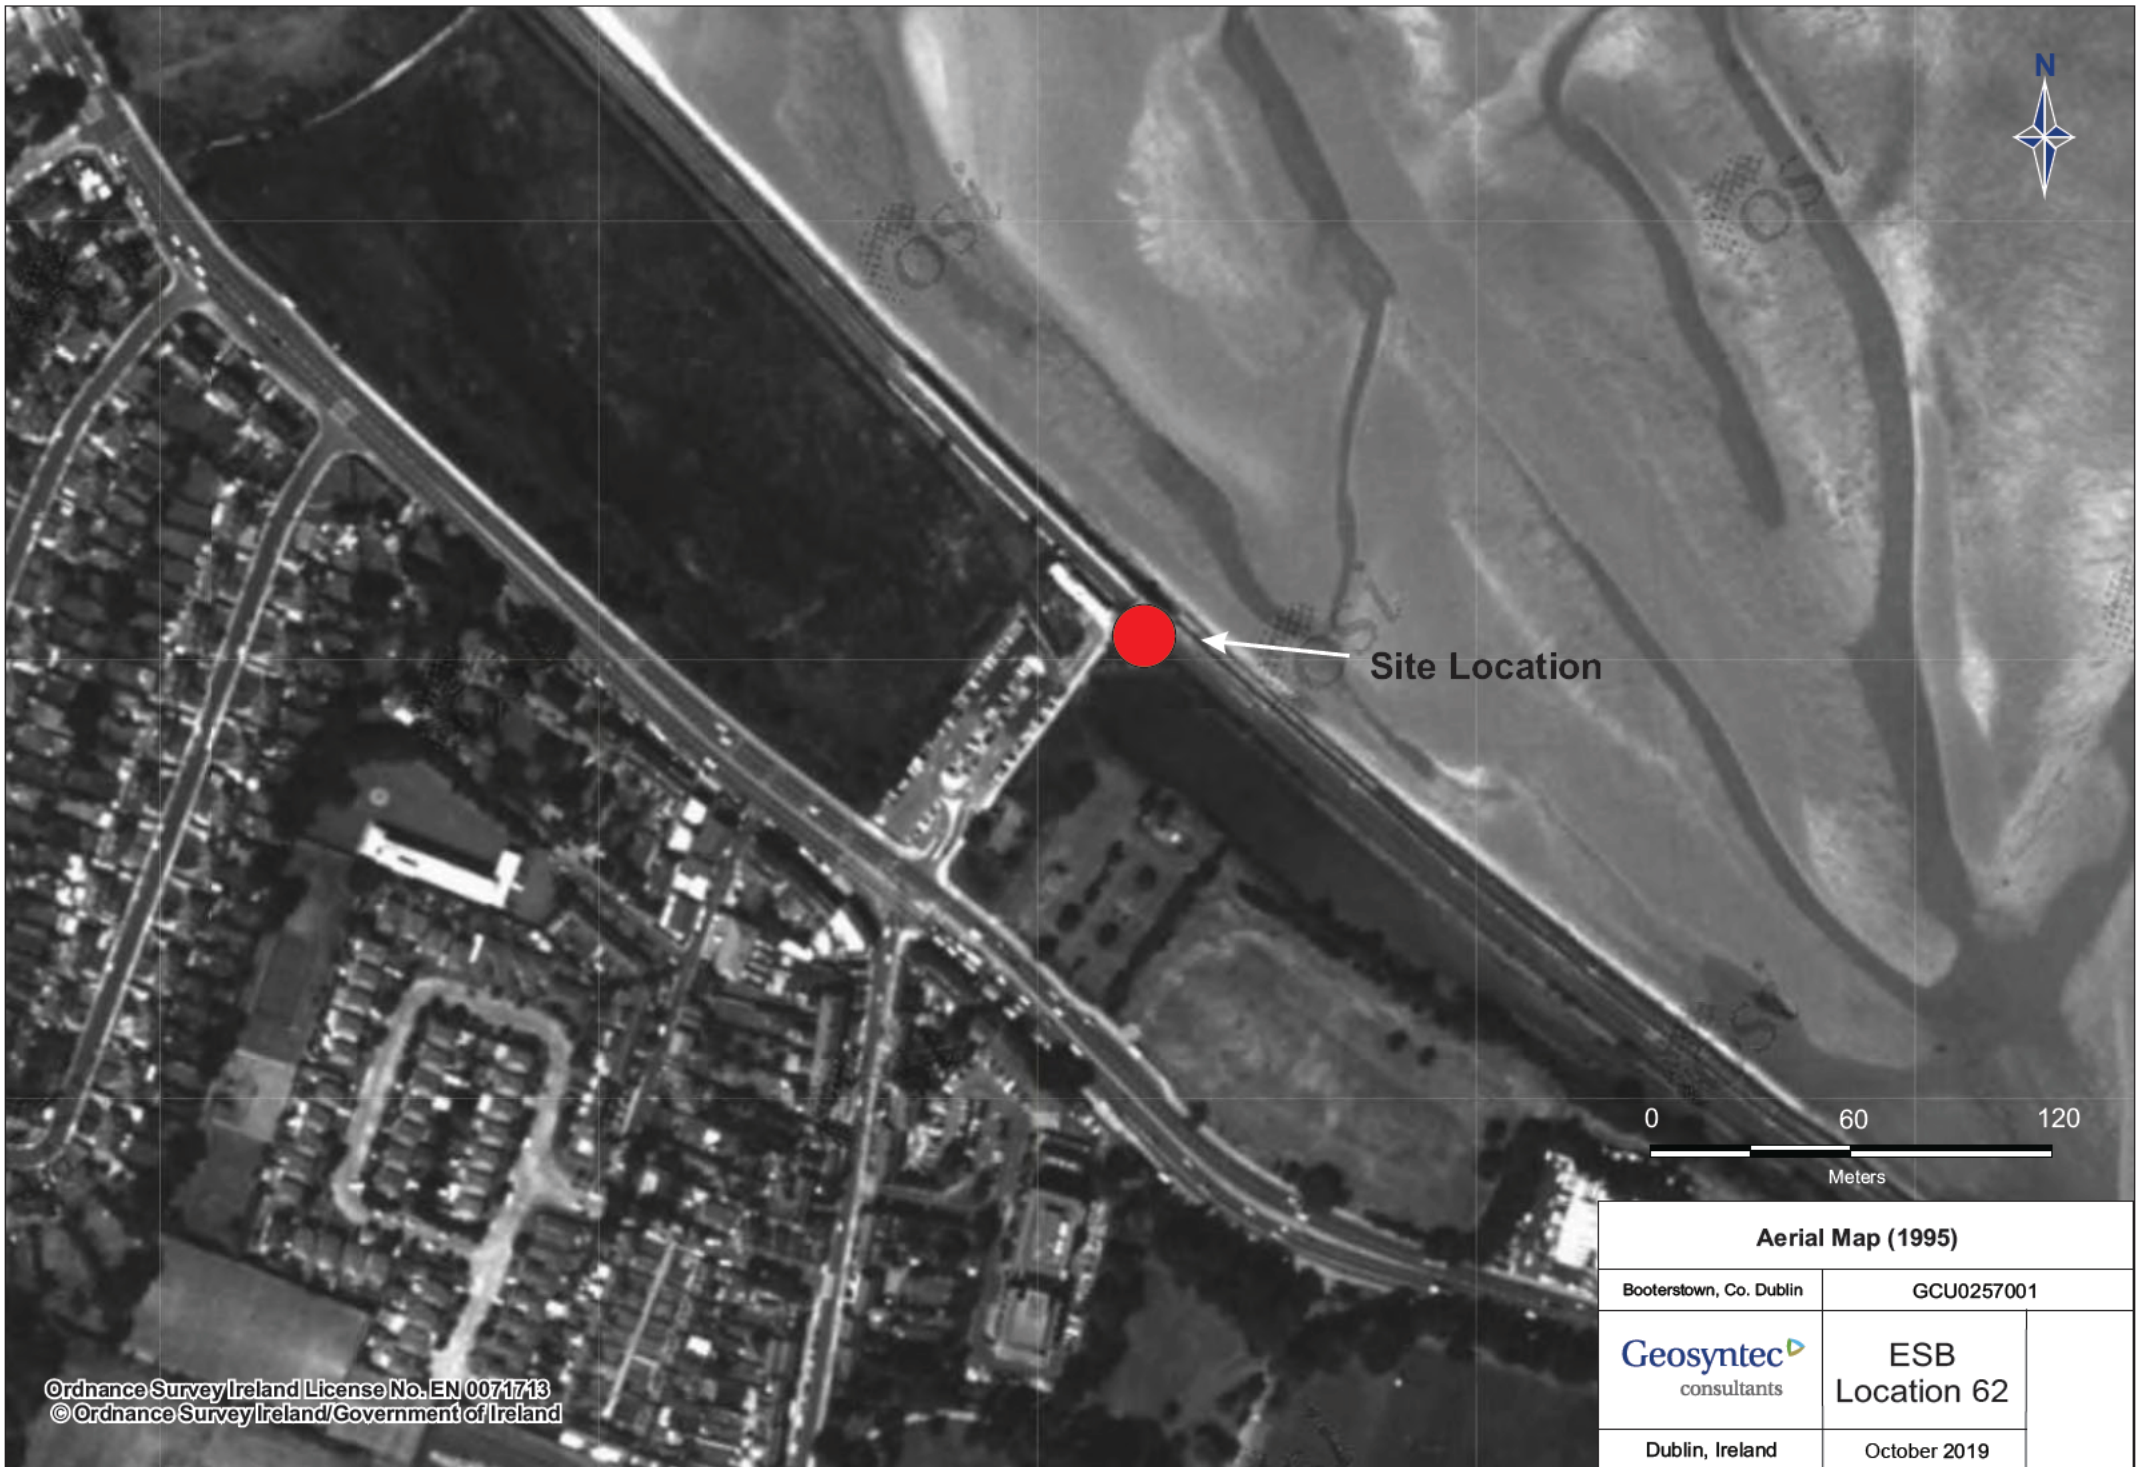
The earliest aerial image available from OSI's website (other than 19th century historical maps) is dated 1995. This image shows the layout of the area close to the leak location similar to that observed today. The tramline along the Rock Road and Merrion Road to the north is no longer present.

Aerial Map (1995)	
Boosterstown, Co. Dublin	GCU0257001
Geosyntec consultants	ESB Location 62
Dublin, Ireland	October 2019
