ESB Networks Historic Cable Fluid Losses: Preliminary Site Assessment

Location 63: Phibsborough – Granby Row 38 kV July 2003

Report Ref: GCU0257001/019

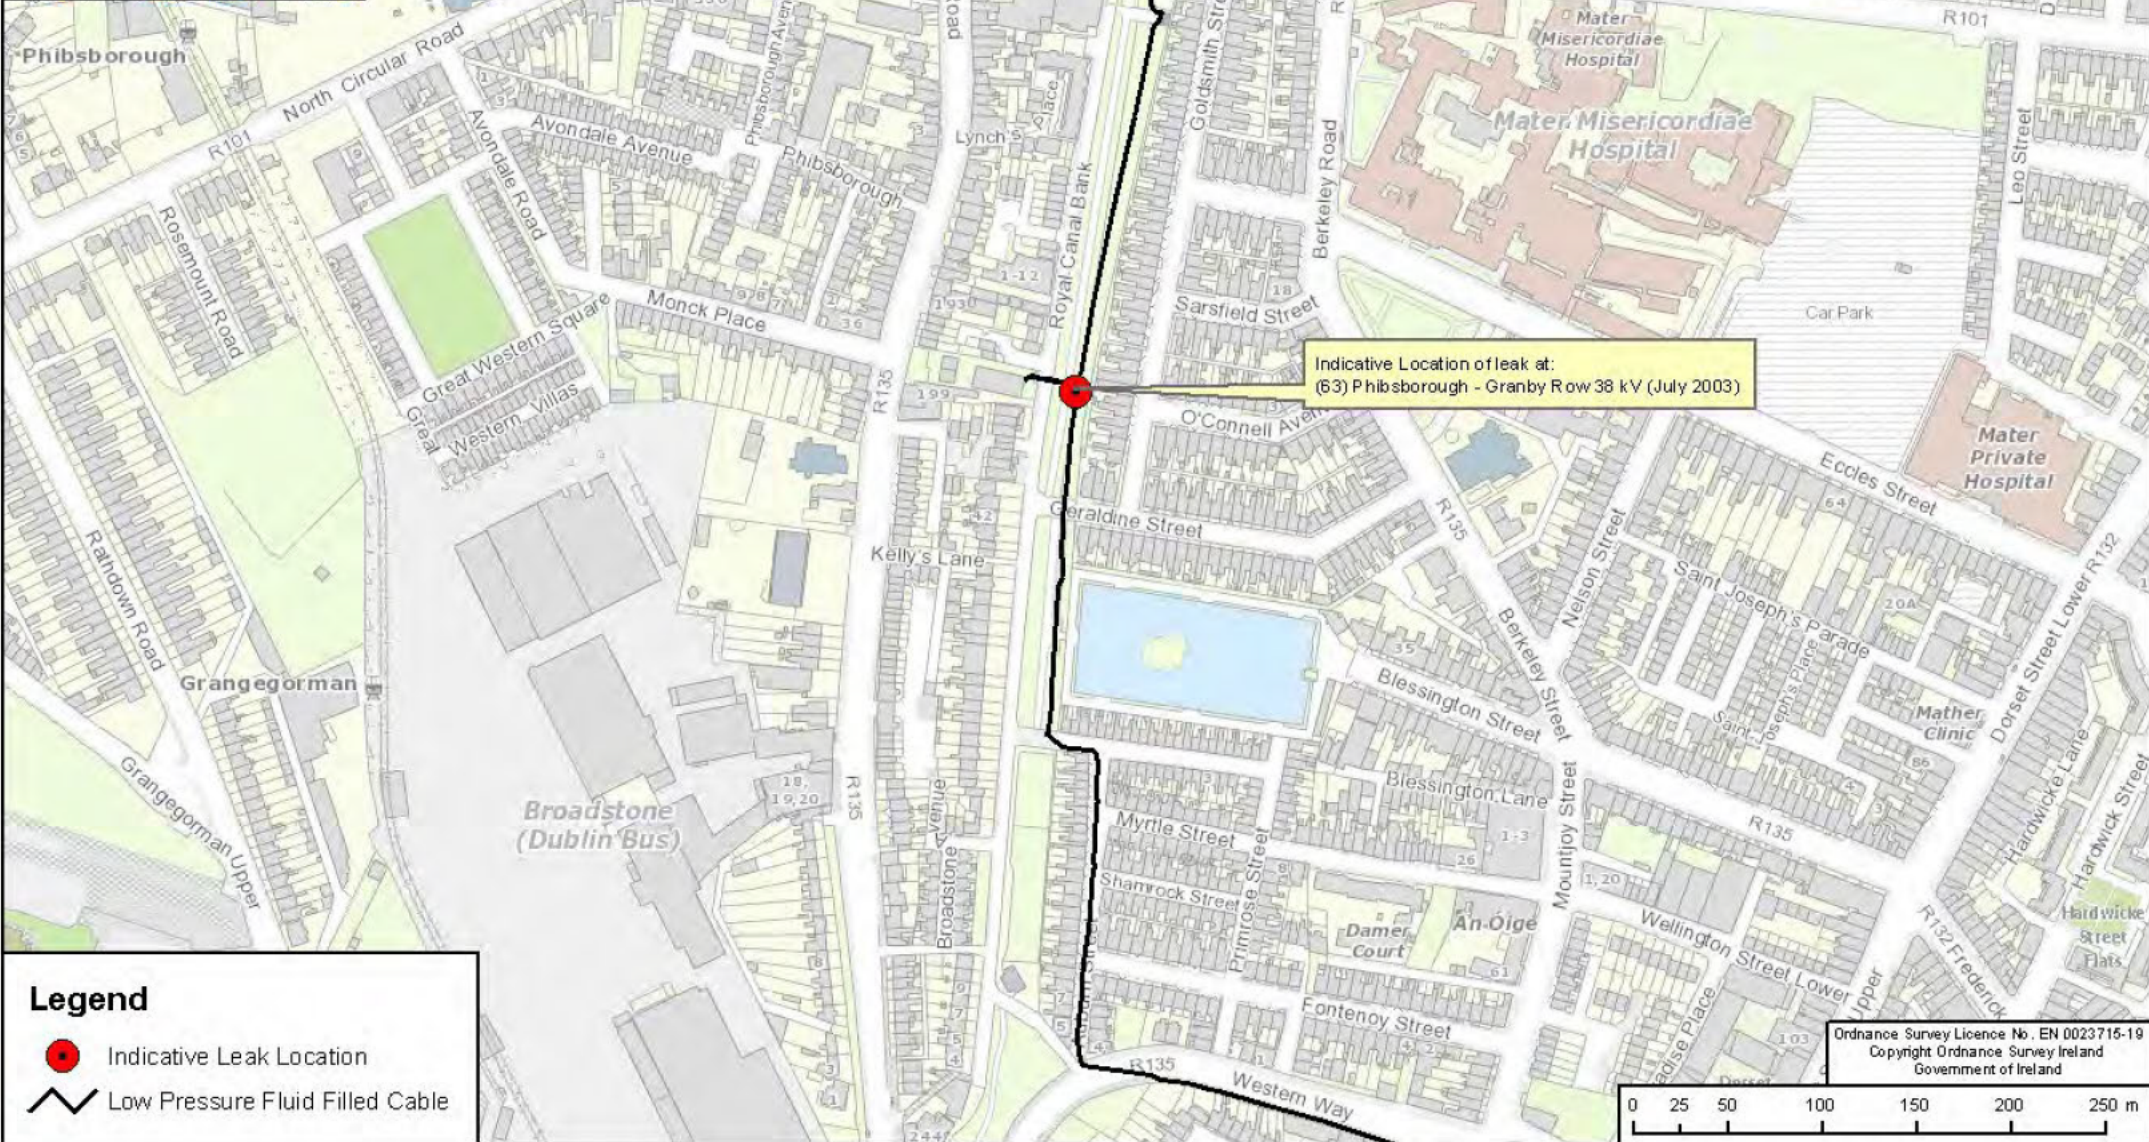
Figure 1: Site Location No. 63

Indicative Location of leak at:
(63) Phibsborough - Granby Row 38 kV (July 2003)

- Indicative Leak Location
- Low Pressure Fluid Filled Cable

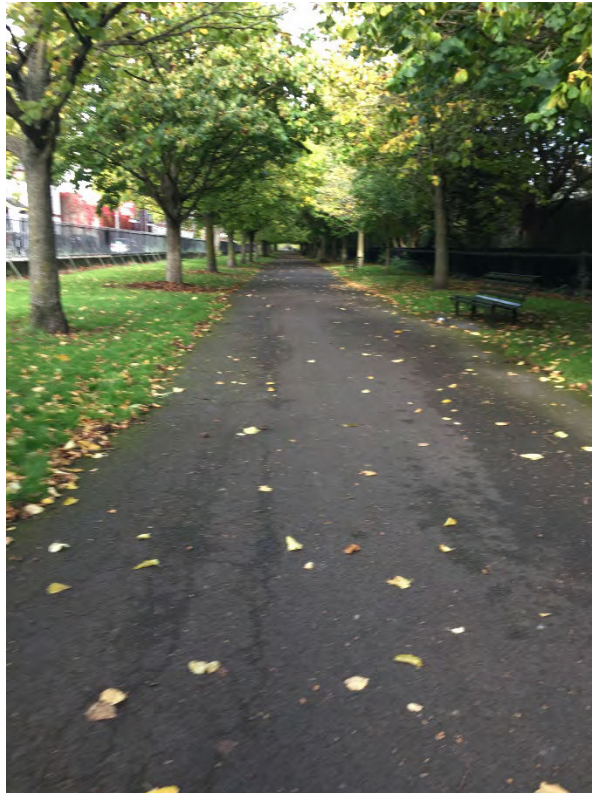
Photograph 1 – Leak location looking north

The leak location is situated in a public amenity space comprising a walkway with mature trees along the east side of the Royal Canal Bank road. The subject section of cable appears to run through a vegetated area along the eastern side of the public park. There is a 3-4m high wall along the eastern boundary of the park beyond which are the rear gardens of a terrace of residential houses that are accessed off Goldsmith Street. To the west of the park is the Royal Canal Bank road, beyond which is a mainly residential area. The closest residential building is approximately 10m east of the leak location.

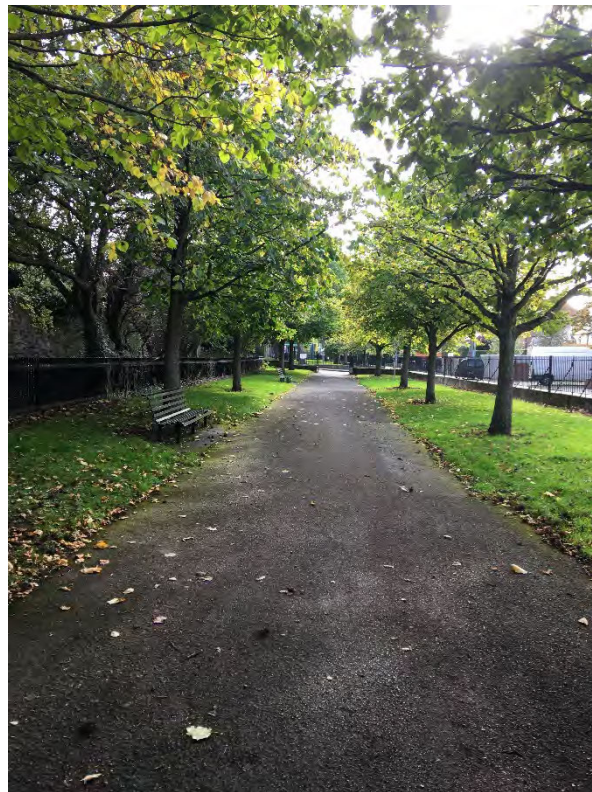
Photograph 2 – Leak location looking south

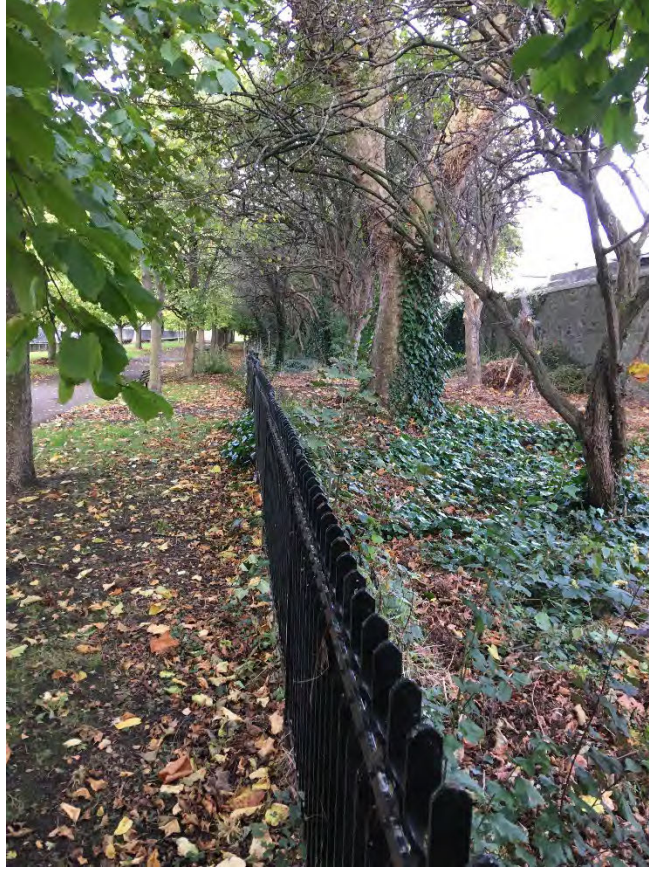
Photograph 3 – Cable route north of leak location

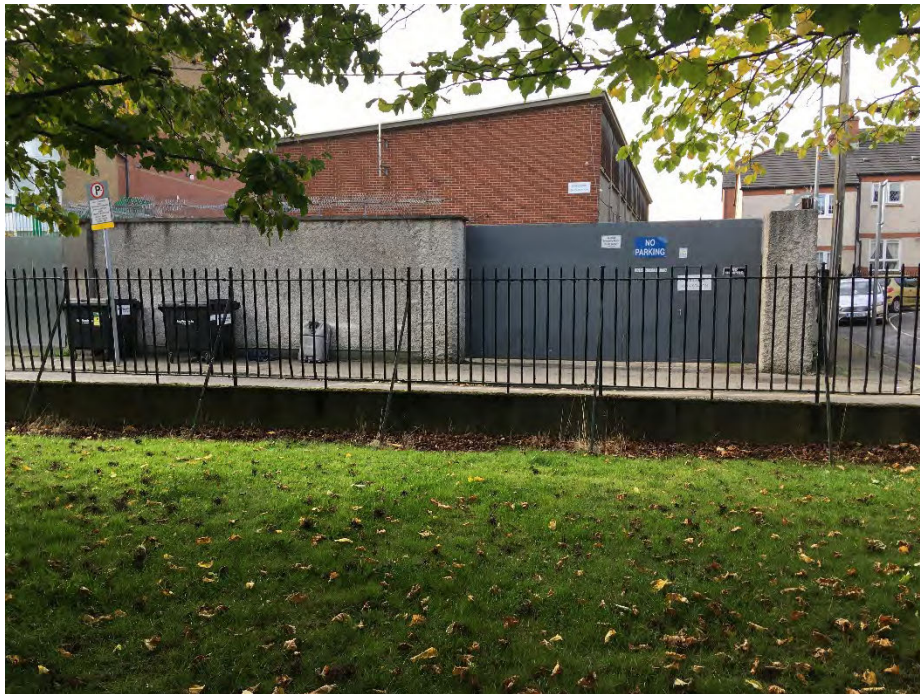
Photograph 4 – 38 kV substation west of leak location

There is a 38 kV ESB substation approximately 20m west of the leak location (to the west of Royal Canal Bank); an underground fluid-filled cable is indicated on ESB drawings running from the vicinity of the leak location to this substation.
