Site 65 Pembroke to Ringsend 38 kV: Preliminary Site Assessment Report for Historic Fluid Filled Cable Loss

ESB Engineering and Major Projects

19126590.65.A.2

24 April 2020

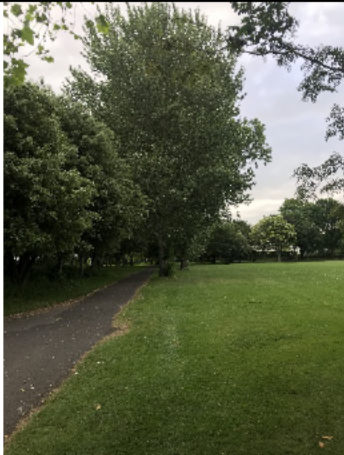
65-01 – Mature tree stands are located along the southern areas of the Ringsend Park footpath and at the Site. Die back was not observed

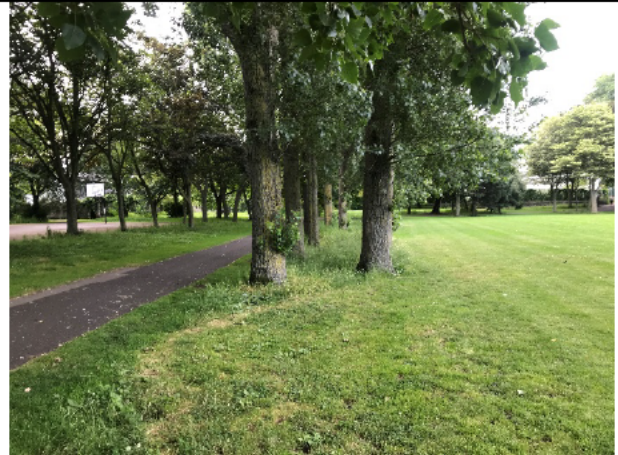
65-02 – Potential for developed and mature root systems interacting with underlying services. Die back was not observed

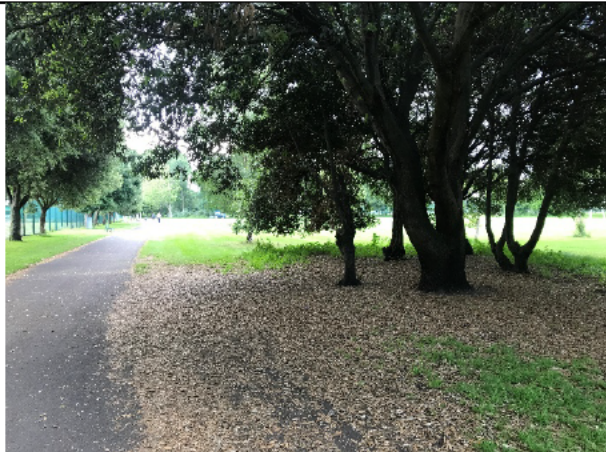
65-03 – Potential for developed and mature root systems interacting with underlying services. . However die back was not observed

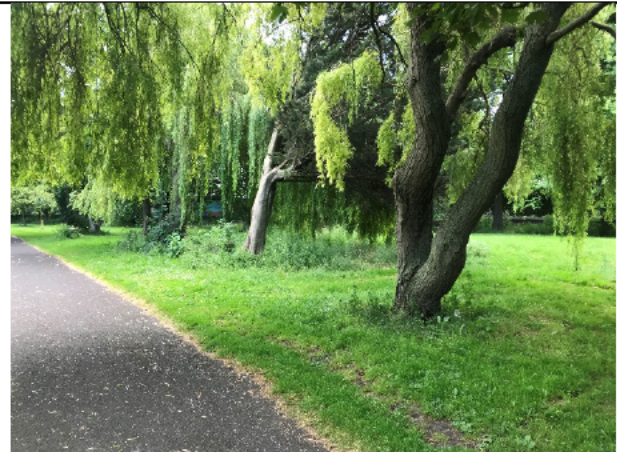
65-04 – Potential for developed and mature root systems interacting with underlying services. However die back was not observed
