Preliminary Site Assessment

Site 9 Inchicore - Poolbeg 220 kV

Electricity Supply Board

Project number: PR-427640_ACM_RP_ENV_004_8

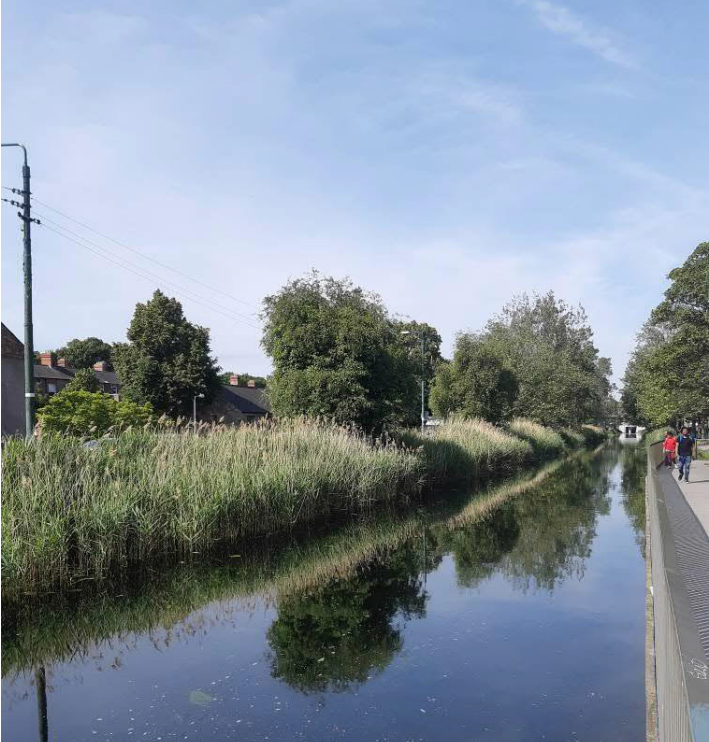
Photo 2	
Description: Southern bank of the Grand Canal adjacent to the site, showing established vegetation

No evidence of impact from the cable fluid release was noted during the site walkover, with strong vegetation growth observed along the canal banks.
