Site 10 Kingsbridge to Watling Street 38kV: Preliminary Site Assessment Report for Historic Fluid Filled Cable Loss

ESB Engineering and Major Projects

19126590.10.A.5

06 May 2020

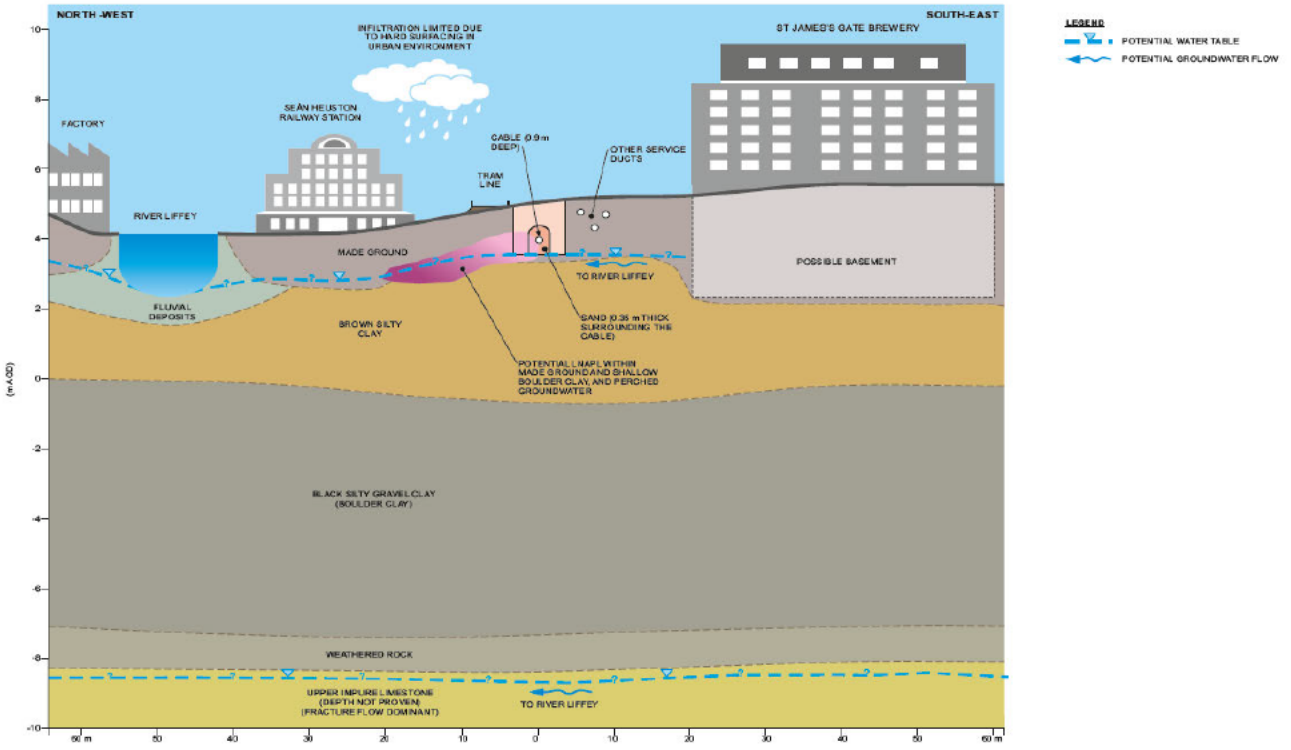
Figure 1: Preliminary CSM for Site 10 (Kingsbridge to Watling Street).

- There is a potential moderate risk to groundwater/surface water from the migration of free phase mineral oil to these receptors along cable ducting and infrastructure in the area (blended mineral oil is classified as hazardous in groundwater); and
- There is a potential moderate risk to the River Liffey from dissolved phase mineral oil migrating to the River Liffey in potential shallow groundwater.
