Preliminary Site Assessment

Site 1 Camden Row - Newmarket 38 kV - May 2019

Project number: PR-427640_ACM_RP_ENV_002_8E

10 January 2020

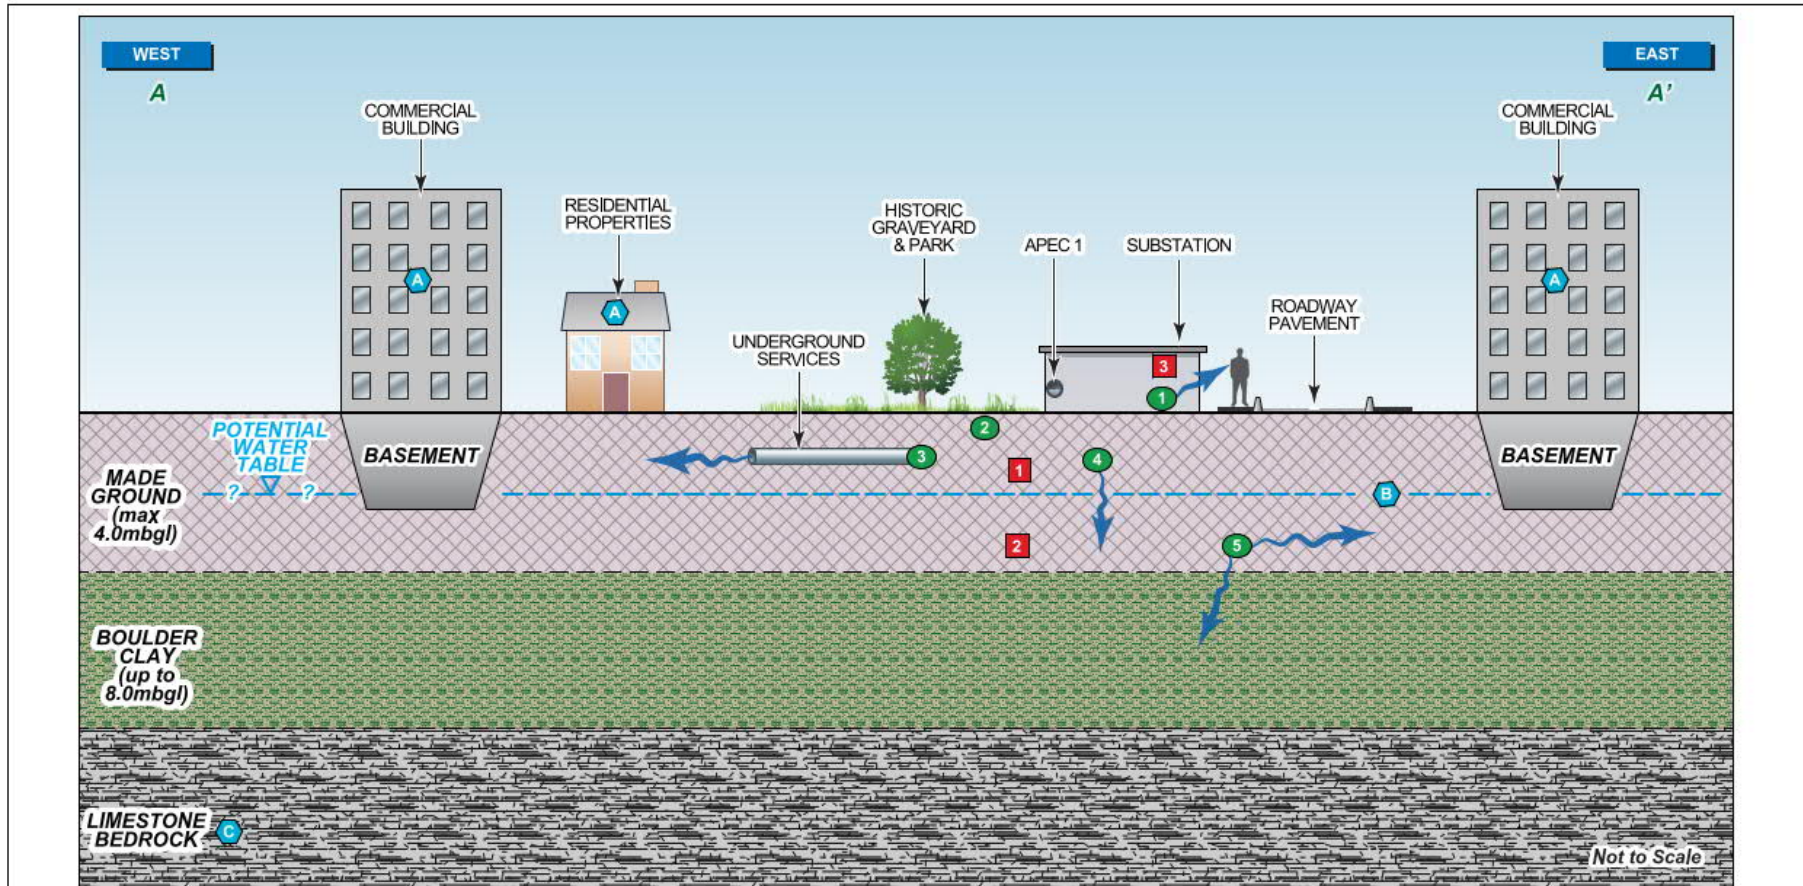
FOR INFORMATION	NOTE	Client	Electricity Supply Board	Location	Camden Row Newmarket 38 kV	FIGURE 3 CONCEPTUAL SITE MODEL	<p>60610407</p>	Design: EDD	Drawn: RSH
	Check: DM	Approved: DM	Date: JULY 2018	Scale: As Shown	Project No: 60610407			Sheet No: 3	Rev: 0

The preliminary CSM developed for the site looked at potential SPR linkages identified during the assessment works and found that potential risks were considered to be low. Based on these findings, further assessment is not considered to be required as no viable SPR linkages have been identified.

SOURCES	
1	NON-VOLATILE CONTAMINANTS IN SOIL
2	CONTAMINANTS IN GROUNDWATER
3	VOLATILE CONTAMINANTS FROM CONCRETE WITHIN BUILDING

PATHWAYS	
1	VAPOUR INHALATION
2	DERMAL CONTACT / DUST INGESTION
3	PERMEATION OF AND MIGRATION ALONG EXISTING UNDERGROUND SERVICES
4	LEACHING FROM SOIL TO GROUNDWATER
5	VERTICAL & HORIZONTAL MIGRATION OF CONTAMINATED GROUNDWATER

There is an aesthetic impact due to the staining of the pumping station walls and grave headstones. A suitable contractor should be appointed to clean these surfaces where possible.

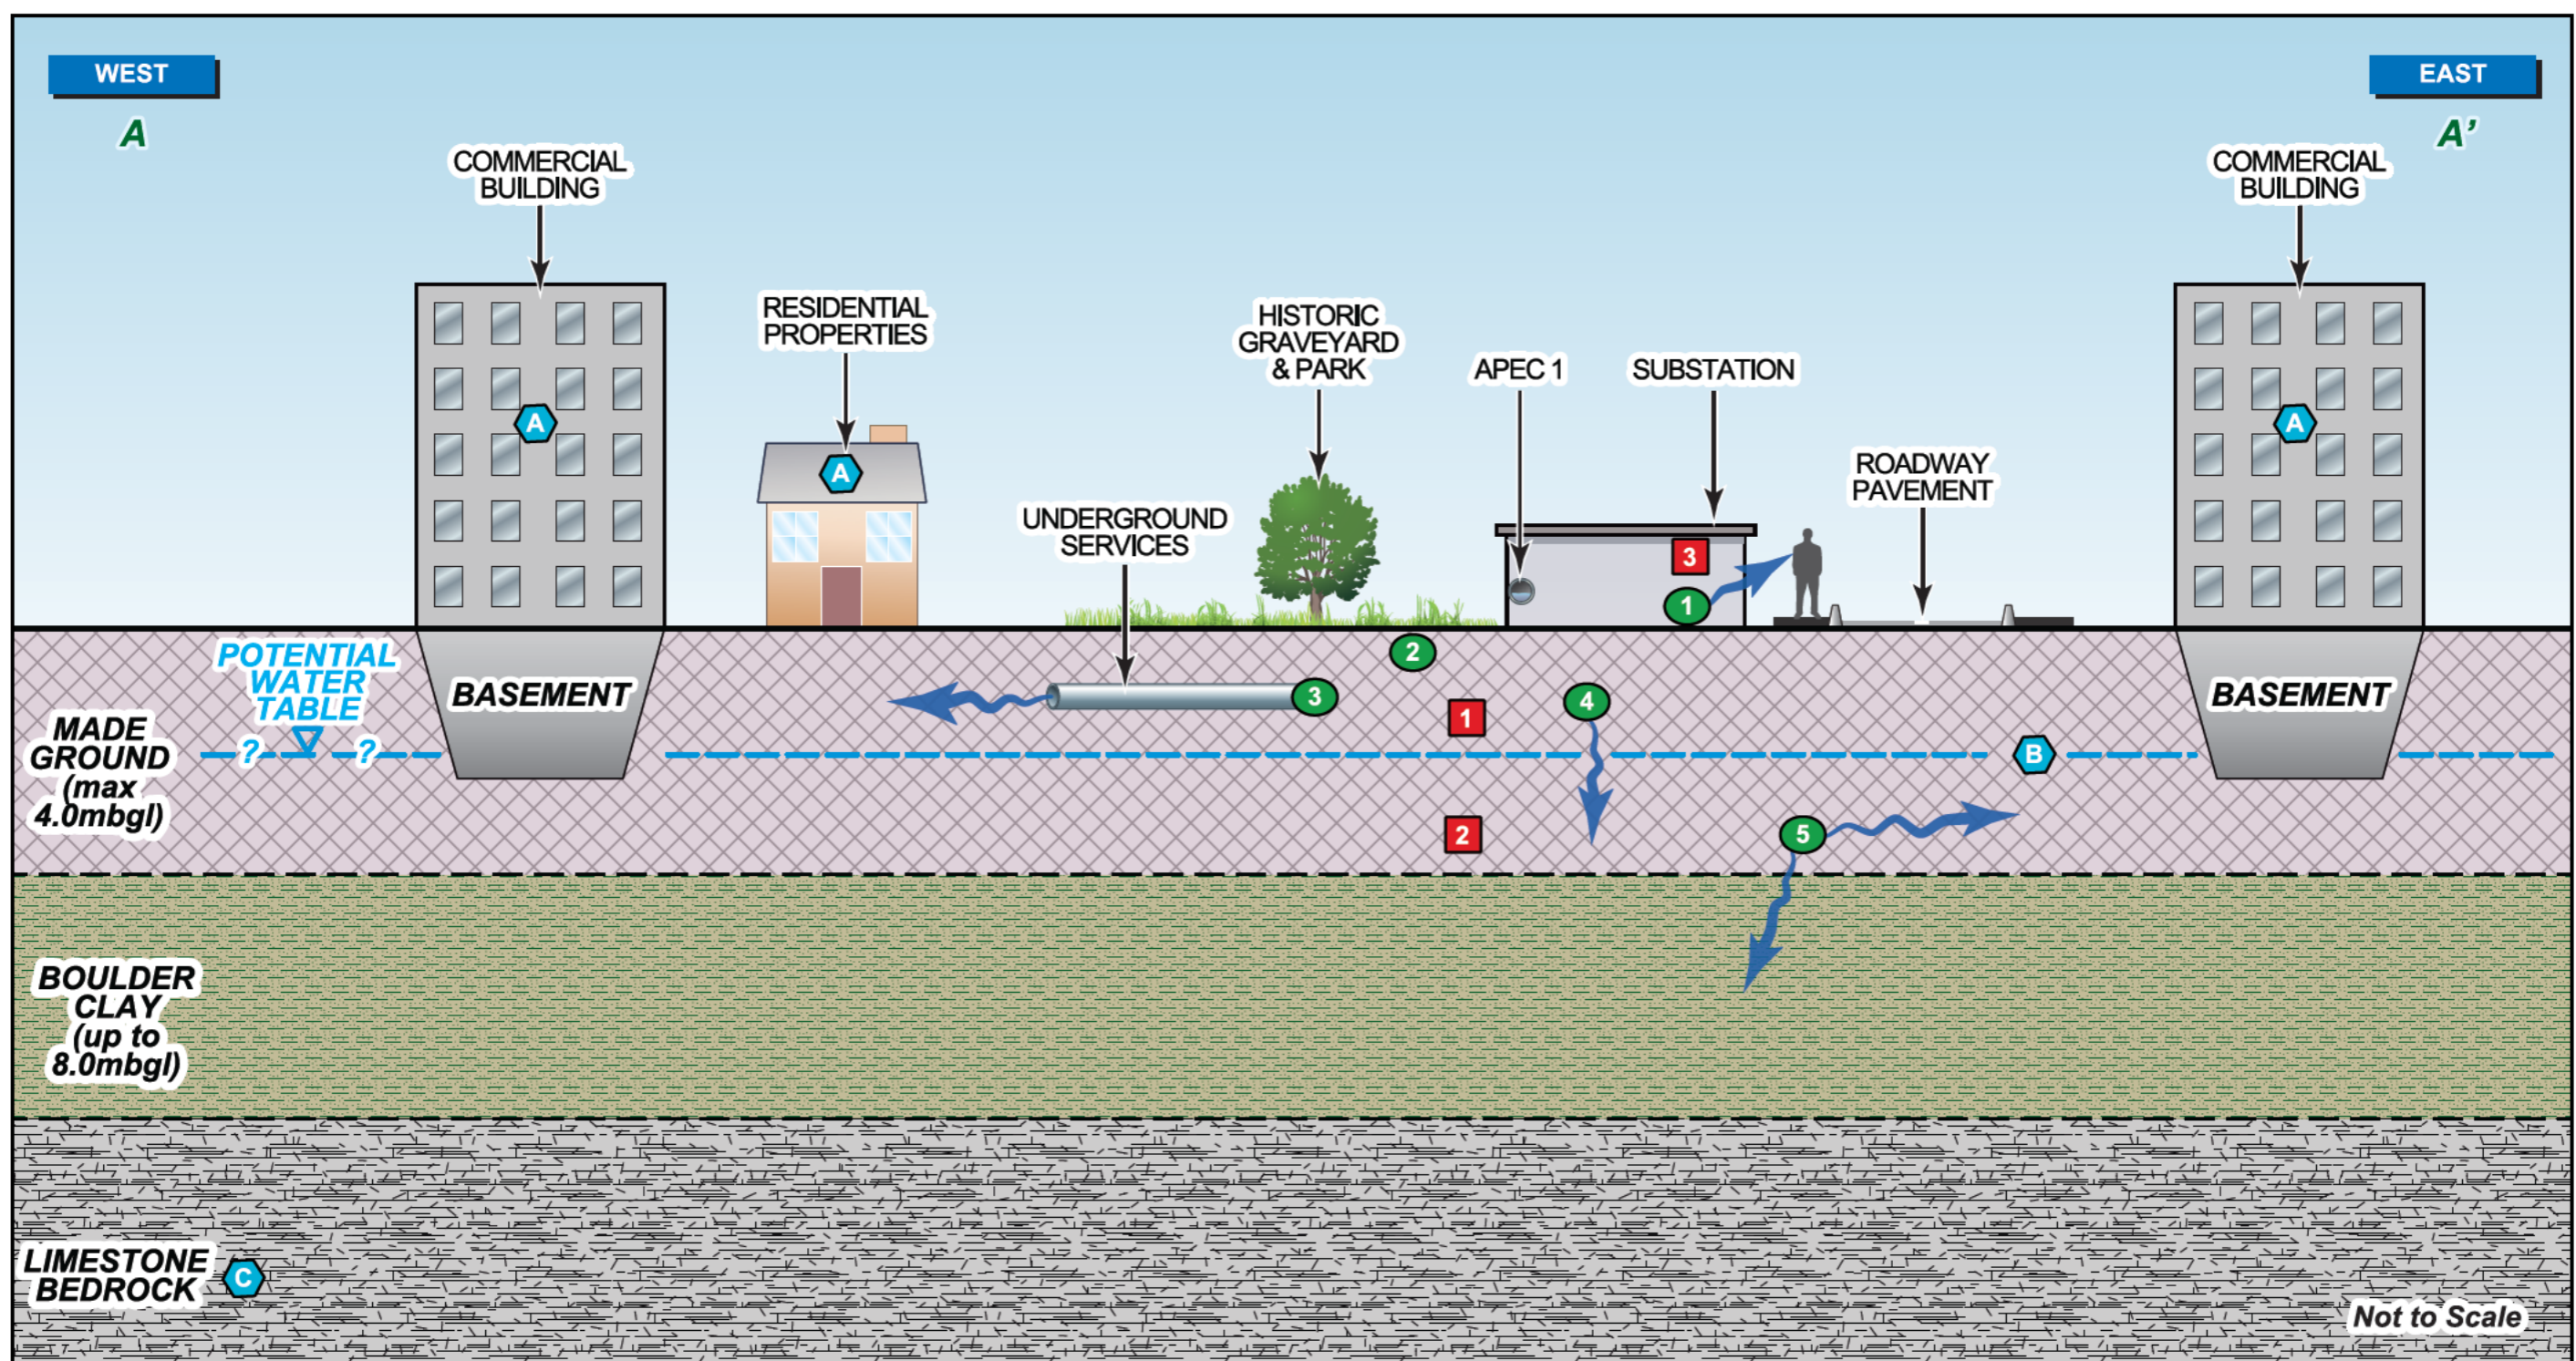
Title: FIGURE 3
CONCEPTUAL SITE MODEL

The preliminary CSM is presented graphically in Figure 3.

- 1** NON-VOLATILE CONTAMINANTS IN SOIL
- 2** CONTAMINANTS IN GROUNDWATER
- 3** VOLATILE CONTAMINANTS FROM CONCRETE WITHIN BUILDING
