ESB Networks Historic Cable Fluid Losses: Preliminary Site Assessment

**Location 21: Carrickmines - Poolbeg 220 kV -
October 2012**

February 2020

Report Ref: GCU0257001/003

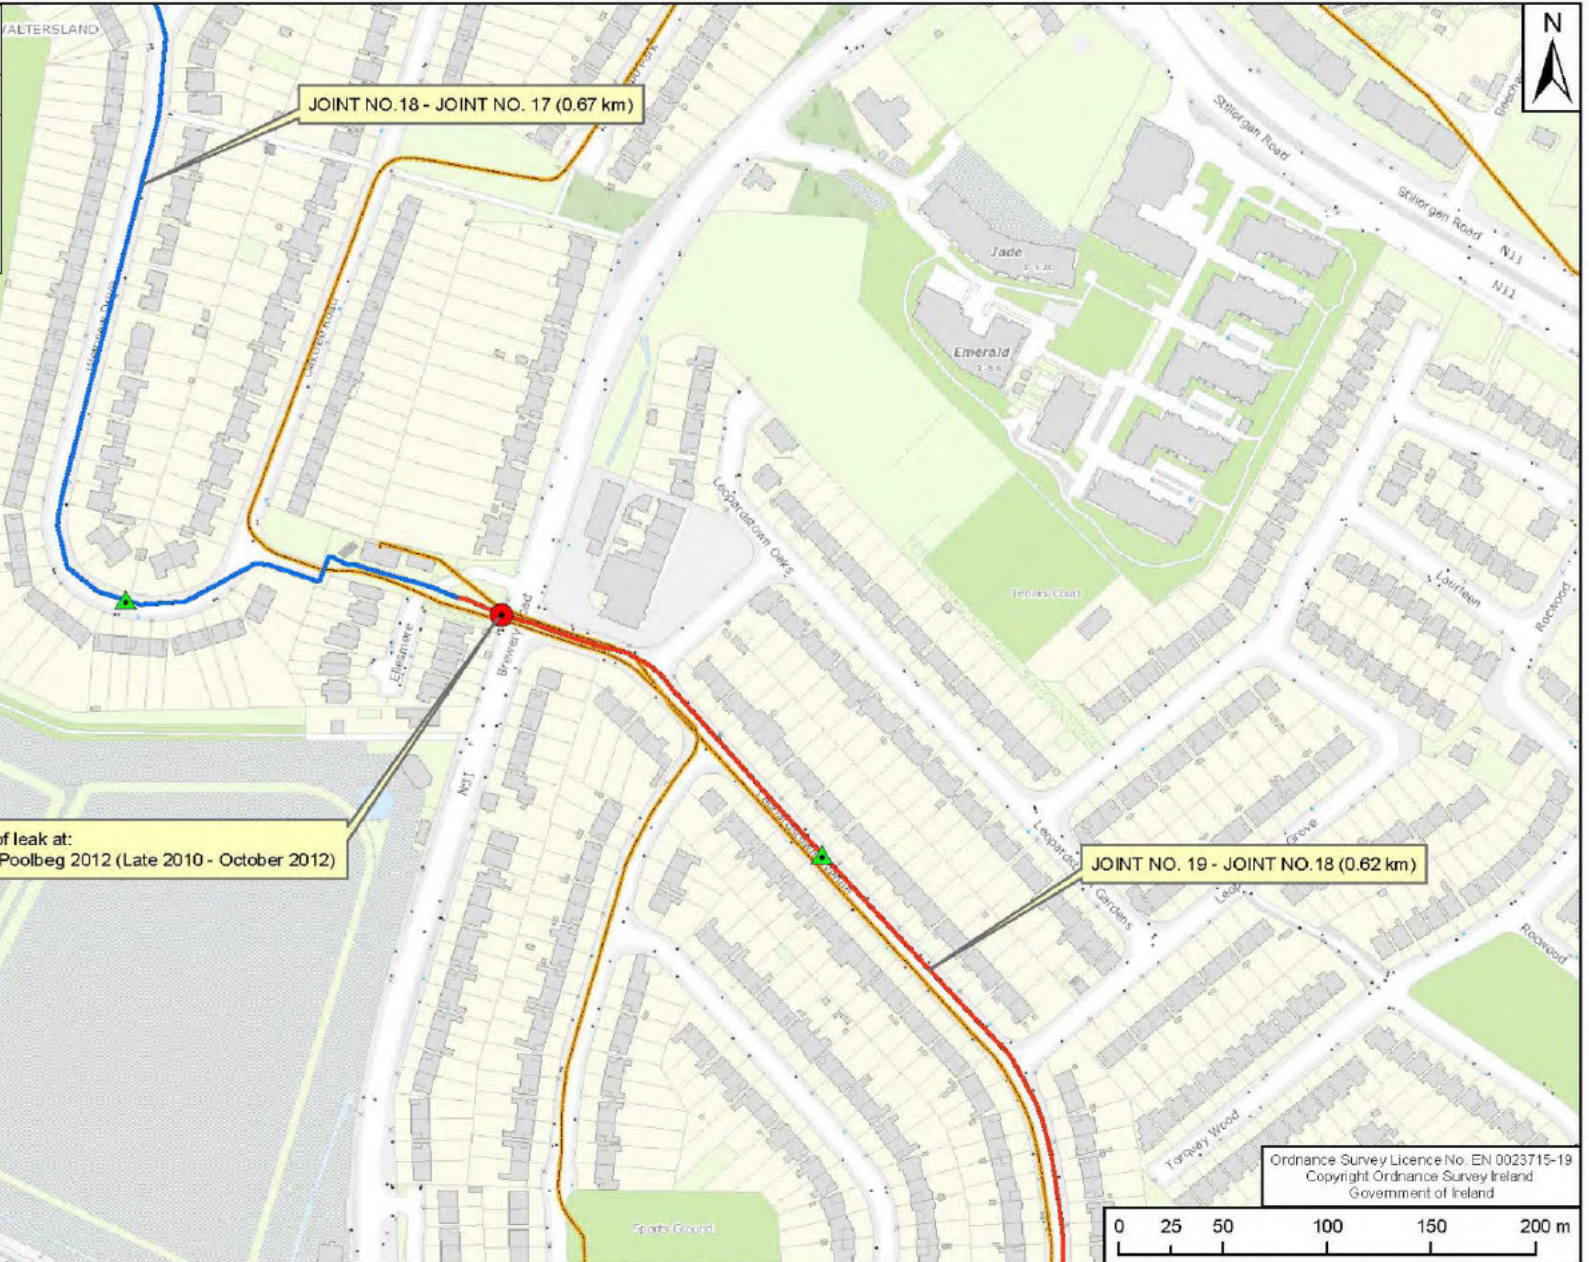
Figure 1 - Site Location No. 21

- The leak location is in a predominantly residential area adjacent to the intersection of Brewery Road and Leopardstown Avenue in south Co. Dublin;
- The topography in the vicinity of the leak location is relatively flat; ground elevations dip down slightly from the south-west towards the north-east, generally along the line of Brewery Road;

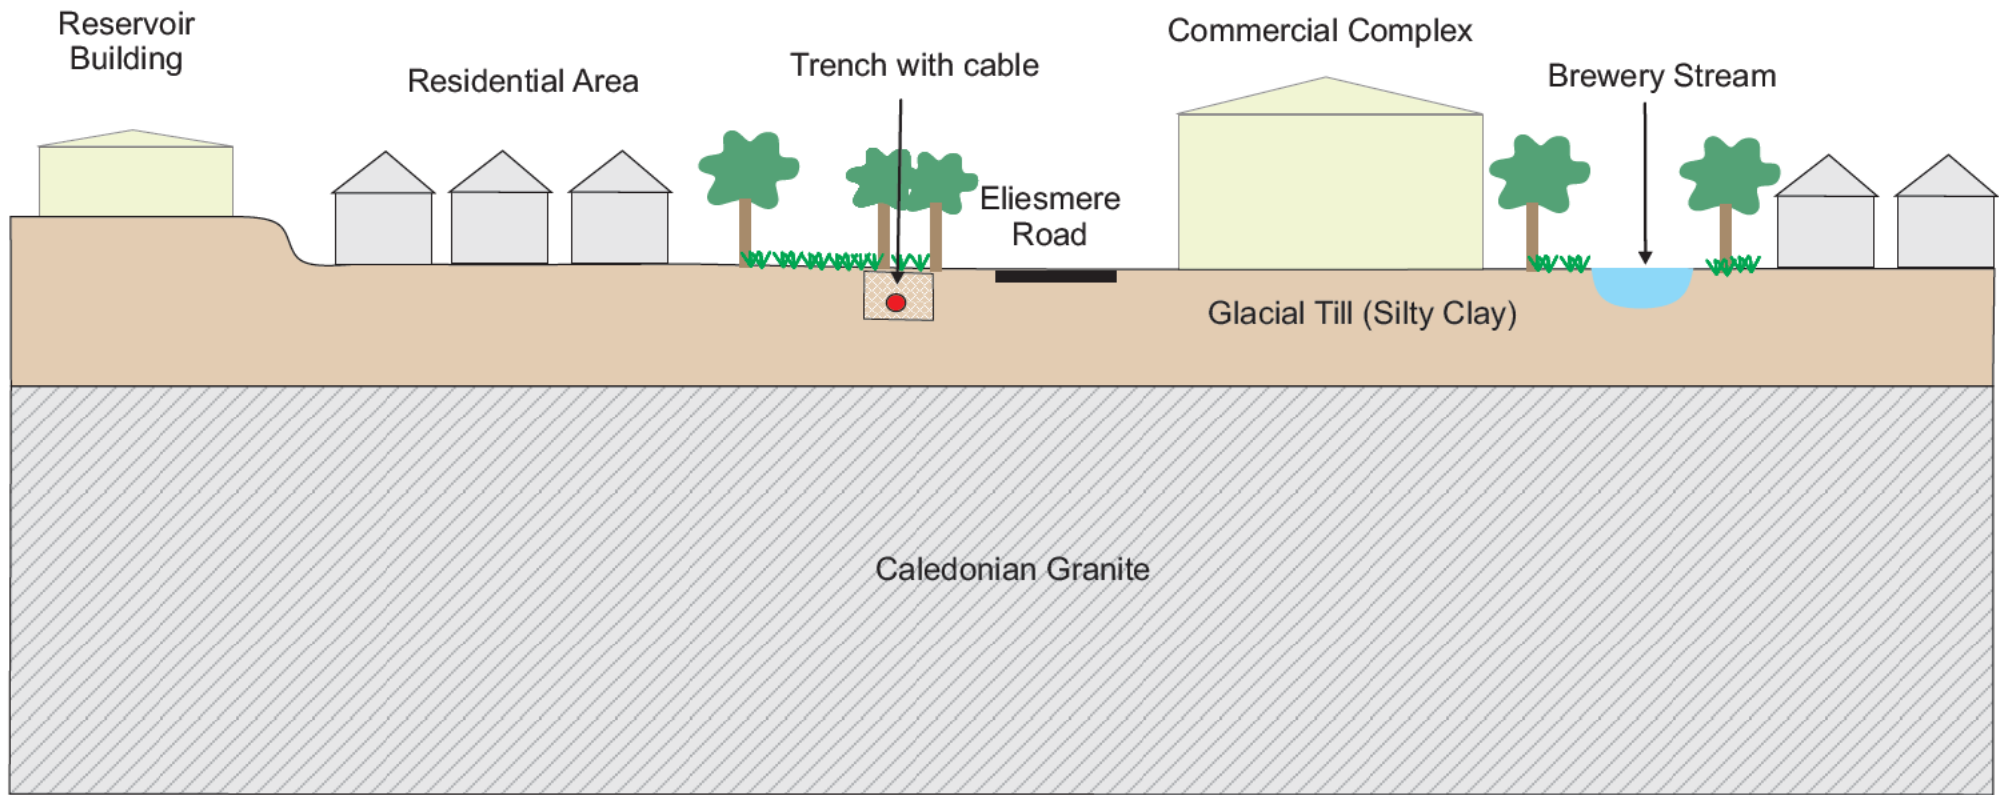
Location 21 - Preliminary Conceptual Site Model		
Leopardstown, Dublin 18	GCU0257001	
 	ESB	Figure 2a
Dublin, Ireland	July 2019

- The key receptors potentially at risk of impact from the subject leak are considered to be Brewery Stream, potentially South Dublin Bay (which comprises two designated sites, the South Dublin Bay SAC and South Dublin Bay and River Tolka Estuary SPA) close to the discharge of the Brewery Stream, ecosystems dependent on these water bodies, the bedrock aquifer underlying the area, water mains in the vicinity of the leak location and occupants of nearby buildings with potential confined spaces;
