# ESB Networks Historic Cable Fluid Losses: Preliminary Site Assessment

**Location 28: Blackrock - Ringsend 38 kV - November 2011**

February 2020

Report Ref: GCU0257001/011

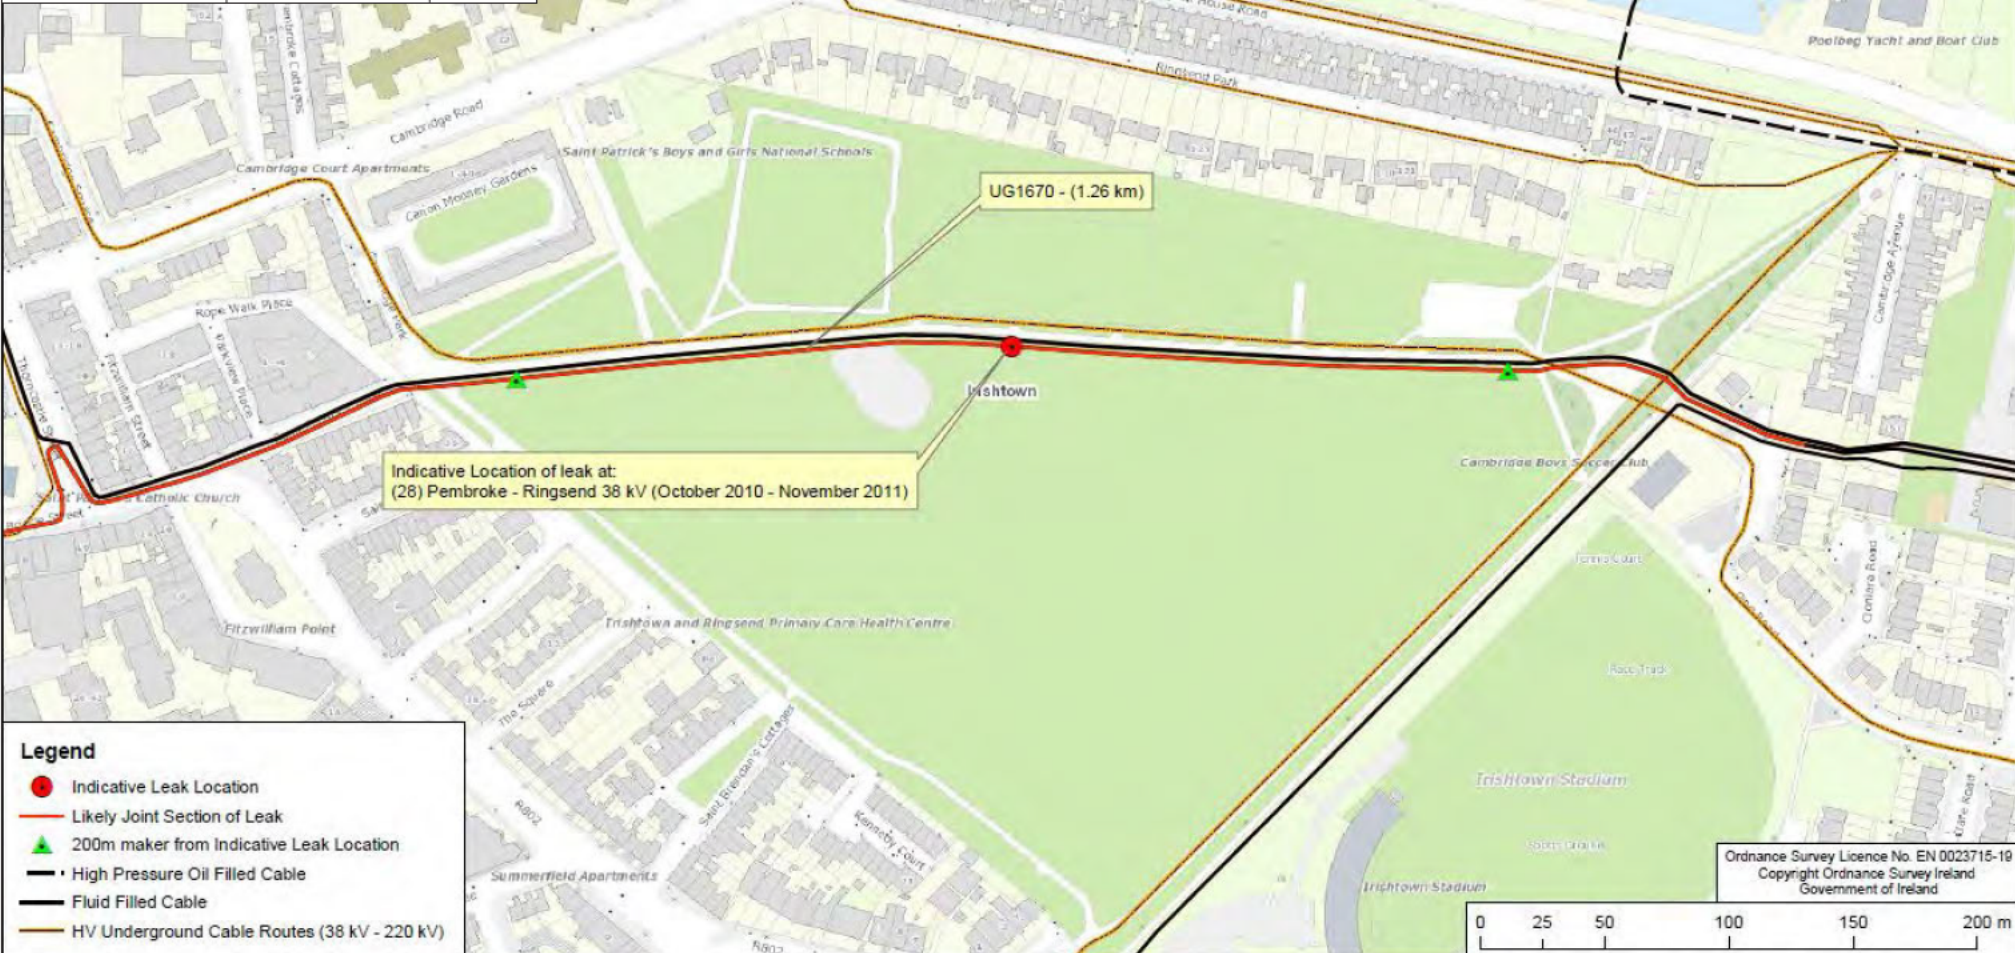
**Figure 1 - Location No. 28**

PRODUCTION UNIT:	<b>Civil &amp; Environmental Engineering</b>
DRAWING TITLE:	<b>Indicative Cable Fluid Leakage Locations &amp; Cable Sections (28) Pembroke - Ringsend 38 kV (October 2010 - November 2011)</b>
