# **Unidare - Whitehall (Site ID 29)**

Preliminary Environmental Site Assessment

602620 – R03 (02)

DECEMBER 2019

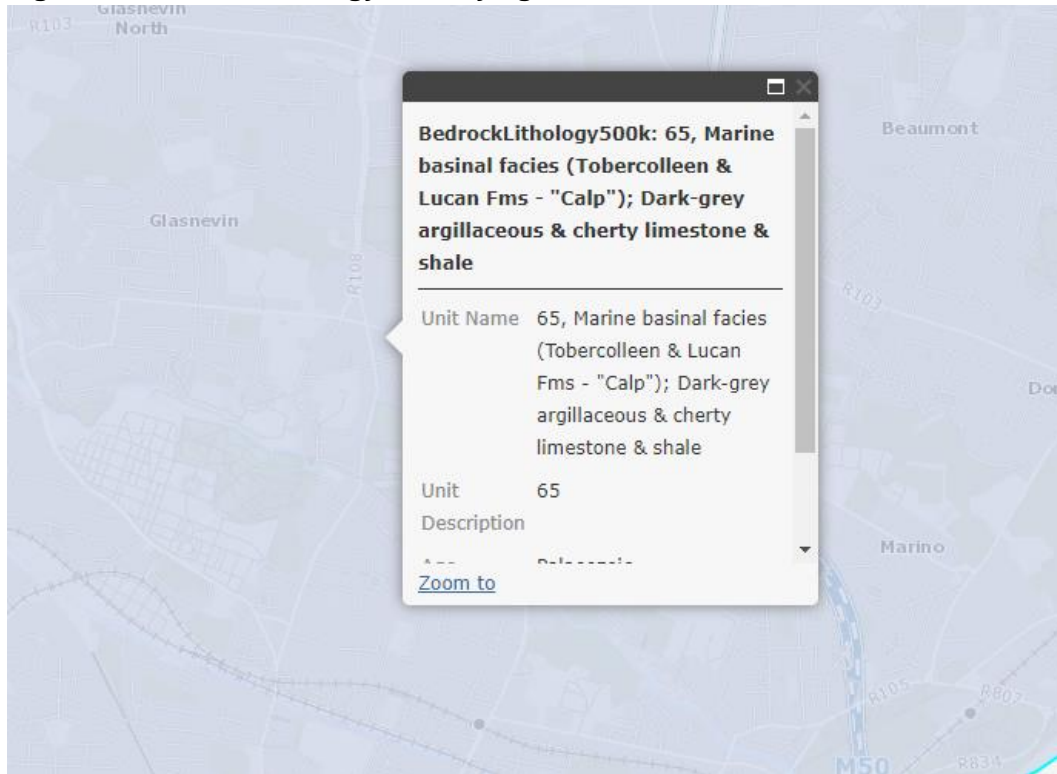
**Figure 3.1 Bedrock Geology Underlying Site**

Information from the Geological Survey of Ireland (GSI) online mapping public viewer <https://dcenr.maps.arcgis.com/apps/MapSeries/index.html?appid=a30af518e87a4c0ab2fbde2aaac3c228> indicates that the solid geology underlying the site is Calp, of the Lucan Formation, as shown in Figure 3.1 below. The Lucan formation comprises dark grey to black limestone and shale.

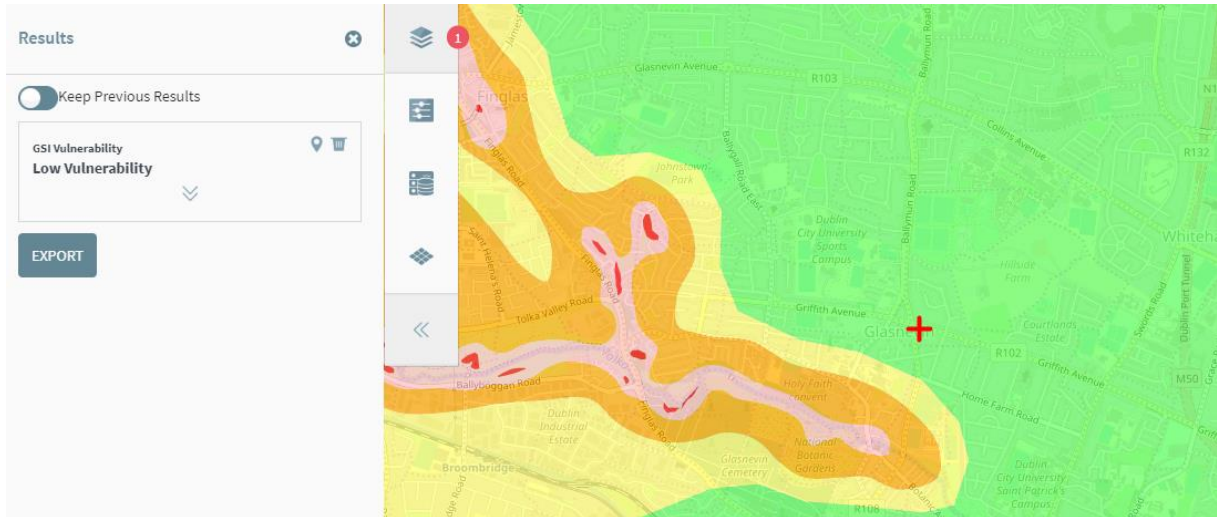
**Figure 3.2 Groundwater Vulnerability at the Site**

Groundwater vulnerability is classified as Low at the site (see Figure 3.2 below). The EPA categorise the groundwater body as not at risk and water framework directive (WFD) monitoring (2010-2015) ranks the water quality as good.

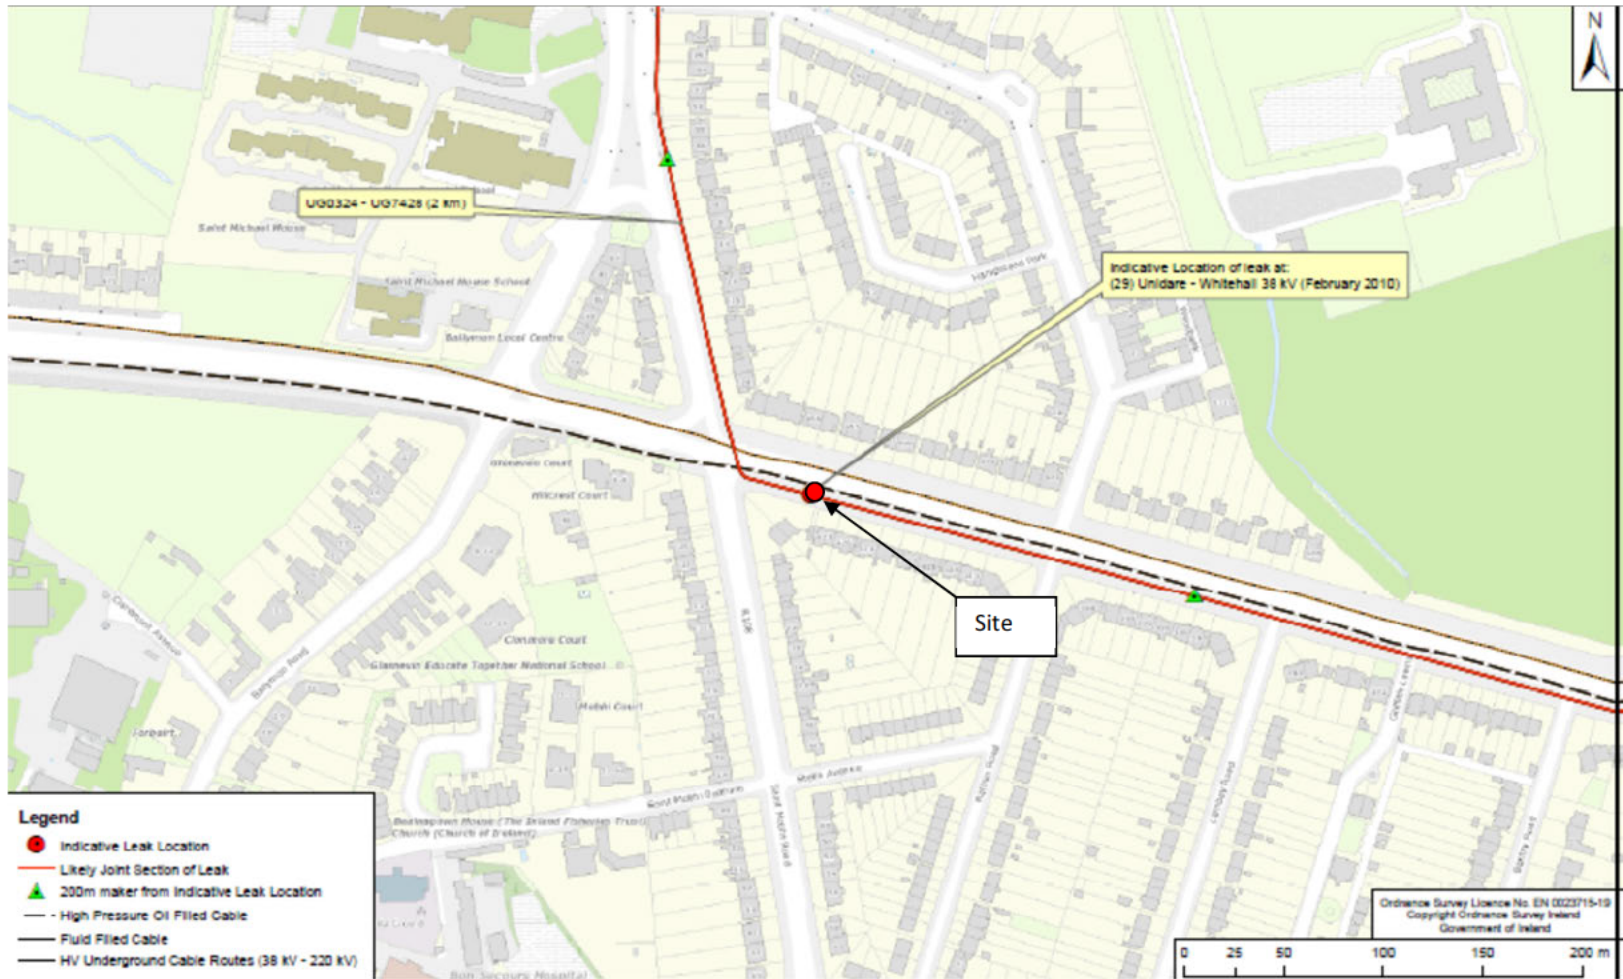
Drawing Title: Figure 2 Site Layout Plan

The site layout is shown on Figure 2. The area around the site is comprised primarily of commercial and residential land uses.

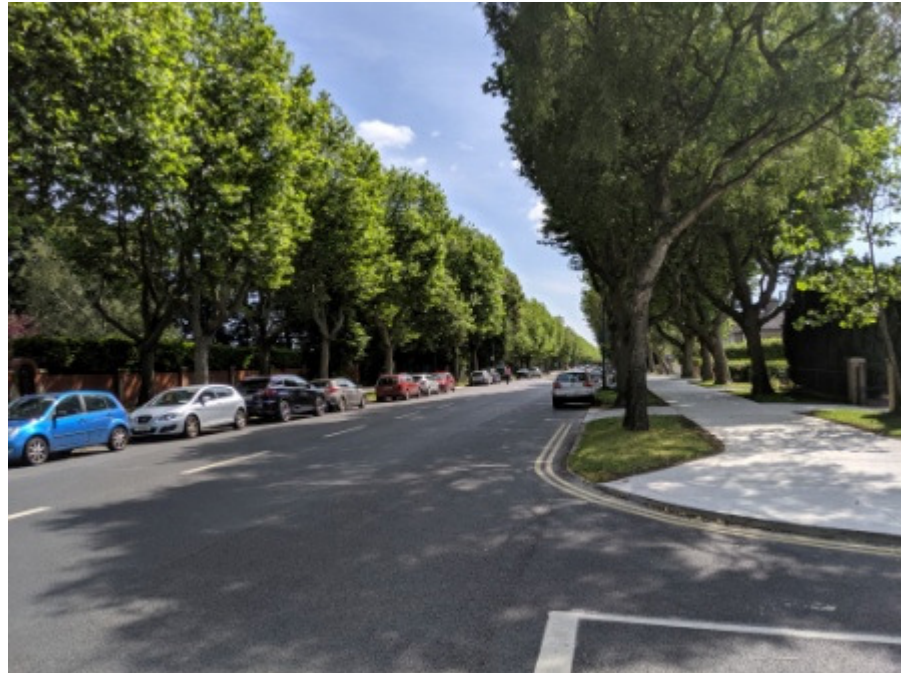
**Photo No.**  
2

View from the junction of Lambay Road with Griffith Avenue. The street is bound on both sides with detached and semi-detached residential dwellings with gardens.

Communal green bands with mature trees line the footpaths.

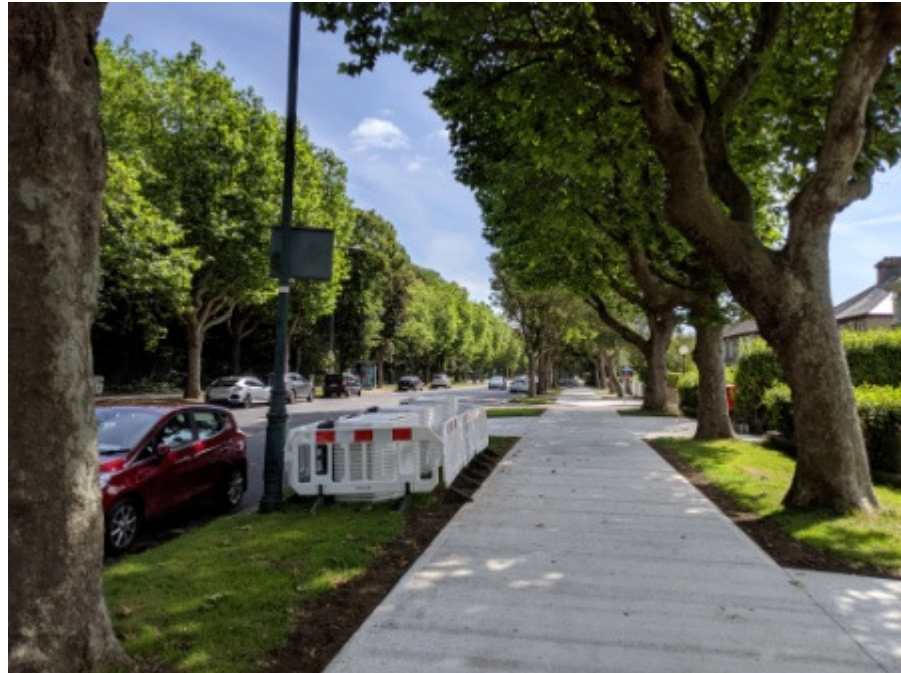
**Photo No.**  
4      **Date:**  
Aug 2019

View of Griffith Avenue. The street is bound on both side with detached and semi-detached residential dwellings with gardens.

Communal green bands with mature trees line the footpaths.

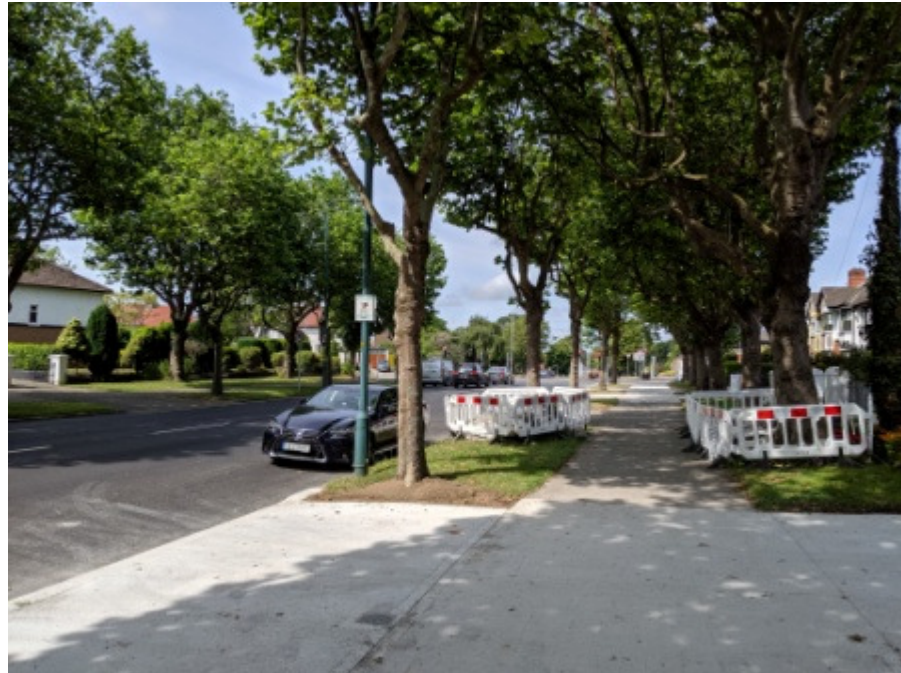
**Photo No.**  
6

View of Griffith Avenue.  
The street is bound on both side with detached and semi-detached residential dwellings with gardens.

Communal green bands with mature trees line the footpaths.

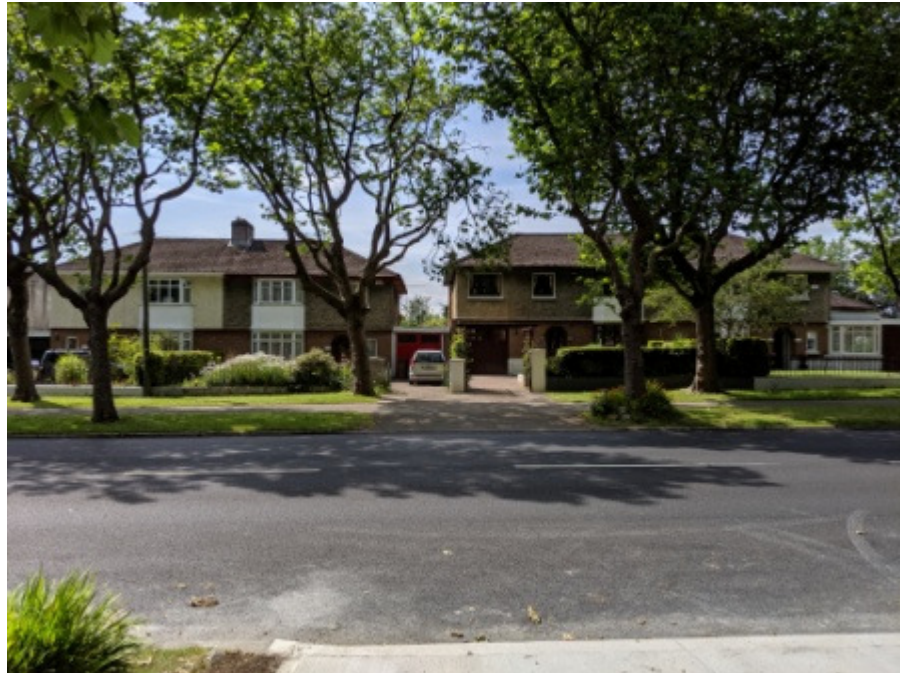
**Photo No.**  
8

View of Griffith Avenue.  
The street is bound on both side with detached and semi-detached residential dwellings with gardens.

Communal green bands with mature trees line the footpaths.

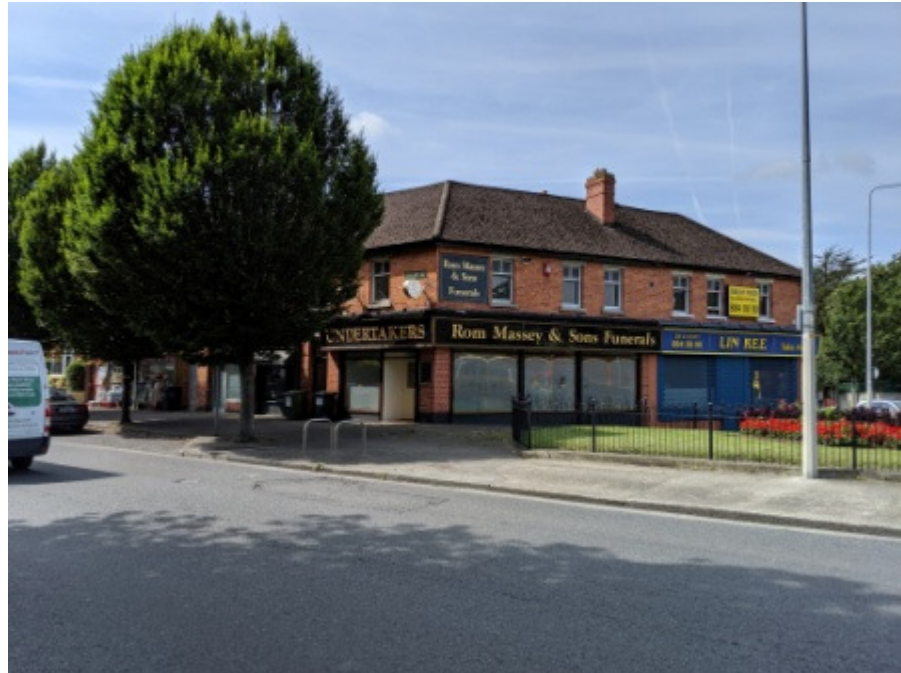
**Photo No.**  
10

Marker (~200m north) from Indicative Leak location.

View of commercial premises' and communal green space located on St Mobhi Road.

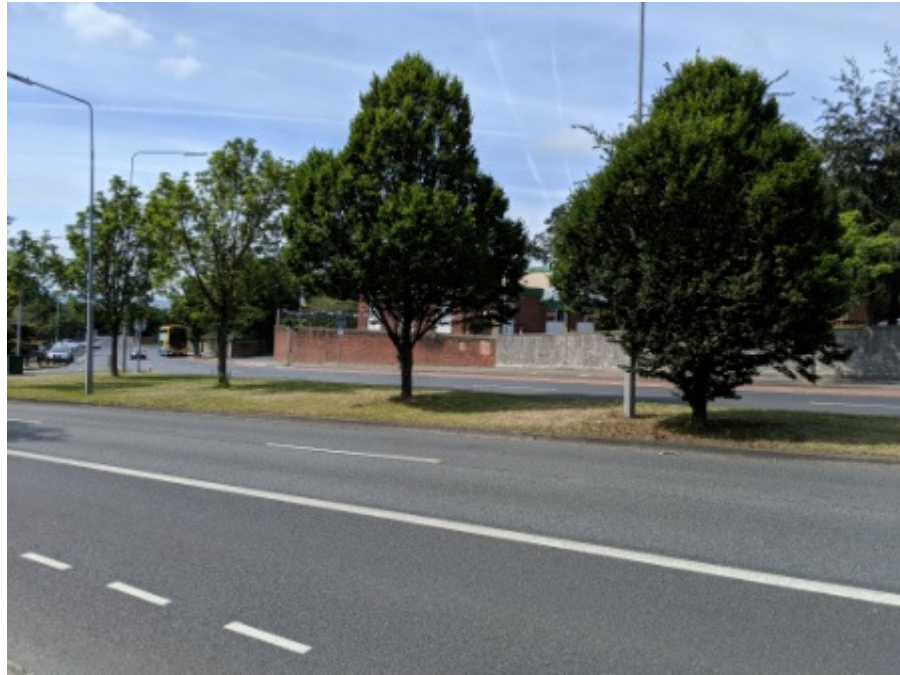
**Photo No.**  
12

Marker (~200m north) from Indicative Leak location.

View of St Michaels House (Special Education School) located on Ballymun Road; located within 200m of the indicative leak location.
