Preliminary Site Assessment

Site 31 Inchicore - Marrowbone Lane 38 kV

Electricity Supply Board

Project number: PR-427640_ACM_RP_ENV_045_2

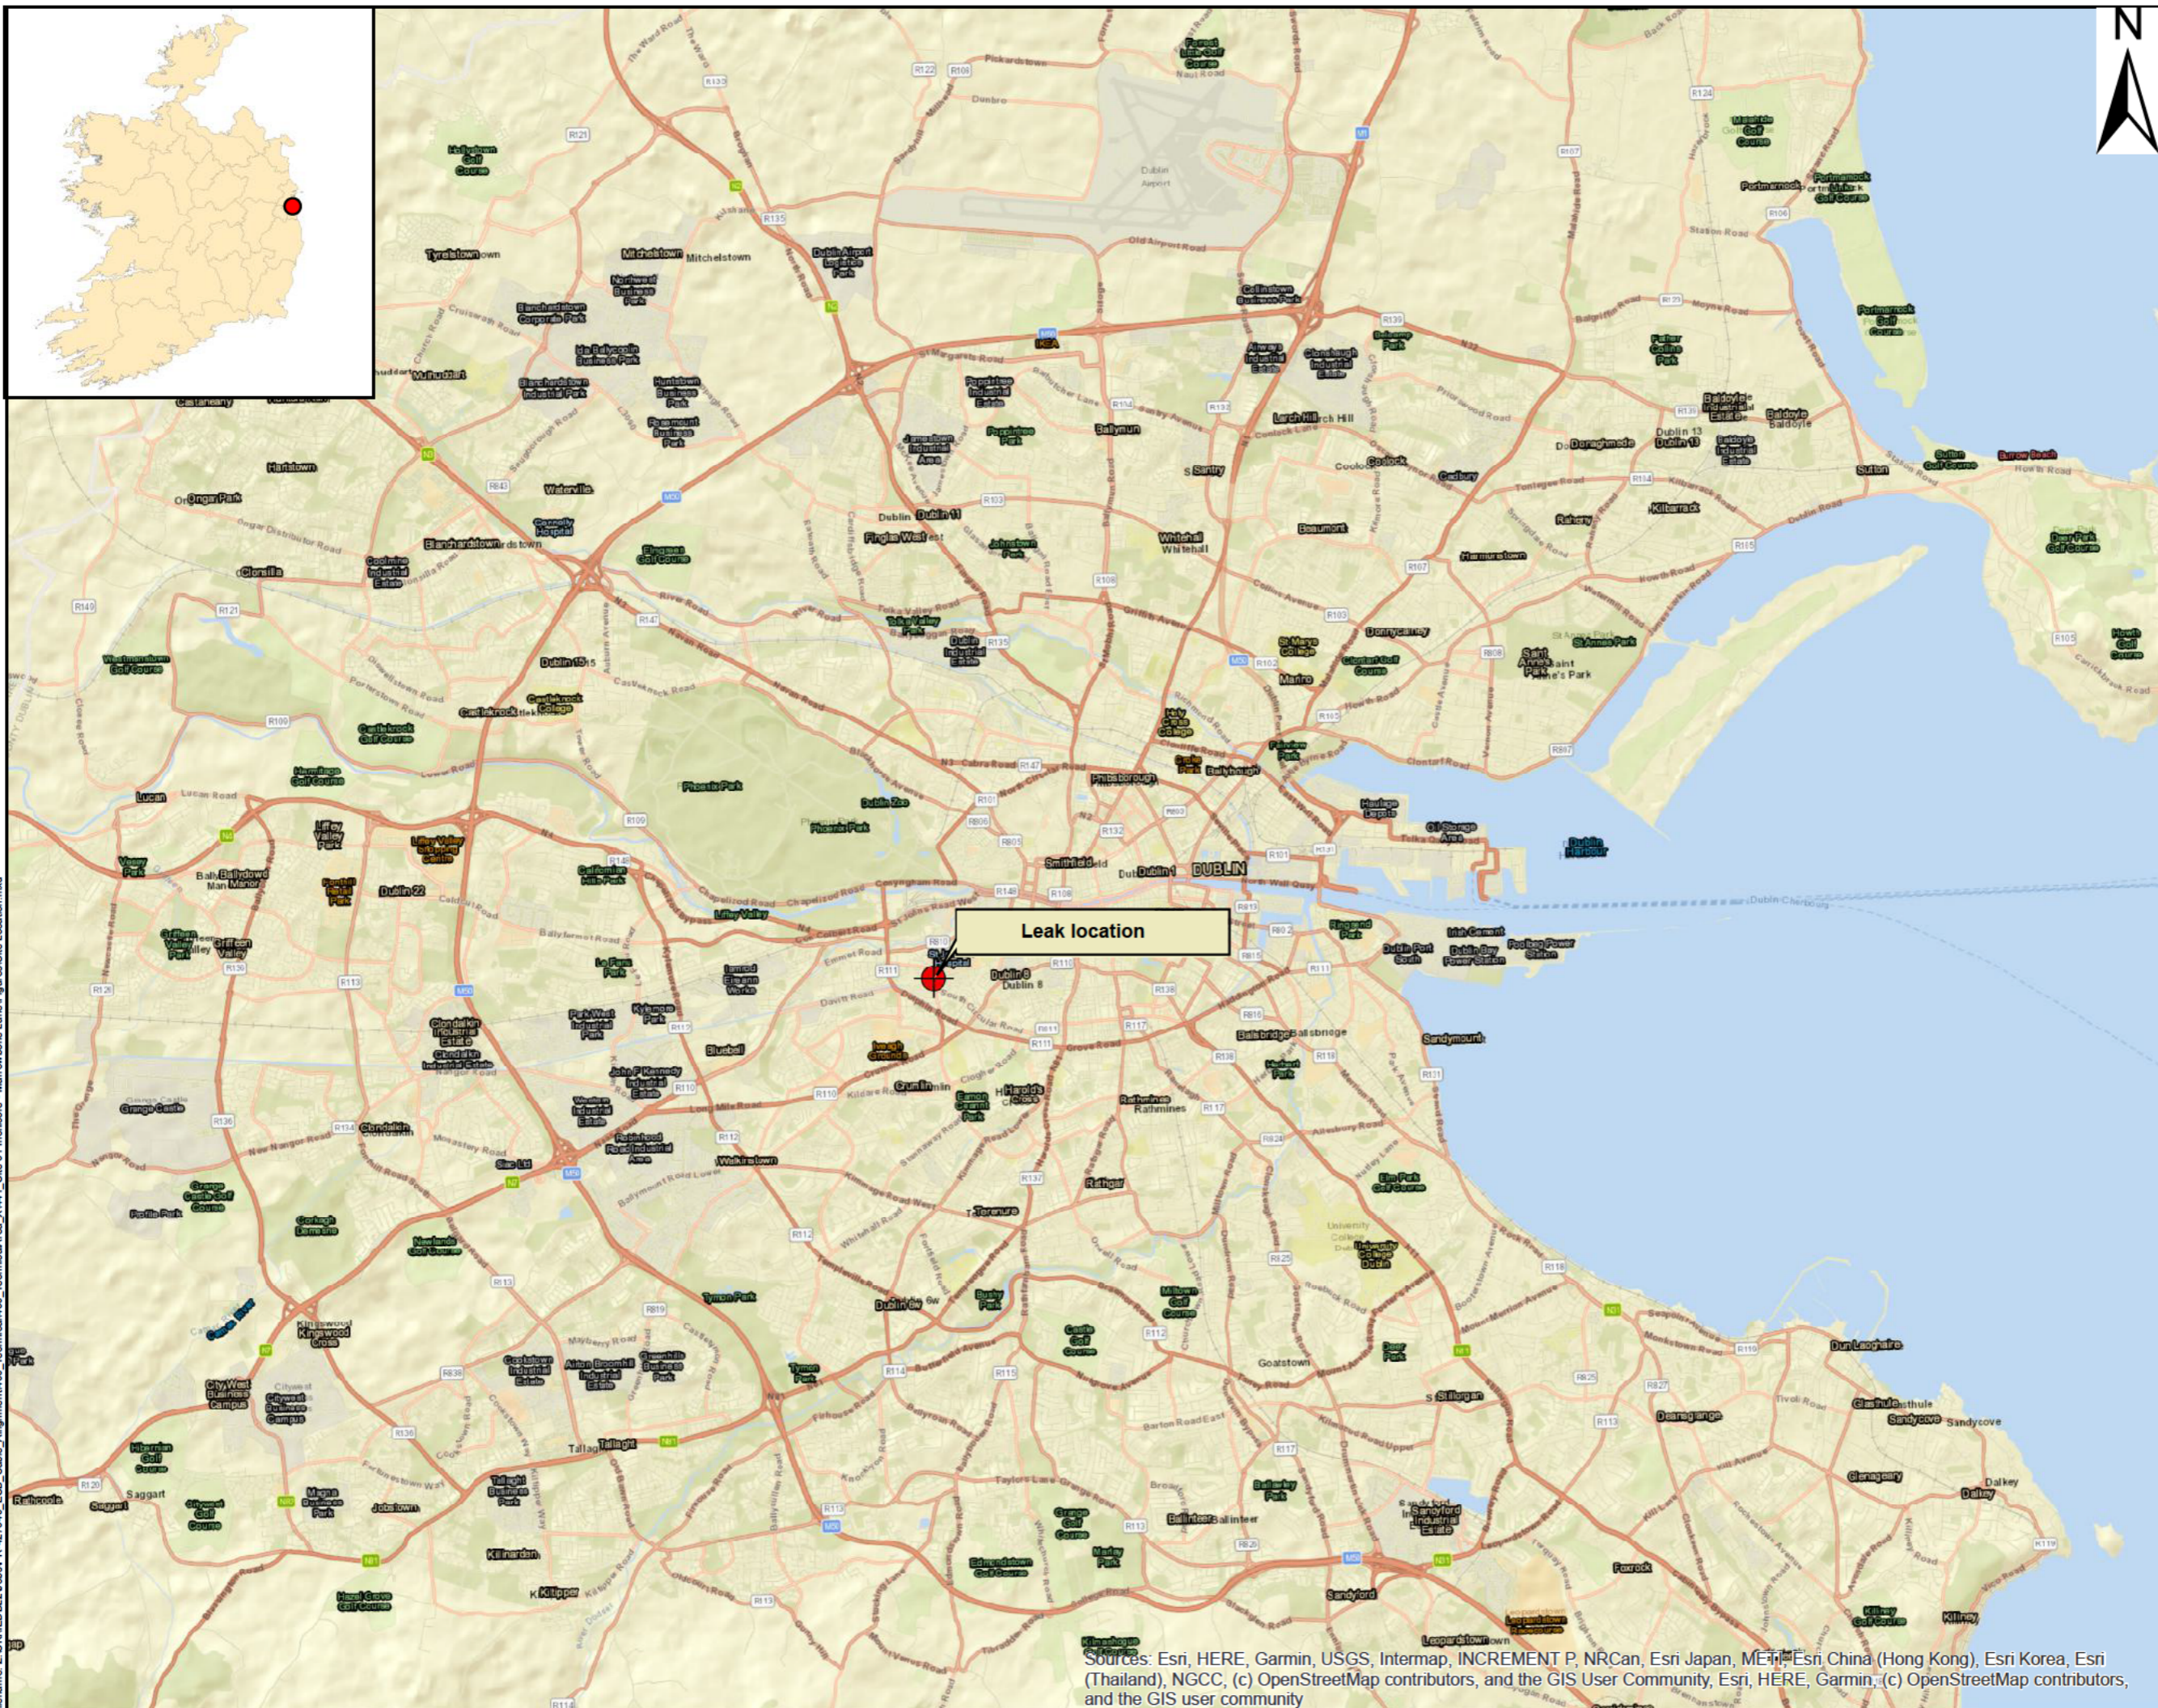
FIG.2 - SITE LAYOUT PLAN

Based on the assessment works completed, the primary Area of Potential Environmental Concern (APEC) for this site comprises the leak location identified by ESB. This is presented in Figure 2 and a description is provided in Table 7.

Leak location
