# Preliminary Site Assessment

Site 32 Harold's Cross - Ringsend 110 kV

Electricity Supply Board

Project number: PR-427640\_ACM\_RP\_ENV\_048\_2

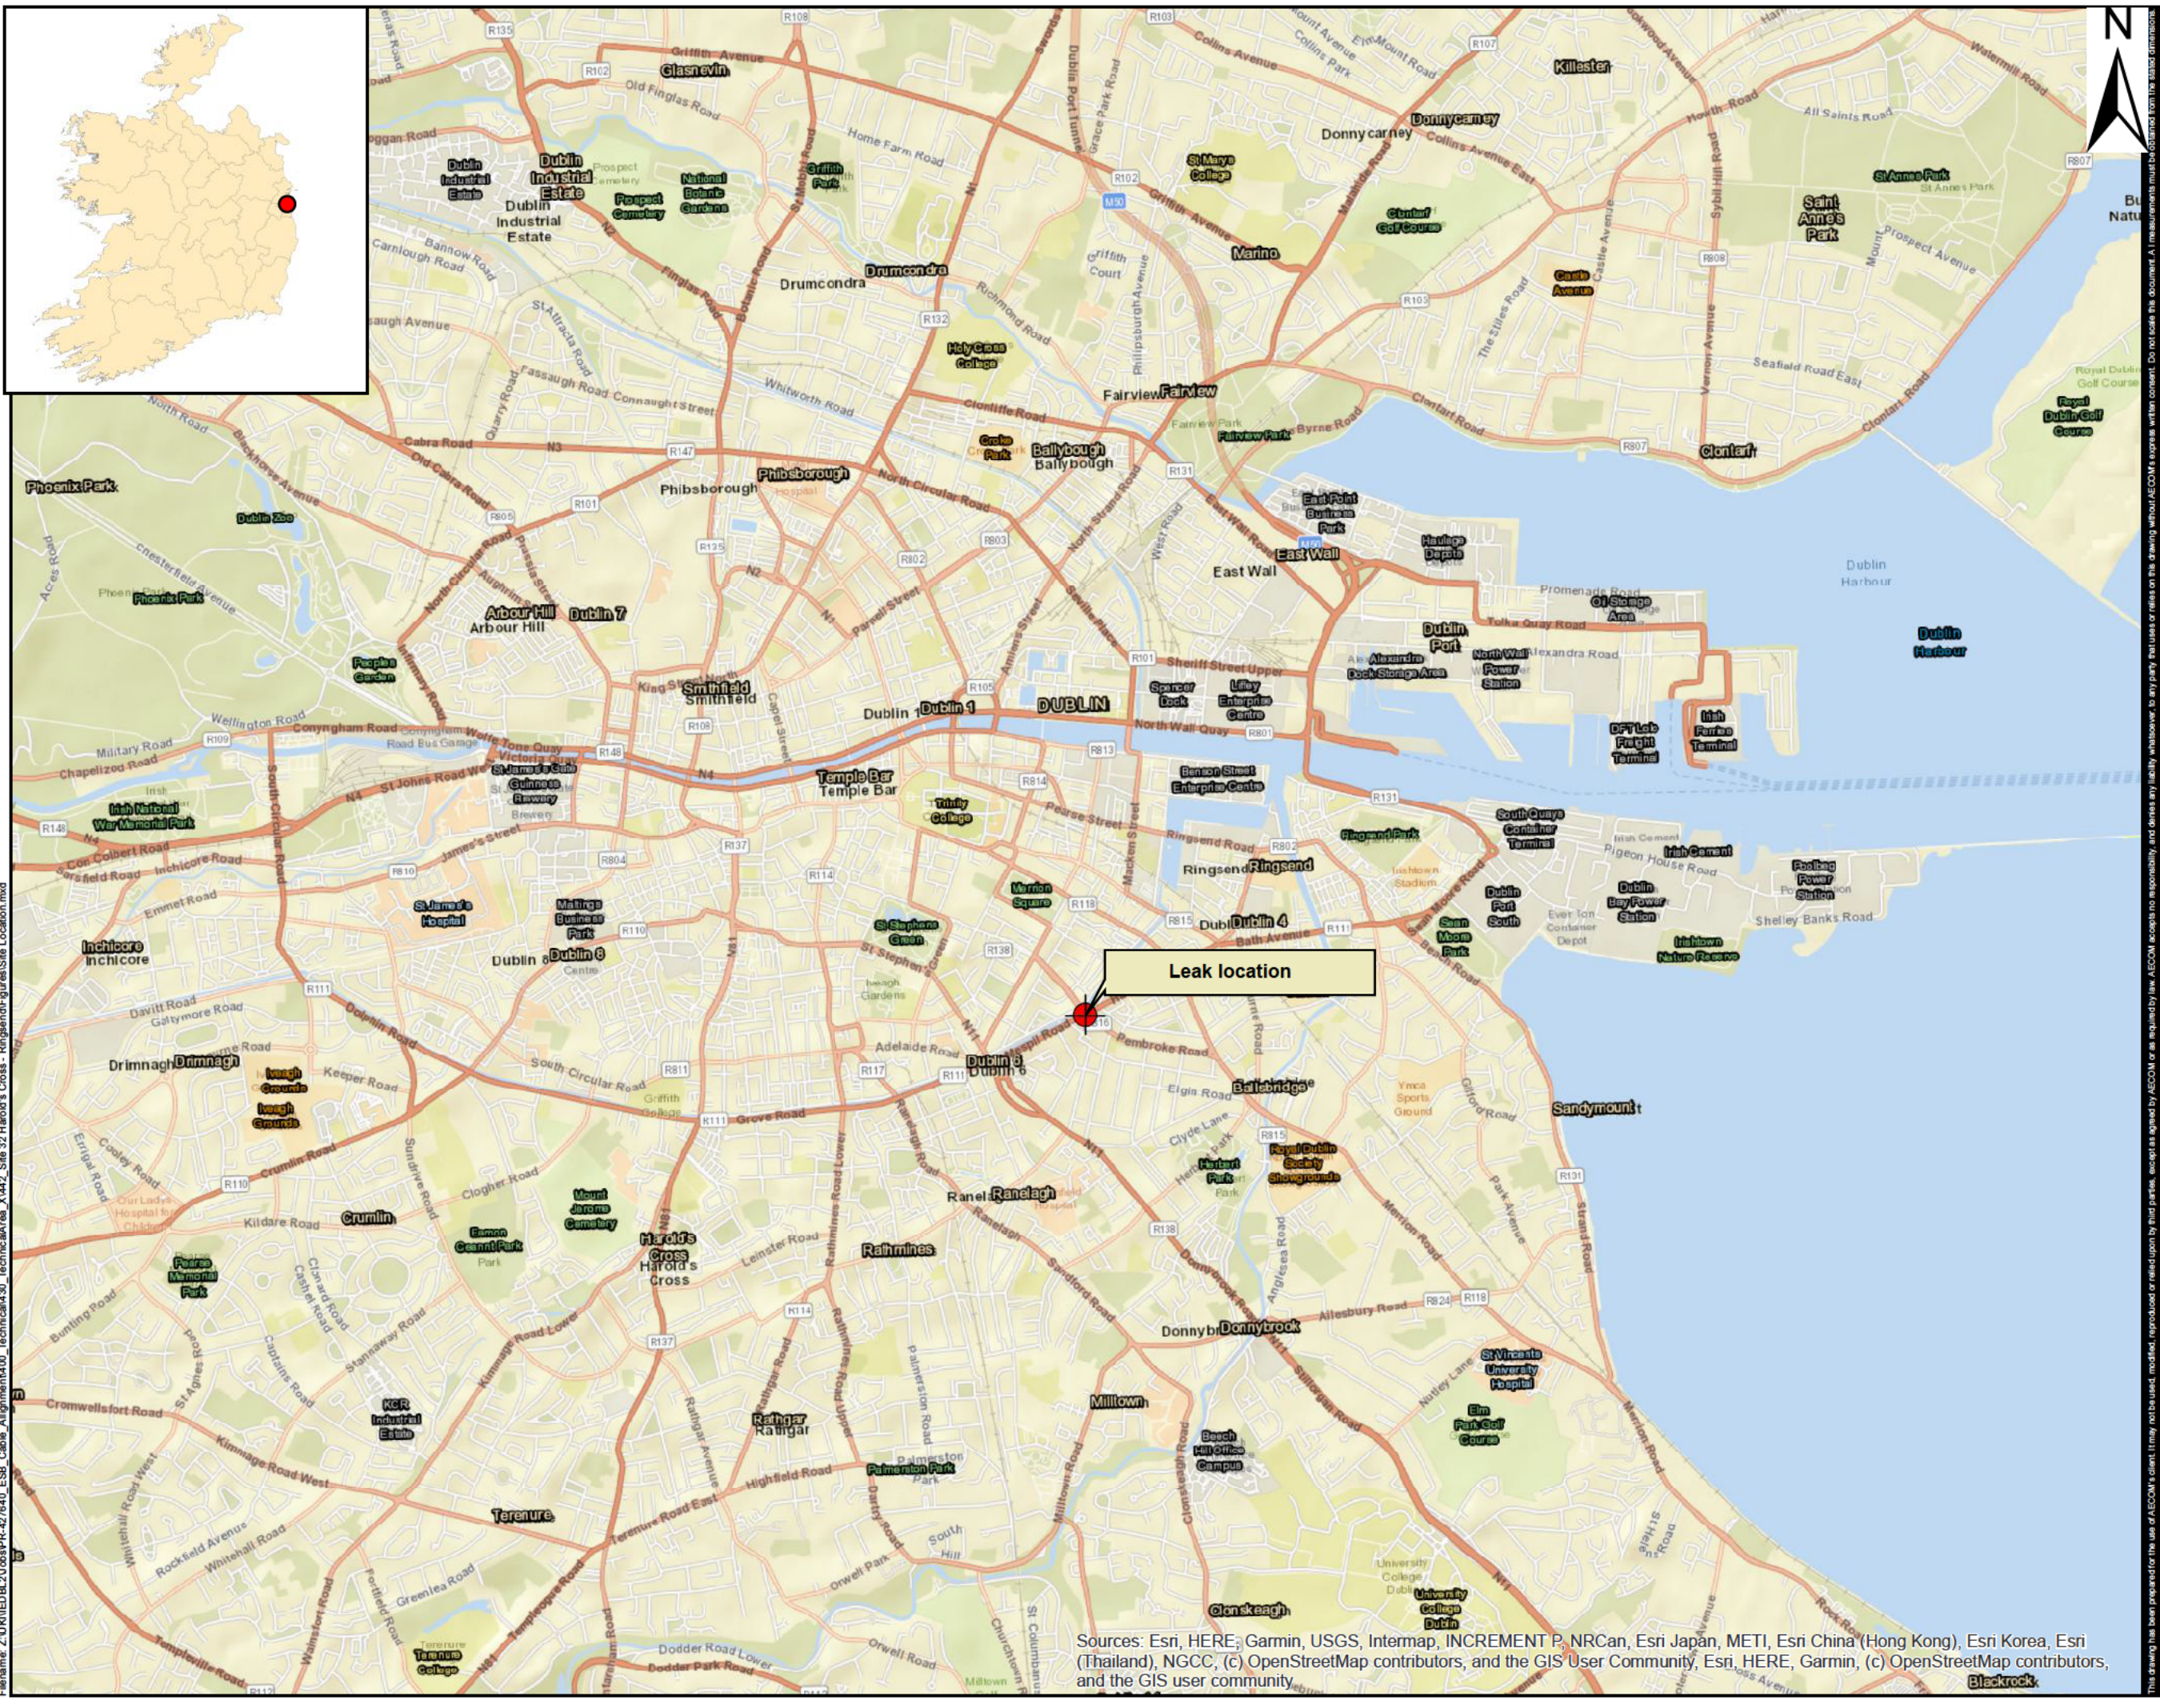
**Drawing Title:**  
 FIG.2 - SITE LAYOUT MAP

The leak location is situated adjacent to the Grand Canal at Baggot Street Bridge in Dublin City Centre. The leak site was located on a section of a 110 kV cable running from Harold's Cross to Ringsend. The cable was originally installed in 1951 with new sections of the cable added in 1986. The cable length is 5.6 km (see Figure 2).

Based on the assessment works completed, the primary Area of Potential Environmental Concern (APEC) for this site comprises the leak location identified by ESB. This is presented in Figure 2 and a description is provided in Table 6.
