# Preliminary Site Assessment

Site 36 Inchicore - Marrowbone Lane 38 kV

Electricity Supply Board

Project number: PR-427640\_ACM\_RP\_ENV\_053\_0

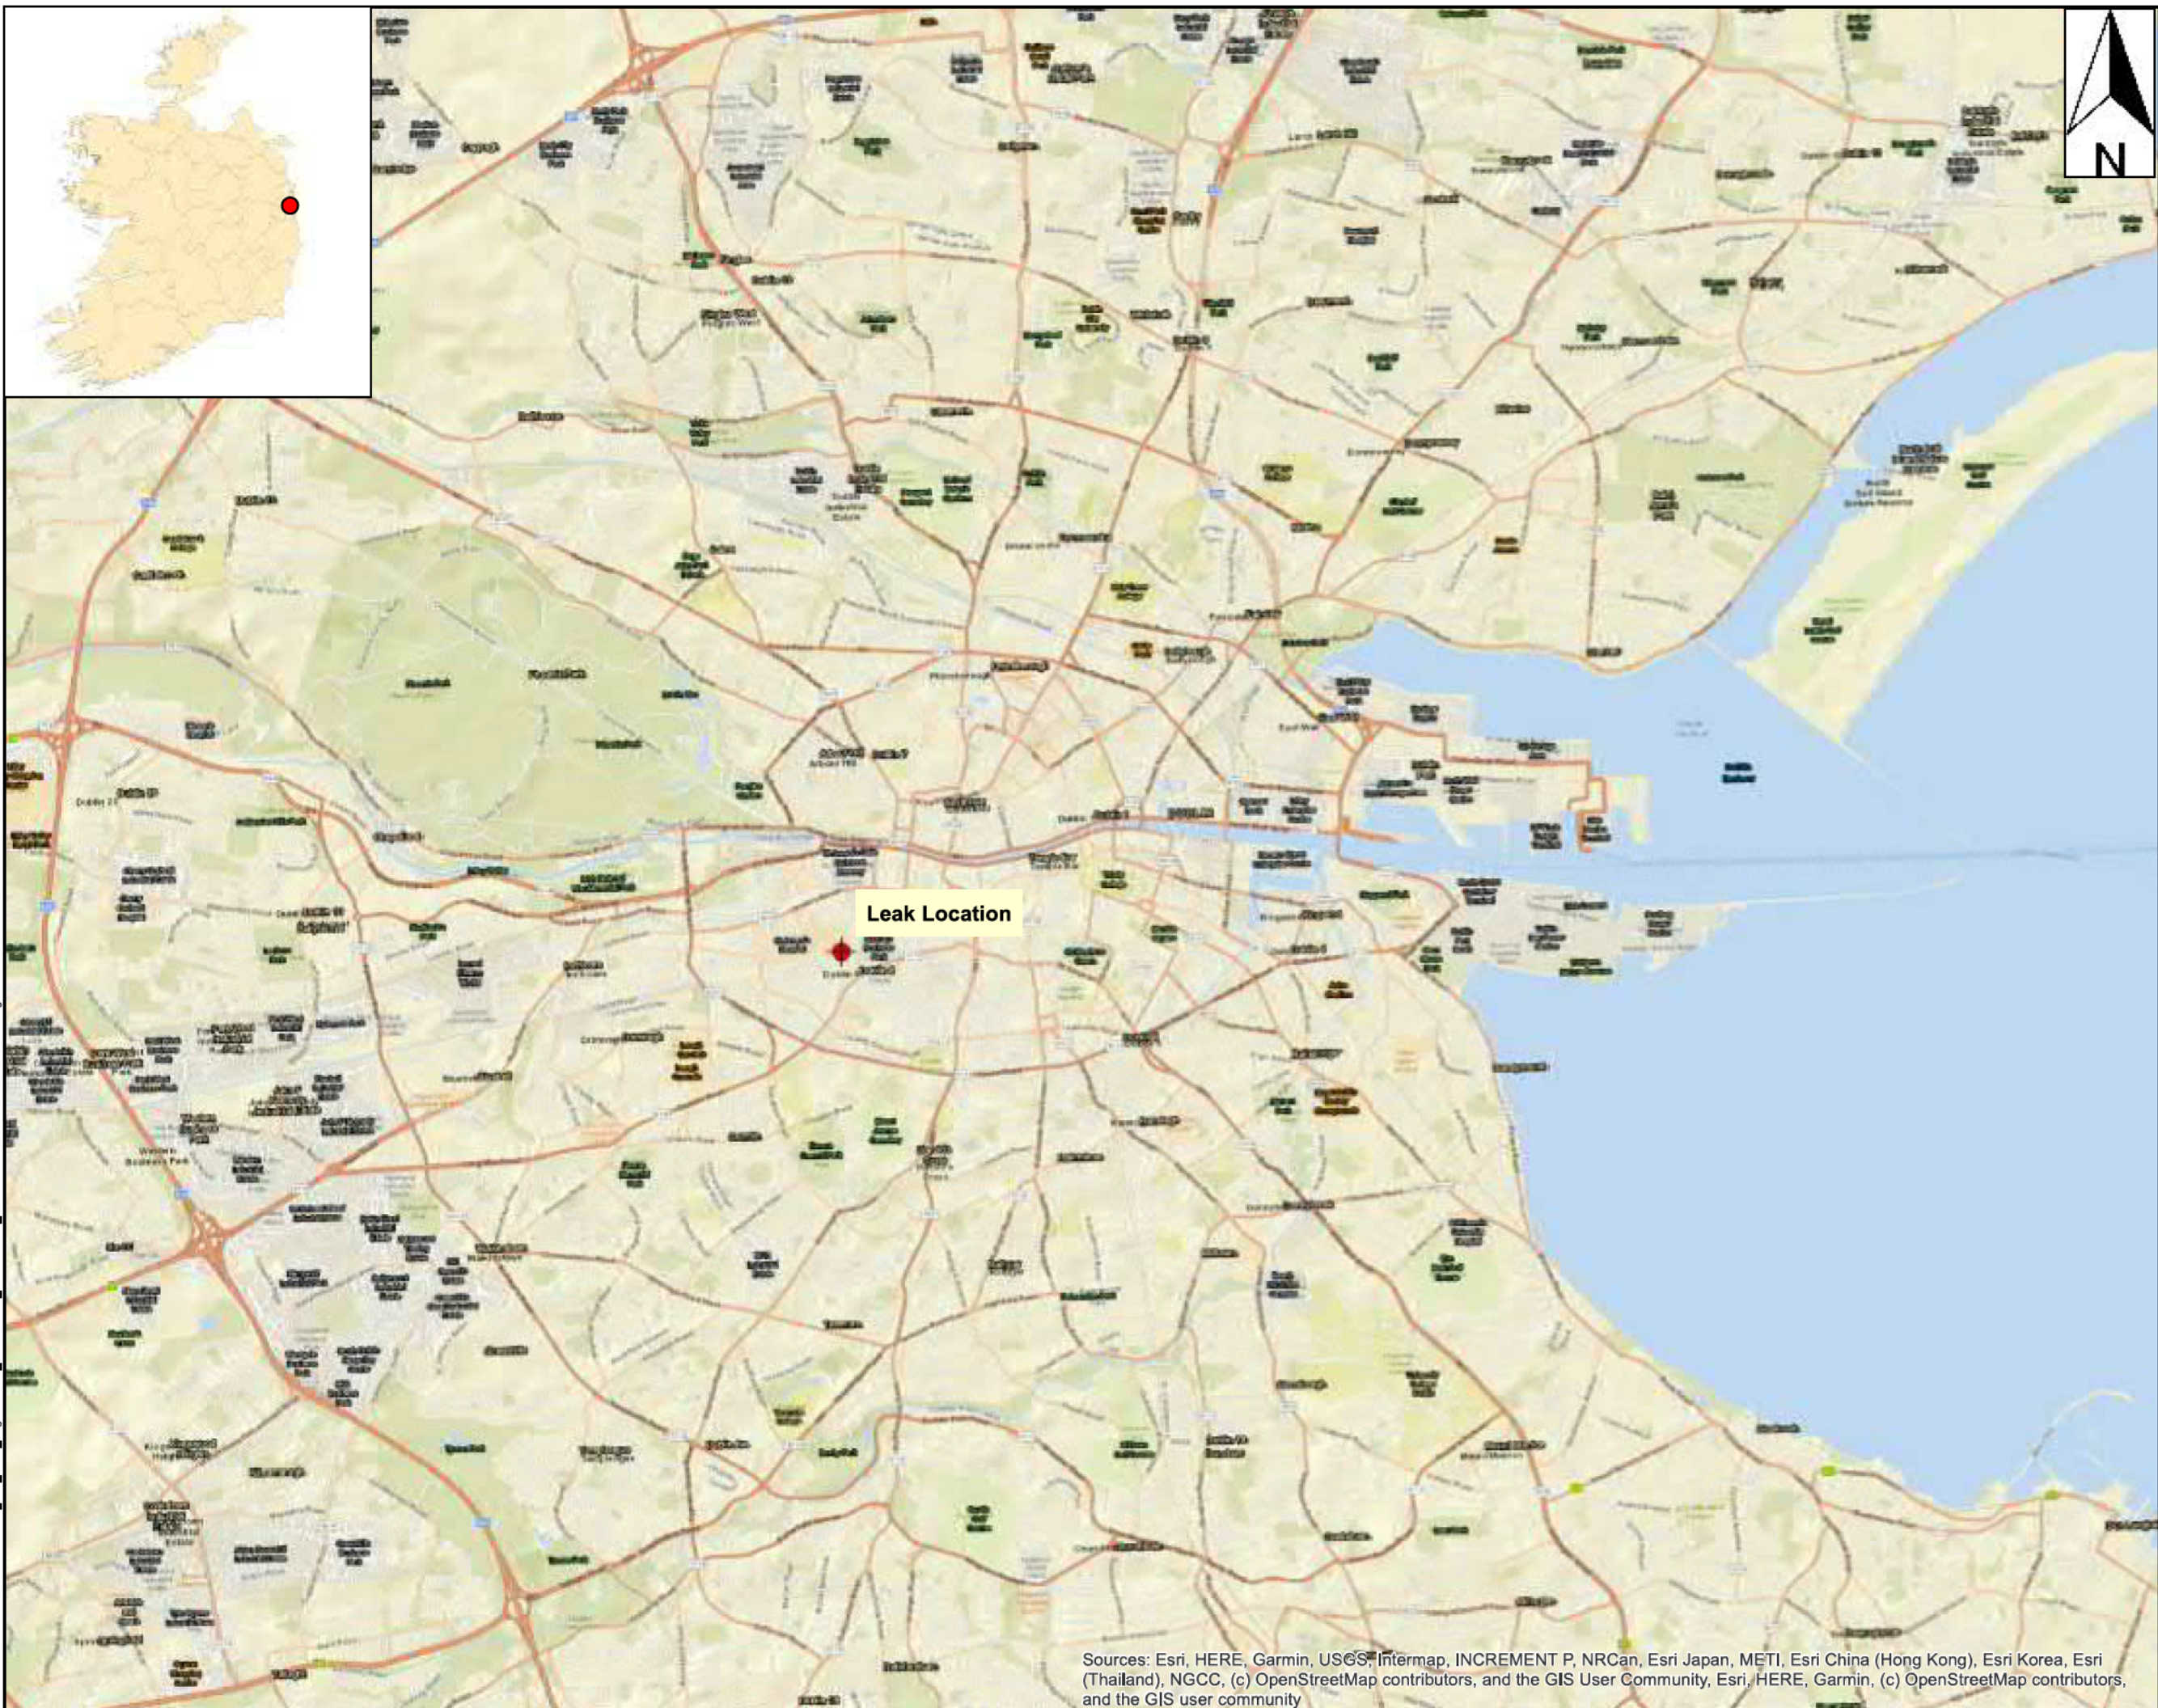
**FIG.2 - SITE LAYOUT MAP**

The leak location is situated at the intersection between the upper part of Our Lady's Road and James's Walk Street, Ushers, Dublin 8. The site is located on a 400 m long section of a 38 kV cable running from Inchicore to Marrowbone Lane. The cable was originally installed in 1950 with new sections of the cable added in 1986. The cable length is 5.6 km (see Figure 2).

Based on the assessment works completed, the primary Area of Potential Environmental Concern (APEC) for this site comprises the leak location identified by ESB. This is presented in Figure 2 and a description is provided in Table 8.

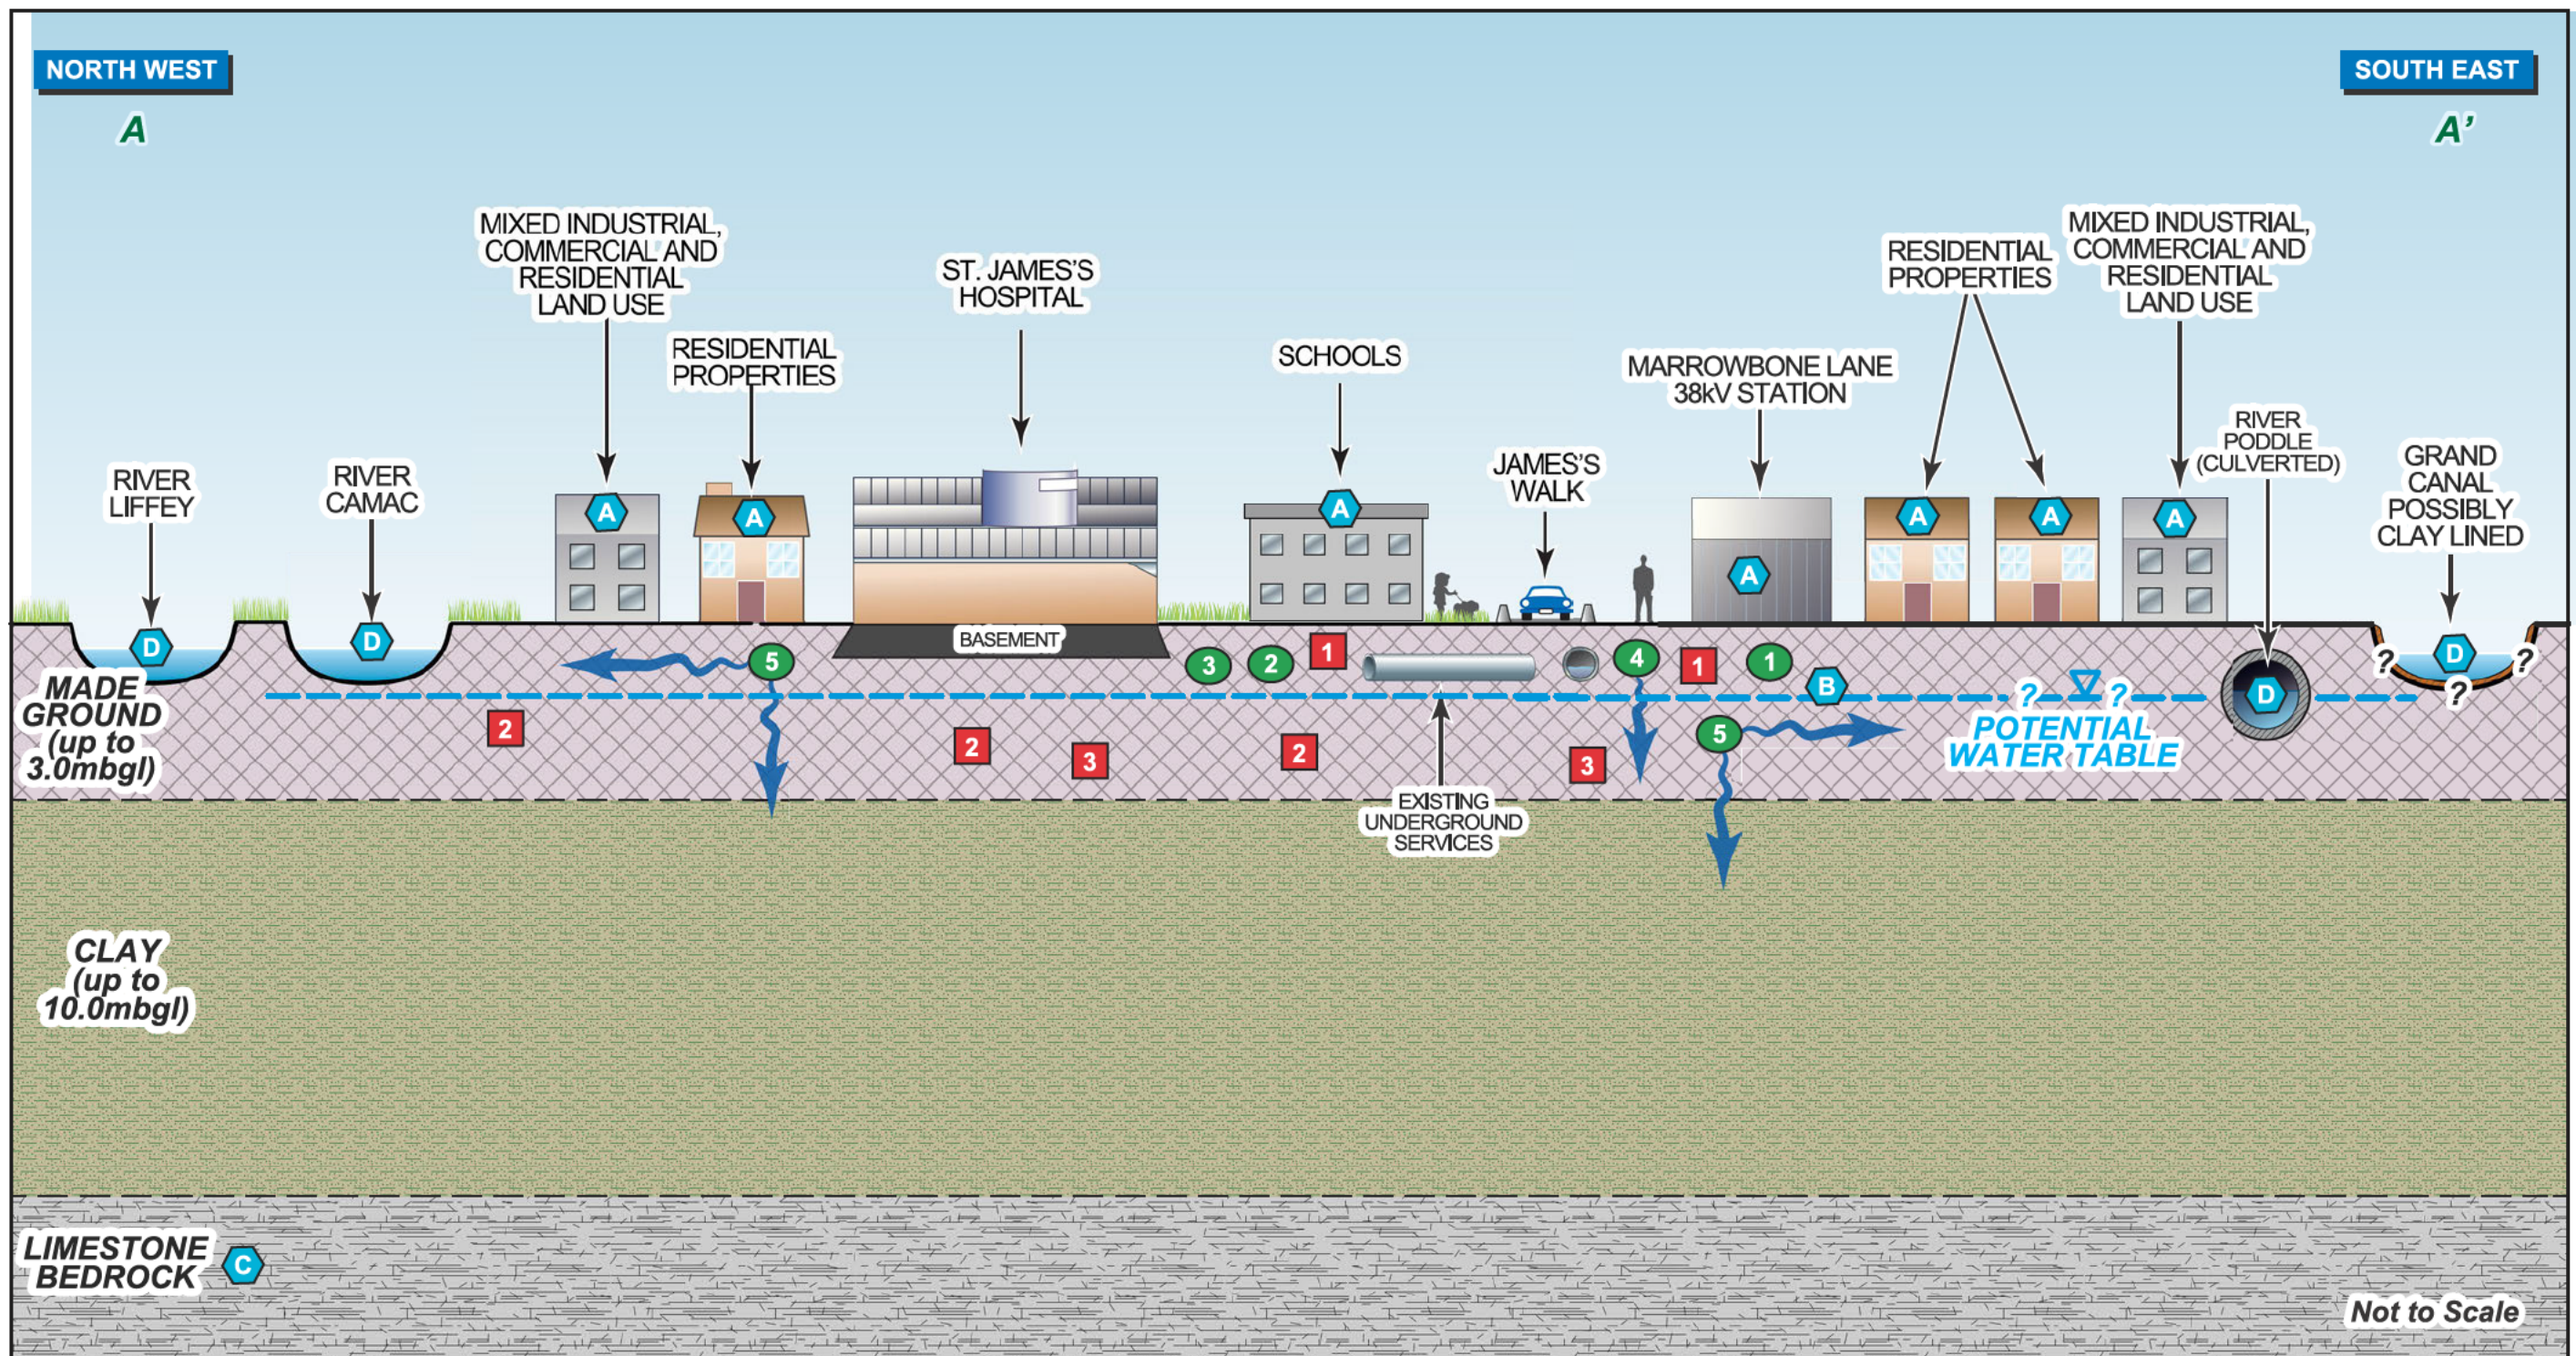
Title: Figure 3 - Conceptual Site Model

Based on information from the GSI, it is likely that the cable on this site is installed within sand and backfilled with made ground, therefore leaked fluid is likely to have migrated through either the sand surround or made ground (if sufficient permeability).

The preliminary CSM is presented graphically in Figure 3.
