ESB Engineering and Major Projects

Blackrock - Ringsend (Site ID 40)

Preliminary Environmental Site Assessment

602749 – R01 (01)

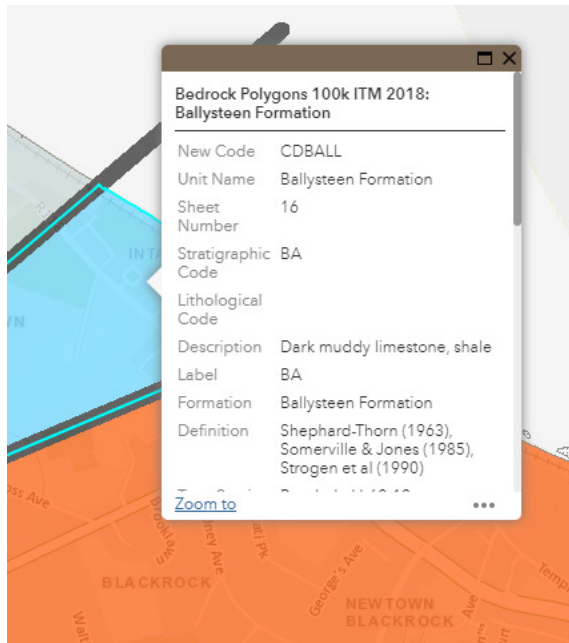
Figure 3.1 Bedrock Geology Underlying Majority of the Site

Information from the Geological Survey of Ireland (GSI) online mapping public viewer <https://dceur.maps.arcgis.com/apps/webappviewer/index.html?id=de7012a99d2748ea9106e7ee1b6ab8d5&scale=0> indicates that the survey area straddles two different bedrock geologies separated by a fault running east-west, crossing the railway at approximately 200 m southeast of the indicative leak location. The solid geology underlying the majority of the site is limestone of the Ballysteen formation as shown in Figure 3.1 below. The Ballysteen formation comprises dark muddy limestone, shale.

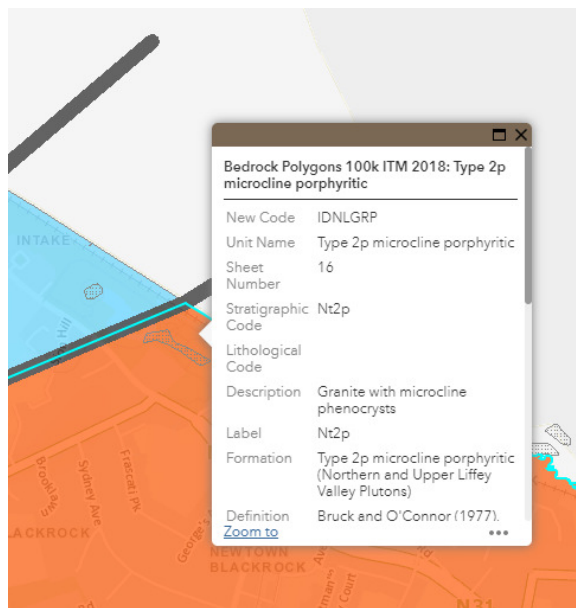
Figure 3.2 Bedrock Geology Underlying Southern Extent of the Site

The southern extent of the site is underlain by granite of the Type 2p microcline porphyritic formation as shown in Figure 3.2. The Type 2p formation comprises granite with microcline phenocrysts.

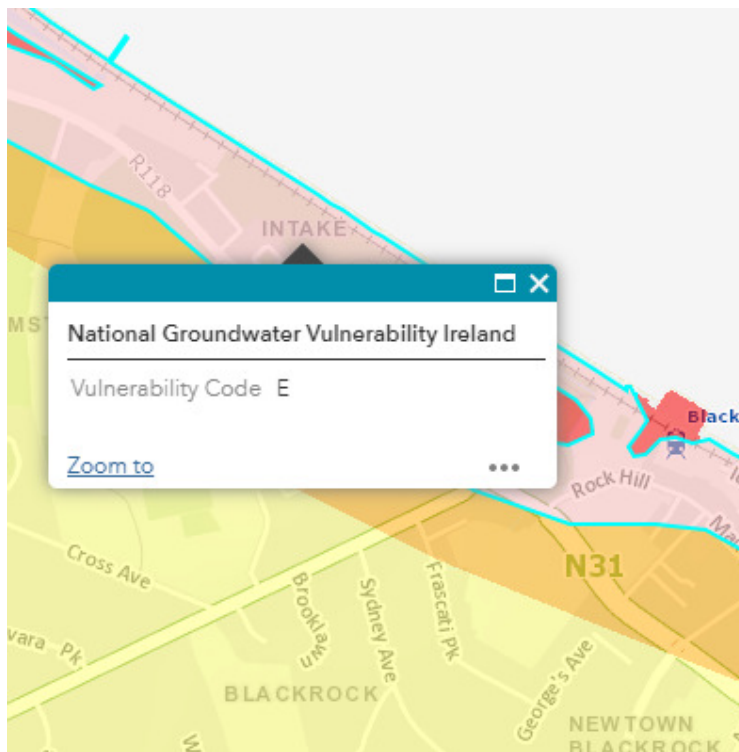
Figure 3.3 Groundwater Vulnerability at the Site

Groundwater vulnerability is classified as extreme at the site (see Figure 3.3 below) with patches of the site (seen in red in Figure 3.3) classified as shallow rock. The EPA categorise the groundwater body as not at risk and water framework directive (WFD) monitoring (2010-2015) ranks the water quality as good.
