ESB Engineering and Major Projects

Carrickmines - Poolbeg (Site ID 41)

Preliminary Environmental Site Assessment

602749 – R02 (01)

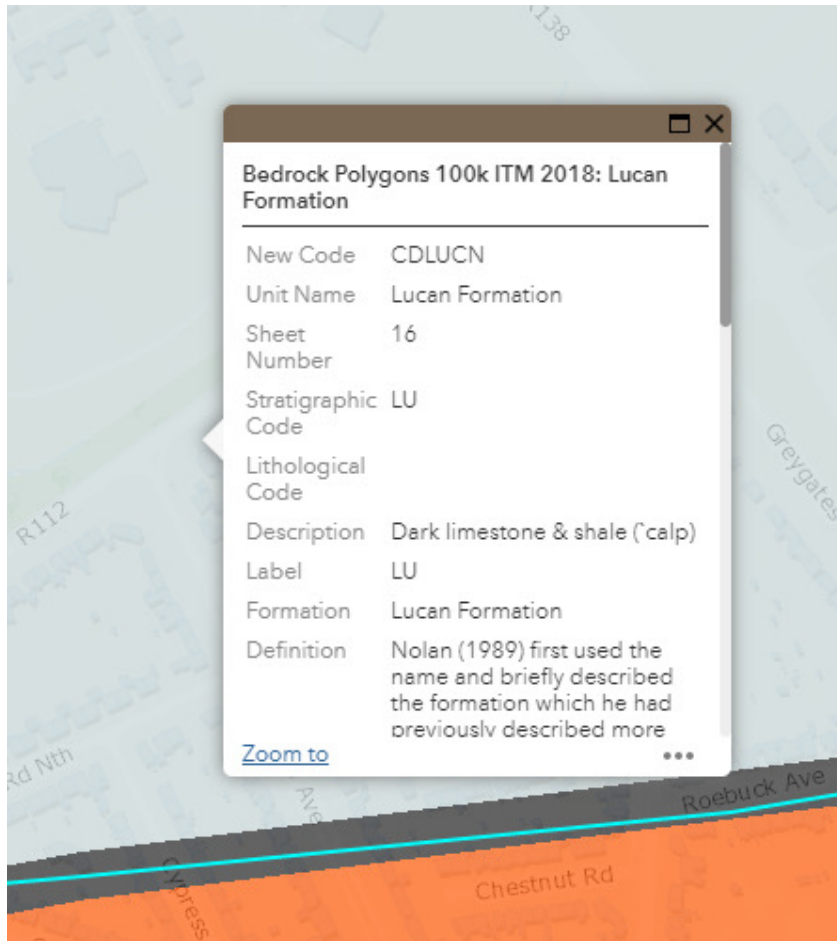
Figure 3.1 Bedrock Geology Underlying Site

Information from the Geological Survey of Ireland (GSI) online mapping public viewer <https://dcenr.maps.arcgis.com/apps/MapSeries/index.html?appid=a30af518e87a4c0ab2fbde2aaac3c228> indicates that the solid geology underlying the site is Calp, of the Lucan Formation, as shown in Figure 3.1 below. The Lucan formation comprises dark grey to black limestone and shale.

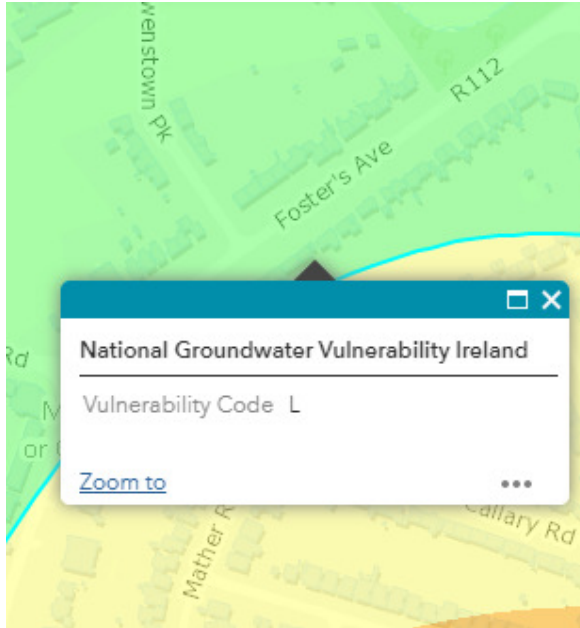
Figure 3.2 Groundwater Vulnerability at the Site

Groundwater vulnerability is classified as Low at the site (see Figure 3.2 below). The EPA categorise the groundwater body as not at risk and water framework directive (WFD) monitoring (2010-2015) ranks the water quality as good.

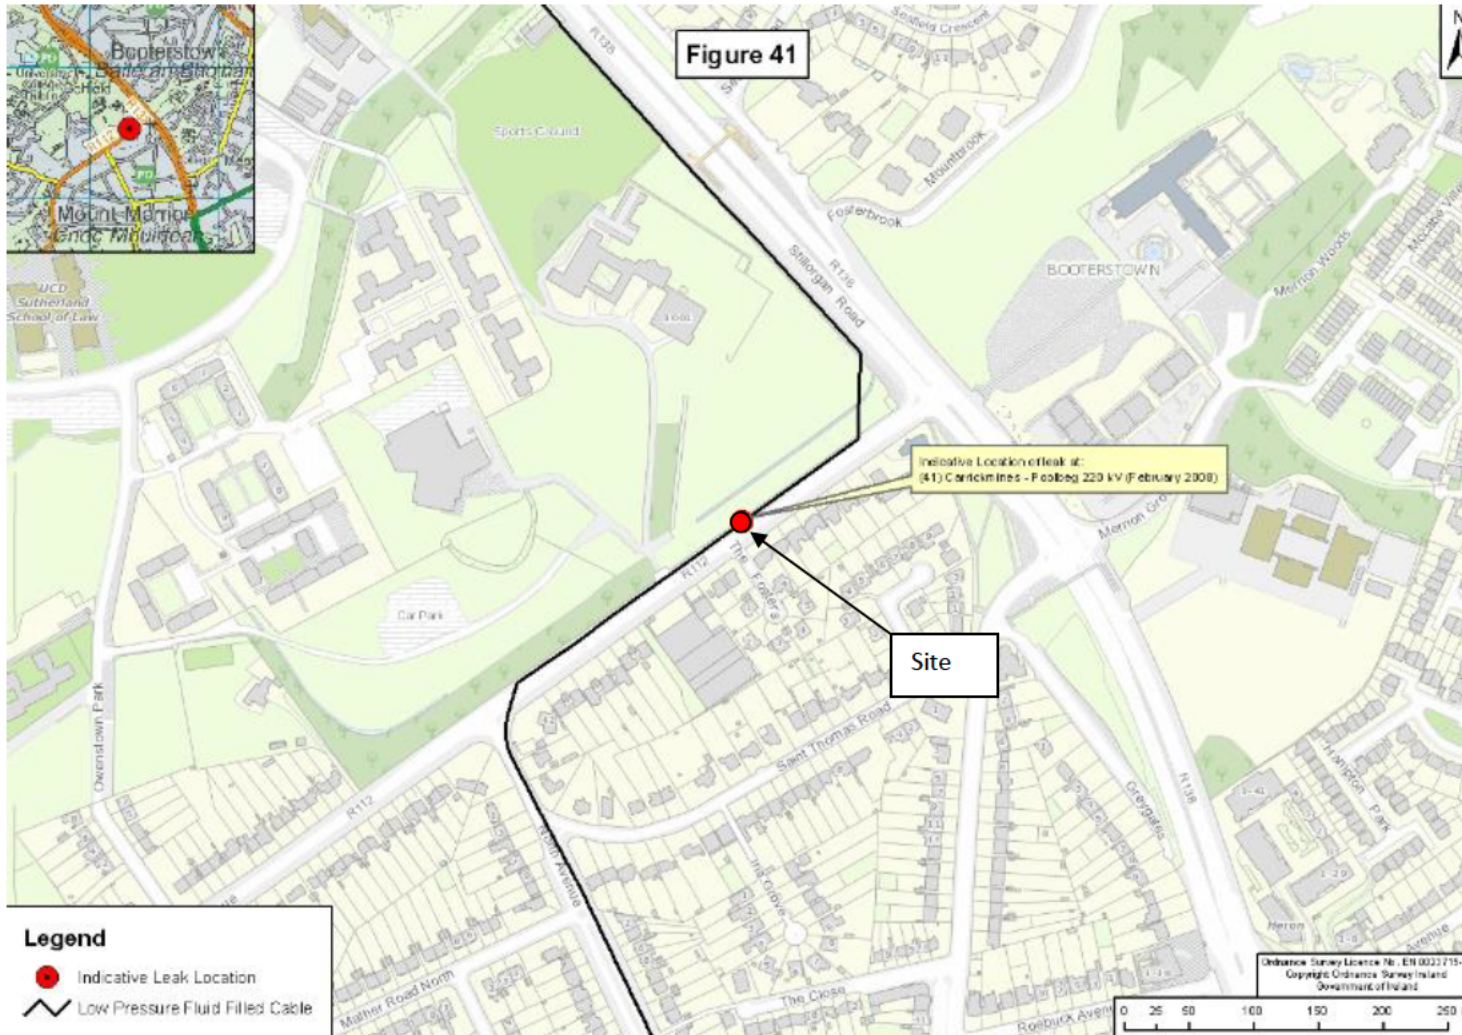
Figure 41

The site is the location of a leakage of cable fluid from a high voltage (HV) underground cable which occurred in February 2008. It is RSKs understanding that the fluid contained in the cable is Linear Alkyl Benzene (LAB) and that the total fluid loss was approximately 590 litres. It is also RSKs understanding that no previous investigations or monitoring has been undertaken at the subject site. The site location is shown on Figure 1.

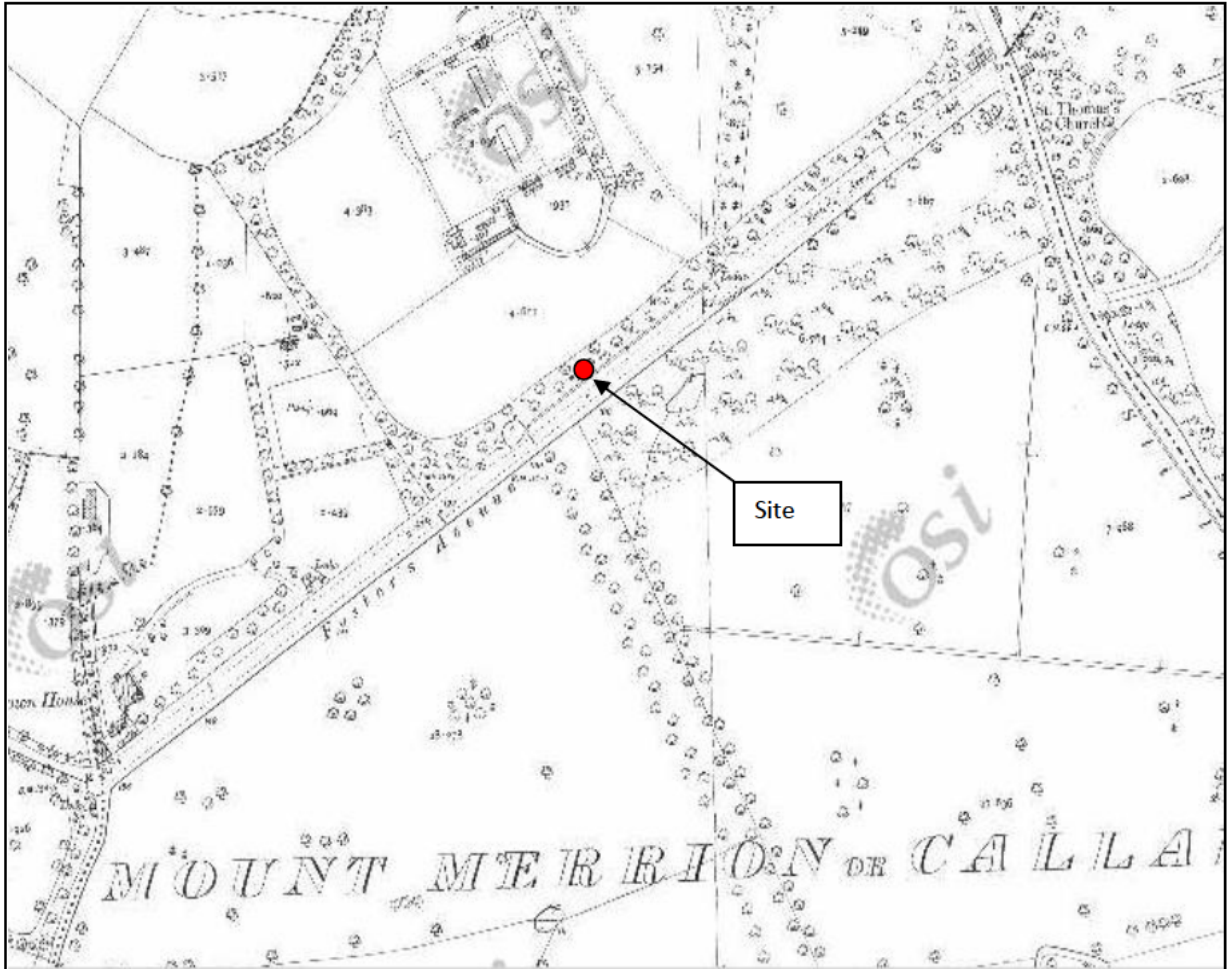
Drawing Title: Figure 4 OSI Historic Map 1888-1913

The OSI online map from 1888-1913 (Figure 4) shows almost no development at the site since the 1837-1842 map, the area remains unchanged. There is relatively little development of Booterstown since the 1837–1842 map. Blackrock, beyond Booterstown to the east, is significantly urbanised.
