Site 60 Pembroke to Ringsend 38kv: Preliminary Site Assessment Report for Historic Fluid Filled Cable Loss

ESB Engineering and Major Projects

19126590.60.A.2

24 April 2020

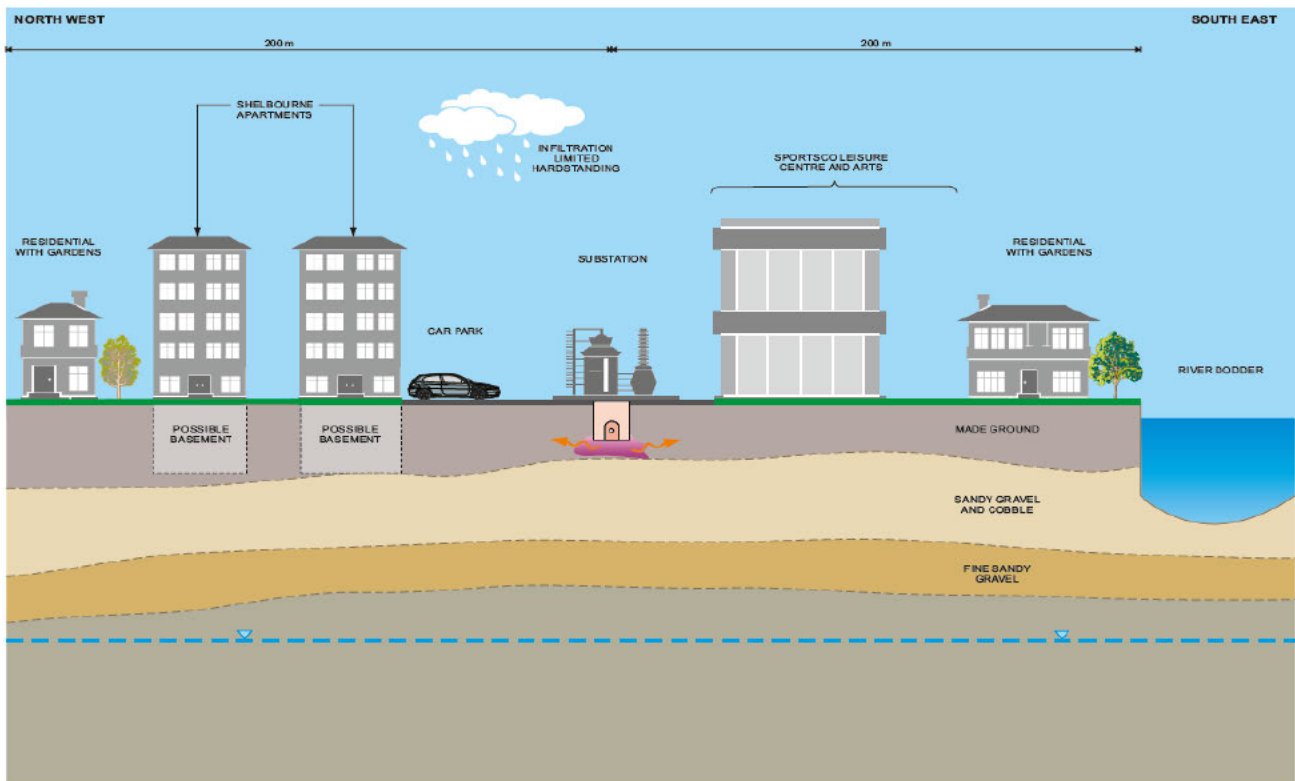
Figure 1: Preliminary CSM for Site 60 (Pembroke and Ringsend).

The Preliminary Site Assessment approach is considered conservative as it seeks to identify the potential source, and a broad range of initially theoretical pathway and receptor linkages present for each Site. The preliminary CSM identified potential source, pathway, and receptor linkages that may be present at the Site or caused by the leak. A qualitative risk analysis and evaluation was completed on each potential pollutant linkage identified. It is noted that where a potential risk is identified at this stage it does not necessarily mean a risk is present but that further investigation is required to either confirm the presence or absence of the risk. Where a potential linkage has been classified as either low or very low in the risk assessment no further action has been recommended to address this linkage as the actual risks identified in the low and very low risks have been sufficiently assessed in the PSA.

Further investigation and analysis are not considered necessary to assess the potential pollutant linkages identified in this report.

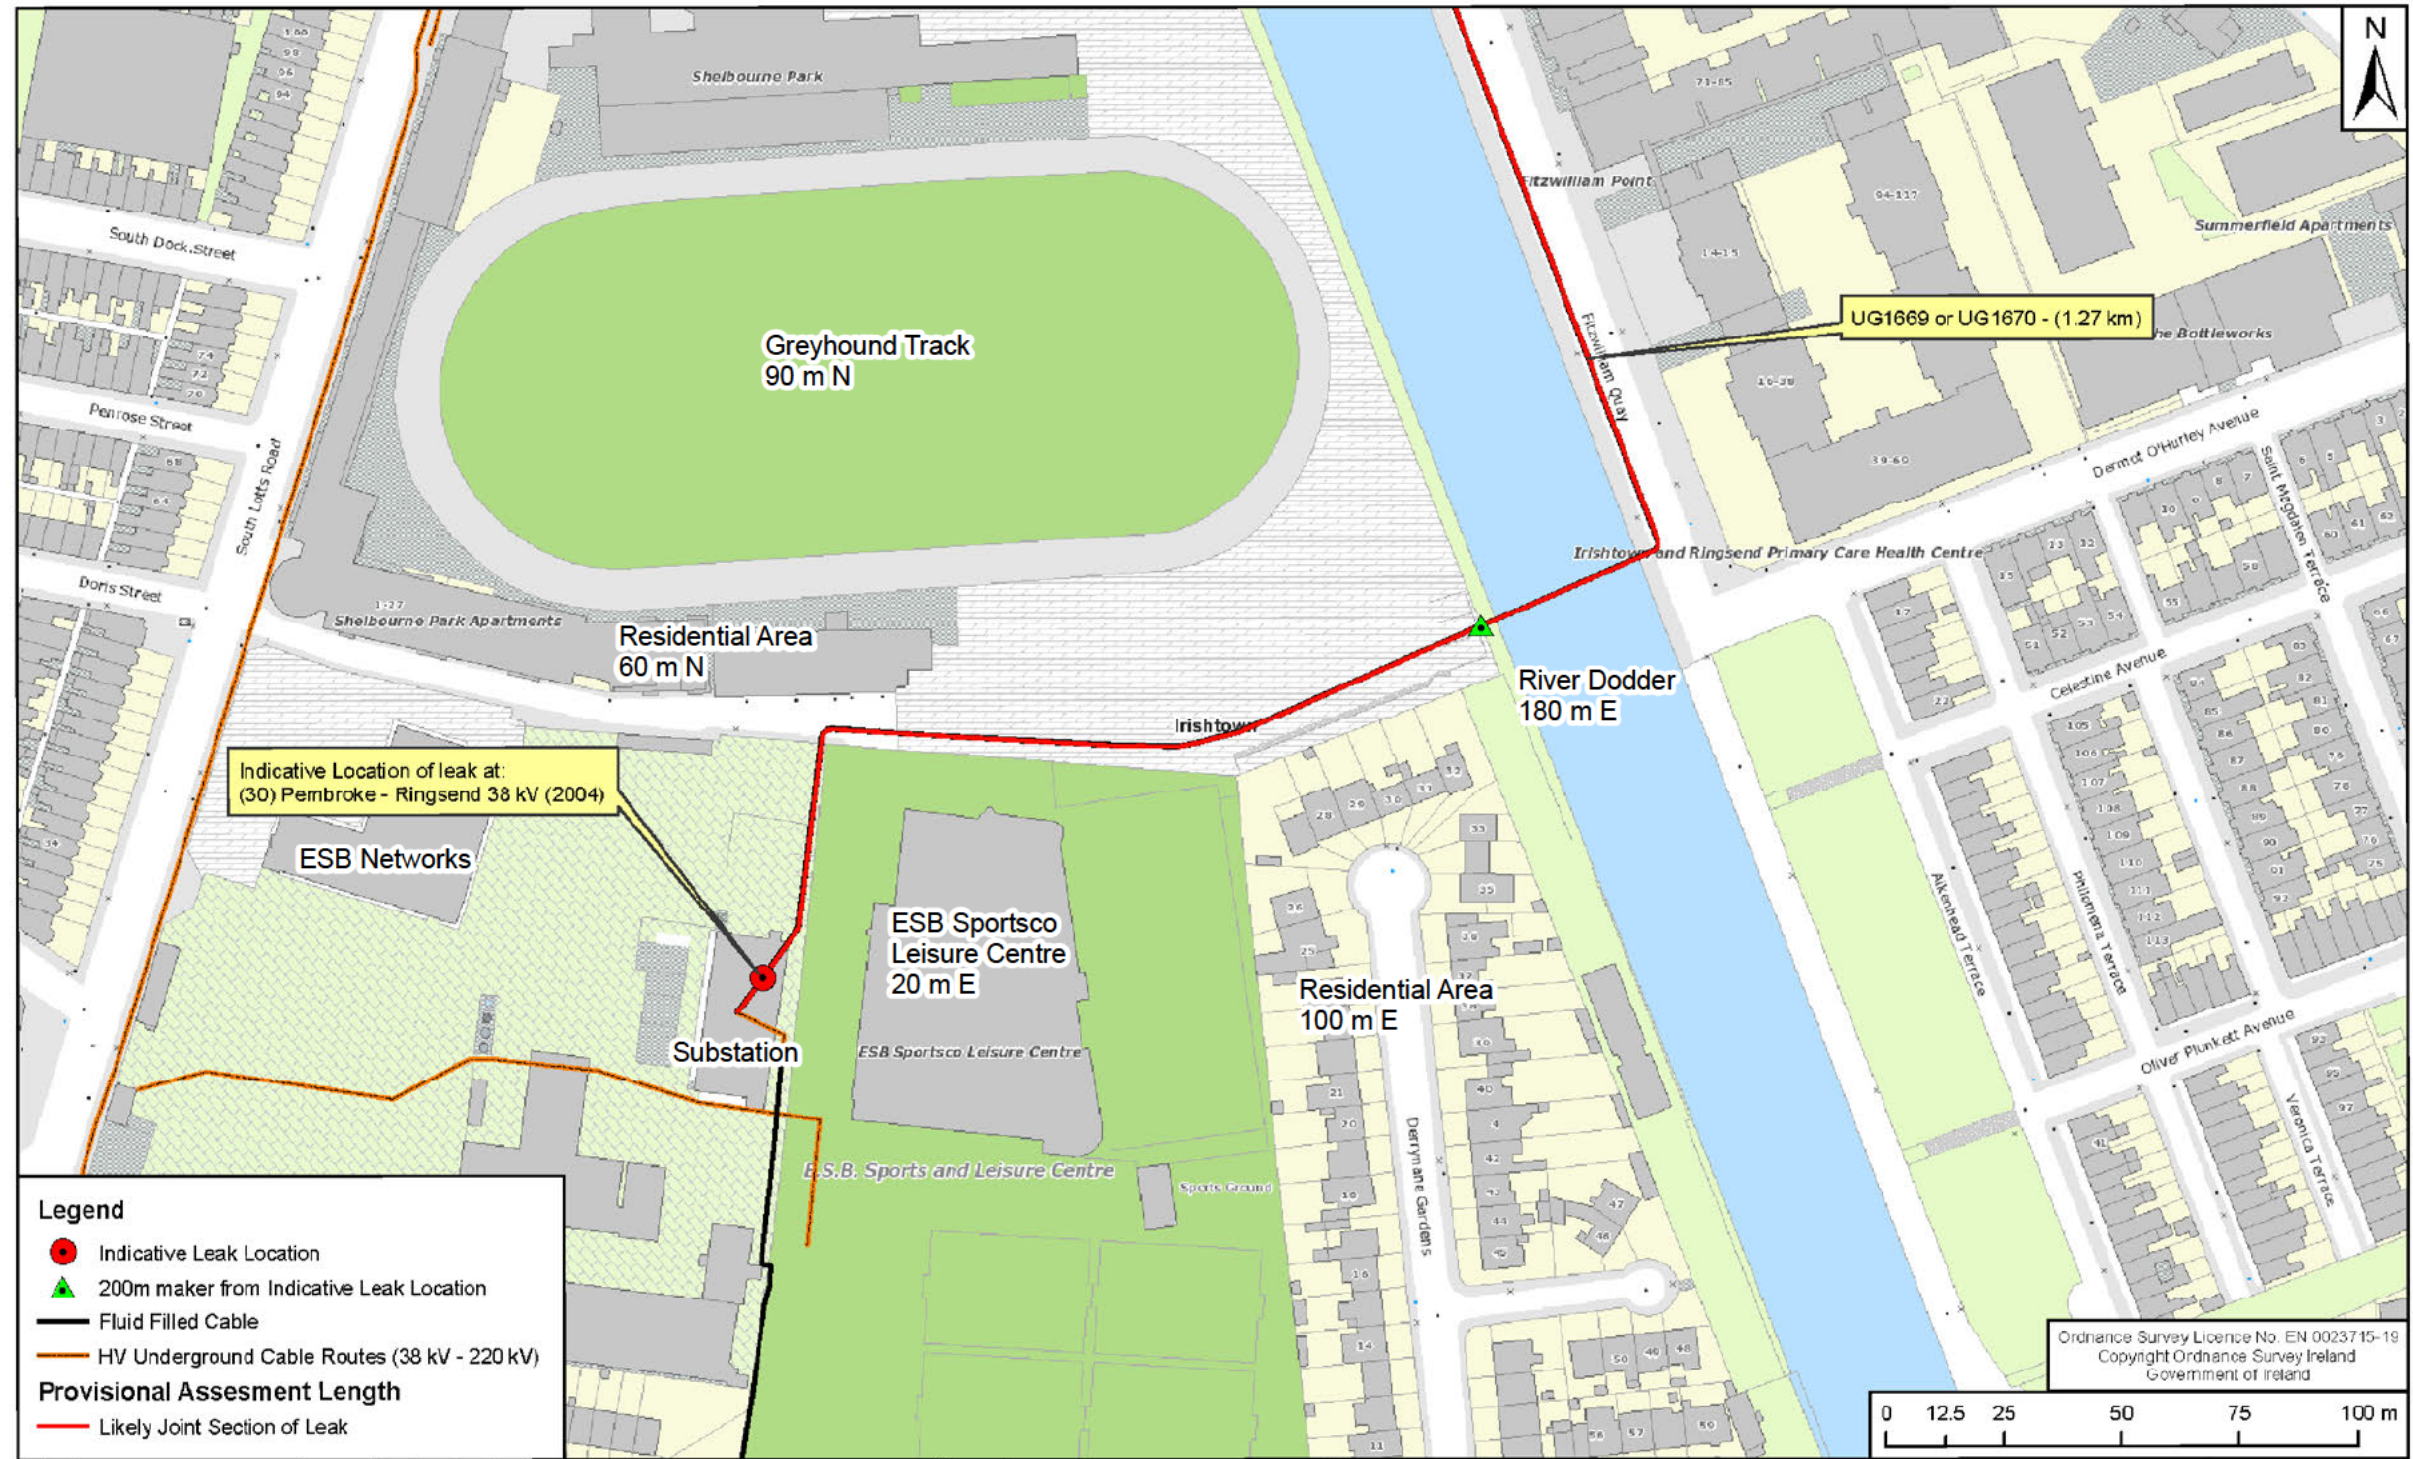
The location of the cable leak, and 200 m Site limits (200 m along the cable length from the cable leak) are summarised in Table 1 and shown on Drawing 1. The cable was not inspected inside private property where no access was possible outside of ESB lands and public roadways.

The Site is located in Pembroke Station adjacent to residential areas of Dublin, approximately 160 m west of the River Dodder. The leak occurred in a basement of Pembroke substation.
