ESB Networks Historic Cable Fluid Losses: Preliminary Site Assessment

**Location 67: Finglas - North Wall - 220 kV
November 1998 - December 1998**

Project Number: GCU0257001

March 2020

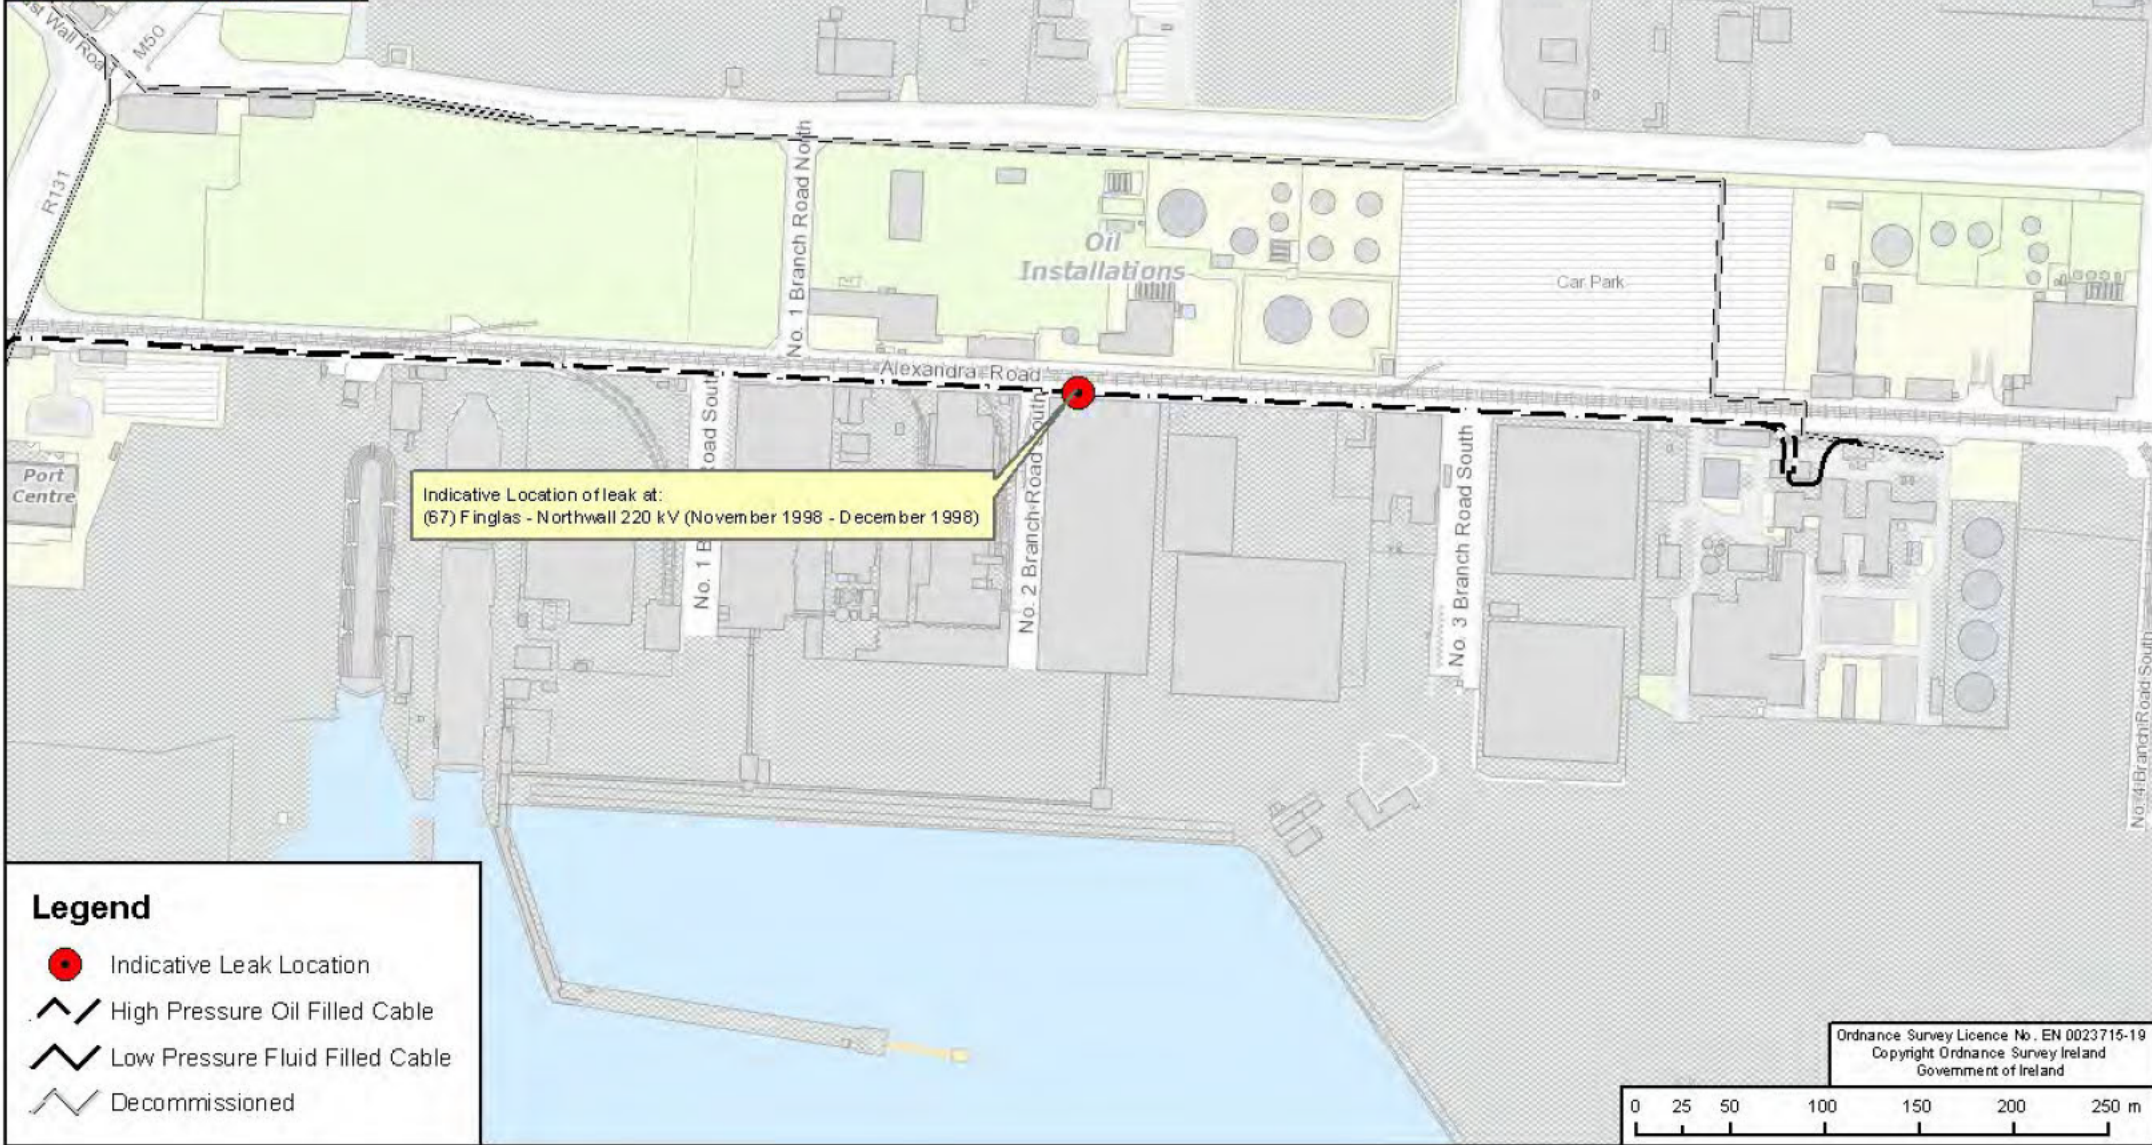
Figure 1: Site Location No. 67

The leak location is situated on the southern edge of Alexandra Road, close to the intersection with No.2 Branch Road South in the western area of North Dock, Dublin Port (refer to Figure 1). The Alexandra Basin is located approximately 250m south of the leak location; this basin is connected to the River Liffey, which lies approximately 550m south of the leak location. The River Liffey is tidal at this point, and discharges to Dublin Bay approximately 1.8 km east of the leak location.

Indicative Location of leak at:
(67) Finglas - Northwall 220 kV (November 1998 - December 1998)

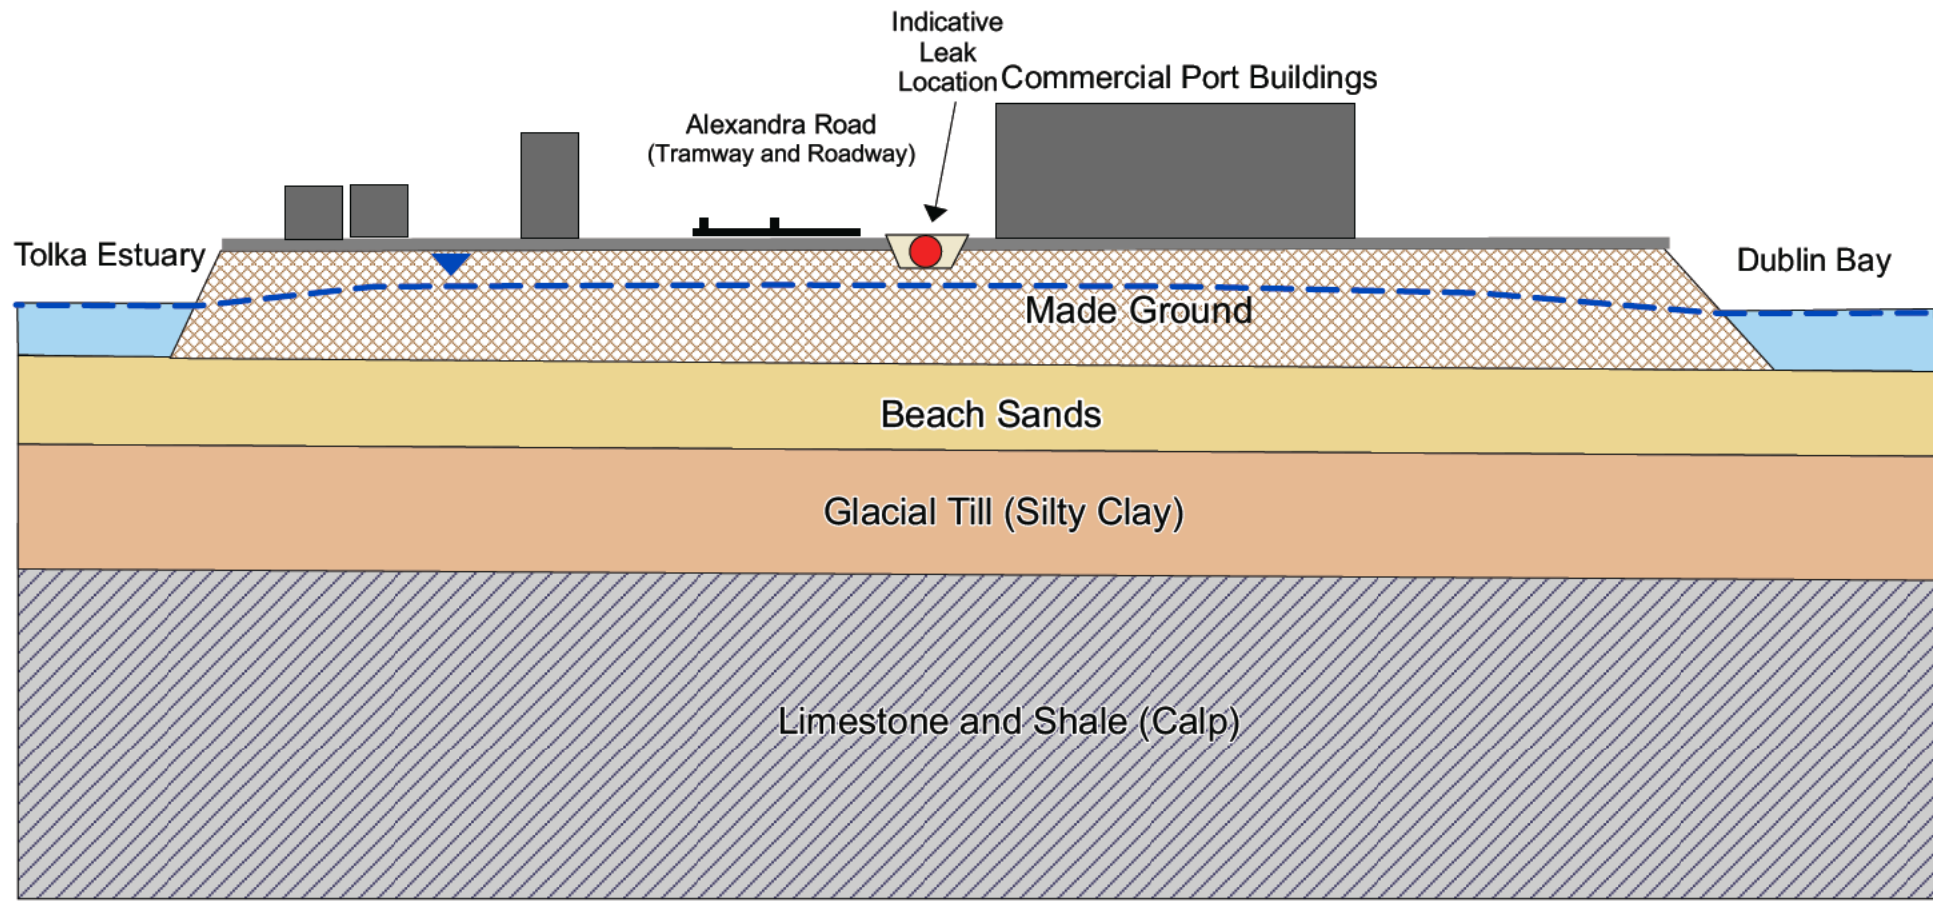
Location 67 - Preliminary Conceptual Site Model		
Alexandra Rd, Dublin Port	GCU0257001	
Geosyntec consultants	ESB	Figure 2b
Dublin, Ireland	October 2019

- The key receptors potentially at risk of impact from the subject leak are considered to be the South Dublin Bay and River Tolka Estuary SPA, including flora and fauna dependent on this water body, the River Liffey estuary, the bedrock aquifer underlying the area, and water mains in the vicinity of the leak location (if present). Occupants of buildings in the vicinity of the leak are also considered potential receptors via a vapour intrusion pathway, although the risk of impact is low;
